ELECTRIC AND FUEL ISSUES

SAFETY SPOT

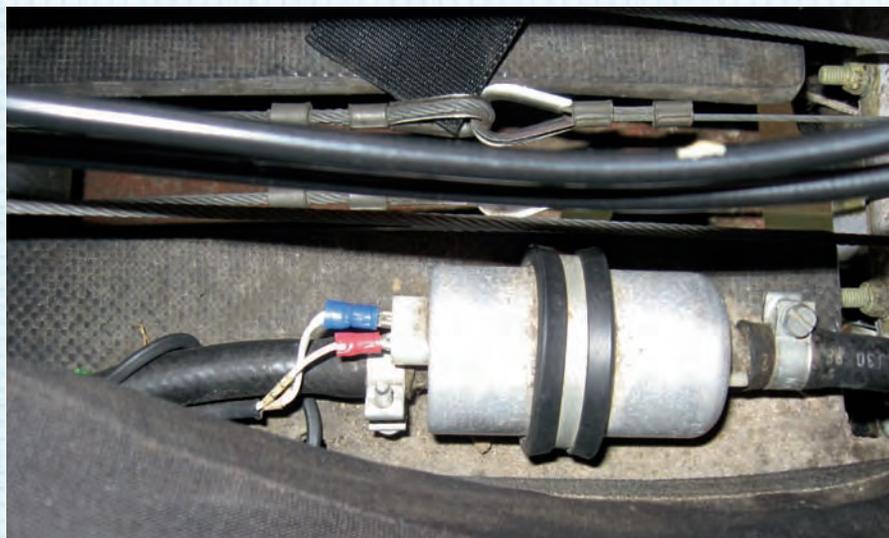
The interesting point about all this is that this pump had been wired up in reverse since before Alan had purchased the aircraft, many flying hours before. So, every time he selected the fuel pump 'ON' he was reducing the amount of fuel available to the Rotax 912 'up front', rather than increasing it. Just at those most critical times during the takeoff or prior to landing when he needed the electric pump to give him an extra safety margin and to keep the fuel flowing if the main pump should fail, the electric pump had been acting against the main one and trying to pump the fuel back to the tank.

This is the reverse-wired fuel pump as fitted to Alan's X'Air Falcon. I didn't spot that it was wired back to front, but I didn't like the tension in the wire very much or, for that matter, the control cables flopping around in the background. It is important to check the complete system after changing any component. Alan did... thank goodness.

The big lesson here, though, is that if any component in a system on an aircraft is changed, then the whole system needs to be checked for correct operation. In the case of a fuel system, this means a proper fuel flow check if components are replaced. To facilitate this, LAA does a fuel flow check sheet to guide you through the process and record the result – it's available off the website. Thanks Alan for dropping in, I enjoyed our chat.

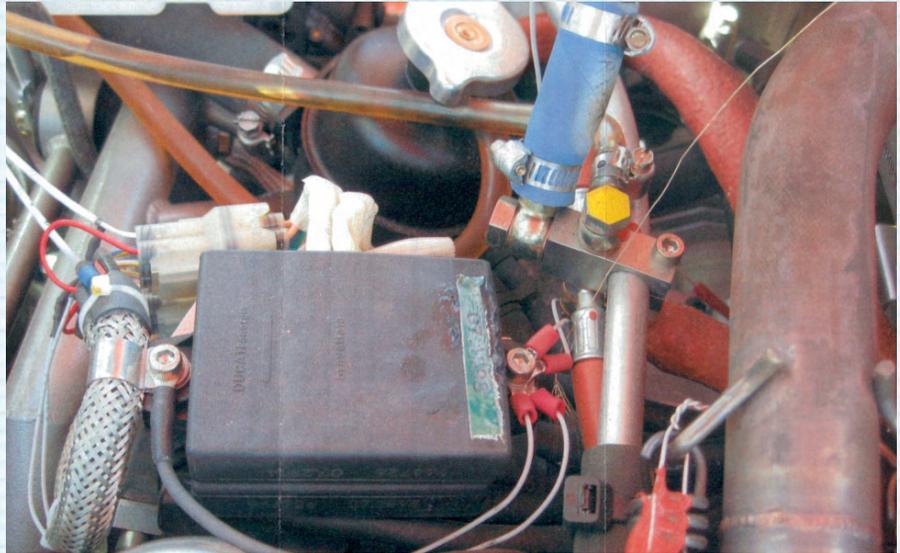
Essentially, this is a Rotax 912 ULS-powered ¾ scale kit version of the 1940's US fighter aircraft. Thank you, Dave, for sending in the Service Bulletin that requires the fabrication of a heat shield to protect the ignition module, which (as you can see from the picture) is located a bit too close for comfort to the exhaust, got cooked and failed.

This engine installation is a bit of a hotch potch and I suppose that I should have saved it for the Christmas 'spot the error' quiz. If the engine compartment looks anything like this on your aircraft please don't fly it because, if you do, you're just asking for trouble. Note the burnt ignition module and its proximity to the exhaust system.

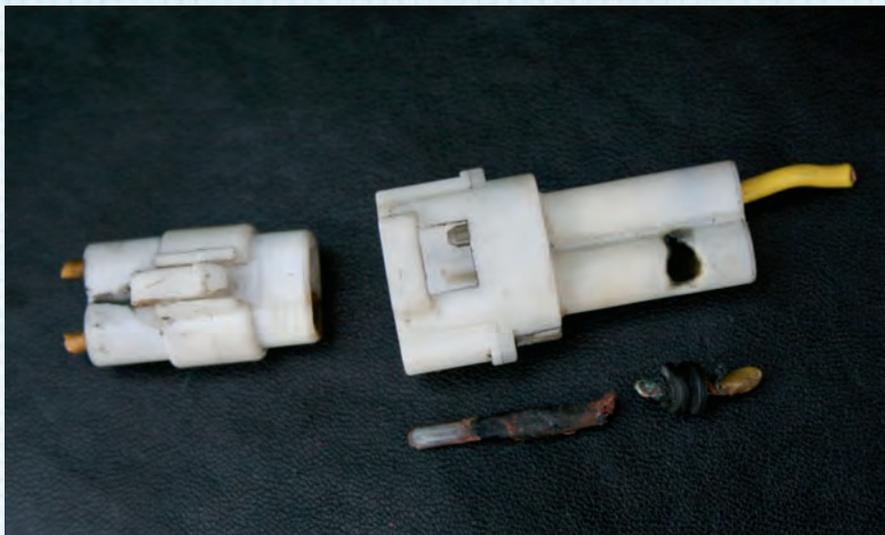
'I found the problem, the connector – see attached photo. However, it worries me as it occurred before the fuse, as recommended, which is fitted after the connection and before the battery. The 'short' or 'arc' seems to have occurred inside the male connector on one of the two lighting coils' wire pins. Once failed, power continued to be supplied, and sufficient heat burnt a hole in the casing, as you can see. This would have meant that sparks could have been emitted within centimetres of the fuel pump and supply pipes.

You can see from this picture why Andrew's battery was failing to maintain a charge; at some point in the past, the connector pin acted like a fuse and gave up the ghost because it was being asked to provide passage for too many electrons per second (current). It's important to look at a failure like this both from the point of view of the failed individual component, ie is it 'up to the job', and from its context as part of the system – in other words, why so many Amps?

The attached photograph tells its own tale and demonstrates again the need not to assume anything, and to regularly inspect all the individual components within a system for signs of a failure in the making. Just because a system seems to be working, doesn't mean that all is well with it. This is specially the case with rather basic systems like this one, where there is less electrical protection than one would expect in a more sophisticated machine. As Andrew points out, fuses and circuit breakers should ideally be placed as close as possible to the source of power so that the possibility of a

short circuit further upstream is minimised. I agree with Andrew that this set-up, often seen with the early microlight engine installations, is not wholly satisfactory and needs to be checked regularly.

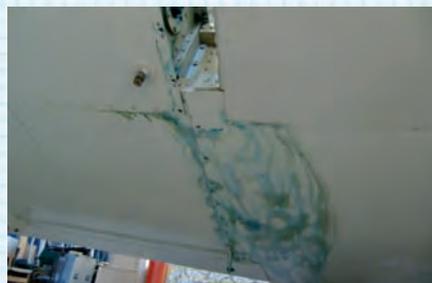
Removal of the wing root fairing revealed the problem. The dye in the fuel had done its work and the leak was obviously coming from the fuel sender unit. To say John was a bit upset would be an understatement; this aircraft was in pristine 'out of the box' condition the last time he had seen it and now, well, you can see the state of the underside of the aeroplane. It had taken John and his wife Sally four-and-a-half years to build (over 4,500hrs). I asked John why he'd painted the aircraft before giving the machine a thorough 'shake down' period and he explained it was cheaper to get the aircraft sprayed bit by bit as it was being built. Quite a few have been done that way apparently.

Avgas, or aviation gasoline, has a dye in it to aid in its identification for reasons of both safety (right fuel/right place, spotting leaks) and taxation. Unless it's wiped away immediately from paintwork, especially new paintwork, it will stain. Here, a leak from a fuel sender unit has wrecked the paint job on the underside of the wing on this brand new RV9.

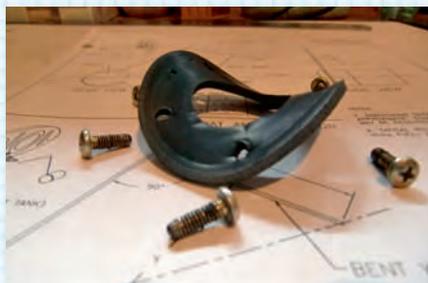
Have a look at the pictures – you will see the tell-tale stain left by a fuel leak and will be able to work out immediately that the gasket, in this case a fuel sender gasket, has been negatively affected by the fuel and has stopped doing its job. You can see that by the fact that the gasket has taken on a weird shape. If you're good at three-dimensional thinking, you have probably worked backwards and realised that the only way that this shape could have been created is if the material from which the gasket was made had expanded. If you cannot do this in your

You can see from this picture why John came back to an empty fuel tank. It looks like the fuel has reacted with the rubber gasket. Van's now advise that this gasket should be discarded and the fuel sender unit 'potted' using Proseal. I'm not sure that I like the use of screws here – remember, a screw has no plain shank. Perhaps I'm just being old fashioned!

John was further miffed as he felt that his complaints to Van's themselves weren't treated very seriously and he was just pointed to the supplier of the fuel sender unit, Stuart Warner. They said that none of their products were authorised for use in aircraft and wouldn't comment further. In other words, not my problem, Guv! Further investigation revealed that this problem had been around for ages, and the latest recommendation is that the fuel senders should be fitted using a fluid sealant, something like Proseal. One or two builders, and thanks must go to our very own Harry Hopkins and Mike Barnard for their help over this matter, have suggested totally covering the gasket with Proseal before fitting.

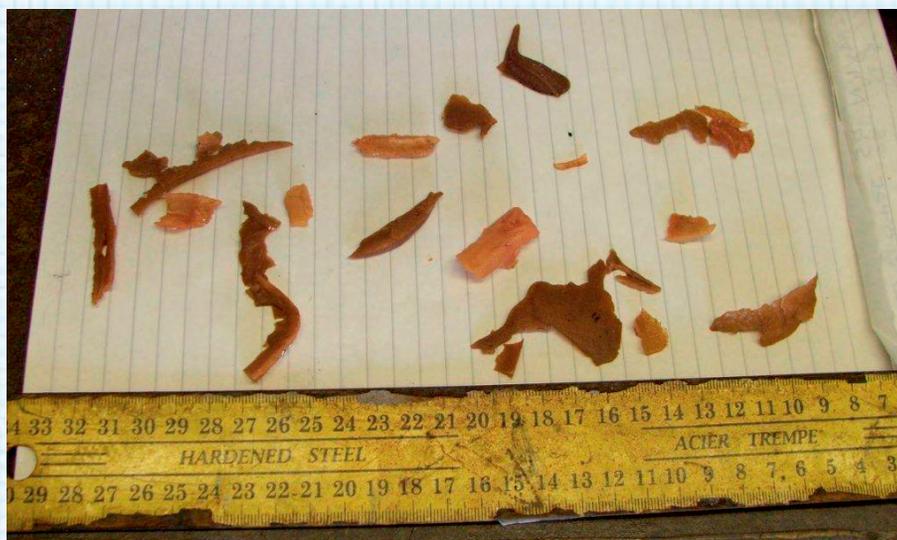
The debris that came out of the tank looks like the remains of a sloshing compound that has detached itself from the inside faces of the tank, but it might just as easily be the residue of the adhesive used during the tank's construction. Either way, this tank is in a bit of trouble. Gary explained that the tank had started leaking a little sometime ago and that he had attempted a repair by 'slightly opening the seams from the outside with a knife, abrading the surfaces, degreasing with Acetone and filling the area with Araldite'. Sadly, this fix didn't work.

Here's the picture of the rubbish that Gary found inside the tank during his investigations into a small leak. Judging by the shape and general look of this crud, I would say that it is possibly sloshing compound. It's very difficult to get anything to stick onto old fibreglass and that's why it's often better to start again and make a new tank if one gets damaged and starts leaking. I have spent a bit of time, as a complete aside, trying to work out that rule; is it just me or is it a bit weird?

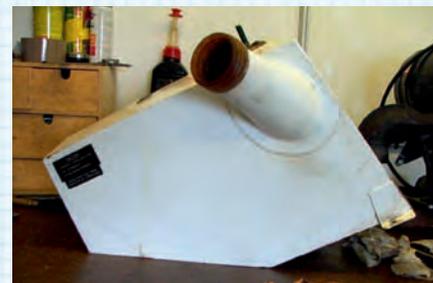
The problem here is the nature of the material, effectively a cardboard inner honeycomb core skinned with fibreglass sheet. This kind of structure is difficult to get clean enough for anything to stick to it at the best of times, let alone after being soaked in two-stroke fuel.

Here is the fuel tank from Gary's Shadow aircraft. It was originally constructed from Fibrelam sheets, which were originally designed for use in aircraft flooring. The flat sheets were glued together using Araldite and the tank sealed with Safe TII Pox. Absolute cleanliness is required when working with these materials.
