NO SPINNER HELPED THIS SPOT

AN EXCELLENT SPOT DURING A WALKROUND PREVENTS AN IN-FLIGHT DISASTER – AND A LACK OF BASIC FITTING SKILLS IS BEHIND OTHER PROBLEMS

SAFETY SPOT

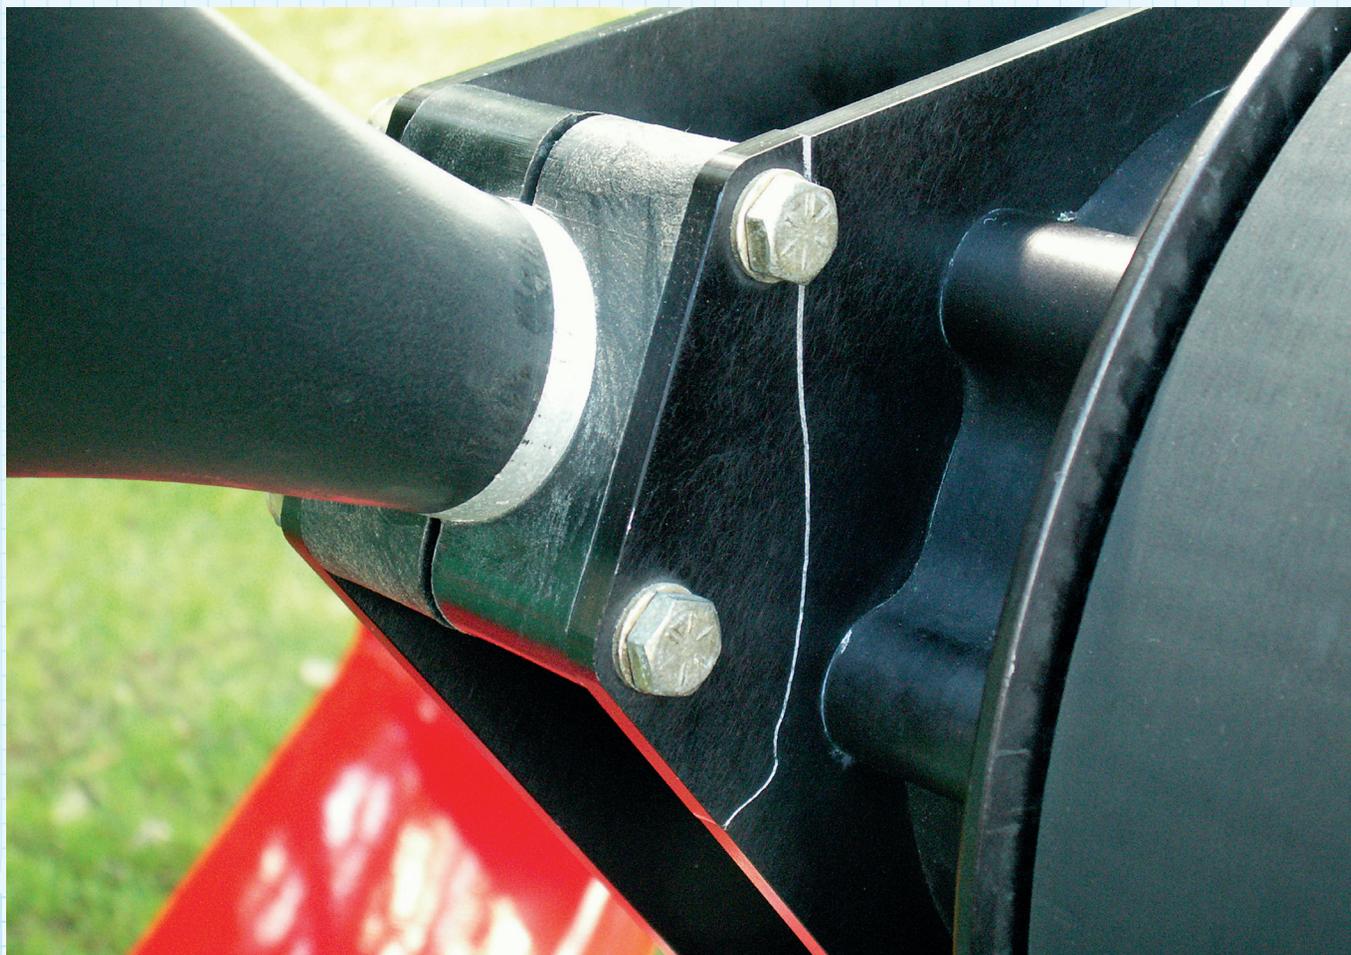
This is a picture of the crack as spotted by the owner on the propeller backplate on his RAF 2000 autogyro. A spot like this reminds us all why good daily inspections are a vital component for safe flying. Metallurgical examination showed that, in actual fact, this plate had been cracked for some time as corrosion products had formed just after the initiation point. It looks like the plate cracked during an engine run, wasn't spotted and then failed completely during the next engine run cycle. Note that the crack passes close to the top bolt/washer (Photo: David North)

You will see in the photographs that there is a high probability that this crack emanated in the opposite face to the edge of an outer attachment bolt's washer; I've discussed the crack morphology in the text below the photographs. In my view there are a number of possible reasons for this fatigue failure and it is worth exploring these possibilities, in general terms, here. I say 'in general terms' because this sort of failure can (and does) happen anywhere on the airframe/engine; designers try to reduce the stress concentration points that can lead to failures and, where possible, eliminate the cyclical loading of a component so that the average stress in any part of the component is low when related to the ultimate materials strength. However, it can be that poor fitting/assembly practices will thwart even the best design intentions!

It might be worth pointing out that covering up a propeller hub with a spinner will undoubtedly improve the looks and may even improve the performance of the propeller a little, but it does come with a cost, as it will reduce the inspectability of this assembly. In the light of this failure, albeit on the drive side of the propeller hub, you might consider looking at your maintenance schedule to see how frequently your propeller hub is removed. Bearing in mind the fact that this failure appeared to be unusual, I felt sure that I had seen a similar thing before and, after a bit of digging, I found a similar report concerning the failure of the hub on a microlight aircraft powered by a Rotax 582 back in 1995. This failure led to the issuance of a Mandatory Permit Directive by the CAA, MPD 1995, 103 requiring checks and modifications.

over 300 hours. In actual fact, looking at these numbers more closely, I noticed that one airframe had completed nearly 1,500 hours (probably an old training machine) so, removing this one from the list, the average drops to about 250 flight hours, worryingly close to the failure case. We'll discuss this failure event during the next Airworthiness group meeting and it might be that we'll issue a bulletin requiring checks.

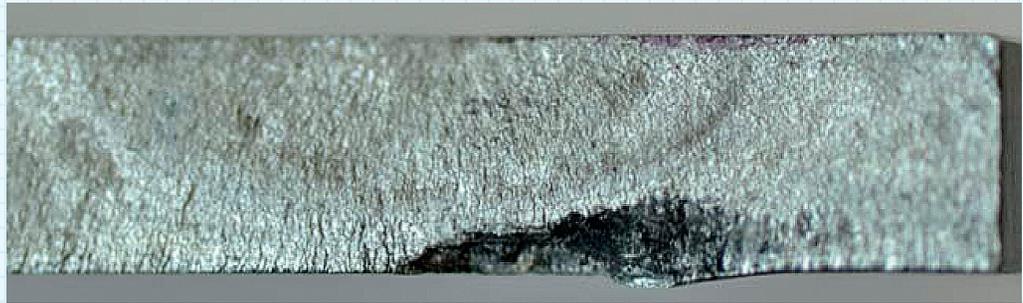
Here is a closer look at what we think is the initiation site for this crack found on the back plate of a Warp Drive propeller. What it looks like is that the plate has been subjected to bending loads and the washer has been acting as a fulcrum around which the loads have been oscillating. The gouge at the bottom of the plate matches the position of the washer. (Photo: Malcolm McBride)

Another factor may be that the damping offered by the belt drive is only minimal and this 200-hour example may be the fatigue limit in this particular plate. I took a look through our fleet records of the RAF 2000 and, for the 24 autogyros counted, the average flight hours for the type was just

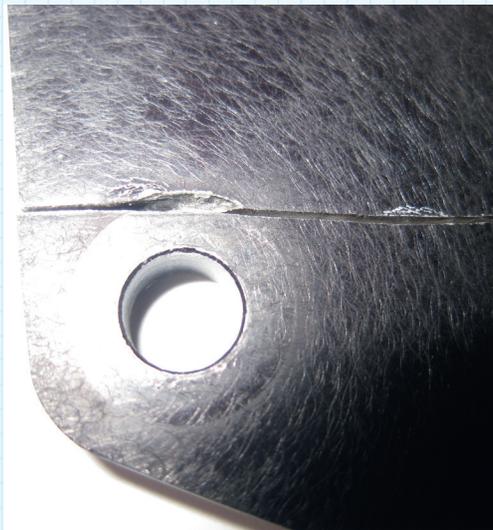
Here is another picture of the failed Warp Drive back plate, this time showing where it looks like the crack started... opposite the edge of this washer. I've used a bit too much light here (on purpose) to help highlight the micro-fractures in the anodised surface; they are not visible to the naked eye. You can see that the general radius of these micro-cracks is the attachment hole; this pattern is repeated around the other outer attachment holes, which suggests that this plate is being stretched to the point where the thin anodic film is failing.

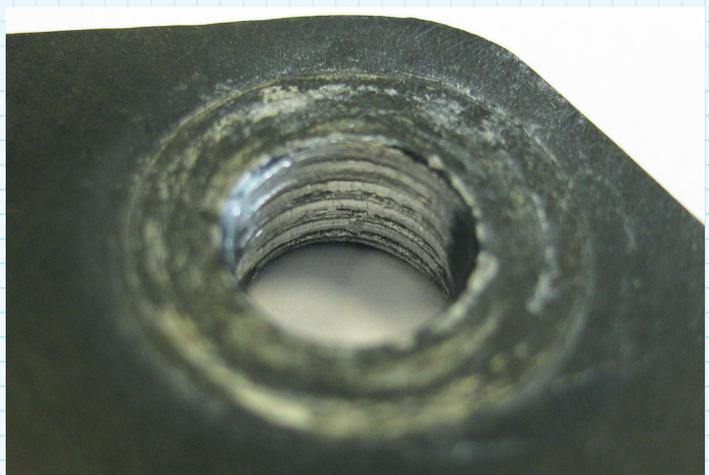
Another cause of cracking in highly-loaded components is stress concentrators; this is a close-up picture of the Warp Drive's front plate. This plate didn't fail but you can see the damage caused to the plate. This was either during the assembly of the propeller (the bolt wasn't correctly aligned) or during service (the plain shank of the bolt was insufficiently long and the threads were impinging into the material). Note that all the outer bolt holes were like this.

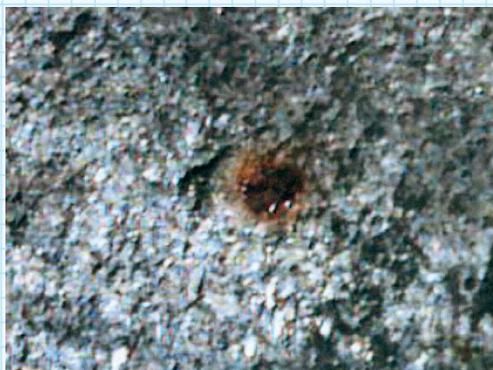
Whilst looking at the micro-structure of the fracture face on the back plate of the Warp Drive propeller featured in the text, I came across this small ferrous inclusion and thought that you would like to see it. Even in the best quality materials there can be hidden defects. Who can guess where this tiny piece of iron originated?

Of course, this failure may have occurred for other reasons, while aircraft materials are made to the highest possible standards there may still be problems; note the picture of the ferrous inclusion in the plate... perhaps a particle of steel from a failing bearing in the rolling machine, maybe a spark from a welding machine nearby carried on a long-passed gust of wind, we'll never know, but it may have been one of the many factors involved in an aircraft accident perhaps many years later.

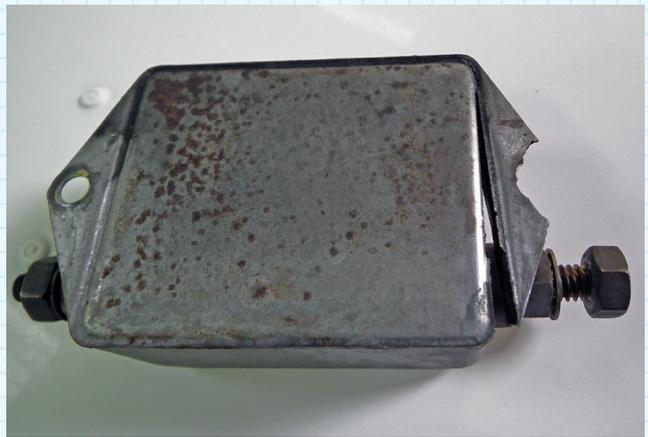
The failed casing of the output filter that caused the alternator failure on the FLS Sprint (Photo: John Webb)

One reset produced an immediate re-trip. Subsequent electrical fault finding revealed nothing and the circuit breaker did not trip. Alternator field current was normal. During the general inspection of the engine bay I noticed that the alternator output filter was slightly loose at one end. Upon removal it became clear that the case of the filter, complete with one mounting lug, had

fractured and there was evidence of burning where the case had been shorting the alternator output lug to ground.

Take a look at the photos and you can see the problem; initially the box didn't quite fit so it was, well, gaunched is a reasonable word for this kind of fitting practice. In this case, the material in the filter box itself was pre-loaded, probably fairly close to the material failure point because the mounting holes didn't quite line up during assembly.

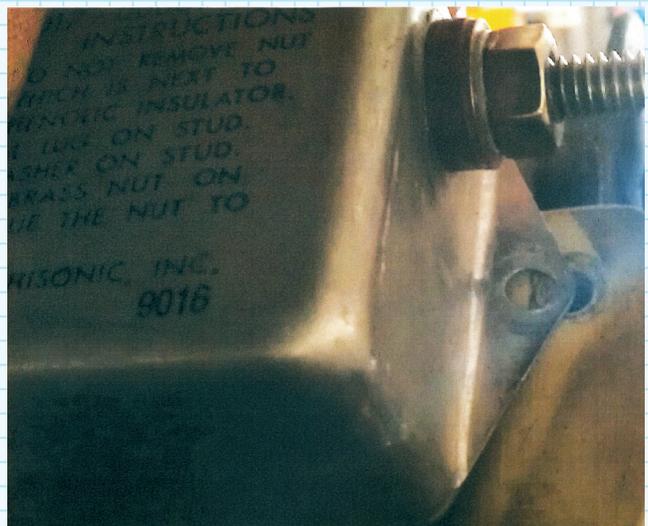
And here's why the case failed! When the new filter was offered up it was almost a complete hole out (3/16 of an inch); that's enough tension in a piece of material to cause a premature failure, which is exactly what has happened... This 'overstretched' case failed at about 100 hours flight time. (Photo: John Webb)

When I went to fit a replacement filter it became clear why the original had failed. The spacing of the mounting holes in the two brackets fitted to the alternator attachments were incorrect, being more than half-a-hole out. It was possible to fit the two AN3 bolts at an angle so, when they were tightened, a lot of stress was imparted to the filter case which failed after a little over 100 hours in service. A trawl of the NTSB data base revealed the loss of a Cessna P210 where the same type of filter had shorted causing an in-flight electrical fire.

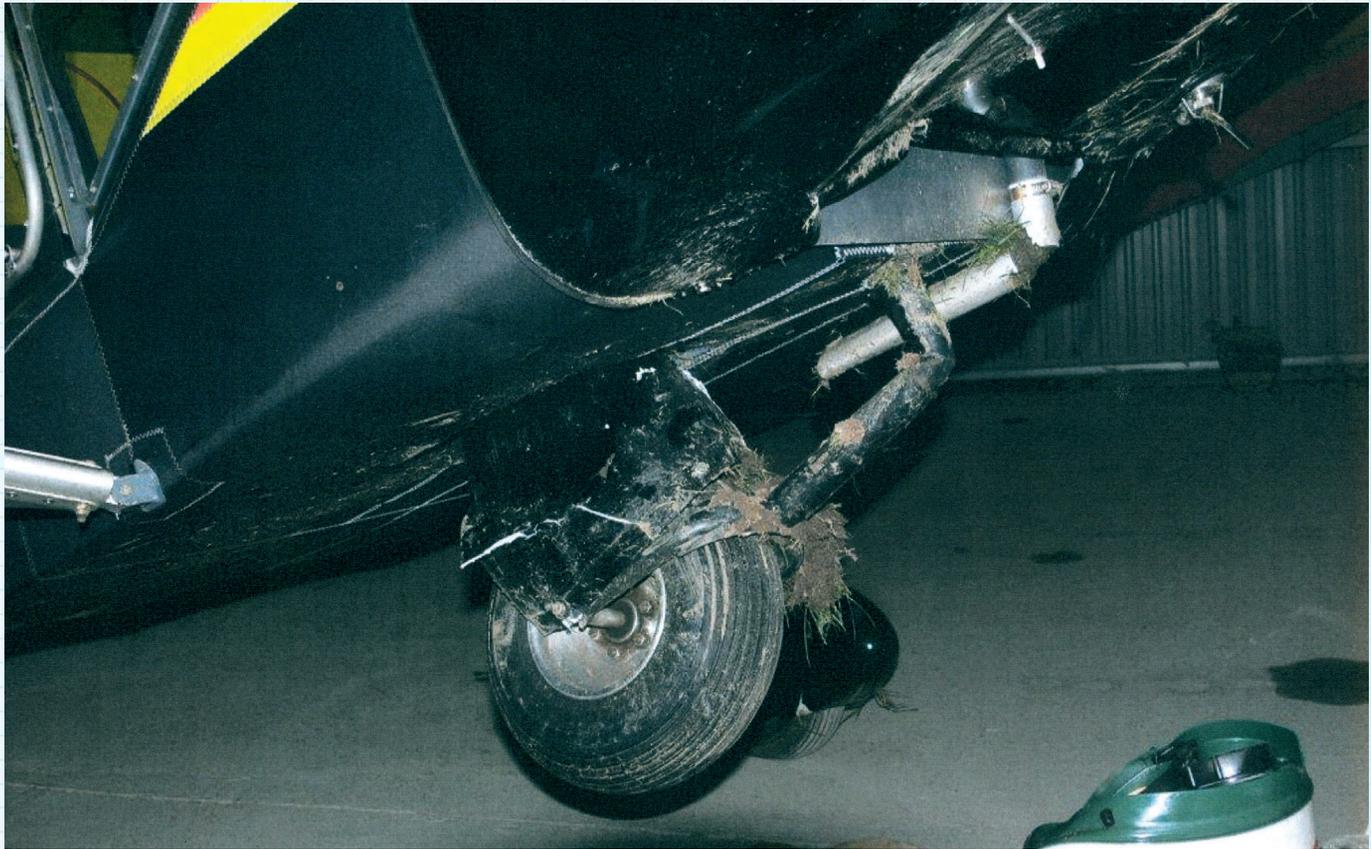
(Above) Good fitting practice is not just about making sure that holes are lined up. The undercarriage on this Rans S6 was damaged during a forced landing caused because the engine failed shortly after take-off. The cause of the engine failure is thought to have been a fuel restriction caused by a kinked pipe this, in turn, was caused by the pipe being fitted through too tight a turn radius
(Photo: Steve Clarehugh)

I shall start this story with the synopsis from the Air Accidents Investigation Branch's report: 'The aircraft engine stopped at low height, shortly after take-off. The pilot turned back to the airfield and attempted a landing on a secondary runway, but the aircraft landed

heavily, causing damage to the landing gear and forward fuselage. Neither occupant was injured.'

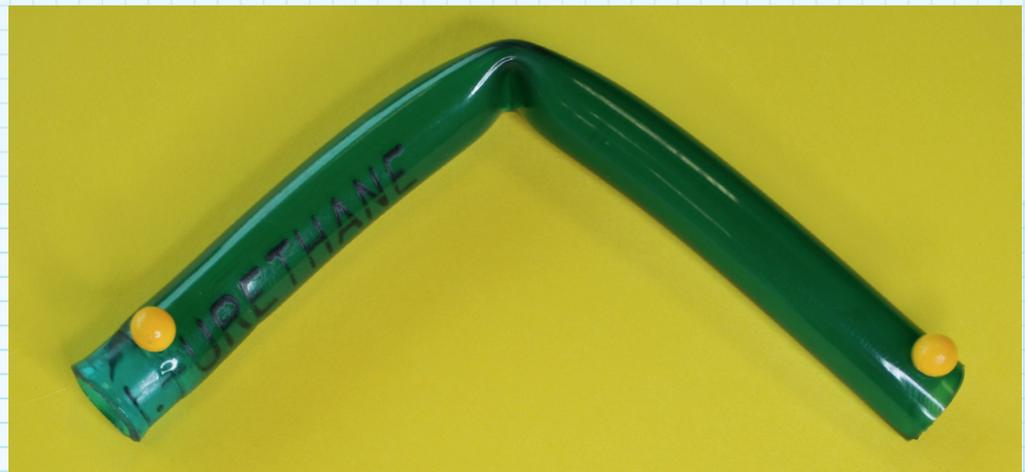
Here is a picture of what happens to a flexible pipe that is forced around too tight a bend... it morphs into quite an effective OFF valve. (Photo: Malcolm McBride)

Dear Malcolm,
Thought you might like this piece of fuel hose taken from a Rans S6 which had an engine failure on take-off. If you bend the end of the tube down the line of the letter E you will feel the pipe kink very easily. This was, we believe, the cause of the power loss (as it was fitted to the fuel selector valve at a very sharp angle).

I had a bit of a play with the fuel pipe and could see exactly what Steve was talking about. You can see from the accompanying photographs that it is very important to ensure that fuel pipes are routed carefully to avoid kinks like this. I expect that this pipe would have looked fine when it was first fitted but, perhaps through ageing, or even a change in ambient conditions, the properties of the pipe's sidewall changed and a kink appeared, shutting off the fuel supply to the engine.

The fuel lines have been replaced using conventional tube.

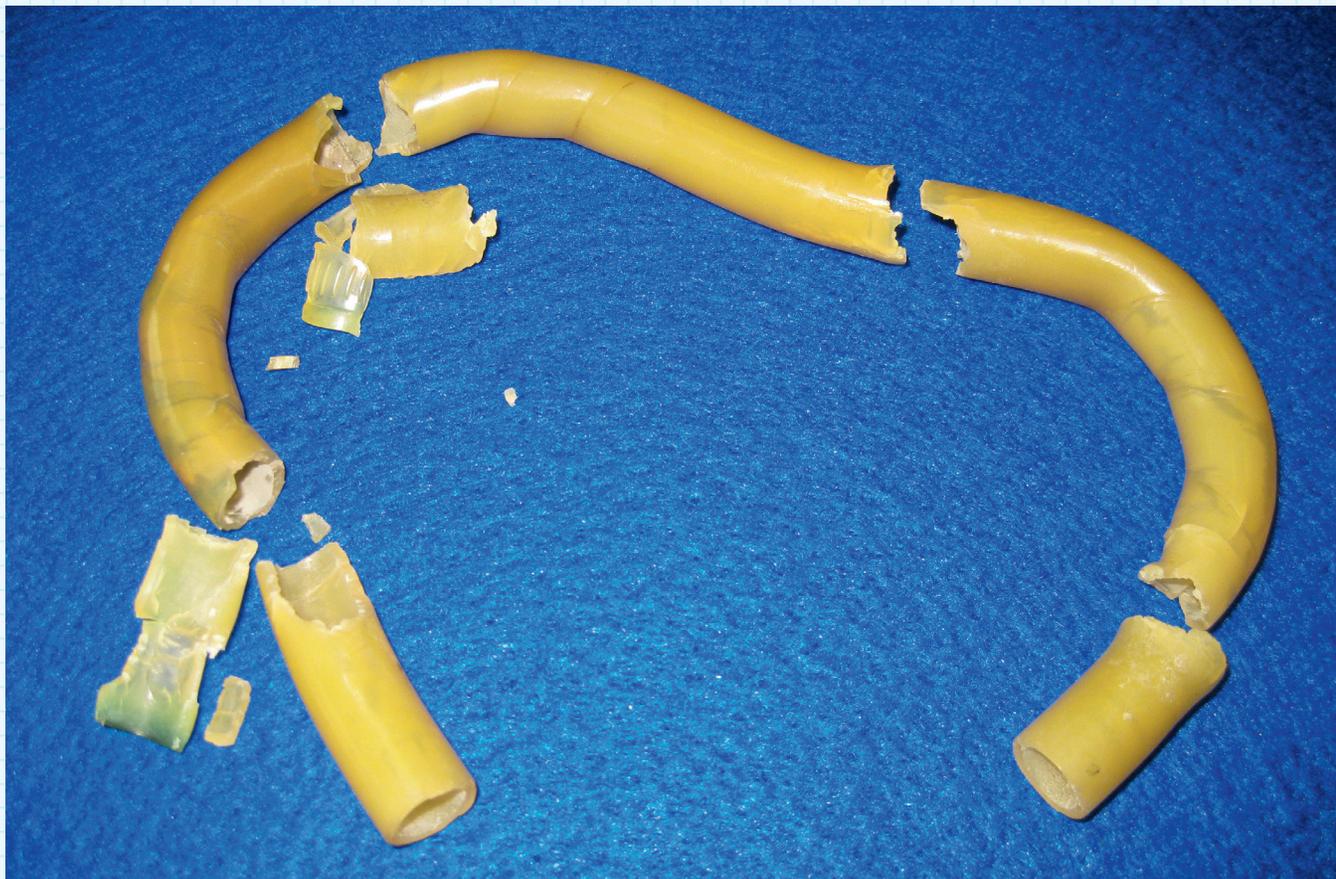
Dear Malcolm,
Please find enclosed the remains of the fuel transfer pipe from the extended wingtip tanks of my Glasair. Each year I religiously check the plane out for its Permit as well as any ongoing maintenance; however, the wing-tanks are held in place by some 30 or so countersunk screws 'loctited' in place. Early attempts to check inside the wingtip to wing joint resulted in destroying the screws. Reading the build manual gave me the impression that it was a 'for life' assembly. So I left well alone.

A fuel leak appeared, so off came the wing tank (30 odd screws scrapped), inside, the horror before you.

This sad-looking section of flexible fuel hose shouldn't really have been anywhere near an aircraft as it's about 17 years old. The reason it was overlooked (and therefore not replaced) is that nobody was aware that the pipe was in the aircraft. It was fitted between a (what was thought to be) permanently installed tip-tank and the wing of a Glasair IIS RG. Luckily, apart from loosing all the fuel over the hangar floor, no harm was done. (Photo: Malcolm McBride)

I believe that there are several Glasairs on the register with tip-tanks. Please let the owners know of this potential fire/accident hazard. The tanks do come off without too much hassle; new screws will be required as well as some proper fuel pipe.

had been the wingtips would have come off. To try to avoid this happening with aircraft operating on an LAA Permit to Fly, where specific major inspections are rarely actually specified, we like to see a complete inspection each three years. By complete, we mean every part of the airframe.

Where lifed items are involved, say an inspection or replacement every five years, these should be listed in (and built into) the aircraft's maintenance schedule so that they are not overlooked. Normally, aircraft-quality flexible pipe is required to be inspected

and pressure tested every six years but it should be noted that CAA MPD 1998-019 RI requires all light aircraft (below 2,730kg) operating on a Permit to Fly to have their fuel pipes inspected 'prior to the issue or renewal of the Permit to Fly'; that effectively means that aircraft operating on

a Permit must have all their fuel pipes inspected annually.
