With Malcolm McBride
Airworthiness Engineer

SAFETY SPOT

SPORTCRUISER: NOSEWHEEL FORKS

JABIRU UL430: MAIN UNDERCARRIAGE FAILURE

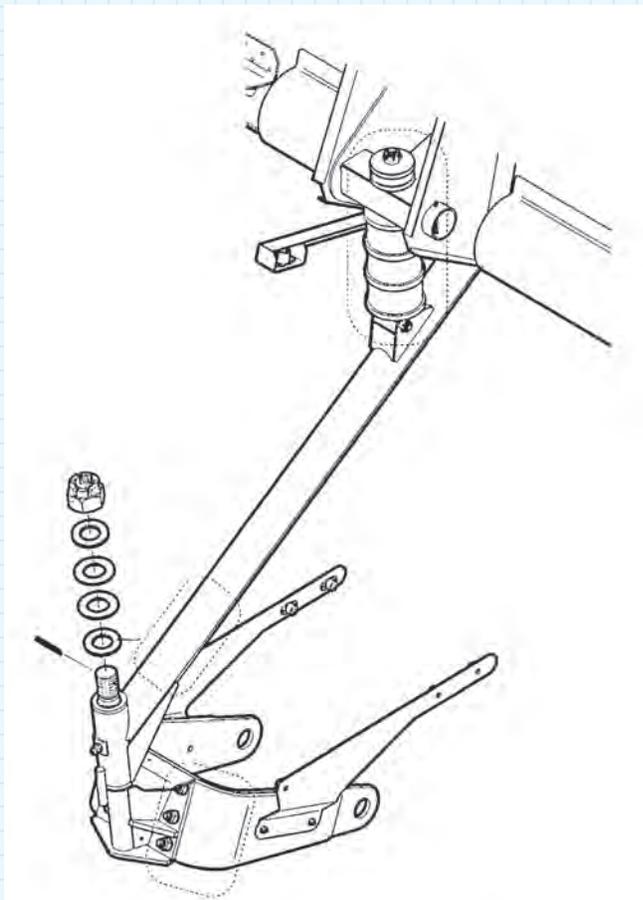
Here is an assembly drawing of the CZAW nose undercarriage assembly. To inspect the fork thoroughly it has to be completely removed from the spindle assembly by removing the six attaching bolts and the rear spreader plate (observed). The LAA now requires that this area is strip-inspected each 50 hours of service life and that, if cracks are found, the part is replaced. (Diagram: courtesy of CSA)

The LAA has issued another Airworthiness Information Leaflet (AIL) requiring checks on these nosewheel forks within five hours of the AIL's issue date, then each 50 hours and annually. We know from experience, as engineers (and tactfully, bearing in mind the fact that all LAAers do good landings), that this type of nosewheel assembly is intolerant of repeated heavy use, so this AIL, unusually, specifies that the leg needs to be disassembled and checked after a heavy landing.

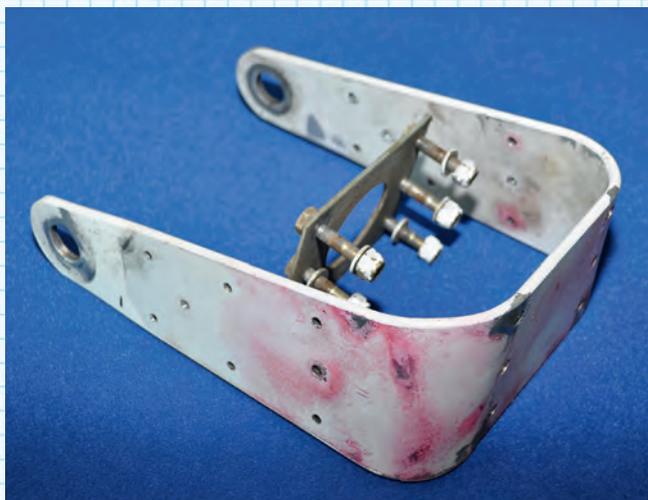
LAA Inspector, Graham Smith, of Sprite Aviation, one of the LAA's Centre of Excellence for SportCruisers, sent me this example of a badly-cracked nosewheel fork. This fork is effectively sandwiched between the spindle assembly and the load spreader plate (shown in this picture with the bolts) so cracks cannot be seen without complete disassembly. Although a failure of this attachment is likely to occur over a longer period than a catastrophic failure of the spindle, cracking in any nosewheel component is worrisome and must be taken seriously. (Photo: Malcolm McBride)

From the returns, it is clear that there has been a developing problem with the wheel attachment forks on this aircraft type and cracking has been discovered on quite a few individual machines. When I first heard about this, I popped down to the workshop and took a look at the example that was sent to us following a spindle failure. It was pretty filthy, so I cleaned it and, sure enough, a crack could be seen at the edge of the component. Once disassembled, small cracks could be seen radiating from four of the six attachment holes but, without thorough cleaning and complete disassembly, it would be nearly impossible to see these cracks.

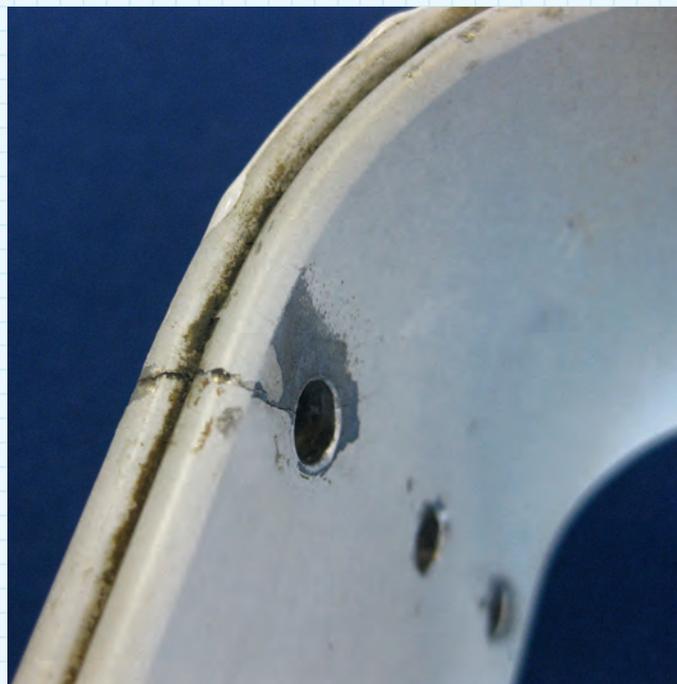
The SportCruiser nosewheel fork is formed from two aluminium alloy components riveted together; the area shown in this picture is the point of attachment to the spindle assembly. Note that this crack has progressed from the top bolt hole right to the edge of the fork and has affected both components. (Photo: Malcolm McBride)

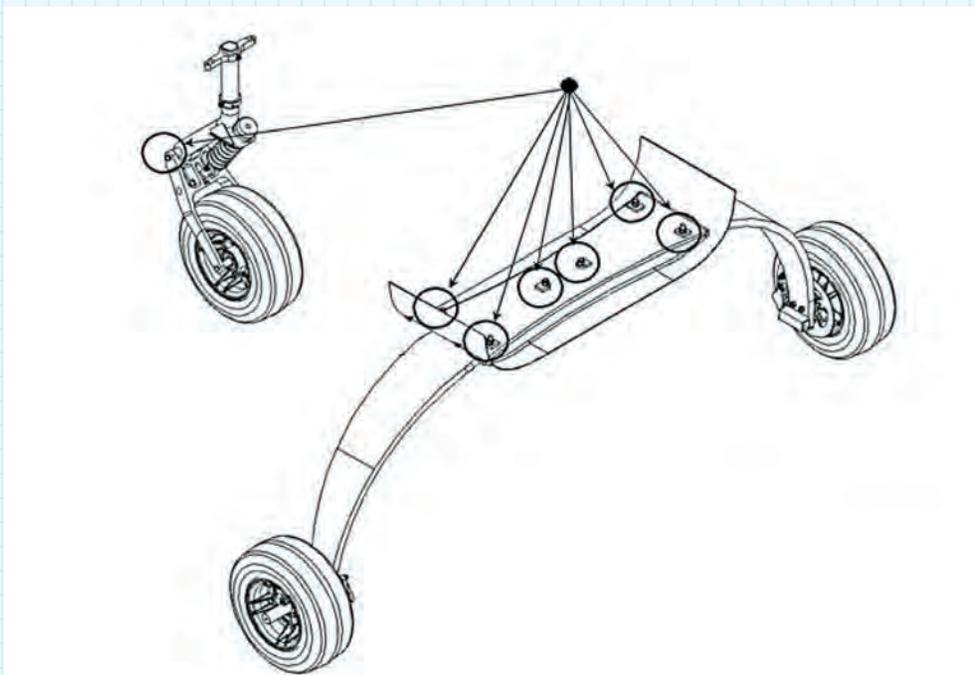
Here is a picture of the general arrangement of the Jabiru undercarriage system, which is principally similar for all types of Jabiru. What this picture doesn't show very well is that the left and right legs are separate cantilever springs. You can see that each main undercarriage is secured by three bolts, the outer two being 5/16in (AN5) bolts fitted through a clamp that holds the leg to the fuselage structure. The inner bolt on each leg is rubber-mounted, which along with the flexible nature of the composite leg itself, affords some flex. The Jabiru main undercarriage leg is canted forward, which creates a loading asymmetry in the clamp itself; you can probably work out that the rear bolt is having to work harder than the front one.

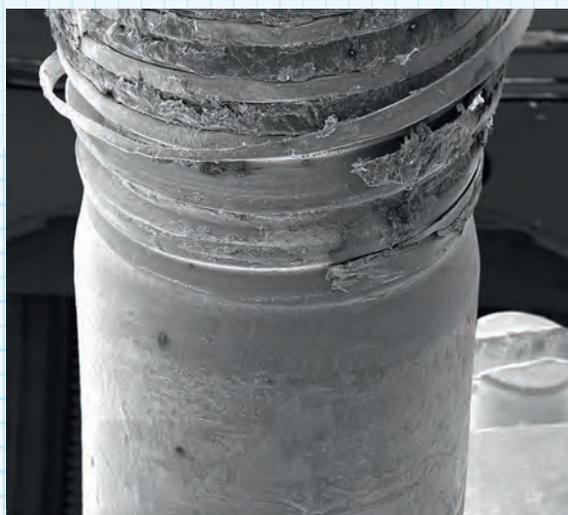
Here is an electron microscope picture of the remains, buried deep in the threads of the bolt, of the failed nut from the Jabiru UL430 that suffered an undercarriage failure. The reason for taking this picture was primarily to establish the material that the nut was made from. EDX analysis determined that the nut was almost certainly a Nylock nut as traces of a polymeric material were seen in the threads. No alloying elements might indicate that the nut was just made from mild steel; zinc traces are indicative of a galvanised (rather than cadmium-plated) finish. These findings suggest that the nut was of commercial quality rather than an aircraft quality part... not in itself an issue in this uncertified machine, providing that the correct part number was used.

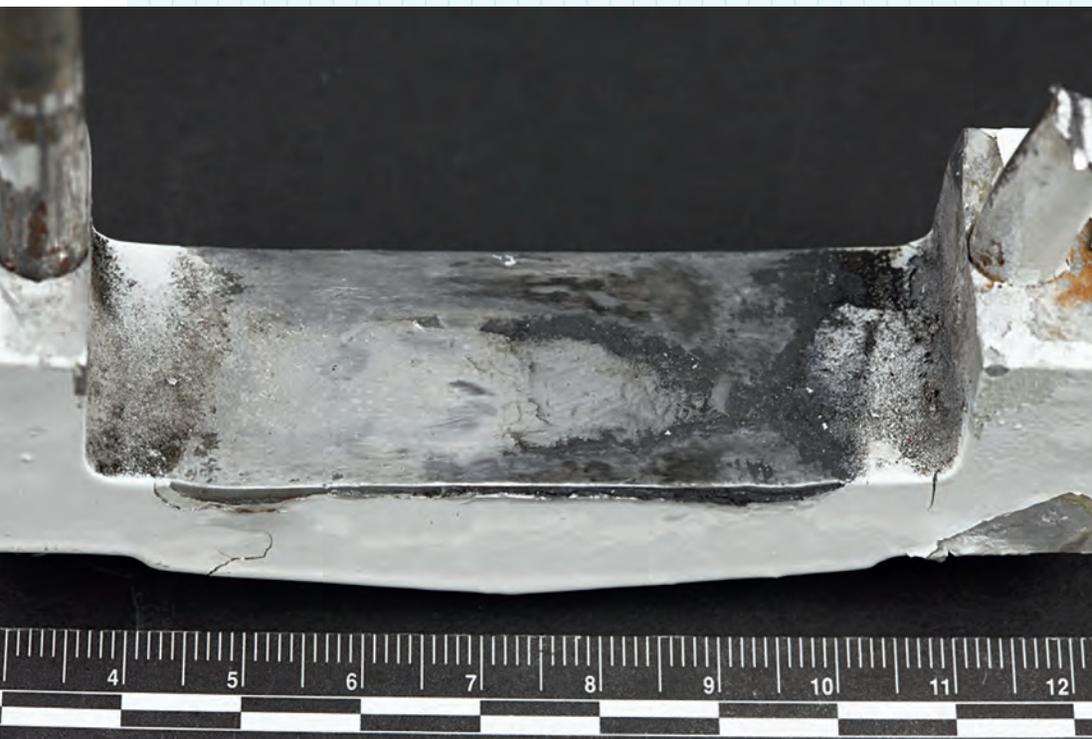
In this picture of the failed starboard undercarriage clamp from an LAA Jabiru UL430 that recently suffered an undercarriage failure after landing, it is clear that there has been previous movement between the leg and the clamp. Note the 'polished' surface on the right side of the clamp. This polishing indicates that the clamping force was insufficient, probably because the nuts had reached the plain shank of the bolt ('bottomed out'). Movement in this type of fixing creates two problems: 1 The movement introduces the possibility of wear, which will create still more room for movement; 2 movement changes the nature of the loading in the joint, often introducing sudden peak stresses but almost always focussing the load into a smaller area.

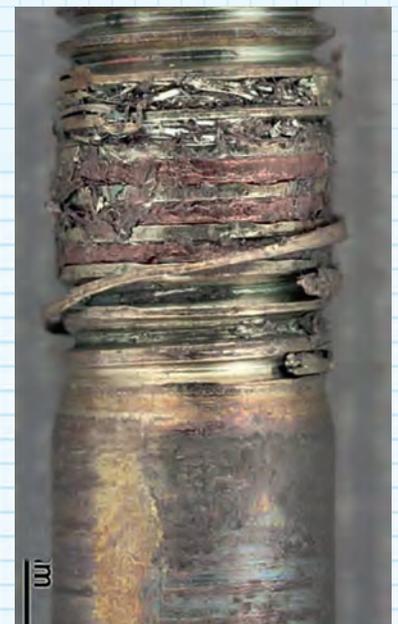
It was determined by the AAIB investigation team that the nut had pulled off the starboard forward attachment bolt; the rear attachment bolt was still in place. This photograph shows clearly the debris from the nut reaching right up to the shank of the bolt, indicating that it had probably 'bottomed out'. Along with the polished surface of the inner portion of the clamp, the evidence points to the fact that the attachment clamp had been loose for some time prior to the failure.

He mentioned a few other things he'd learnt during this event, which he felt were worth sharing. The first of these was that, like many LAAers, he's a pretty busy chap running a business and that he hadn't found the time to check through the Engineering Bulletins for the type. Had he done this he would have known that there have been a number of Bulletins, published by the manufacturer and available on its website, which require both upping the size of the attachment bolts from 5/16in to 3/8in (JSB 008-1, 2005) and limiting the life of these bolts to 500 hours (JSB 025-2, 2009). John's aircraft had clocked more than 600 hours.

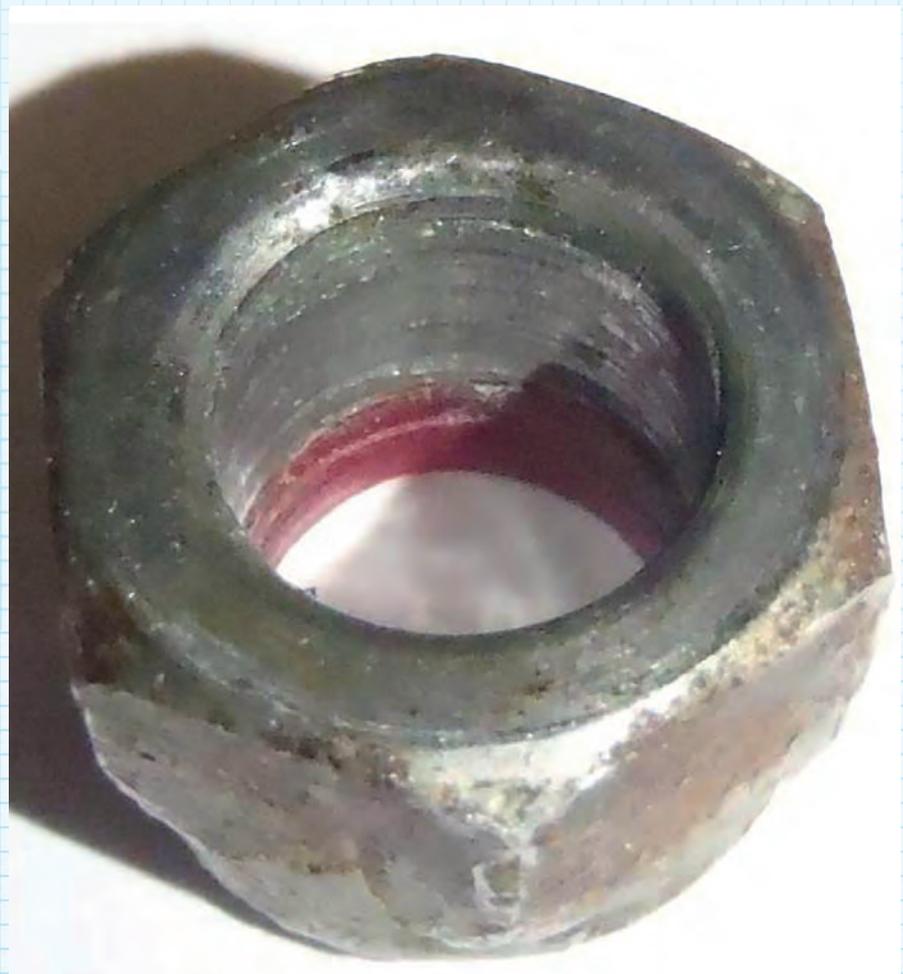
Here is a picture of the AN365-524A whose threads were stripped as the main undercarriage failed on the Jabiru UL430; this nut was found in the aircraft as it was being scrapped, the damage to the airframe being so bad that it was considered unviable to effect a repair. Interestingly, an earlier EDX analysis of the remnants left in the threads of the bolt suggested that the nut was made from Mild Steel. Dave Almey, the nut's finder, has sent this nut to the AAIB for analysis and it will be interesting to see what they find. (Photo: Skycraft)

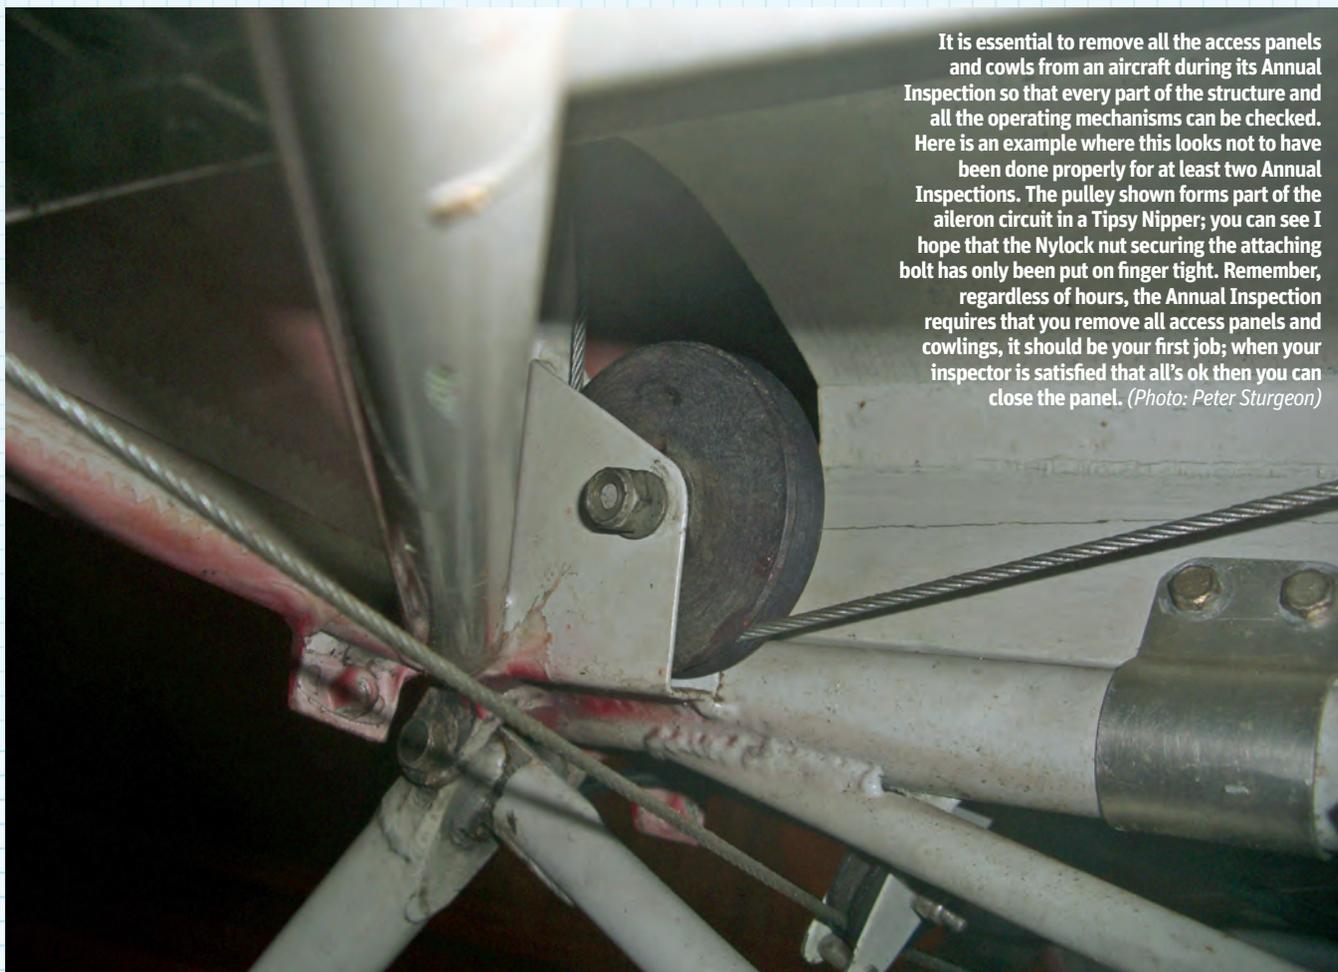
It is essential to remove all the access panels and cowls from an aircraft during its Annual Inspection so that every part of the structure and all the operating mechanisms can be checked. Here is an example where this looks not to have been done properly for at least two Annual Inspections. The pulley shown forms part of the aileron circuit in a Topsy Nipper; you can see I hope that the Nylock nut securing the attaching bolt has only been put on finger tight. Remember, regardless of hours, the Annual Inspection requires that you remove all access panels and cowlings, it should be your first job; when your inspector is satisfied that all's ok then you can close the panel. (Photo: Peter Sturgeon)
