## CABLES AND SPRINGS

The LAA has to ground all Aeroprakt A22L Foxbats due to severe rudder flutter issues

### AEROPRAKT A22L FOXBAT SERIOUS CONTROL FLUTTER

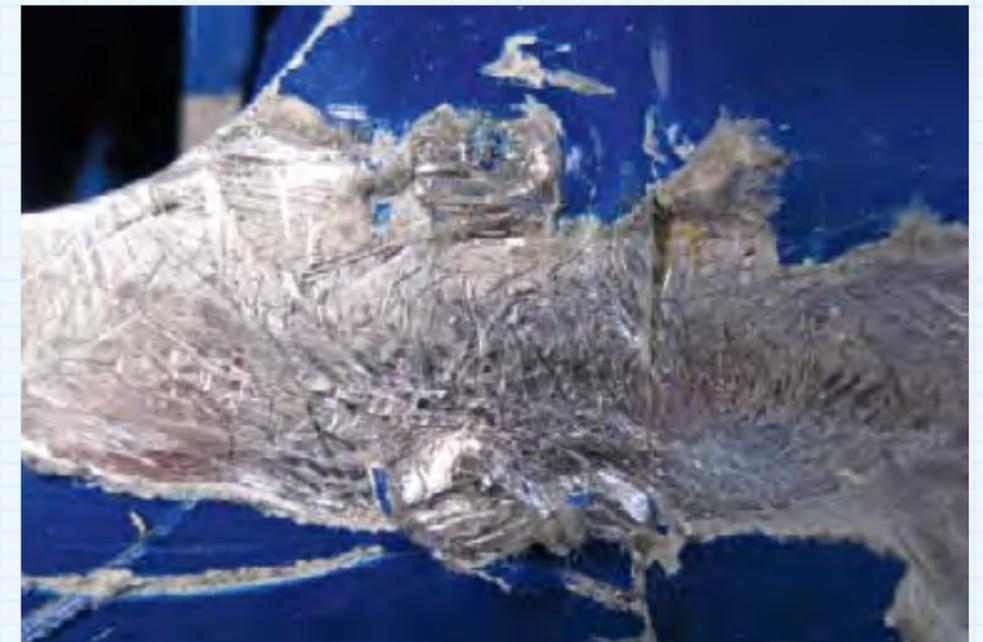
Left: in this picture, which focuses on the empennage of the Aeroprakt A22L Foxbat, you can see that the rudder anti-balance tab lower (of three) hinge attachment has failed. The exact reason for this bolt failure is not clear, in fact it is not possible to determine conclusively whether this attachment bolt failed and initiated the flutter event or the 3mm screw failed because of the flutter event. You can see clearly that the damage to the top of the elevator, caused by the rapid oscillation of the tab and the rudder, is restricted to an area over the elevator's aluminium leading-edge. It's likely that the rudder/elevator jam was caused because the failed anti-balance tab drive horn buried itself into the fabric skin of the elevator; the rear of the two holes fits the shape of the bent drive horn nearly exactly. Remember, the elevator would be slightly up during level flight. (Photo: Malcolm McBride)

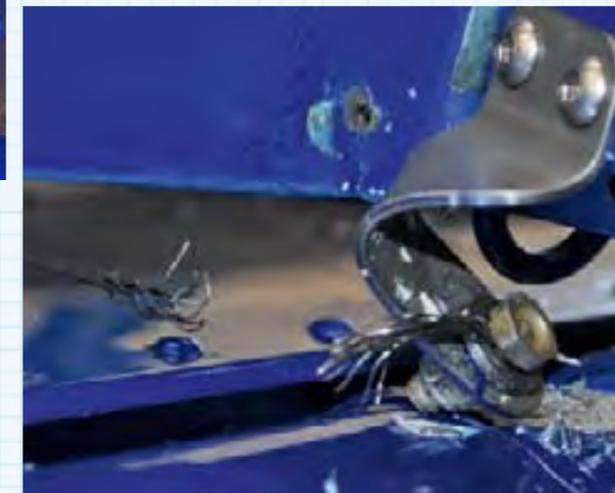
In the pictures left and above, both ends of the Bowden cable can be seen. Note that the cable has failed at a point nearest the tab but the other end of the cable is undamaged. This suggests that the cable failed due to fatigue created as a result of the extreme (and rapidly changing) bending loads and not because of a tensile overload. When this cable failed the tab itself was free to move backwards and, at this point, the vibration stopped and the controls jammed. (Photo: Malcolm McBride)

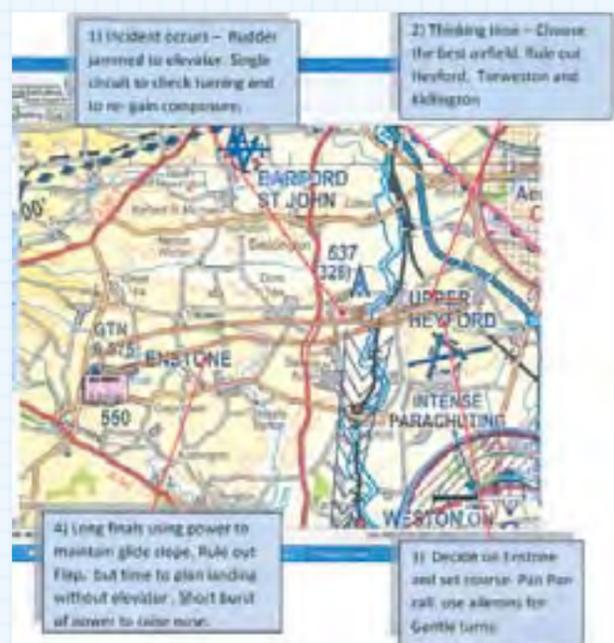
Here's a screen-print of Peter's flight, taken from the aircraft's GPS. His track across the ground is painted in brown; start at Enstone and follow the loop clockwise. The comments in the blue boxes are Peter's own. The approach chevrons are for the (fairly) new ILS for R20 at Oxford; Upper Heyford is no longer active. I know this area pretty well and I can say that it's not the best for a forced landing. Peter found himself in an aeroplane with limited controllability and, in my humble opinion, made all the correct decisions which enabled him to land the aircraft safely. (Picture: Peter Goff)

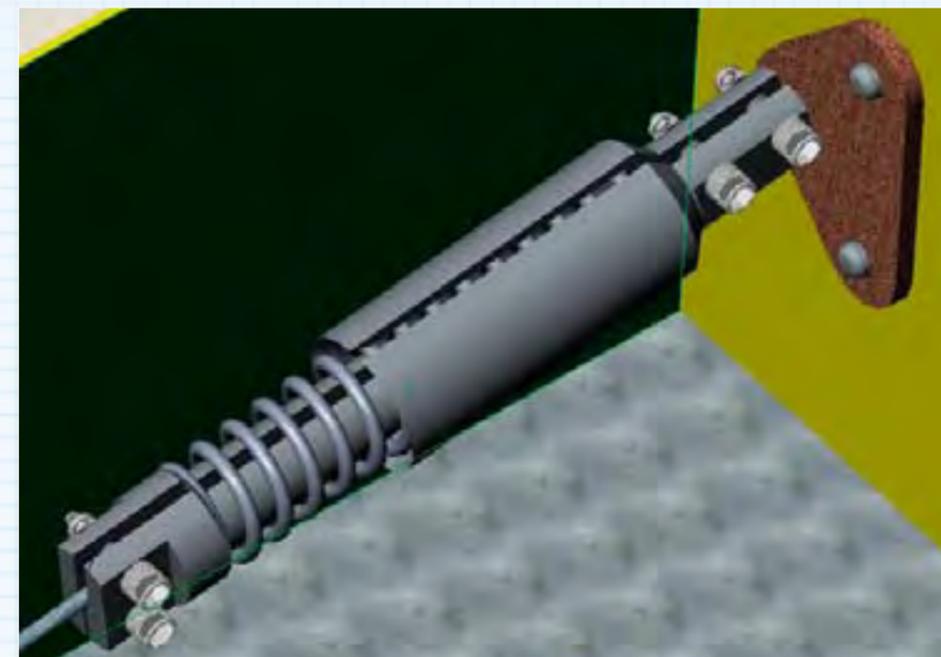
Because of a number of failures in service, we have decided that the Bowden-cable-operated anti-balance tab is not safe to use on the Aeroprakt A22L Foxbat. Independent further flight testing has confirmed though that the aircraft's directional control is, in effect, only neutrally stable. What this means is that, if you were to apply full right rudder and then take your feet off the control, the rudder would remain fully deflected. The rudder return therefore does not meet the required 'proportional force' requirements of BCAR Section S. Here is one solution, devised and made by LAA member Paul Trimble, which has been approved by the LAA's Design Department. This little unit provides a spring force which returns the rudder back to the neutral position. (Photo: Paul Trimble)

we were able to simulate this clicking by rotating the spring/hinge one way, then the other. This might indicate that there was some extra resistance in the hinge at one point in its range of movement, which might have upset the dynamics of the system enough to cause the servo tab to flutter.

Another thing that was immediately obvious was that the tab's bottom hinge attachment screw was missing. It is possible that this broke during the flutter event but my view is that it could also have been the initiating failure. If this screw were to fail (or the nut become loose and fell off) then the bottom of the tab would have been free to flail around in the air stream. If this screw had failed then spring tension would become very much reduced and we already know that, when the spring becomes ineffective, tab flutter will result.

One further thing that might be relevant was that the leading-edge of the tab itself had been rubbed on the trailing-edge of the rudder. This may have been due to an over-close fitment when the aircraft was manufactured but, in my view, it's more likely to be a result of the loose hinge fittings found. I think that this looseness was due to the trailing-edge of the rudder itself yielding against the reacting hinge loads.

enough is enough and the LAA Engineering team elected to publish an AIL grounding the machine immediately until a more robust design of rudder centring system can be fitted.

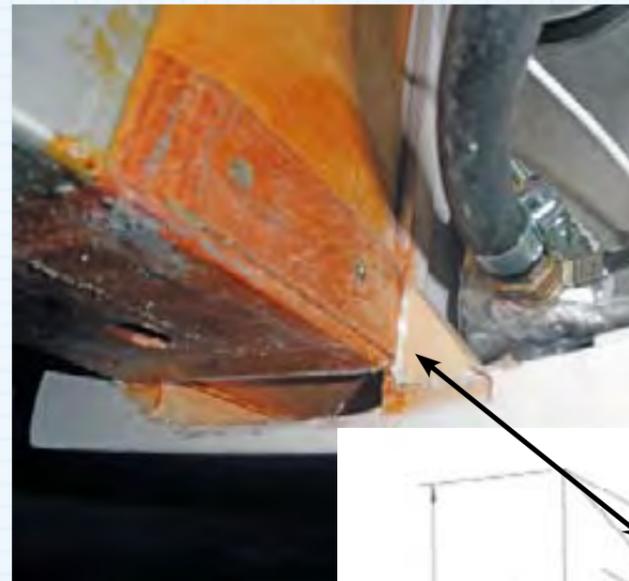
**Pioneer specialist, Tim Skinner, has noticed that a number of aircraft he's worked on recently have suffered from separation of the inner wing rib to spar joint. There have been various suggestions as to why this particular joint is failing but, whatever the reason, the LAA's Design Engineer, Andy Draper, wants this weak joint beefed up a bit. Here is a picture of the solution, a small gusset.**  
(Photo: Tim Skinner)

This item involves a recurring problem with the leading-edge root rib on the wooden Pioneer 300 suffering a glue joint failure causing the rib to lose some of its rigidity. This particular joint failure has been seen on a number of Pioneer aircraft so we will be issuing an AIL requiring checks and strengthening in this area at (or before) the next Annual. The reason why I write about it here is that I know that many Pioneer owners will be having their wings off shortly to replace the suspect fuel fitting (See 'Safety Spot', May 2011) and that will be an ideal time to do this minor repair/strengthening job.

There are a couple of possible explanations as to why the glued connection between the bottom of the inner wing rib and the spar is coming adrift, and it has been the subject of hot debate. I spoke to the UK's design consultant for Alpi aircraft, Dave Simpson, and he did some maths to demonstrate that the aircraft's structure wasn't in any danger. One suggestion as to cause is that the joint cannot tolerate the loads imparted to it if people sit on the wing leading-edge to reach into the cockpit – the hardened walkway is to the rear of the wing and the leading-edge is not designed to take heavy point loads.

Another reason might be the fact that the fuel tanks, which are fitted inside the wing leading-edges, might under some circumstances apply a point load right at the joint itself. Either way, we're going to require the fitment of a small gusset to strengthen this area a little.

Any modification will require an improvement here.

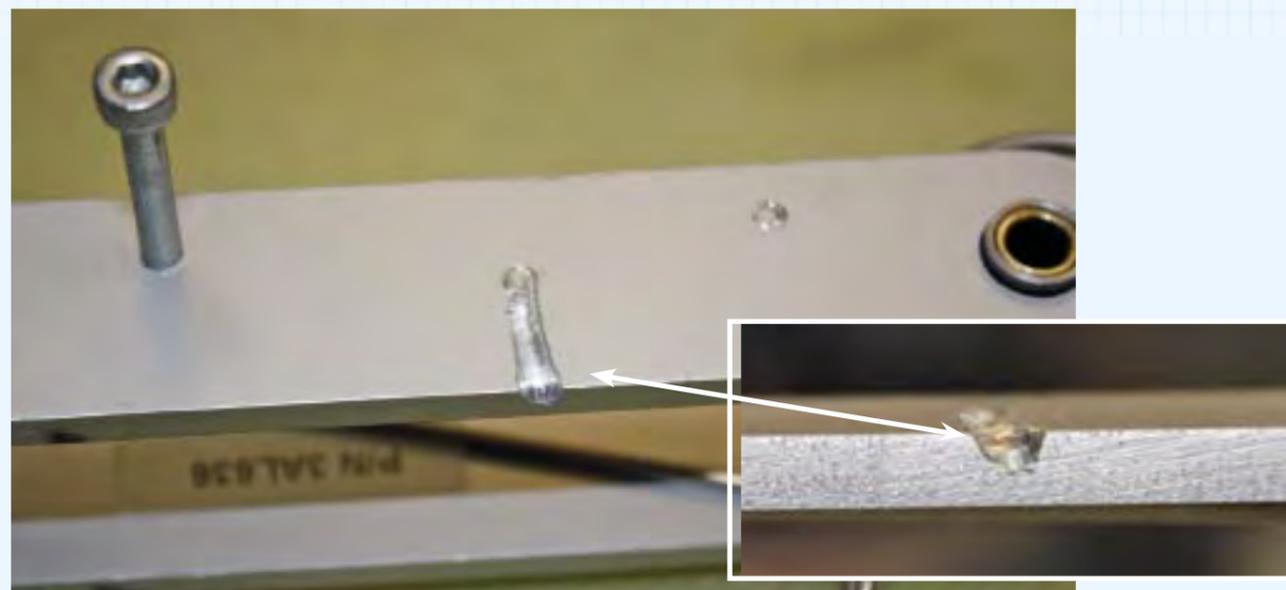
(Photo: Toby at Targett Aviation)

**Toby, from Targett Aviation, found this gouge in a Pioneer 300 main undercarriage side stay while he was fitting assist springs to aid the over-centre lock. The damage was caused because the screws holding the DOWN indicator microswitch were too long and, each time the undercarriage was operated, material was removed in a machining action from the side stay. It's essential that operating mechanisms on aircraft are checked regularly on the ground and this is especially true when fitting a new component (in this case a microswitch). When you are designing the Maintenance Schedule for your aircraft, build into it regular 'panels off' inspections so that the normally hidden parts can be checked and, where necessary, lubricated.**

This 'Spot' was sent to me by Toby, an aero engineer working at Targett Aviation based at Nympsfield. At this point, it's probably worth viewing the picture which shows a large gouge in one of the undercarriage side stays. Note that a considerable amount of the material has been lost and there will have been a consequential loss of strength in this component. Toby tells me that the cause of the damage, which had it not been spotted would most likely have continued until the part was seriously compromised, was that as the retractable undercarriage cycled, the part was rubbing against the

end of an overlong screw used in the fitment of an 'undercarriage down' indication microswitch. Toby wouldn't have spotted this fault but for the fact that he had to remove the wings to change the fuel outlet.

There are a few lessons that can be learnt from Toby's spot, the biggest of which is that whenever items are introduced to a system, full checks must be made. In the case of this undercarriage, clearly this was not done otherwise the overly long bolt would have been found.

What should have happened is that the aircraft should have been placed on jacks and each leg should have been watched through its operation to check that there were adequate clearances all round, nothing was snagging and the gear was over-centring properly and moving from stop to stop. In the case of retractable undercarriages, this sort of check must be done annually; Pioneer specialists recommend that full retraction checks should be conducted each 25 flying hours.
