STOPPING TROUBLE ON THE SPOT

Good inspection practices, typical schedules and potential problems well spotted

SAFETY SPOT

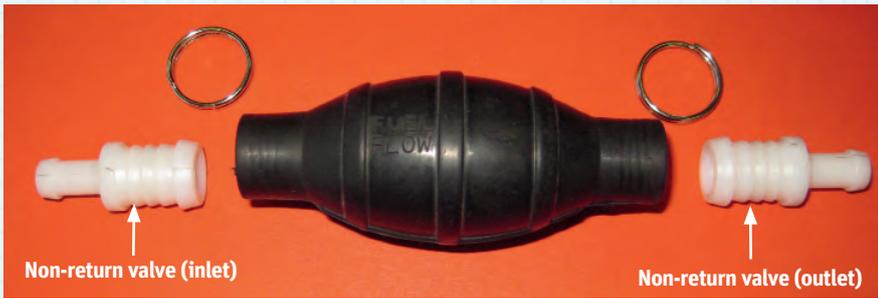
Left and above: here is the Kimpex fuel primer bulb that caused a restriction in the fuel supply on the Rans S10. The primer consists of a squeezable rubber bulb and two non-return valves (NRV) to control the direction of flow. (Photo: Malcolm McBride)

Opening this particular package I found a brand new rubber fuel primer. I could tell it was brand new because, unlike many of the fuel-related parts that I receive, Fiona didn't immediately close her office door because of the smell. With the primer, which incidentally looked and felt fantastic, was a compliment slip from Skycraft so I gave Dave Almey, Skycraft's boss, a call. Dave explained that he was inspecting a Rans S10 after its annual maintenance review and that he had decided to replace the fuel primer because the old one was looking past its best. Dave fitted a new primer from stock and checked that it was working correctly and thought no more about it. Later, when the weather improved, Dave began his engine ground runs; everything seemed to be working well and he started to make plans for the test flight. Then the engine stopped. After investigation, it was found that the new primer pump wasn't allowing fuel through under gravity feed. He changed the primer bulb with one from a different manufacturer, ran the engine again, and this time the engine ran perfectly.

Dave checked the suspect primer bulb and realised that this pump was a type new to him. He checked his stock levels and this was the first primer pump from this batch that had been fitted to an aircraft. Phew! Dave has now withdrawn this Kimpex pump from stock and sent an example, off the shelf, to me. Good decisions all round as far as I'm concerned.

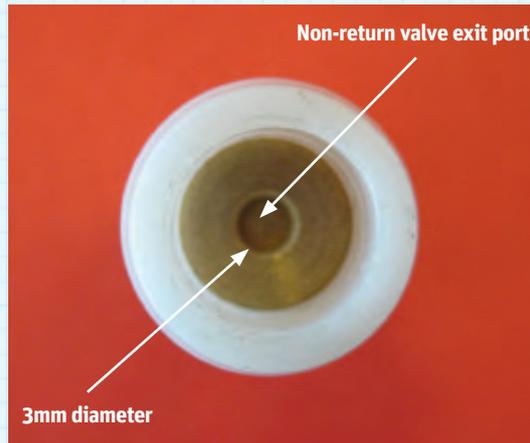
This picture shows an end view of the outlet side NRV. The valve itself is normally held closed by light spring pressure; note that the area upon which the fuel pressure is reacting is very small and the load applied will be proportional to this area. (Photo: Malcolm McBride)

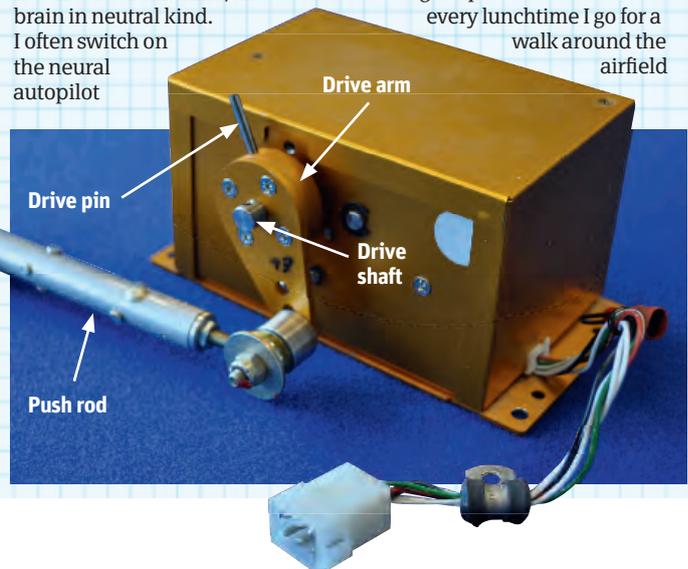
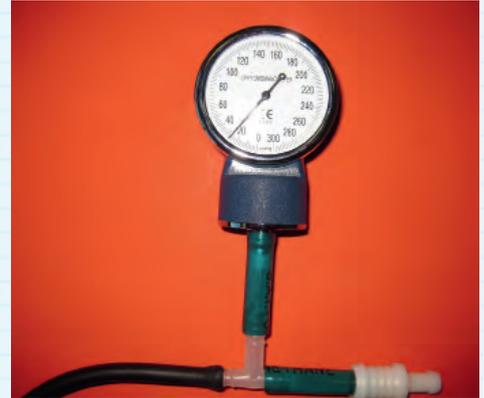
By using a pressure gauge from a blood pressure measuring cuff, the pressure required to overcome the spring pressure in the NRVs was measured. The pressure required to open the inlet NRV was only just measurable but the outlet spring resisted about 24 mmHg before it opened. This relates to a minimum acceptable line pressure of 0.46psi and that relates to a fuel head of about 450mm (17.6in) – this is much more than the system on the Rans S10 could provide and the answer to why the engine failed. It makes sense to thoroughly test a fuel system if any changes are made to it; this engine failure on the ground is a good example where testing probably prevented an engine failure on climbout. When you test the system, think about the worst possible case as far as the pressure head is concerned. In a gravity-fed system, you must ensure that the fuel flow is at least 150% of the engine demand. (Photo: Malcolm McBride)

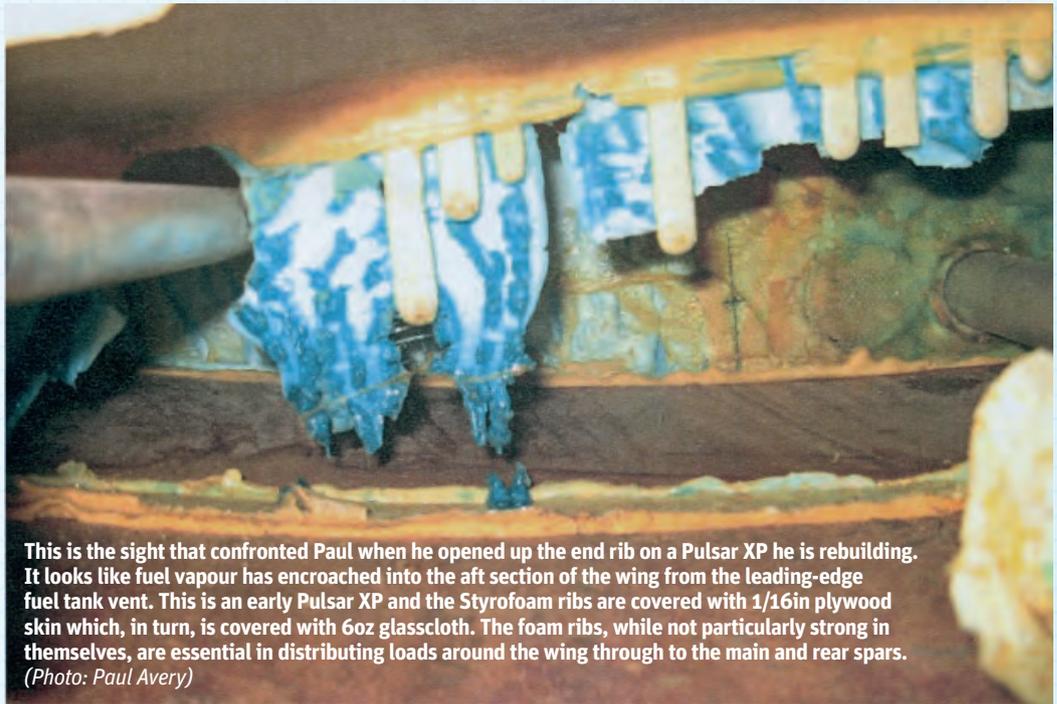
This is the sight that confronted Paul when he opened up the end rib on a Pulsar XP he is rebuilding. It looks like fuel vapour has encroached into the aft section of the wing from the leading-edge fuel tank vent. This is an early Pulsar XP and the Styrofoam ribs are covered with 1/16in plywood skin which, in turn, is covered with 6oz glasscloth. The foam ribs, while not particularly strong in themselves, are essential in distributing loads around the wing through to the main and rear spars. (Photo: Paul Avery)

The wings were inspected the following day. Luckily the aircraft was built with two inspection panels on the underside of the wings, one being just outboard of rib three; a snap-on optical borescope was fed through the aileron drive aperture in rib three - ribs one and two on both wings were found to be almost totally dissolved.

The aircraft was purchased and transported to my workshop where the fibreglass covering on the wing-roots was removed and it was found that the damage to the ribs of both wings was almost identical. The fibreglass covering had a very poor bond to the wing-rib epoxy and I don't believe it was part of the original build. In fact, on further investigation, it seems to be a mixture of glass and carbon fibre. There was also some evidence of another substance, perhaps builders foam.

The wing ribs, albeit only soft foam, are an essential part of the structure on the Pulsar aircraft; failure of these ribs could lead to a structural deficit and a possible wing failure. Clearly, regular inspections are required and these have now been called-up by the reissue of the LAA's ALL. This is a good example of the need for a thorough inspection of the aircraft's structure at regular intervals and we now require internal structural checks on the Pulsar aircraft at each annual inspection. This particular machine was first Permitted 20

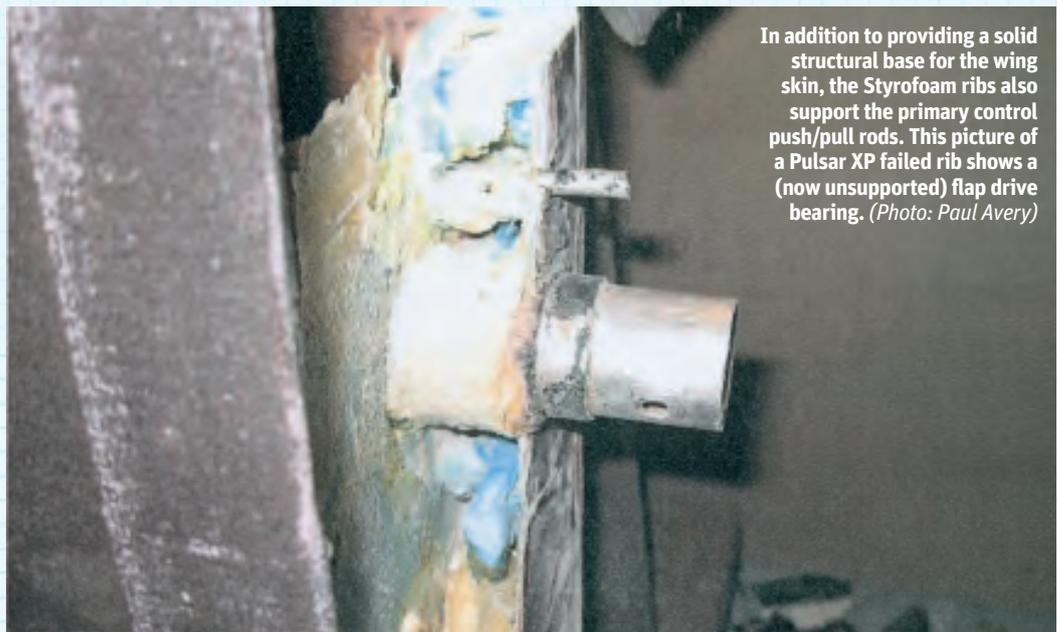
In addition to providing a solid structural base for the wing skin, the Styrofoam ribs also support the primary control push/pull rods. This picture of a Pulsar XP failed rib shows a (now unsupported) flap drive bearing. (Photo: Paul Avery)

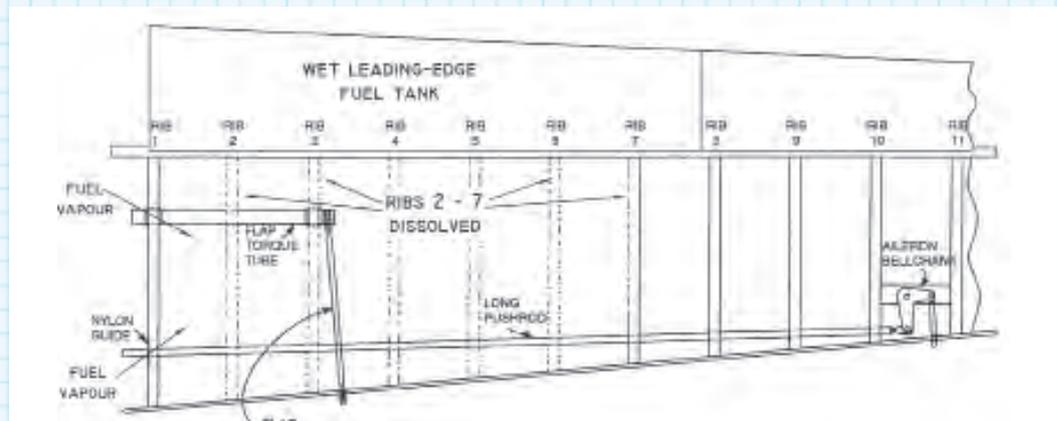
This drawing shows the wing plan form of the Pulsar XP (starboard wing, looking from above). Damaged ribs have been found on ribs 1 through 7 (Drawing: Malcolm McBride)

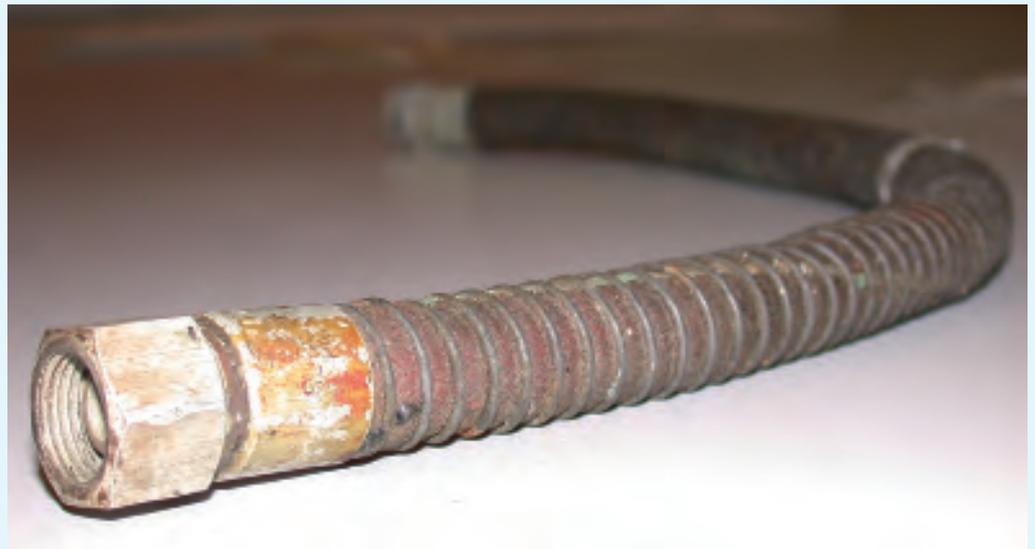
Here is a picture of a Superflexit fuel hose that has been removed from a DH 82A Tiger Moth. There's a good chance that this fuel hose has been performing well for sixty or seventy years but nature demands that these natural rubber components will have a life. Rubber tends to harden with age and you will notice that a flexible item retains its 'fitted' shape when removed. The reduction in flexibility in a fuel pipe can lead to cracking, which may not be visible from the outside of the pipe; this, incidentally, could result in a sudden failure at any time. I always thought that the wire wound around this sort of pipe was to increase the pipe's pressure tolerance and resistance to kinking, and was surprised to hear that the wire is there to provide an electrical conductor.

The hoses that DHSL suggests are suspect are Superflexit, Avioflexus and Pertroflexus types and, while they may look OK from the outside, internal deterioration and loss of flexibility is almost inevitable. DHSL recommends that all these older types of pipe should be replaced with modern equivalents and recommends that fuel hoses should be replaced with new items every 15 years.

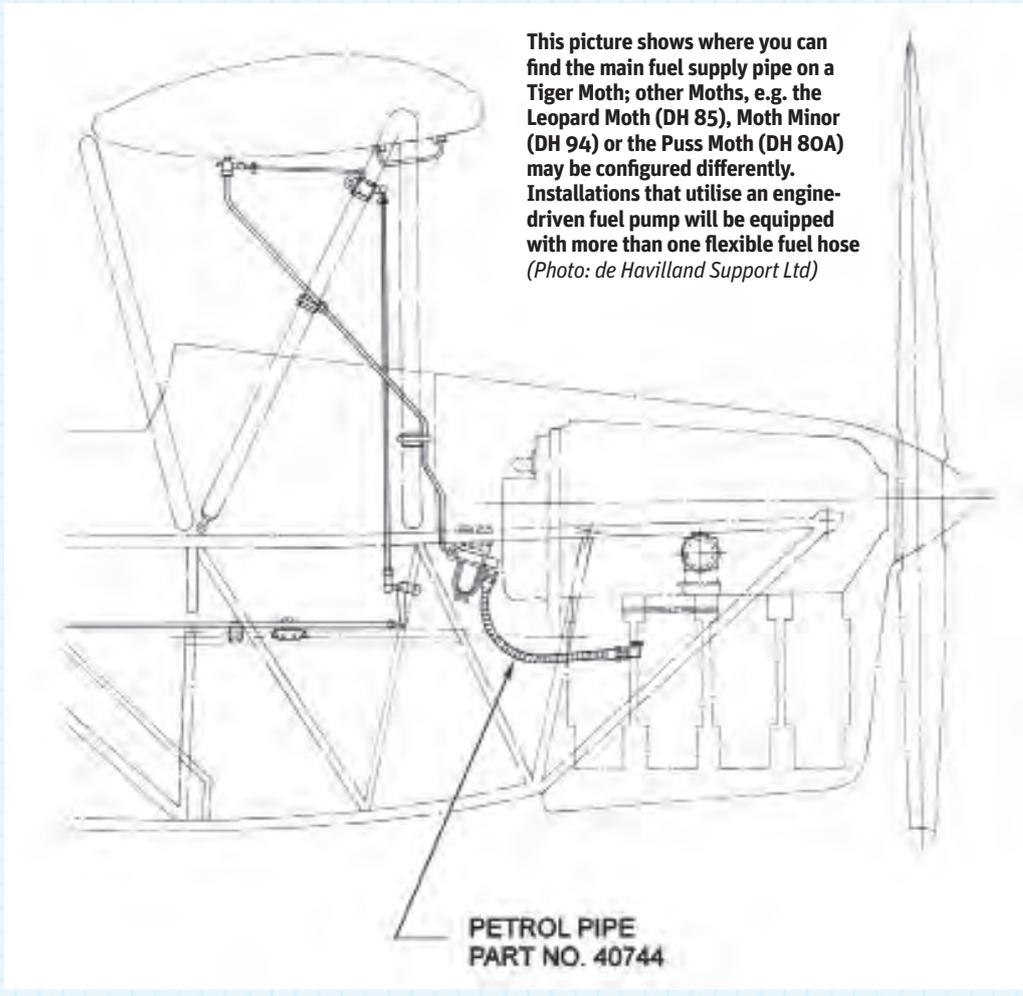
This picture shows where you can find the main fuel supply pipe on a Tiger Moth; other Moths, e.g. the Leopard Moth (DH 85), Moth Minor (DH 94) or the Puss Moth (DH 80A) may be configured differently. Installations that utilise an engine-driven fuel pump will be equipped with more than one flexible fuel hose (Photo: de Havilland Support Ltd)

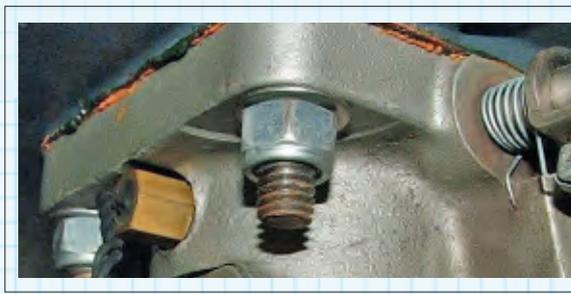
Here's a close-up of a carburettor flange from a picture I featured in December's *Light Aviation*. LAA Inspector Robin Dispain wrote to me pointing out that gasket sealant had been used during the assembly and that this shouldn't have been necessary. Robin made a good point, which I promised to share. If there's excess sealant on the outside then there's a good chance that there will be excess on the inside. Food for thought! (Photo: Barry Smith)
