THROTTLE SPRING SAGA

More views and experiences with throttles that spring to full on... or off. Which do you recommend? A Kingsland provides a 12-year detective mystery

ENGINE MOUNTING-BOLT FAILURE ON AUSTER KINGSLAND

RUDDER-CONTROL FAILURE ON JABIRU SPL

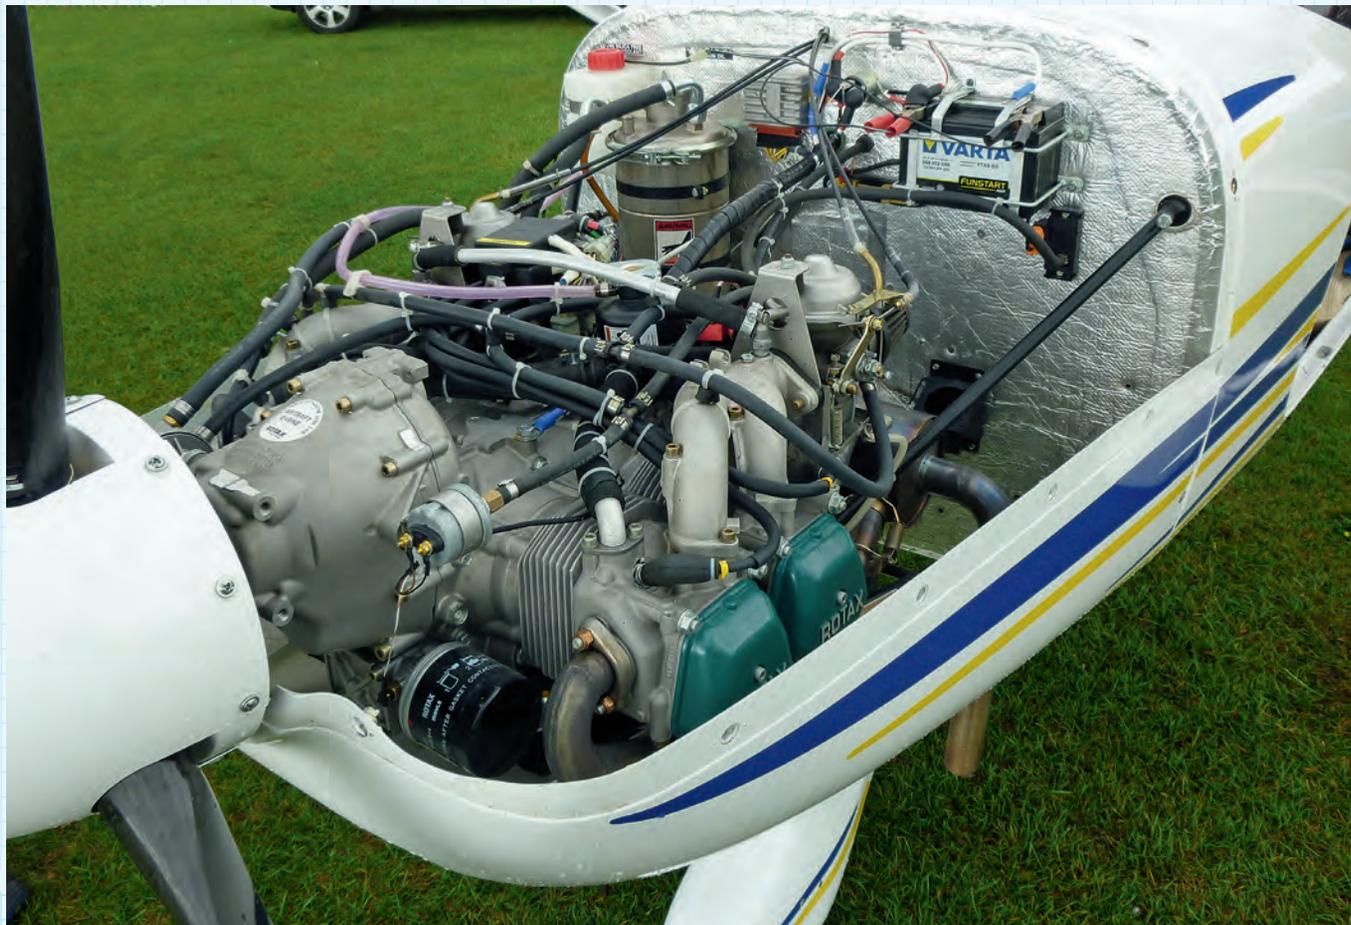
A typical Rotax 912 installation. The twin carburetors have a spring bias to default to fully-open should the throttle cable break. The problem is the springs can cause the throttle to open unintentionally (Photo: Brian Hope)

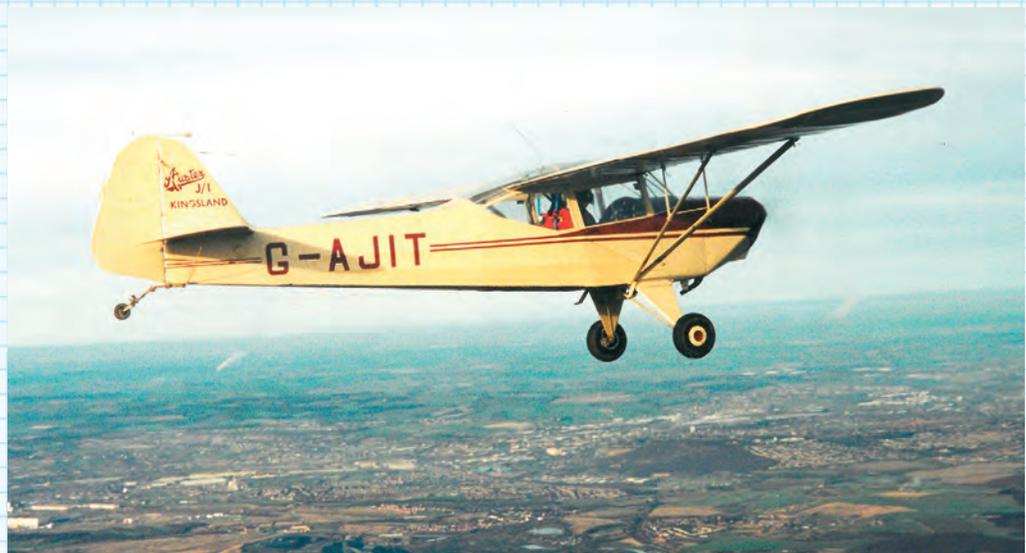
Here is a photo of G-AJIT flying over Sheffield some 12 years ago, I hope that you agree with me that this is a fine-looking aircraft. Actually, Andy tells me that this was a memorable flight as he was a passenger. His newly-qualified 17-year-old daughter, Kirsty, was at the controls! This photo, for the anoraks out there, was taken from Mike Watts' Chipmunk, both aircraft having taken off from Netherthorpe. G-AJIT is now back in the air after the engine mount bolt failure and, by all accounts, flying well (Photo: Andy Kay)

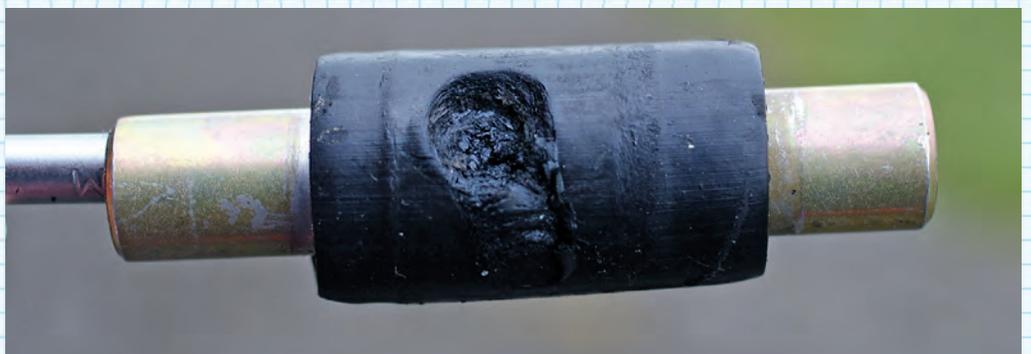
Here is a picture of the likely cause of the bolt failure; note that the stud is protruding through the encasement into the rubber. The effect of this would have been to seriously reduce the damping effect of the rubber mount which may have led to the early failure of the bolt due to fatigue (Photo: Suzie Quinn)

by the Sheffield metallurgist, Richard Green, himself and Suzie. You can see from the selection I have included what looks to have happened. At some time in the past an electrical earth has been attached to the engine mount lug; you can see that the attaching stud has been screwed right into the area normally occupied by the rubber engine mount jamming it fairly solidly. I think that this has effectively stopped this engine mount from working correctly and this, in turn, has lead to a fatigue failure of the left-hand lower bolt. Once this bolt had failed, the load into the remaining three fixings would have been increased. What happened next is, naturally, an educated guess, but I think that the right-hand lower bolt was probably a little loose and could have been rotating under some loading conditions.

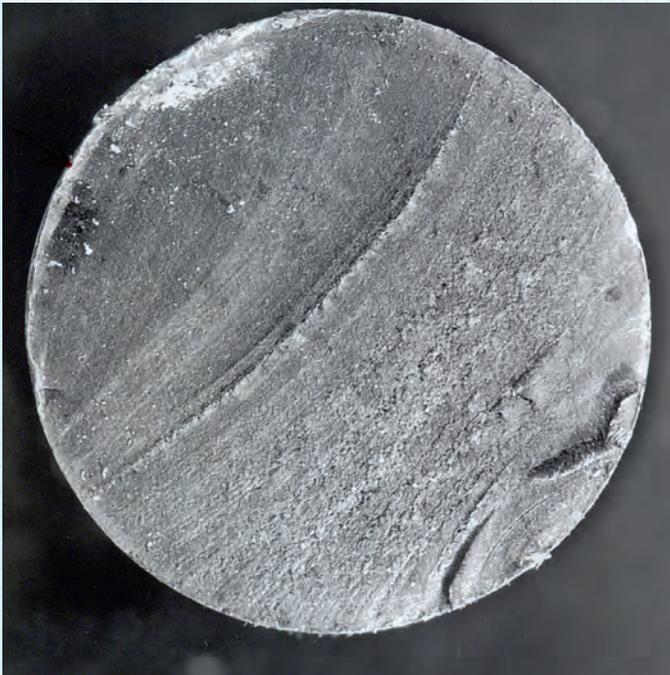
This is a classic picture of a sequential fatigue failure in bending. This is the fracture face of the lower left-hand engine mount bolt that remained with the aircraft after its failure. It is likely that this bolt initially failed at a point around the 5 o'clock position. Note the distance between the beach marks increases as they are created from lower right to upper left in this shot, this is due to the steadily increasing point loading as the bolt failed. The final failure zone (about 11 o'clock) covers about 20% of the surface and would have occurred quite rapidly (Photo: Richard Greene)

Take a look at the fracture face picture; this shows that the bolt has been overloaded in bending at different points in the circumference of the bolt. Hence the view that the applied load or the bolt could have been rotating; loads through rubber can exhibit strange effects, but I think that it's more likely that the rotation came through the bolt occasionally changing its radial orientation.

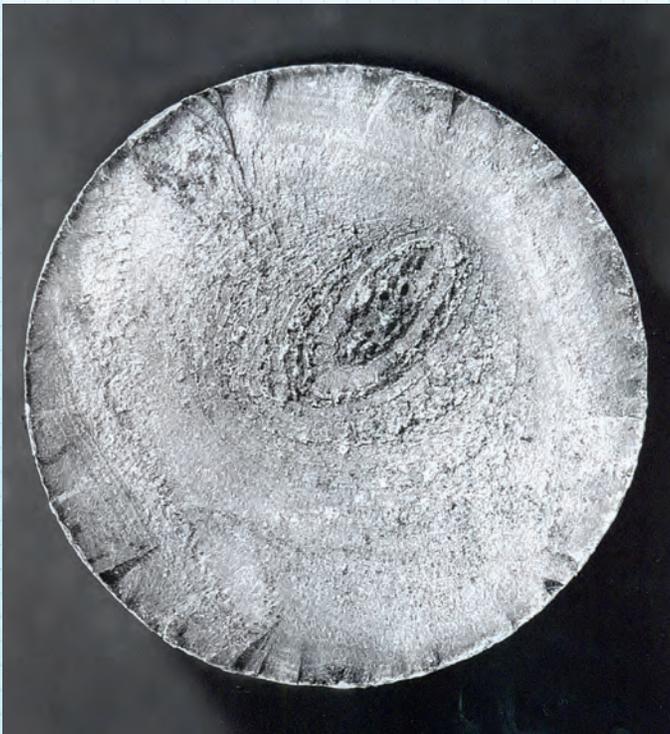
I have to say that I absolutely love this photograph of the fracture face of the lower right hand engine mount bolt. It is impossible to say exactly what's going on here but the picture shouts out 'I'm turning' quite loudly. I think that this is a bending failure due to fatigue. I can see six general 'fronts' where the applied load appears to have been pure bending until, that is, the failure reaches about half the radius, and then the load begins rotating. If you have any thoughts about this please feel free to let me hear them, I'm all ears when it comes to fractography (Photo: Richard Greene)

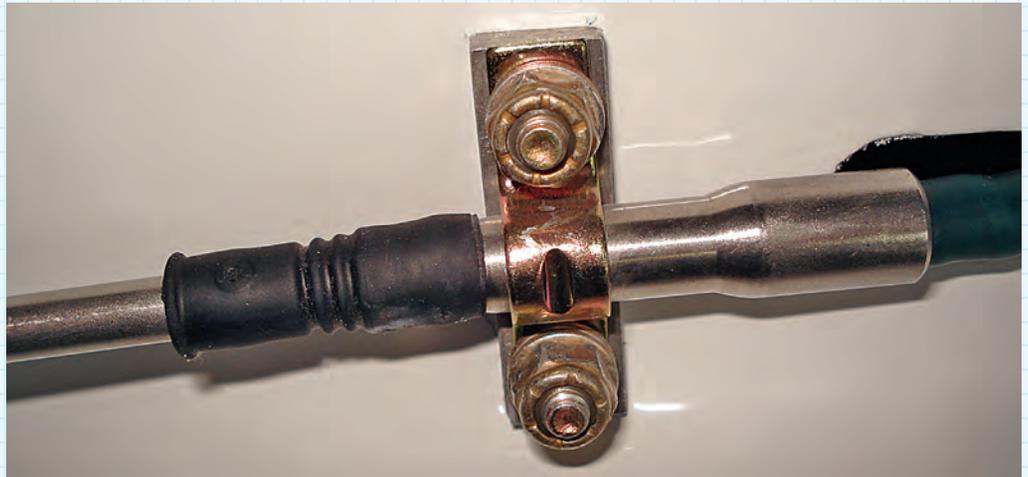
It is notoriously difficult to make a mechanical connection between a fastener and a composite structure. Roger explained that the front rudder cable connection is riveted because of reduced access in the Jabiru airframe; I questioned the sense in this as I know that compressive forces caused as a blind rivet is formed can cause local material failure and delamination. Roger sent me this picture of TLR rivet which is designed to increase the surface area of the rivet in the rear surface; you can see from this picture that this increase in clamping surface area claimed is actually an illusion. Certainly the rivet is unlikely to pull-through as there is a lot of material folded but, because of the small clamping surface area, it is very likely to come loose if oscillatory loads are applied. (Photo: Roger Lewis)

Roger explained that the forward control attachment is attached using special 'TLR' rivets which are specially designed to fix to fibreglass. I hadn't heard of these and Roger kindly sent me a picture showing how they work. I hope that you can see, by studying the picture that the bearing surface at the blind side is pretty small even though the actual arms are long. I'm not convinced that these rivets would be any better at holding something solid than a normal Cherry Lock. Anyway, Roger's point that anchor points can loosen through 'fair wear and tear' is a really good one; it's well known that it's difficult to connect anything to fibreglass, that's why we carry out regular inspections after all.

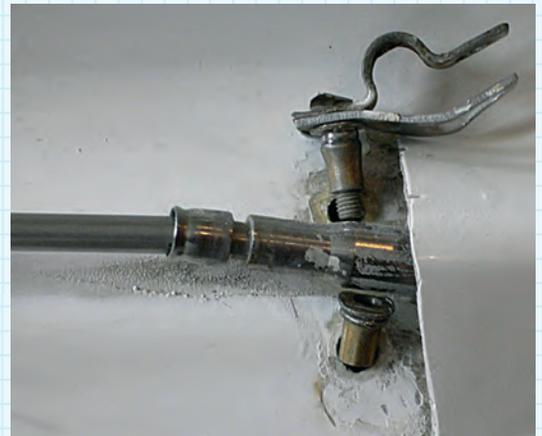
The picture above has featured in 'Safety Spot' before and, before you go completely mad looking for the problem (well, this is 'Safety Spot'!) let me explain that there isn't anything wrong with the Teleflex clamp shown in this picture. Note that the clamp is bolted through the fibreglass structure firmly and that the indent in the outer clamp is fitting snugly in the recess in the cable's outer sleeve. This is the rear attachment of the rudder operating Teleflex (push-pull) cable. Fittings in fibreglass need continual inspection because the slightest looseness will cause a premature catastrophic failure. Previously, we have had problems caused when the indent wasn't properly located in the outer sleeves recess and, with a Teleflex cable, if the clamp fails in any way then its operation is lost.

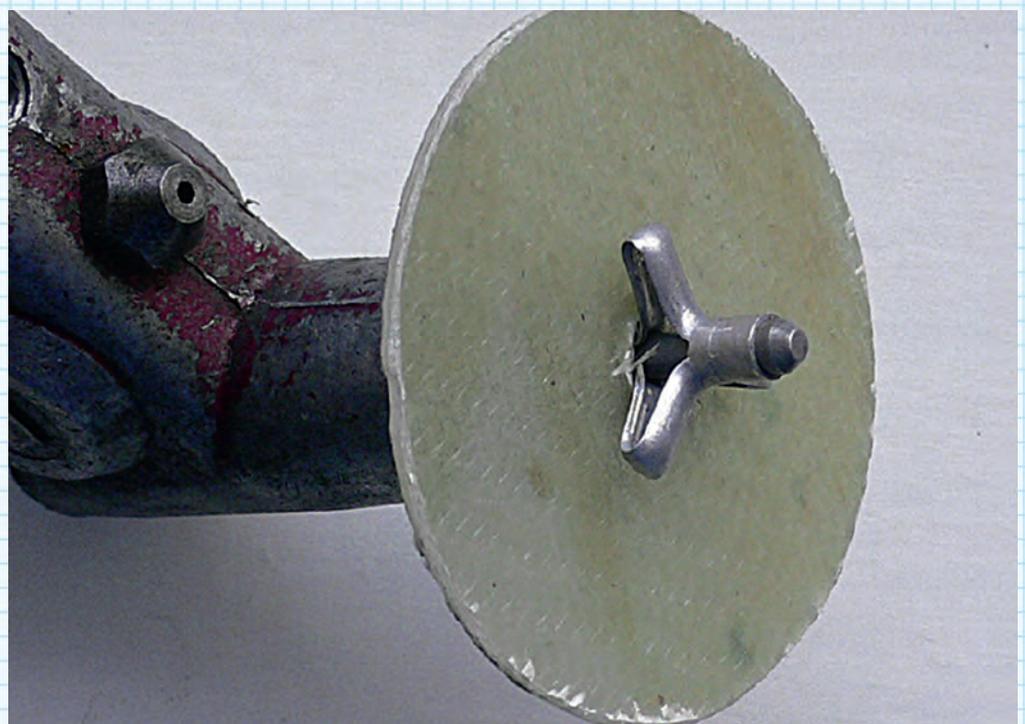
Pictured above is a rudder cable clamp failure as found by LAA Inspector Roger Lewis. The use of Rivnuts in this sort of application is a definite no-no and should really have been spotted during previous inspections. Roger applied a small load to the clamp and felt a little movement... so he applied a fraction more... (Photo: Roger Lewis)

I have enclosed a picture for your information. The builder used a threaded fastener that was 'push fitted' from the outside and held with resin flock. Over a period of time, the fasteners have worked themselves loose resulting in the play that could be seen during inspection. The significance of the play, which was minimised by a filler, became apparent once the area was cleaned off and the anchor point removed.

You can see that this attachment has been held on using Rivnuts, which are essentially a tubular, counter-bored and threaded-alloy rivet. They're great for attaching tertiary items where access, especially from behind, is difficult, but they're certainly not designed to hold primary structures or controls together and are not featured in the Jabiru Build Manual, so this was an unauthorised change.

- 1 Any play between any flying control cable and the anchor point is unacceptable and must be investigated. There is no redundancy so inspections should be frequent and thorough.*
- 2 Owners should be aware that anchor points can loosen through fair wear and tear. What is secure one day may not be secure the next.*
- 3 Failure of an anchor point will invariably lead to loss of control.*
