COCKPIT DECISION-MAKING v REHEARSAL

Malcolm looks at engineering failures which required fast decision-making in the cockpit

LOSS OF CONTROL ON START-UP IN PIONEER 300

GLASAIR SUPER IIS RG: THROTTLE LINKAGE FAILURE

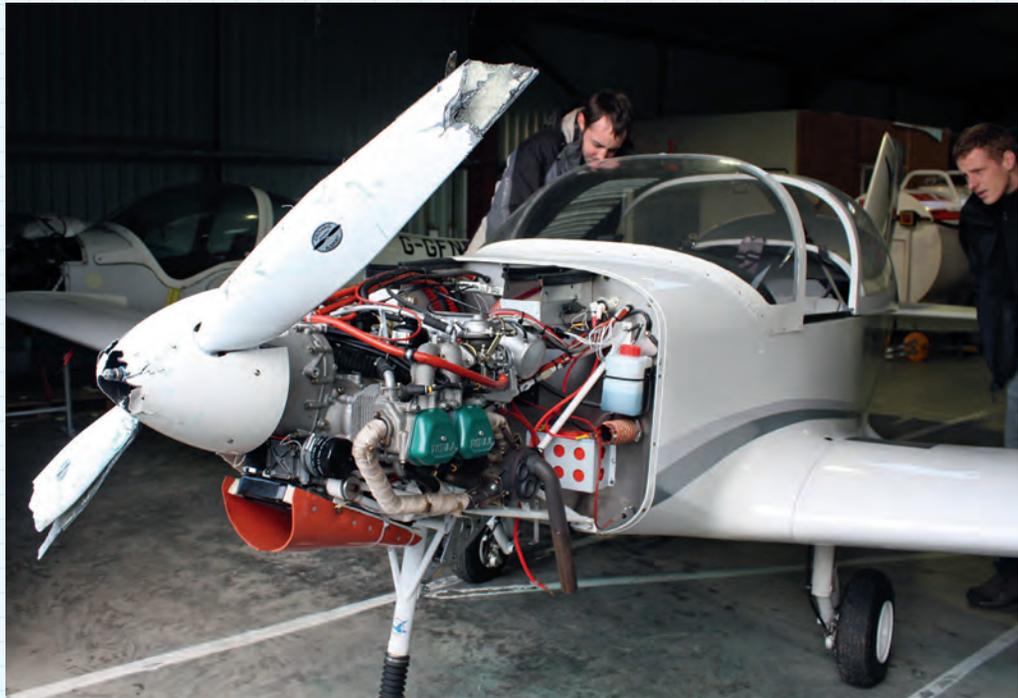
This is a picture of the Pioneer 300 after it had been pulled clear of the shipping container, the damage to the spinner and propeller is obvious as was the damage, after cowling removal, to the engine bearers. After an impact like this it is essential that every part of an airframe is checked as damage can occur a long way from the actual impact point. (Photo: Toby Wilcox)

The throttle was closed, i.e. pulled fully toward me, I thought. I turned the key, the engine immediately burst into full power. The aircraft rushed forward, onto the apron, across the taxiway and into a steel

container, even with the brake on. The brake is set on this aircraft with a small lever on the middle consul. It seems that I had not tightened the lock enough on the throttle. The damage to the aircraft was extensive.

I think that the primary reason for this expensive incident is that the pilot failed to go through the pre-start drill from the beginning on his second attempt at starting the engine. This is a common human error in this type of incident and, perhaps, the primary lesson to be learnt here is that if, for any reason, you interrupt an operation before completion, it's essential that you restart an operation from a fixed reference point... normally the beginning!

The lesson for me is to never start an engine unless the aircraft is facing a very clear area. Ironically, I was intending to fit toe-brakes, which may have given me a little more time.

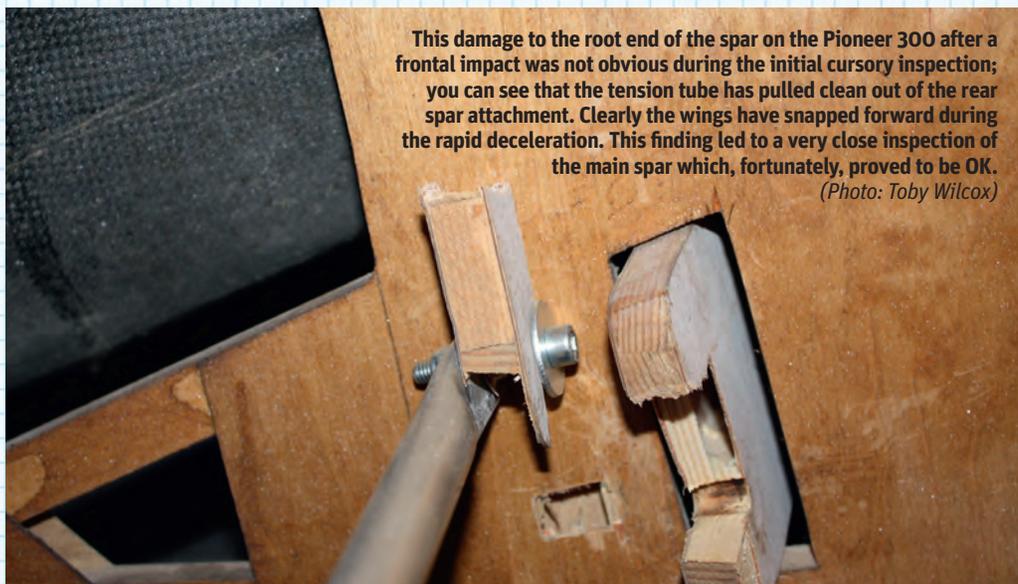
This damage to the root end of the spar on the Pioneer 300 after a frontal impact was not obvious during the initial cursory inspection; you can see that the tension tube has pulled clean out of the rear spar attachment. Clearly the wings have snapped forward during the rapid deceleration. This finding led to a very close inspection of the main spar which, fortunately, proved to be OK. (Photo: Toby Wilcox)

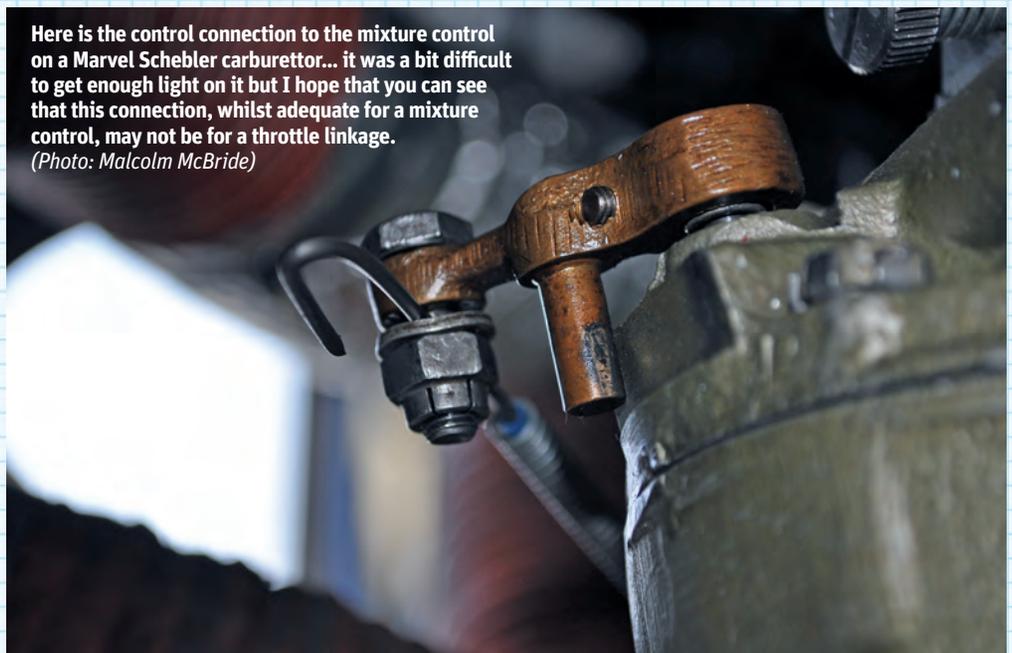
Here is the control connection to the mixture control on a Marvel Schebler carburettor... it was a bit difficult to get enough light on it but I hope that you can see that this connection, whilst adequate for a mixture control, may not be for a throttle linkage.

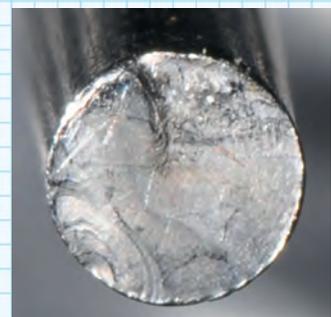
When I first heard about the cable failure on Nigel Smith's diesel-powered Murphy Rebel Elite, I felt sure that the cable had pulled out of the fitting. This proved not to be the case when Nigel found the broken end. Piano wire is manufactured from tempered high carbon steel (sometimes referred to as 'spring steel') with an ultimate tensile strength of at least 300,000psi. Nigel's throttle cable was made from 14swg wire which means that it shouldn't fail before a load of about 900lb is applied to it... not likely, even during a jam case. You can see, from this photo, the mode of failure: the notch (at about seven o'clock) has led to a stress concentration and this cable has probably failed because of fatigue in bending. How this could have occurred is a bit of a mystery. The picture right shows the point of failure. (Photo: Malcolm McBride)

In cruise at about 1,500ft the power cable broke at the point where it exits the wire grip (as shown by the pointer in the picture). The short length inside the wire grip was removed later during examination – the cable had not simply pulled out of the wire grip.

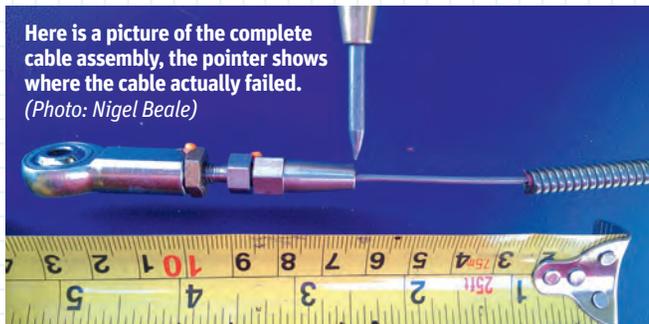
Here is a picture of the complete cable assembly, the pointer shows where the cable actually failed. (Photo: Nigel Beale)

I would recommend that anyone using single core cables of this type ensure that a spring is fitted to

the control arms on the engine to ensure the power and fuel shut off arms will travel to full open under spring action in the event of a cable brake.

I am also changing the power cable in mine to a Cessna type threaded end multi core cable.

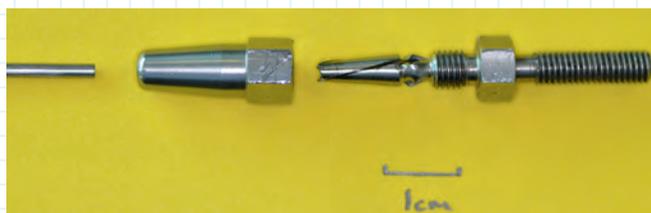
Here is a picture of the Wire Grip type end fitting used on the piano wire throttle cable from the Wilksch WAM engine that failed during a test flight on Nigel Smith's Murphy Rebel Elite, putting the aircraft into a field. I've not seen this type of connector before. You can see that the piano wire (left in the picture) is pushed through the barrel into the tapered clamp. I was very impressed with the clamping force applied to the piano wire even when only hand tight although, whilst this sort of fitting might be OK for a heater control I personally don't think that it should be used on a primary control. Nigel, incidentally, had already made that decision before chatting to me and he has now replaced the throttle cable with a Teleflex cable. One good thing about this type of fitting is that a standard ball end can be used which, in my view, has to be better than crushing the cable between a nut and bolt, an often-seen tertiary control system practice. (Photo: Malcolm McBride)

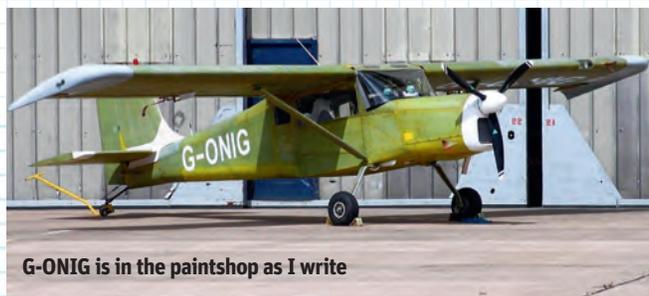
G-ONIG is in the paintshop as I write
