TAILORED MAINTENANCE SCHEDULES

ALTERNATOR FAILURE IN NSI EA-81 ENGINE

SAFETY SPOT

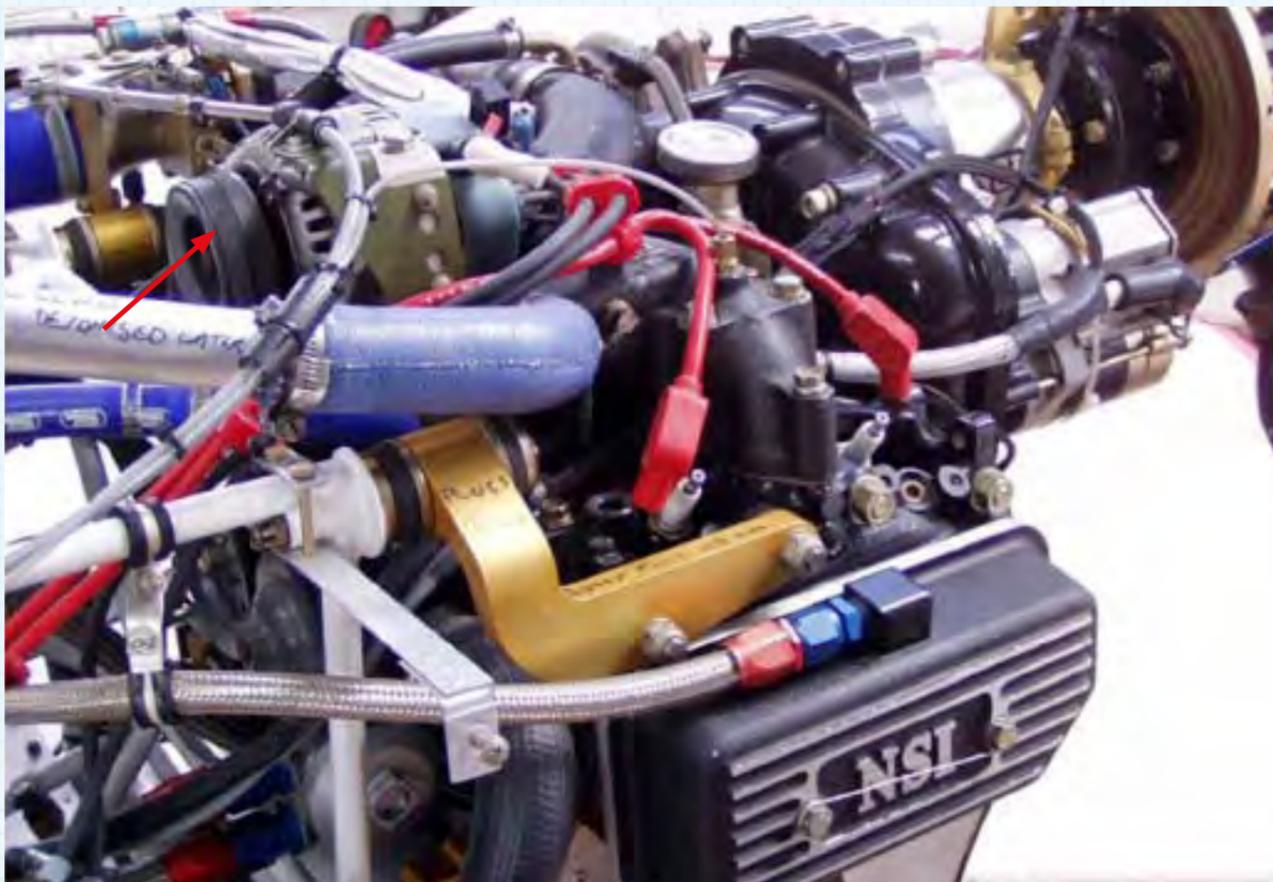
The NSI aircraft engine is based upon the EA-81 Subaru car engine. This liquid-cooled, horizontally-opposed, four-cylinder injected engine is fitted with a purpose built geared reduction drive system that has proven to be problematic. This example is fitted to LAA Inspector David Hunter's Cvjetkovic CA-65 which, incidentally, was started in 1974 and may win a prize for the LAA's longest build. Note the alternator mounted at the top of the engine (see arrow) which is belt driven. David has collected most of the UK's NSI spares and is a fount of knowledge about the type.
(Photo: Malcolm McBride)

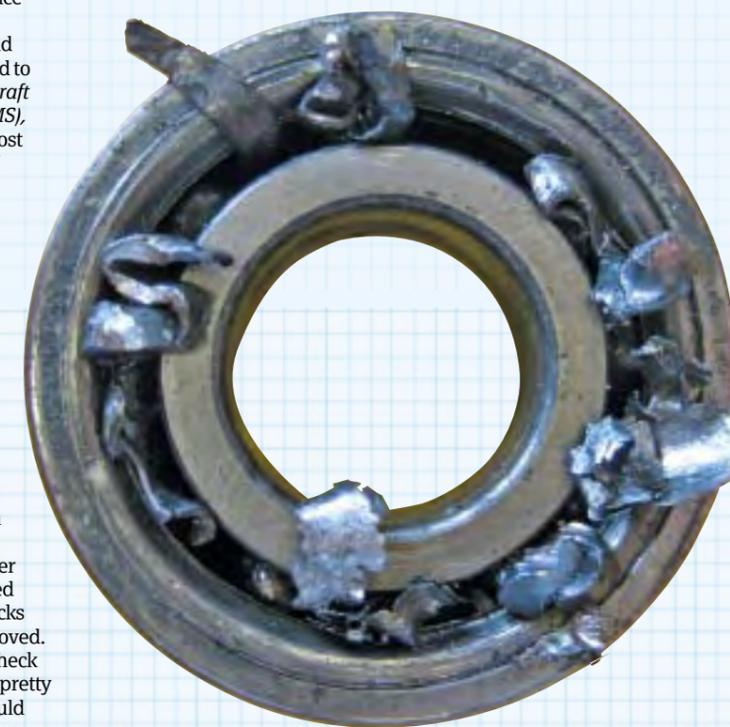
You can see that this alternator bearing is way past its sell-by date. The AAIB investigators felt that the bearing failed due to lack of lubrication; it looks like the first component to fail was the bearing's cage, which rapidly led to a complete seizure. Interestingly, the seizure of the alternator was enough to drag the engine to a complete stop. Naturally enough, the heat generated by the frictional forces between the belt and the pulley created a fair amount of smoke which exacerbated the problems in the cockpit. Because the NSI reduction system employs an unusual sprag type drive gear in the reduction drive, the propeller can freewheel after the engine stops. It was noted that a freewheeling propeller creates far more form drag than a static (or slowly rotating) one which can lead to alarmingly high descent rates.
(Photo: Malcolm McBride)

An old saying, on this occasion without the magic ring of truth is, 'There's no smoke without fire'. A subsequent inspection of the engine revealed that the cause of the engine failure was that the main bearing in the alternator had failed catastrophically and, as a consequence, had seized. The smoke had come from the alternator drive belts (which hadn't broken), the resulting friction dragging the engine to a standstill. I don't blame Gary one bit for his decision to get the nose down and get on the ground quickly; smoke in the cockpit would have a similar effect upon me. But with hindsight, the outcome may have been better if a more measured approach had been taken.

As previously stated, the alternator fitted to the NSI Subaru engine is now required to be checked each 50 hours, but when did you last check the bearings in your alternator? Does it even figure in your maintenance schedule? If it doesn't, perhaps it should.

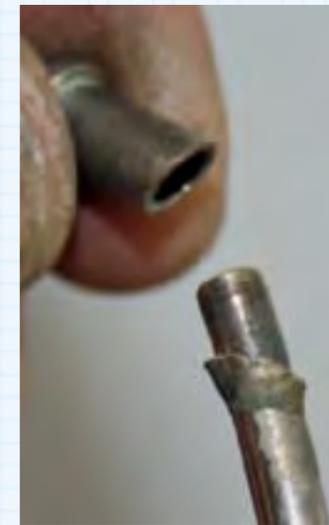
This failed IO-360 fuel injector pipe was found on a Lycoming engine... it was a Superior IO-360. Lycoming's *Mandatory SB 342F* describes checks for staining, dents, pits or nicks on these injector pipes each 100 hours. This failure was found by accident on a 300-hour powerplant. When designing a maintenance schedule on LAA types, which may include uncertified/unregulated components, it is necessary to think outside the box when deciding what (and when) things need checking. Factory advice may be very limited, but lessons from the past shouldn't be ignored just because of lack of a legal applicability chain. (Photo: Roy Sears)

I enjoyed my conversation with Mark, a seasoned builder who has previously built a Taylor Monoplane and a Pietenpol Air Camper, the latter having (rather coincidentally) the first Subaru engine fit. Mark, who had completed his RV-7 from a quick-build kit in 2007, explained that the end fitting had failed at 170 hours, some five years after original fit.

The Lycoming SB that covers checks on these fuel injector pipes came about because there had been instances of support clamps being omitted after service or repair; when you think about it an injector pipe on an engine is an injector pipe on an engine... it shouldn't matter really who built it, previous service experience still applies if. The biggest problem can be laying your hands on the information.

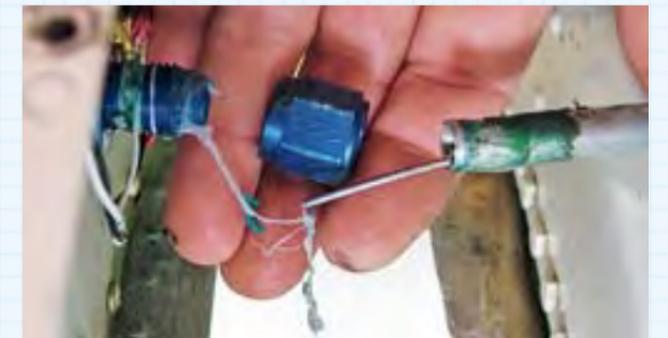
LAA inspector Tony Troughton sent me these two pictures showing what he discovered while searching for the source of a cockpit fuel smell. For some reason (not discovered), the fitting was made without a flare and was able to be pulled out without much trouble, hence the leak! The smaller picture shows a correctly made connection (which includes the flare at the end of the pipe). As a aside, I hope that you can see the blue staining on the pipe in the picture on the left. This is a dye added to aviation fuel. I couldn't remember whether this dye was added to the fuel so that leaks could be more easily seen or for fuel identification purposes. Both Ken Craigie and Barry Plumb put me right on the matter – it's the latter. Thanks to Barry for the acres of literature he's just sent me on the subject! (Photo: Tony Troughton)

worked and had failed to flare the end of the pipe during the assembly. He or she had pushed the end of the pipe into the fitting and secured it with plumber's tape and it was glued in place with a fairly liberal dose of bathroom sealant. Mmm, not quite the method described in AC 43 or CAIPS.

This particular RV-7A had done over 300 hours since its original build back in 2006 and the leak hadn't been spotted during the previous four annual inspections, which is rather worrying. Tony

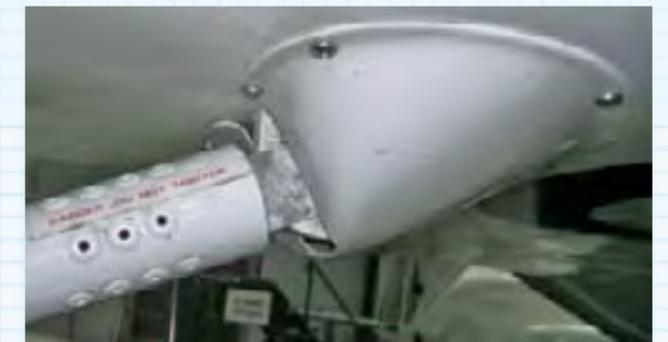
Trevor Villa, BMAA Inspector and LAA member, sent me this picture of a lift strut/wing connection on a Jabiru UL he was asked to inspect. You can see clearly that the corrosion has become established in this fitting and may be beyond recovery. (Photo: Trevor Villa)

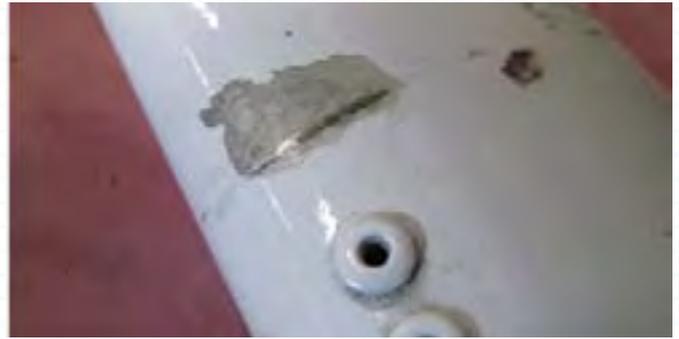
Here's a picture of some light corrosion on a Jabiru strut after the paint had been removed. The owner noticed that the paint was chipping away from the surface and decided to investigate why. This sort of surface corrosion must be removed quickly and the surface re-protected. This strut is a highly-stressed structural member on this aircraft type and will be subject to stress corrosion cracking. It is well known that cracks can start at corrosion pits in the surface of a material and can lead to structure failure. (Photo: Winston Lee)

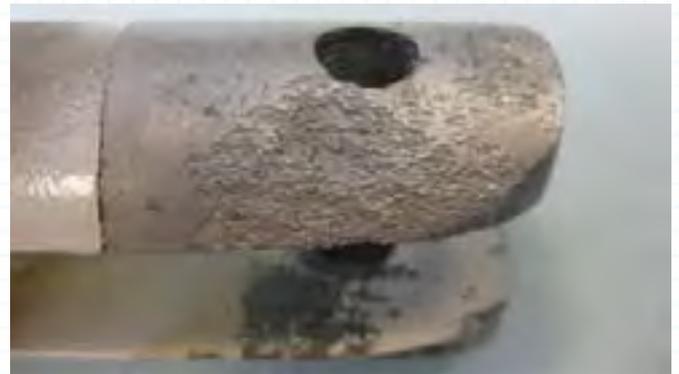
This is the strut end fitting brought into the office by LAA inspector Gary Cotterell. You can, I hope, see that this end fitting is a write off. Corrosion like this is essentially an electrical process and electrons tend to discover a line of least resistance – this is why only one area of the strut is badly affected. Note that the corrosion products have actually been removed by bead blasting, which clearly shows how much material has been lost. The corrosion here is unacceptable not just because material, and therefore strength, has been lost but in some ways more importantly, each portion of corrosion can act as a stress raiser and may lead to local cracking and component failure. (Photo: Malcolm McBride)

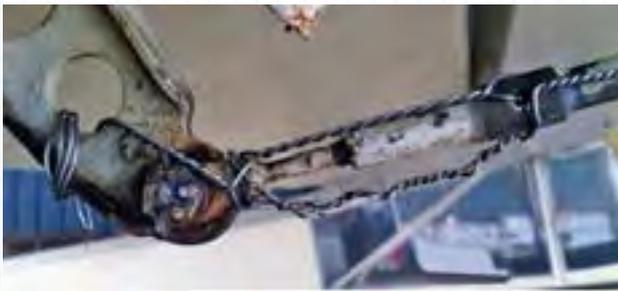
Here's a picture of an aileron turnbuckle sent to us by an LAA Inspector recently; he was worried that maintenance standards were slipping. I suppose, after a fashion, the wire-locking would work but I think that I would be hard pressed to score it for 'artistic merit'! Personally, I'm a bit more concerned about the other errors in this primary control cable attachment. Without pressing the corrosion point too hard, and let's not even think about the blobs of weld, this turnbuckle is not in safety as threads are showing. Perhaps that's the reason for the extra wraps of lock wire... just in case the screw pulls out of the barrel! (Photo: LAA Library)
