SAFETY SPOT

HIDDEN DEPTHS

SOME PROBLEMS ARE BURIED DEEPER THAN OTHERS, IT'S IMPORTANT TO CONSIDER THIS IN YOUR TAILORED MAINTENANCE SCHEDULE

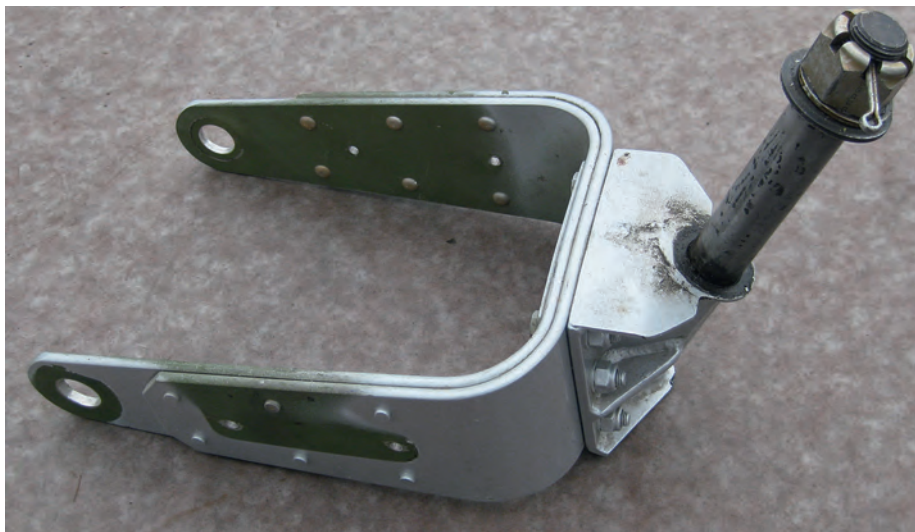
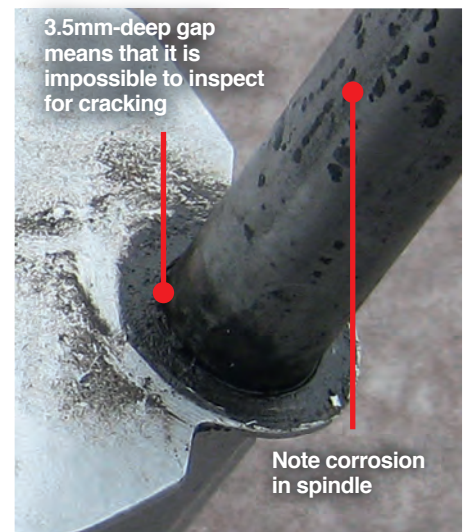
Here's a picture of the CZAW SportCruiser nosewheel fork assembly that's causing us, and some owners, sleepless nights. The real problem with this design, and the reason why the LAA has decided to withdraw the component from service, is that it's impossible to check for cracks. (Photo: Malcolm McBride)

It became quite clear as the worksheets started to arrive that there was a fleet-wide problem with corrosion within this component and the spindles on some of our members' aircraft were in such poor shape that the LAA Inspectors involved were forced to ground the aircraft until replacement parts could be sourced. I should mention here that we've got 74 SportCruiser aircraft on our books, of which 46 are fitted with this type of spindle assembly. Another problem that soon became apparent was that it was impossible to check the spindle itself around the area of maximum bending moment because the spindle is hidden within the attachment at this point. In effect, the most important part of this assembly cannot be inspected effectively.

Because LAA Engineering has got serious concerns about the suitability of the CZAW design of nosewheel spindle it has taken the decision to withdraw this item, as soon as is practical, from service.

no longer exists, various member replacement options have been discussed. Our primary requirement, apart from the obvious strength and durability needs, is that this spindle must be 'inspectable' and, if subsequently found to be corroded or cracked, easily replaced. At the time of writing, two home-grown design options have been submitted to our Design Department for their consideration and, hopefully, approval once flight tests are complete, but right now, the only approved replacement is the very expensive CSA PiperSport nose-leg assembly.

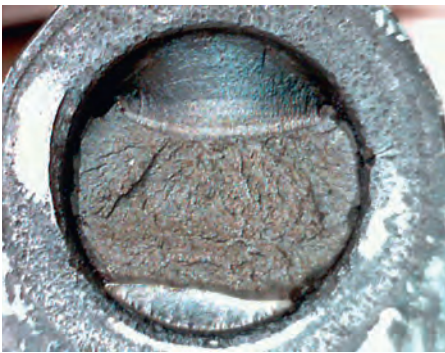
The photo above you've seen before, it's the fracture face from Neil McAllister's SportCruiser after the initial 'Skegness' failure. This rather simple fracture face is actually deceptively complex and, what initially looked to be a straightforward fatigue failure has all the hallmarks of stress corrosion cracking, almost impossible to predict. The picture below is the photo of a spindle failure in the US and you don't have to have studied Metallurgy to see the similarities. What really worries us at HQ is that should this Spindle fail at high speed the rest of the undercarriage could be driven into the cockpit area with terrifying results. (Photos: Malcolm McBride)

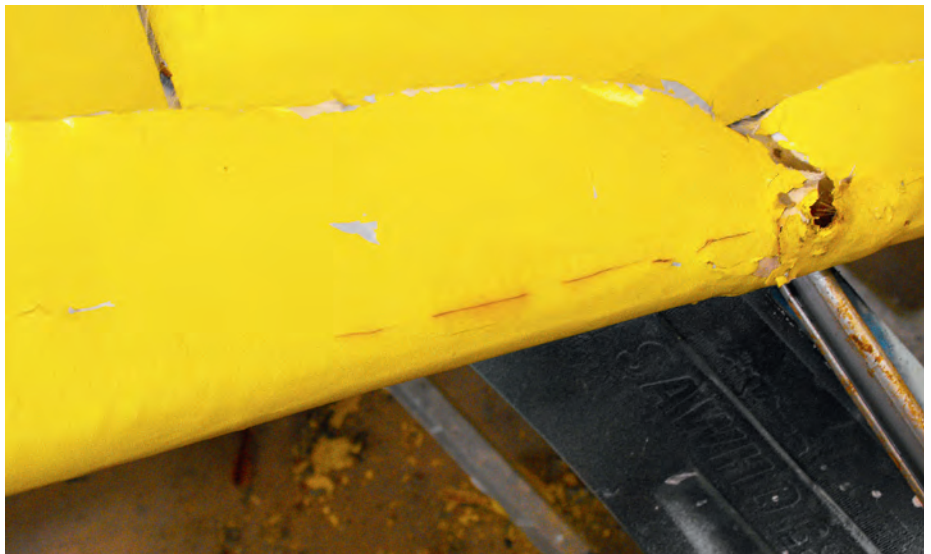
Above is Mike's photo of the rust 'staining' on the outside of the fabric; you're looking at the elevator's leading edge. Just because the paint looks good...! (Photo: Mike King)

our borescope. It was clear in inspection that the staining was oxidation seeping through cracks in the paintwork on the stabiliser.

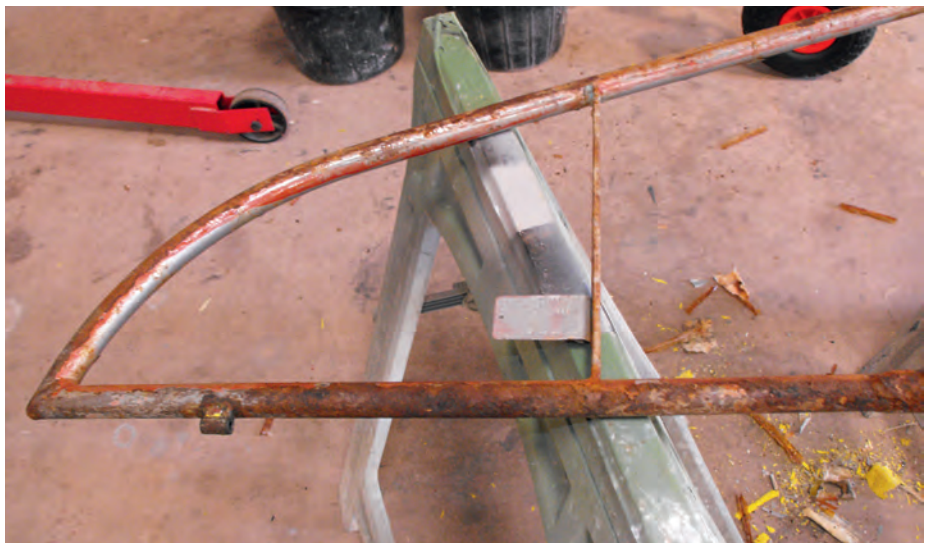
When Mike removed the fabric for a closer look he discovered some serious surface corrosion starting to form around the hinge; luckily for the owner, it cleaned off easily and Mike considered the component serviceable after re-protection. (Photo: Mike King)

Naturally I removed all the fabric from this flying surface and you can see from the attached picture that most of the tube work is in pretty good condition, the area under the staining is in a poor state but, fortunately, appears only to be surface corrosion and is cleaning off fairly easily.

As far as why this area was so badly affected I am fairly certain it all came down to preparation from the previous restorer. The steel was painted using Cellulose, which offers only little protection from moisture, the frames were then covered (quite nicely) and painted in a 2K Acrylic finish. The Acrylic was put on quite thickly and with no plasticiser. I think that this finish started cracking not long after recovering and the airframe soon became no longer watertight. The water simply tracked through these cracks and the Acrylic paint held the water in against the frames, oxidation did the rest!
Regards Robin.

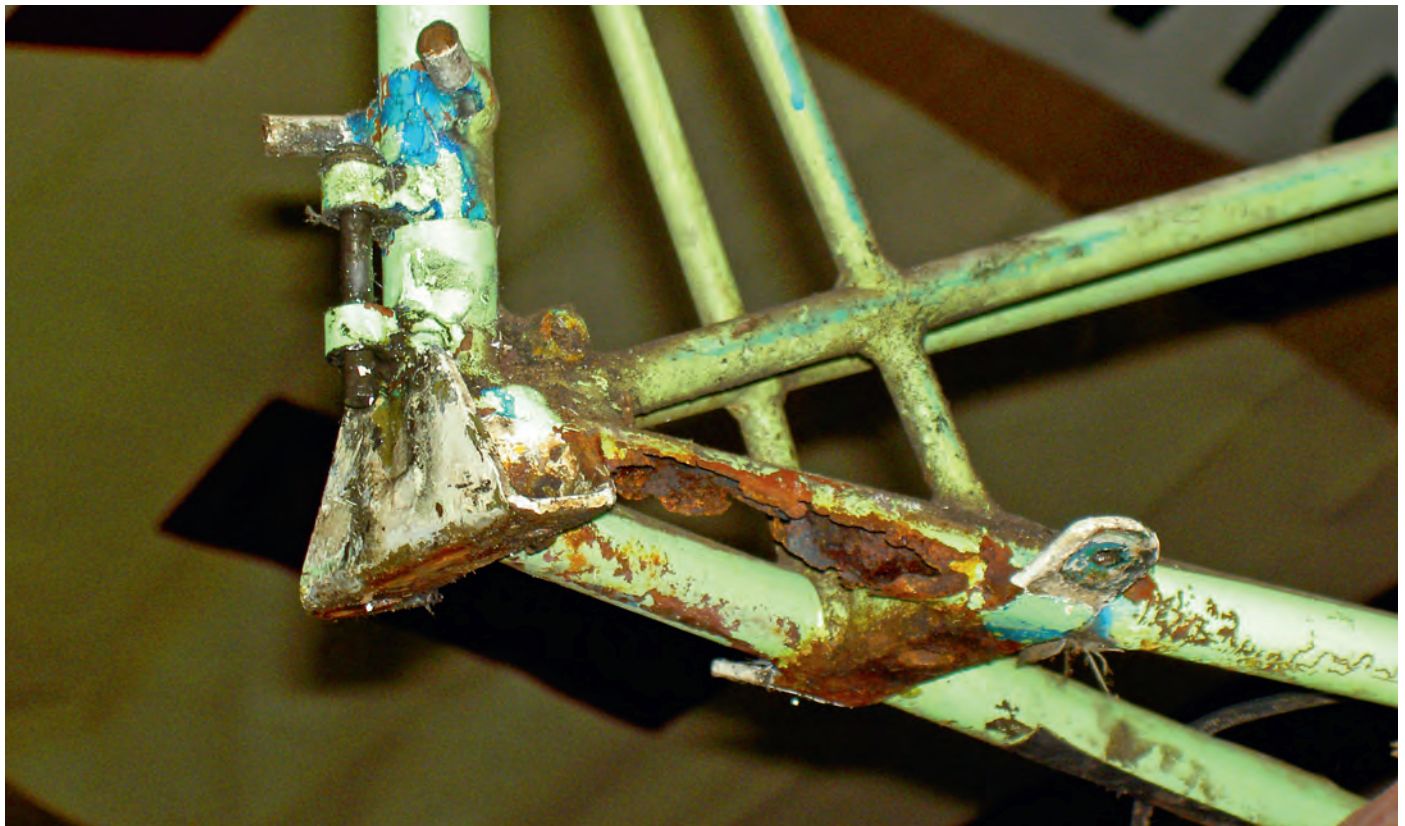
Thanks to re-build specialist, Miles McCullum, for sending this picture of the Vagabond back end. Miles said, "This Vagabond exhibited classic Piper rot. However, what was not apparent until the fuselage frame was blasted and inspected inch by inch was that the entire longeron up to the strut mount was rotten, as evidenced by a pinhole in the tube about every 18in.

"I would think that in such cases, further investigation is necessary – perhaps drill holes to verify tube thickness/condition (which can simply be welded shut) – also the area around the strut fixing is quite susceptible to similar rot if the frame hasn't been protected with corrosion proofing. I believe there is a requirement for external pitting to be not more than 5% of tube wall thickness, presumably if it affects more than a certain percentage of area.

"I take quite a conservative view here, and for instance find that Auster rear window lower tubes and the rear floor cross tubes and corner plates are often badly corroded – I'm sure that there is a certain amount of 'That'll be OK' attitude out there because of the cost (the last two airframes I've done needed an average of £4,500 of welding repairs done to them)." (Photo: Miles McCullum)

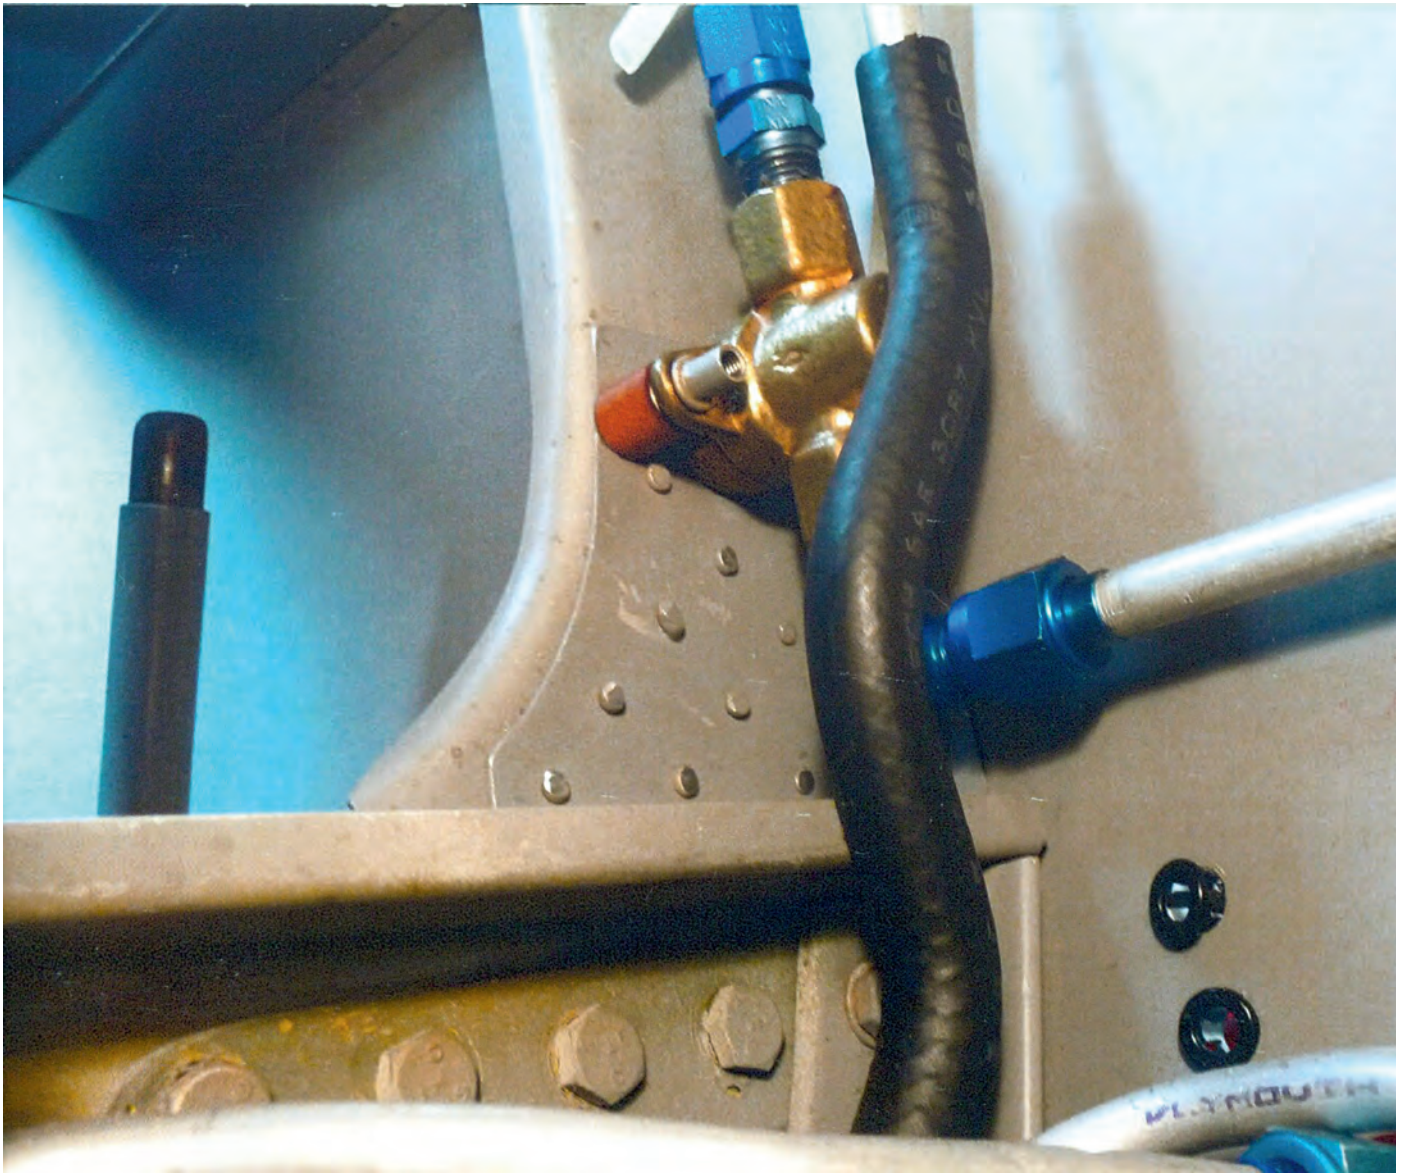
This picture of the wing forward attachment was taken from the foot pedals so you're looking at the inside of the bracket. This riveting is definitely below par and needs to be replaced. (Photo: Roy Holder)

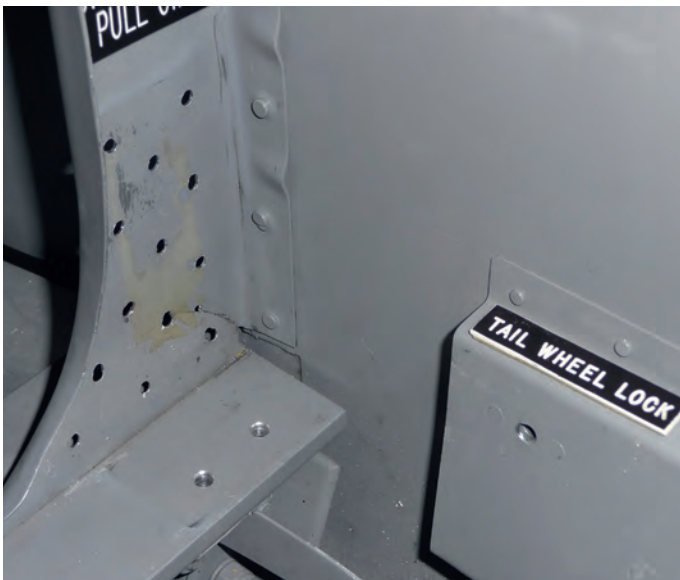
Francis Donaldson came into the office with a wry smile; he's generally a pretty cheerful chap but, as he pulled up a seat he looked like a cat that's just found the cream. Francis lent forward and passed me the featured picture of a horrible crack in the frame supporting the forward wing attachment of a Midget Mustang. We call this sort of find a 'spot' in the trade, and always feel rather self-satisfied when we find a good one. Not that Francis was pleased that the aircraft was cracked of course – his smile signified his intense relief that the checks needed before a Permit to Fly is issued had succeeded in apprehending the aircraft, and that his instruction to remove the doublers, based on a hunch after several weeks of worrying about it, had not been misplaced.

Francis certainly gets top marks for spotting this crack as it had been completely hidden behind a riveted-on strengthening plate. I asked Francis what made him think of asking for this plate to be removed so that he could get a closer look. He explained that, firstly, he'd seen problems in this area on a Midget Mustang before and had approved a repair on another machine a few years back... that's experience. Also he added, "To be honest, I just didn't like the quality of the riveting, which was a fair way from perfection in this critical area, and well below the standard of the rest of the aircraft." That's fastidiousness, a very good quality in an Aero Engineer.

When Roy drilled out the rivets he was aghast to find that the frame had cracked through; note the stop drill at the end of the crack – clearly the engineer who did this was rather behind the common sense curve. (Photo: Roy Holder)

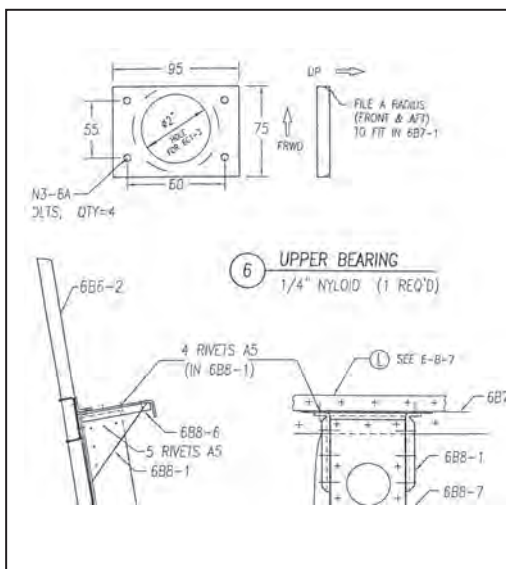
LAA Inspector Pete Murray, who hails from north of the border, called a while back and explained that he'd found a crack on a local CH601XL and asked I thought that it was repairable; he sent down the picture that I've featured, showing what he'd found. My first thoughts were that this looked eminently repairable but, because I hadn't seen a crack in this position before I asked Pete to dig a bit deeper to find out what may have caused this failure. After some to-ing and fro-ing the owner of the aircraft, LAAer Larry Johnson asked LAA Inspector Sandy Hutton, to take a look and gave him the drawings of the assembly.

One of the important functions of an inspector signing off an aircraft for its first flight is that the machine is built to the drawings. Any deviation from the design is a good reason not to sign off the aircraft as even the smallest changes might cause trouble later on. In this picture of the upper nose undercarriage attachment fitting of a Zenair CH601XL, you can see that the four attaching bolts form a rectangle. Take a look at the picture of the fitting that cracked on Larry Johnson's machine and it's difficult to find a match! Sandy Hutton, Larry's inspector, thinks that the reason for this crack is that the aluminium support below the plate was not accurately radiused. (Photo: LAA Library)

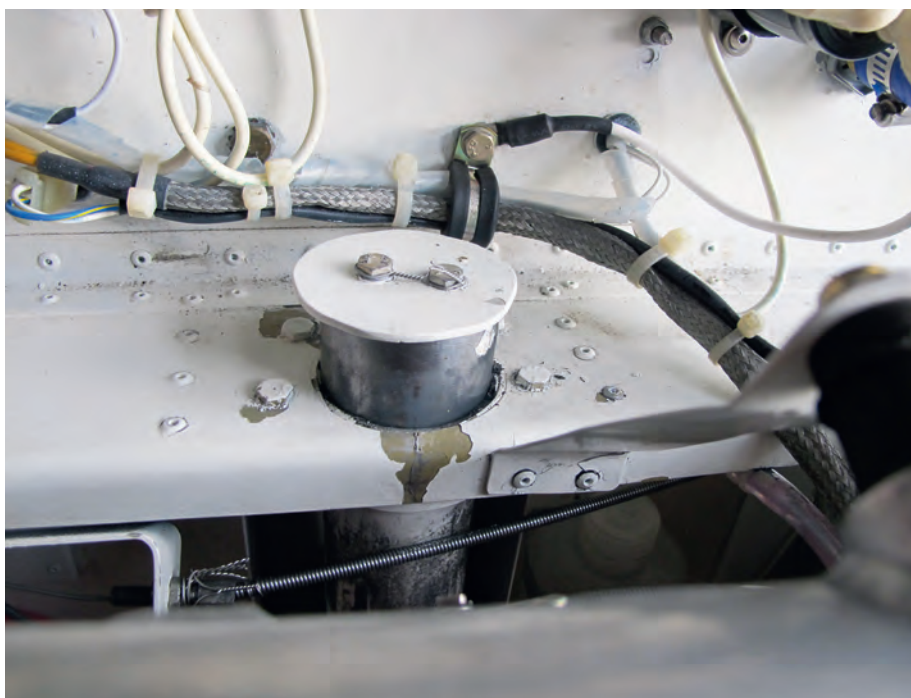
I've featured the relevant part of the drawing and, as I hope you can see, there's quite a big difference between what should be there and what is. I'm going to take up Larry's suggestion when I told him that I was coming down with something... "Get yerself ta bed laddie, and tack a hot toddie..." Actually, I'm going to eat some chocolate, watch the Simpsons and, well you know the rest. Fair winds. ■

Here's a picture showing the dimensional differences between the drawing and real life. When you buy a second-hand aircraft never assume that all's well – check, check, check. (Photo: Pete Murray)
