A GOOD PRE-FLIGHT ROUTINE

Another year and we've made it through – in the final Safety Spot of 2013, we look at the importance of a thorough pre-flight routine

DENNEY KITFOX II – UNDERCARRIAGE FAILURE

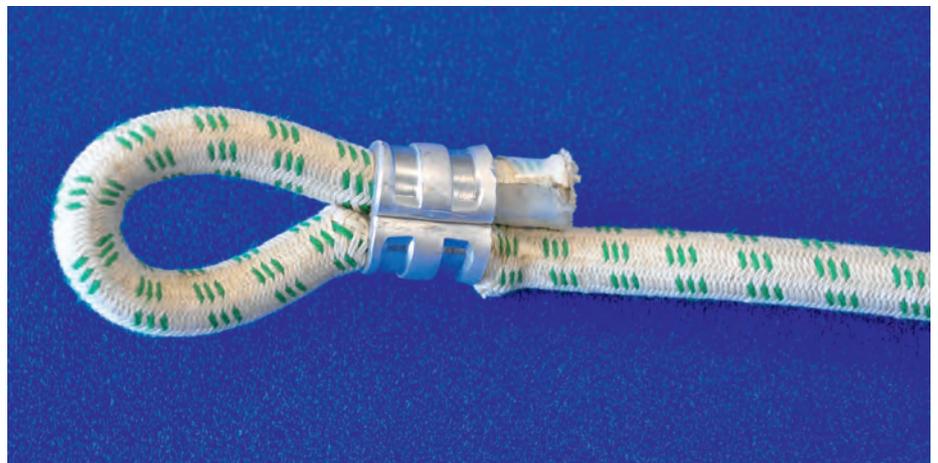
Once LAA Inspector Colin O'Neil had got the bungees off, it was easy to see how the failed bungee could get through an initial inspection – although a closer look would soon tell you that all's not well with this component. (Photo: Malcolm McBride)

I wasn't surprised therefore when one Monday morning recently I arrived to find two undercarriage bungees resting on my keyboard without a note. I took a quick look at the two very new looking items to try to see what might be wrong whilst my mailbox went through its opening routine. Mm, it was clear that the crimp which turned a length of 10mm bungee cord into a component had, during the crimping process, cut the bungee and caused it to fail. Take a look at the accompanying pictures and you'll see what I mean. Each length of bungee was terminated at each end by a two centimetre (inside diameter) loop and it was clear that the rubber strands had failed at the crimped connection at all four ends.

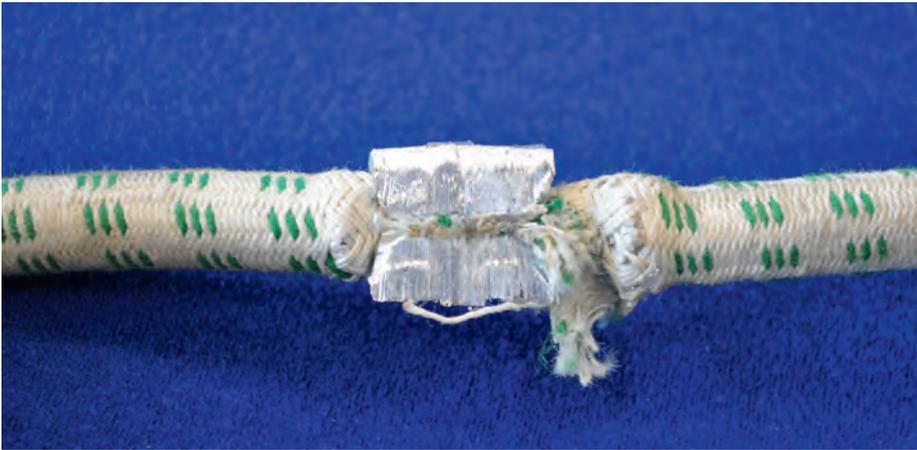
You can see from this picture of a sectioned ferule that the ferule itself has cut through the shock cords that make up the bungee. What may have happened here is that the wrong swaging method has been used; my guess would be that a Nicopress hand swaging tool has been used when the ferrule was designed to be used with the Tallurit system. Both systems, incidentally, were originally designed for use with steel cables, not bungee cord. (Photo: Malcolm McBride)

I decided to section the crimped ferrule and, as I hope that you can see from the photos above, almost all of the rubber strands have been sheared by the ferrule itself; this was most likely to have occurred during the component's manufacture. I asked Colin if he knew where the parts had originated and he explained that the owner had bought them from the Kitfox agent in the US some time ago and that these parts had served less than five hours in service. Well done Colin for an excellent spot.

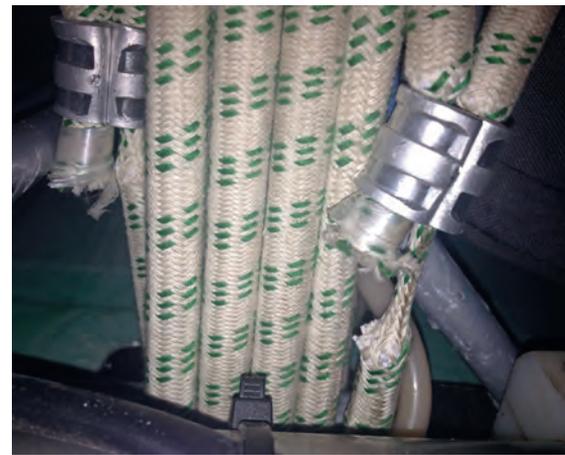
Above is a picture showing the very nearly failed suspension bungee from a Kitfox II. A spot like this reminds us all of the great importance of a thorough pre-flight inspection – this bungee would probably have failed during the next landing. There's another lesson here; these bungees were nearly new and probably wouldn't have been high on the pilot's list of things to worry about. (Photo: Colin O'Neil)

I agreed that this was always a good idea with 'Hangar Queens' and asked whether the aircraft sat OK on the tarmac. Colin replied, "Absolutely, in fact the actual ferrules sit up inside the airframe and I wouldn't have spotted this, or should I say these, failures had I not been so thorough."

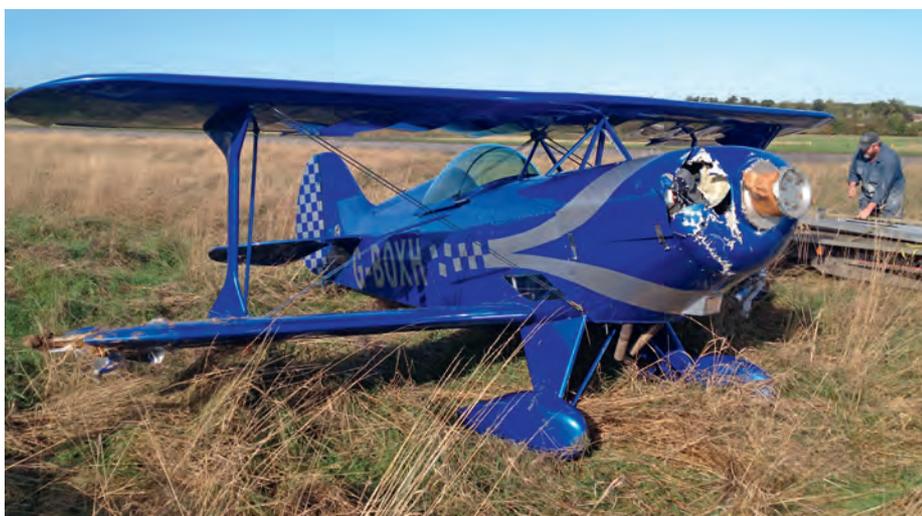
Gary explained, "I knew what had happened as soon as I was able to get a look at the tailwheel control cable... the connecting link, which looks like a small Carabina, had failed. I will send you the bits. The day started well, but 3,000 hours of work over 3½ years came to nothing when this two quid component gave way."

Looking at the component it's clear that the threaded part of the locking turnbuckle has pulled free from the barrel. My guess is that this part has been coming loose for some time; the threads are all still in place and, although the actual fit is very loose, I

couldn't pull the thread from the barrel so the thread itself hadn't failed. It may be that the barrel has become unwound slightly and the resulting vibration in the component caused significant wear... take a look yourself at the picture showing the broken connector.

(Above) After 3,000 hours rebuilding this Pitts Special, LAA'er Gary Cotterell was naturally very upset when he ended up in a ground-loop shortly after landing. One experienced tail-dragger pilot I spoke to when discussing this incident says, "Well there's those that have – and those that are going to." In truth, Gary was lucky that the damage was not more extensive (main undercarriages don't like sudden side loads) and he walked away without a scratch. Gary considers that the primary cause of this ground loop was the failure of one of the steering links (see below) although the general consensus amongst tailwheel experts is that the actual steering effect on a tailwheel through this link would (or, at least, should) have been minimal and this component's failure wouldn't result in a ground-loop. The tailwheel steering system works through springs primarily to limit the potential load through the system generated by rudder action; at best, steering can be accomplished at low speeds with this system; at high speed, rudder should be used to keep the aircraft straight. When this becomes less effective as the aircraft slows, appropriate application of differential brake should be used. (Photo: Gary Cotterell)

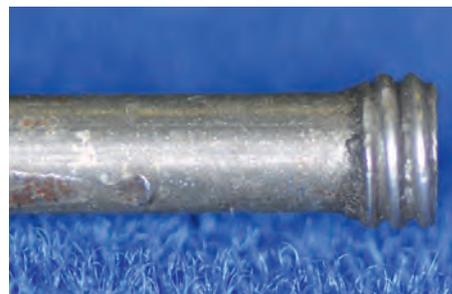
A closer look at the threads from the failed steering link shows the effects of wear; notice how the threads themselves are rounded. It's possible that shimmy has exacerbated this wear... note that there are actually only a couple of threads engaged when fully assembled.

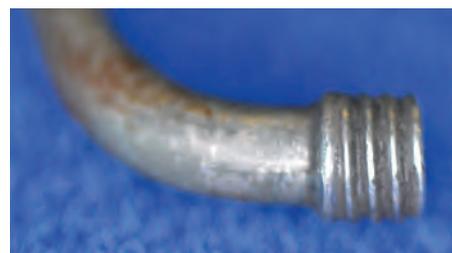
Here's a close-up of the threads from the 'un-failed' link. Notice that there are a lot more threads engaged although this thread is also badly worn.

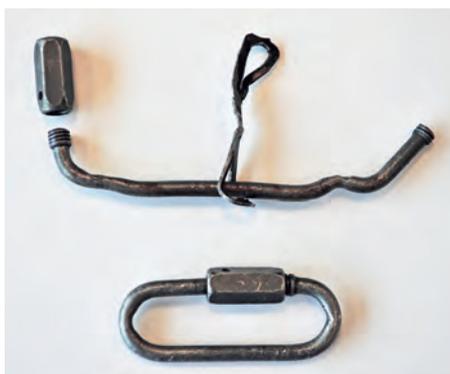
(Left) I hope you can see that this component wasn't really designed to take huge loads. It's not possible to know whether this component failure was the cause of the accident or broke as a result of it. The bottom item is the assembled link and the top item shows how the link has pulled straight when the threaded barrel has worked itself undone. Opinions vary about how the spring tension should be set-up to give optimum steering, but one thing is for sure, operating with very tight springs will mean that there will be (potentially) much higher loads in the attachments. (Photo: Malcolm McBride)

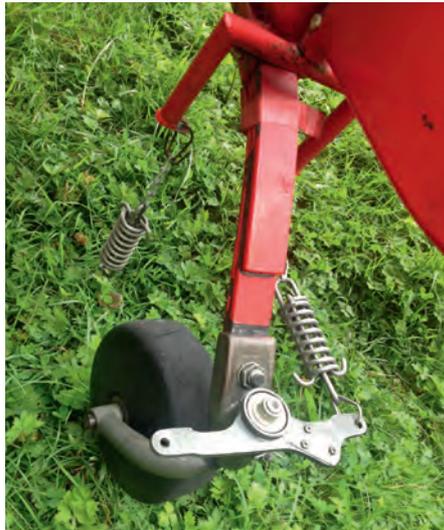
This photo comes from another example of a Pitts ground-loop. This time the owner was not so lucky and the sudden swerve did break one of the main undercarriage supports. You will notice that the spring is connected in this case using a simple one-piece link... one of which has failed. Another thing to notice is that this system uses a compression type of spring (they pull from the inside and can compress fully if not correctly set up – this in effect means that the sprung connection becomes a solid one). This type of Maule tailwheel has a massive trailing angle and therefore naturally wants to go straight if set-up correctly; the Pitts has a maximum rudder angle of $\pm 30^\circ$. Even at full rudder deflection the turning force to the wheel is miniscule compared to the forces keeping it straight.

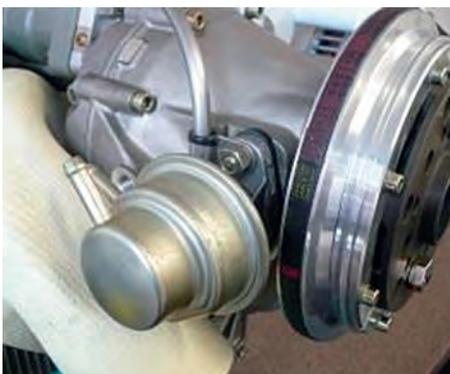
(Left) Here's a picture of an installed AC mechanical fuel pump that's being withdrawn from use by Rotax although the service history of this pump in the UK has shown that it works well. Interestingly, Rotax suggests that all mechanical fuel pumps should be replaced after five years, although operating under the LAA's 'On-Condition' scheme, the LAA has examples of pumps lasting many years longer. The pumps originally fitted were manufactured by Pierburg – when these became unavailable Rotax swapped to a Bing (AC) pump. It's these pumps that Rotax wants to replace. The latest pump is manufactured by BCP Corona and produces slightly more pressure and this increase in fuel pressure has led to some problems with some installations, primarily carburettor flooding. Strangely, some manufacturers have advised owners not to use their auxiliary (electric) fuel pumps during take-off because of reported rough running. LAA advice is that if the engine runs roughly during normal operation, the cause needs to be established and the issue resolved. In general, adjustment of the fuel system pressure can be accomplished by adjusting the size of the flow return restrictor. LAA Inspector and Conair boss Conrad Beale suggests, "Ideally, the system should be set up so that the pressure falls midway between minimum and maximum permitted fuel pressures; this works out as about 0.3 bar. On most installations this needs a 0.35mm restrictor – although systems vary". (Photo: Skydrive)

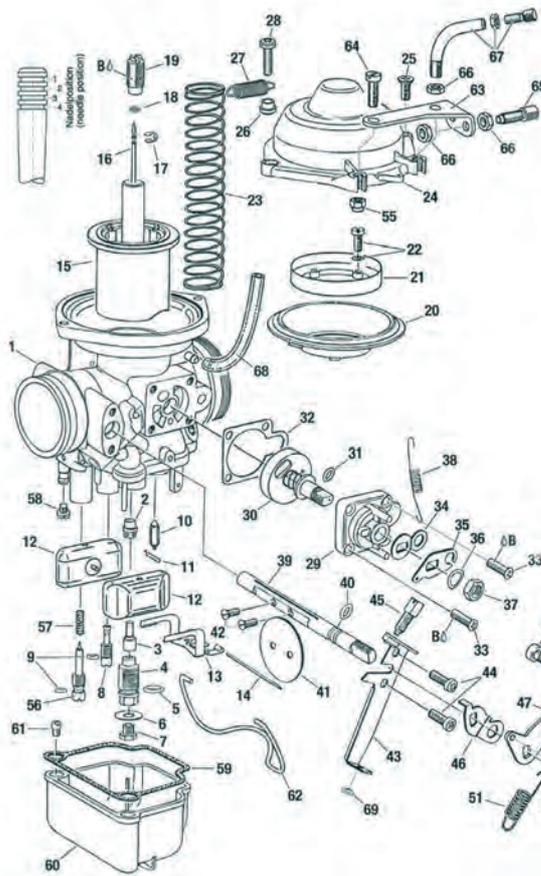
The Bing constant depression carburettor is a complex device as can be seen by studying this parts drawing; the needle valve is there to keep the fuel level correct in the float bowl. Should this level change for any reason, it may result in a change to the fuel/air mixture to the engine – when the bowl completely floods, neat fuel will be ingested into the respective cylinders and the engine will run very roughly or possibly even stop.
