TAILORED

MAINTENANCE

SAFETY SPOT

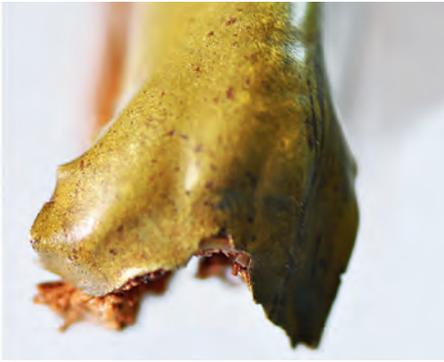
Here's a close-up of the leading edge of the failed propeller at the point of the failure; you're looking from front to back. Initially, this looked like the point of an impact but, by looking very closely at the shape of the damaged leading edge protection strip, we think that the actual impact was further outboard; notice the symmetry created as the leading edge strip was ripped apart.
(Photo: Malcolm McBride)

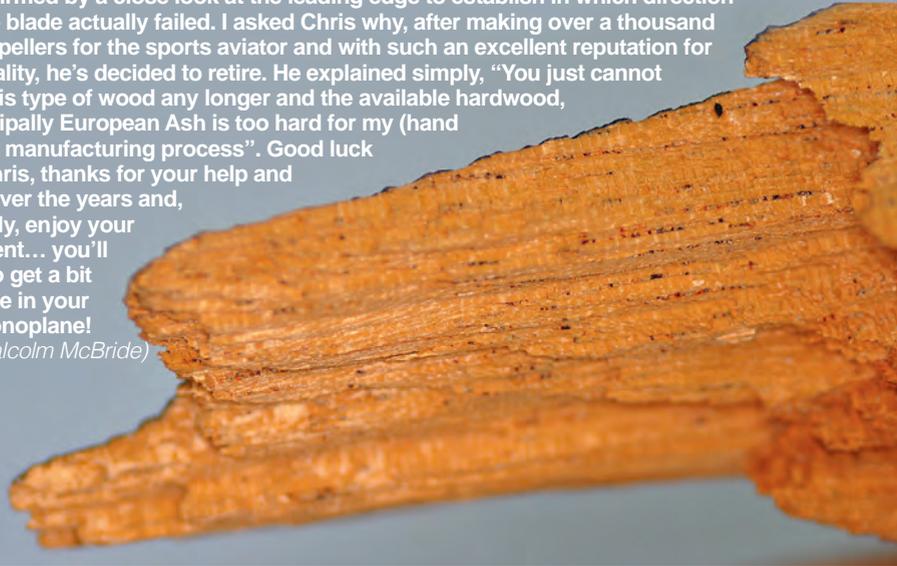
Here's a close-in shot showing point where the Lodge propeller as fitted to the Aeronca failed; the important point is that the grain of the wood used in the propeller's construction is straight and perfectly orientated along the length of the propeller, just as it should be. Chris Lodge, the original manufacturer of this propeller, always used either Brazilian or Honduran mahogany in the manufacture of his propellers; when we chatted about the possible causes of a propeller failure like this, Chris explained that it was almost certainly due to leading edge impact damage, but this would need to be confirmed by a close look at the leading edge to establish in which direction the blade actually failed. I asked Chris why, after making over a thousand propellers for the sports aviator and with such an excellent reputation for quality, he's decided to retire. He explained simply, "You just cannot source this type of wood any longer and the available hardwood, principally European Ash is too hard for my (hand made) manufacturing process". Good luck

Chris, thanks for your help and advice over the years and, naturally, enjoy your retirement... you'll be able to get a bit more time in your Taylor Monoplane!
(Photo: Malcolm McBride)

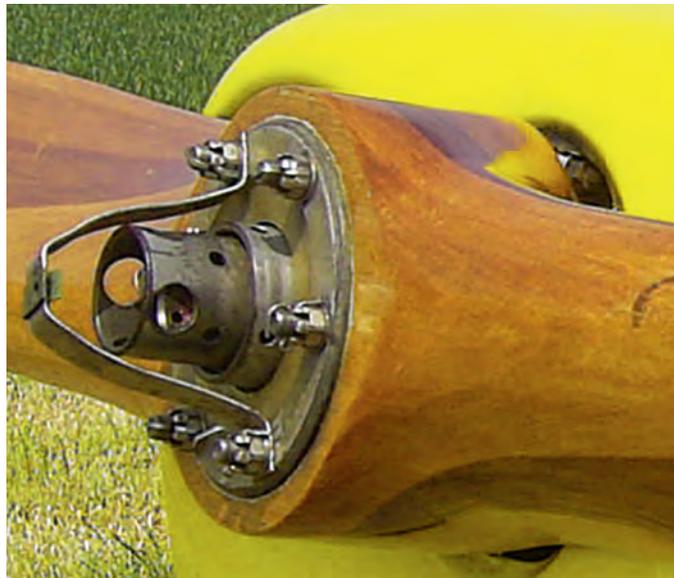
What came first, chicken or egg? Early thoughts were that the failure of the propeller led to sufficient vibration to dislodge the spinner; now we've had a closer look at the failed propeller we think that the first thing to fail was the PK screw holding the spinner on... It's certainly worth checking the security of a spinner during the pre-flight walk around.

We've taken a close look at the broken propeller here at Turweston and the failure shows all the hallmarks of a leading-edge strike so, perhaps, the lesson here is that, during your pre-flight walk around, always check the spinner for security. This one was only held on with a single self-tapper through a U-type Tinnerman nut and any aero engineer will tell you that this isn't the trustworthiest of fixings, especially in areas where there might be vibration.

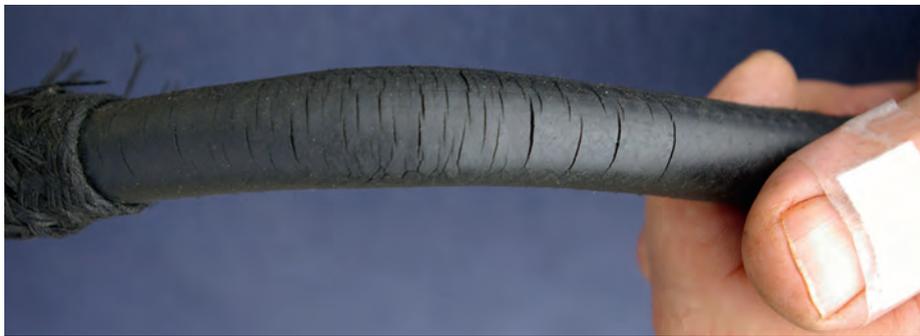
Here's a picture of the fuel hose that started to leak one evening at Haverfordwest airport, note that the outer braid has been pulled back to reveal the reason for the leak; this hose has completely perished, and it's only been in use for a couple of years. This fuel hose appears to be of the correct specification and has been supplied as fuel hose and this surprise premature failure should encourage us all to consider reviewing the time between checks of fuel system components when creating our Tailored Maintenance Schedules. (Photo: John Jones)

After removing the hose and stripping back the cotton braid around it, the photographs show what we found. The hose has completely cracked but is not hardened, it's as soft and supple as it was when new; the aircraft was first flown in 2010 and has run about 115 hours.

I wrote back to John thanking him for the email and explaining that I hadn't seen this Cohline hose before and that it looked unusual in that it appeared to be homogeneous through its cross-section. I asked if he could send a sample for us to look at here at LAA HQ. What I mean by 'a homogeneous cross section' is that the whole hose appears to be manufactured from one specific rubber-based compound; the braiding, folded back in the attached photo, is not integral to this compound being woven around the outside.

Why this has happened? The hose is not close to any high heat source – only the normal heat of firewall forward components, but as this particular make has only been used firewall forward; we're going to replace this suspect hose with SYTEC manufactured type as we still have some of this left over from the aircraft's initial build. We intend to keep a close eye on the entire fuel system.

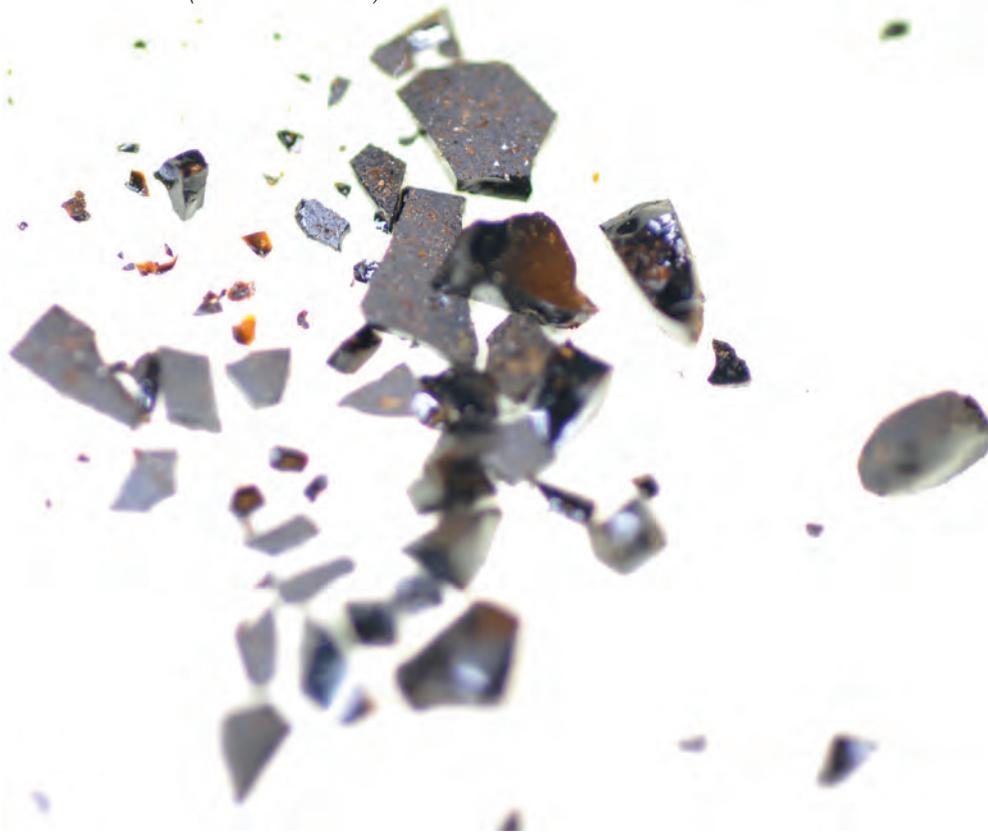
Some time ago I did a solvent wash of a fuel filter that was used on an aircraft that had never used fuel containing alcohol, the filter had prematurely blocked and the owner of the aircraft was concerned that his tanks were disintegrating... if you look closely at these particles, and the biggest is about 1/10 mm across, you will see that they're actually an agglomeration of all sorts of still smaller bits and pieces; that's, after all, why designers fit filters into their fuel systems. (Photo: Malcolm McBride)

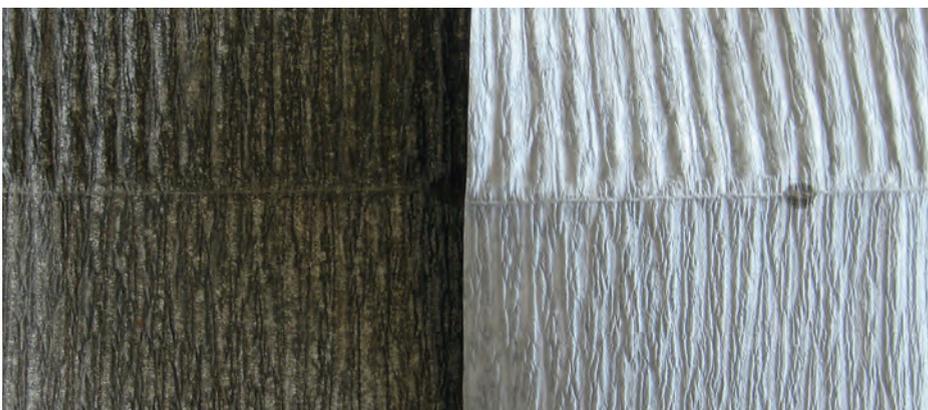
Here's a similar photo of that on p47 of the inside/outside (i.e. pump side/engine side) of the element from the high pressure section of the fuel system discussed in the text. You can see that the filter has been doing its job well but surface build-up has restricted the flow severely... to such an extent the pump was 'struggling'. (Photo: Malcolm McBride)

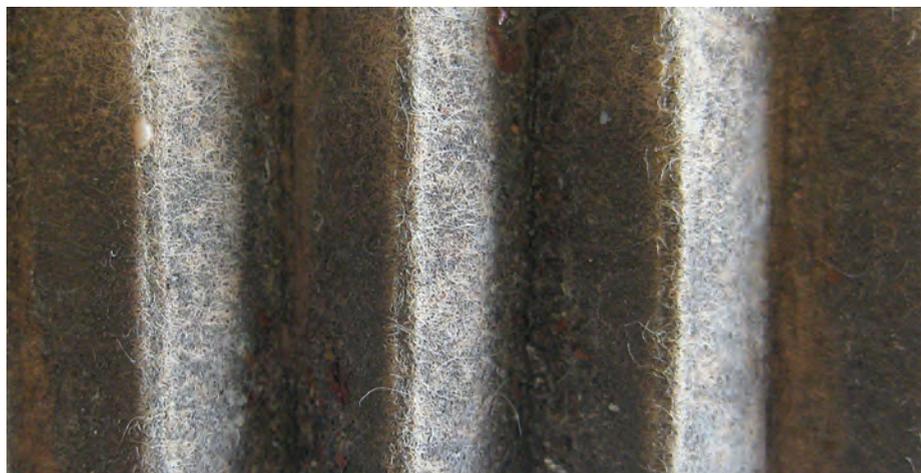
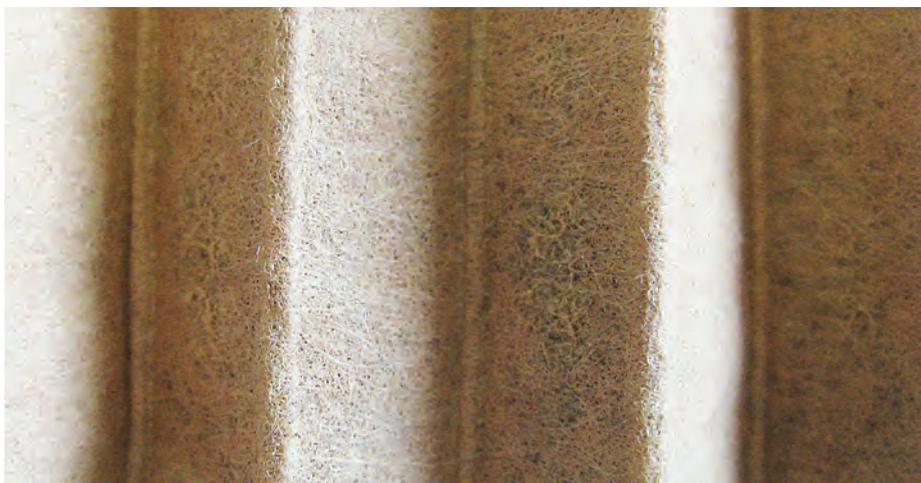
These pictures show the inside and outside of the pre-filter element from a UL260i engine that has run for 115 hours. The owner found that it was nearly impossible to blow through this 'large particle' filter and, after it was changed, the fuel pump sounded 'far more relaxed'. It is my opinion that fuel filters on aircraft operating in the Permit to Fly environment should be changed at least every 50 flying hours or at the annual, especially if the aircraft is being operated on Mogas. (Photo: Malcolm McBride)

After cutting it open there was no sign of any debris within but the element is coated with some brown goo which has seriously closed the pores of the filter. Likewise with the main high pressure filter the blow-through test was the same; it was very hard to blow through it. This filter is also coated with a brown substance only it seems finer, the fuel pressure up to this point was not affected still holding a steady 40psi although after fitting the new filters the fuel pump now runs a lot quieter.

We don't have the equipment here to isolate the chemistry of the, to use John's description, brown goo, but I think that it is likely that this will be microscopic amounts of fibreglass resin, or perhaps tank sealant that's being washed off the surface of the fuel system's internal components, probably the tanks. If the G-LEEK syndicate has been using mogas, there's a very good chance that they've been inadvertently operating with alcohol in their fuel system but, even if this isn't the case, modern motor fuels vary considerably in their make-up and that's why it is essential that if you're using motor fuel in your aircraft you take this into account when designing your Tailored Maintenance Schedule (TMS).

The engine manufacturer states that the filters should be changed every 200 hours but with hindsight I think perhaps 75 hours would be more appropriate, at least until everything is settled down – these filters have run about 115 hours.

Certainly 200 hours between service intervals on fuel filters, regardless of manufacturer recommendations, is too long in my view – perhaps as this incident perhaps demonstrates. >

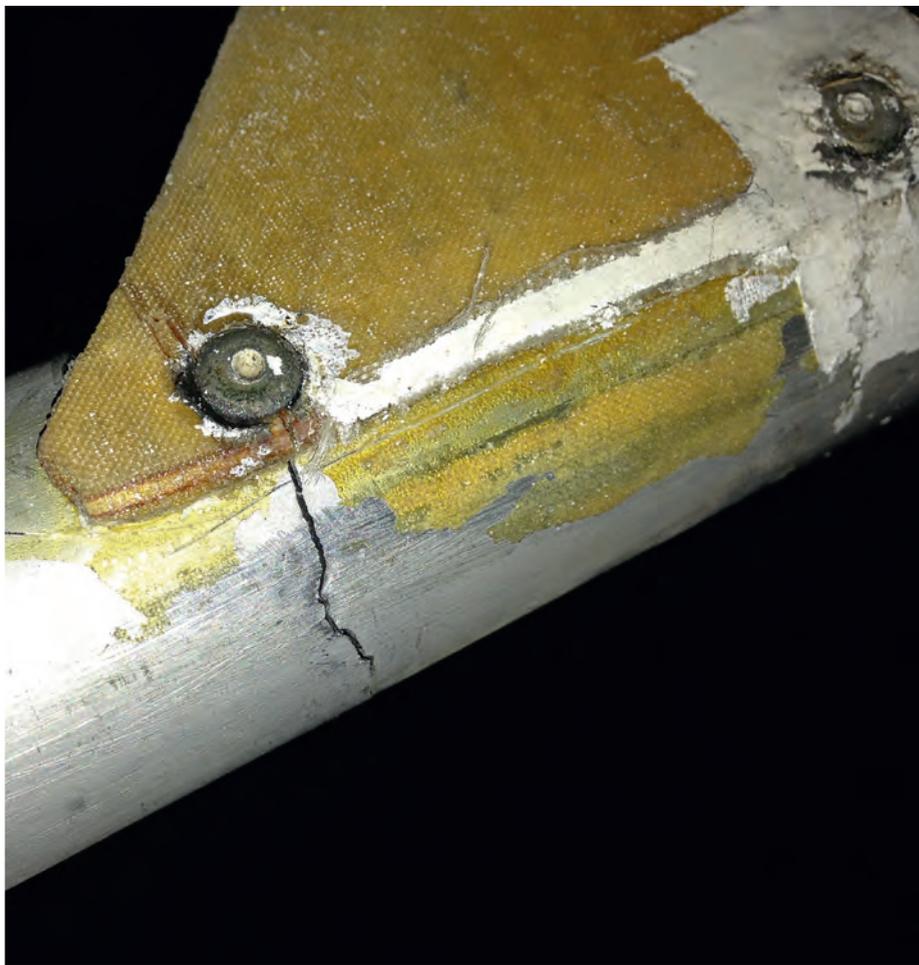
Attached photos of the Fin Post (T147) from a Streak Shadow showing cracks found by the owner when he noticed an unusual movement in the fin post when he was preparing for flight. Historically MPD 1998 -013 R1 was raised after cracks had appeared at the top of the fin post where it enters the boom and mandated the fitting of the additional inner sleeve. The inner sleeve (T188) is intact in this case and has done its job.

Interestingly, the failure on this fin post was not at the top by the first line of rivets securing the wooden gusset as had been seen before but at the second, lower, set of rivets. This machine has flown nearly 700 hours and has a Rotax 618 fitted. This is a heavier engine than the standard R582. She also has a fixed rudder trim which was found to be very loose on inspection the week before. (A possible suspect for the unusual damage?)

Certainly a crack like this is serious as progression of the crack could lead to the complete fin and rudder assembly separating from the aircraft. The Streak is a famously benign handling aircraft, but losing the fin and rudder would be likely to result in pretty disastrous directional instability. We discussed this failure at one of our regular engineering meetings and the Chief Engineer suggested that I ask the aircraft's designer, another old friend, David Cook, what he thought about it.

Here's the reason why a good walk-round inspection could prevent a good day from becoming a bad one. This is a picture of the Fin Post (less the fabric covering) from a Streak Shadow complete with a nasty crack near the point where the fin post enters the fuselage boom. The owner only noticed it because he felt an unusual movement in the fin... well done to him for having a good feel. Humour, such as it is, aside... I think that it's always a good idea to have a good pull and prod on bits of the aircraft to check whether one bit is moving correctly against another and to detect whether there's movement where their shouldn't be. (Photo: Fiona Luckhurst)

We'll be discussing the way forward with this issue at the next Airworthiness Review Meeting, but meanwhile this cracking does provide a timely reminder of the need for careful pre-flight checks and always being on the alert for anything that doesn't look or feel as it should, especially with the very lightweight structures on microlight and similar airframes which, designed for flight loads, may not be too tolerant of ground abuse.

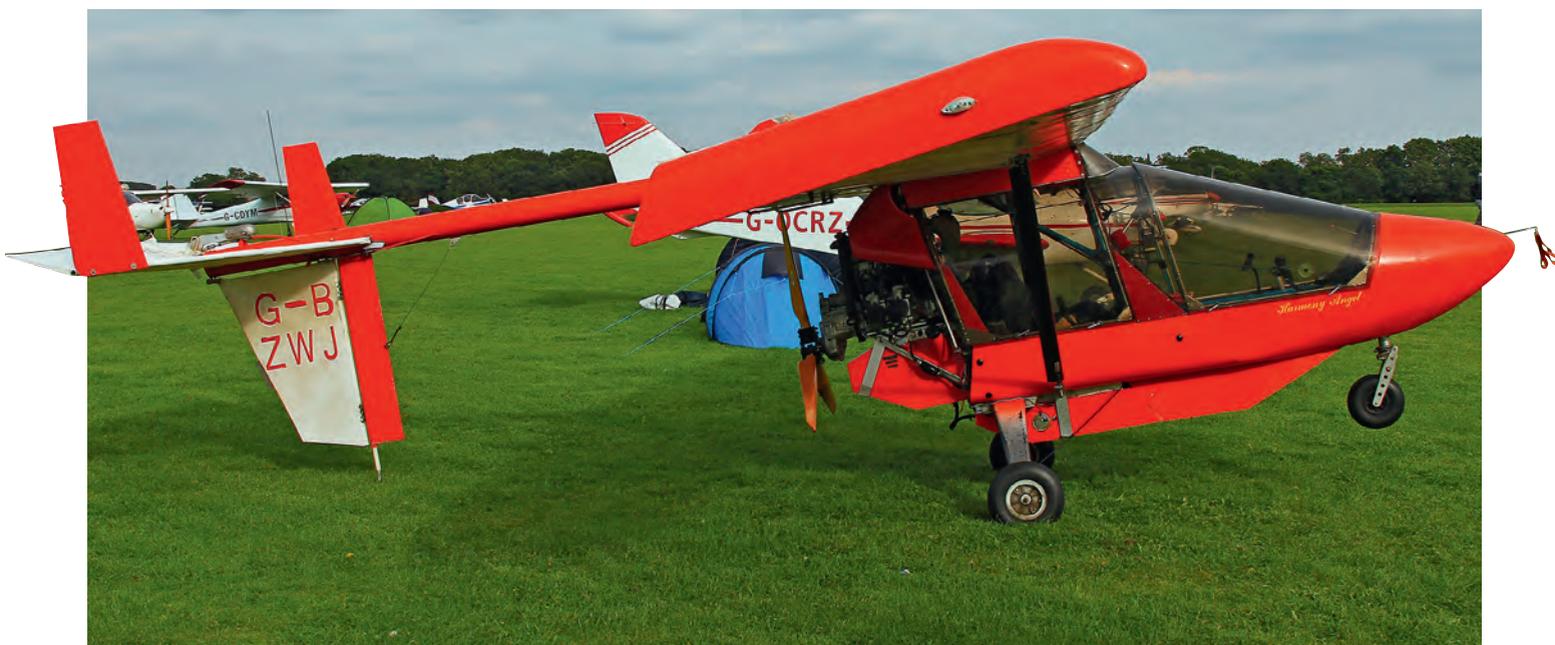
Because of the nature of the design, the Shadow series of aircraft rest on their tail when the pilot's weight is removed; you can see that it would be easy to inadvertently impart quite large loads through the fin post into the fuselage boom and it's definitely worth taking this into account when pull starting the engine. (Photo: Richard Hamblin)

“I agree with Francis,” David explained, “and it wouldn't be good if a pilot lost his fin, that's why we reinforced it with the extra internal tubework early on.” David continued, “I think that it's most likely that the reason for this fatigue failure is that, either the aircraft sits outside and is being blown from side to side by the wind or, and this is the most likely, the owner is starting the aircraft with the tail still on the ground.”
