HOT AND BOTHERED

AERONCA 7AC CHAMPION PROPELLER FAILURE

AVIONS FAIREY TIPSY NIPPER WING FAILURE

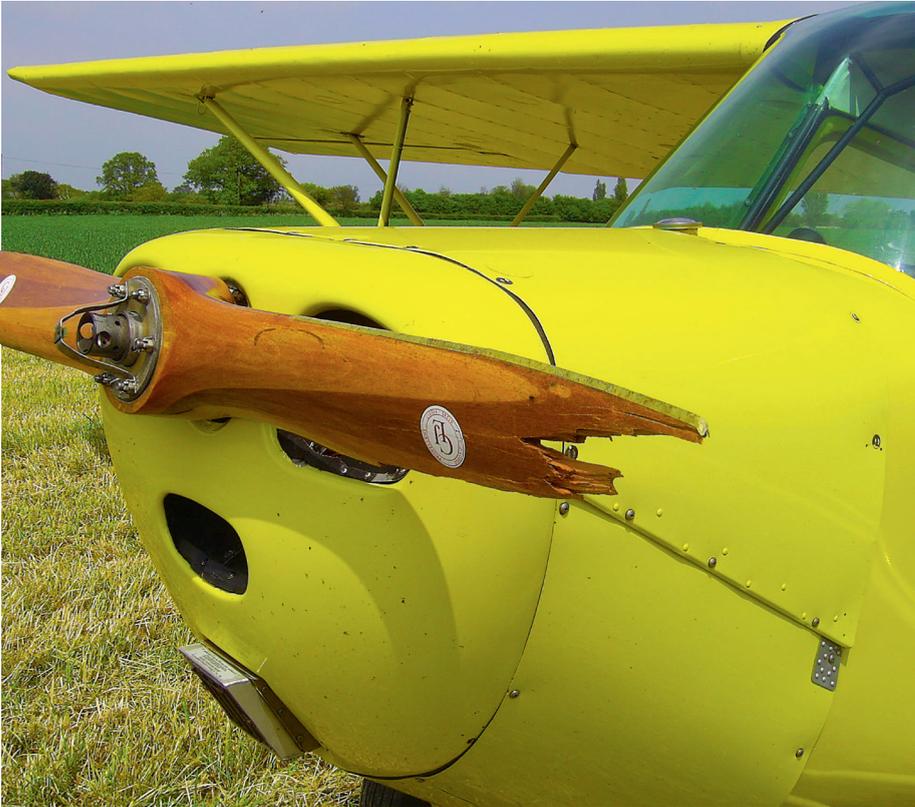
You can see that approximately 30% of the blade has disappeared from this ten-year-old mahogany propeller during the cruise. The pilot was able to switch the engine off almost straight away and it looks like there's no further damage to the engine/airframe attachment. This sort of materials failure is fortunately very rare and we're looking forward to receiving the prop here at HQ so that we can take a close look at the wood grain structure in the area of the failure. You will notice that the spinner is missing; of course it's possible that the spinner came off in flight and struck the leading edge which could have caused a local over-stress but both the owner and the engineers here don't think that this is likely. (Photo: James Day)

If you take a look at the picture of LAA member James Day's Aeronca you will notice that quite a chunk is missing from one blade of his propeller; we haven't yet taken a close look at the failure to establish why this may have happened, but as I write the propeller is in the post to us for analysis. This sort of catastrophic failure is worrisome and it's important that we find out why the mahogany has 'let go' like this – this propeller is about ten years old. Here's James' report:

My syndicate colleagues lost a spinner once before and it caused only the slightest of grazes near the hub, so I am inclined to think the catastrophic tip loss was as a result of stresses on the change of power loading. I also think that the black object departing was the black painted back of the prop tip. I can't actually remember if the prop windmilled, but I wasn't conscious of it, only that the severe shaking had stopped. There was no ➤

evidence of birdstrike, but clear evidence of a longitudinal fracturing of one side of the prop for considerably more of the length than was lost. The task now is to find what caused the weakening that led this to happen.

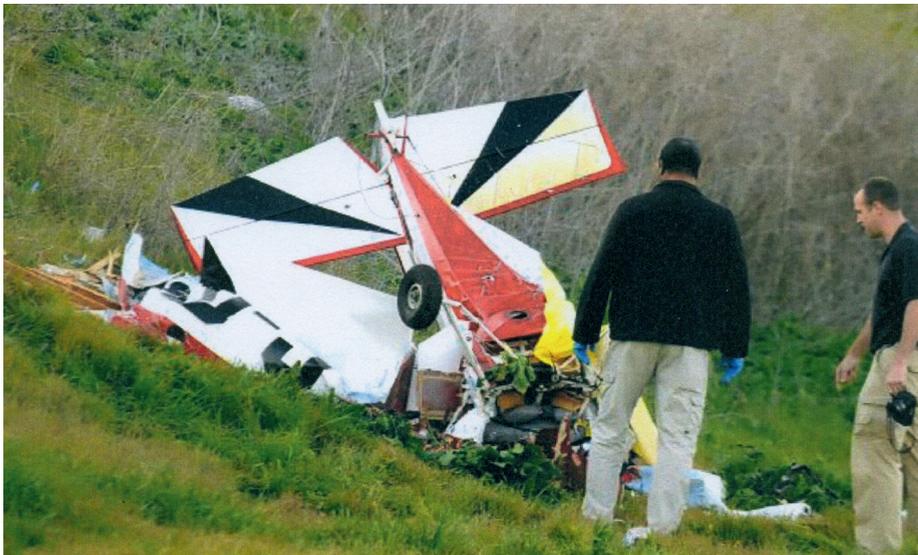
The US Investigation team begins their investigation into the mid-air structural failure of this Avions Fairey Topsy Nipper; the LAA keeps a close eye on failures overseas which affect aircraft types that our members fly here in the UK. This particular machine was exported to the US recently after being sold by the UK owner. This factory built (Belgium) example was over 50 years old and there were concerns that the wing failure may have been due to 'age related decrepitude' – which was fortunately not so, as the cause was eventually discovered to be a bird strike.

The formal report into this crash has not yet been published but I have permission to reveal that the cause of this wing failure has been determined as a bird-strike. DNA analysis has established that the actual bird was a turkey vulture, common in the southern United States, and the point of impact was about four feet from the wingtip. The turkey vulture is a very large bird; adults can weigh up to about 2.5kg and often have two-metre wingspans. I spoke to the US investigator in charge, Jim Struhsaker, and he explained that the US Highways Department had actually found the bird, a protected species, but it took a while to match up the separate tragedies; the DNA analysis work was completed by the Smithsonian Museum in mid-May.

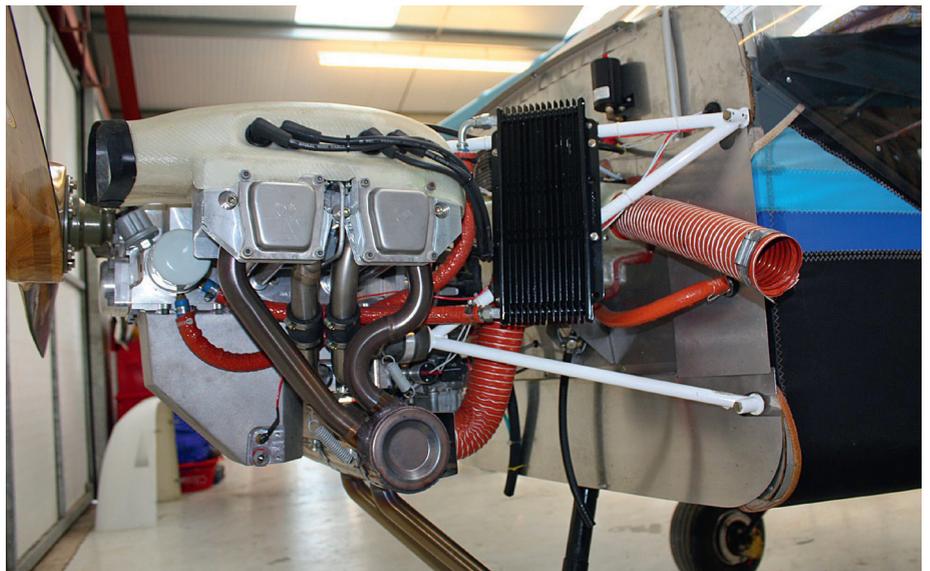
Here's a picture of the Jabiru 2200 engine installation as fitted to the Rans S6-ES that's just been completed by the Stroud Build-A-Plane project... and very well done to them. The initial shake down flying, done by LAA-er Toby Wilcox, went very well and, apart from the addition of a rudder trim tab and the fitment of a better fuel valve, the test flying has gone without too many teething problems. After the first flight Toby noticed a small weep from the oil cooler so he removed it... sure enough, there was a small crack near the oil inlet pipe's attachment and Toby, thinking that the pipe may have been over tightened by one of the student builders, ordered a new cooler. The new cooler, manufactured by Goodrich, soon arrived and the test flying continued. After about 4.5 hours he landed and the engine cowl was completely covered with oil; you can see why by referring to the picture overleaf, yes, there's that crack again. I haven't had any reports before of problems with this type of oil cooler and the agent, Skycraft, tells me that this is the first (well, second) reported failure. If you've had problems with this type of oil cooler can you let us know about it here at Engineering HQ? (Photo: Toby Wilcox)

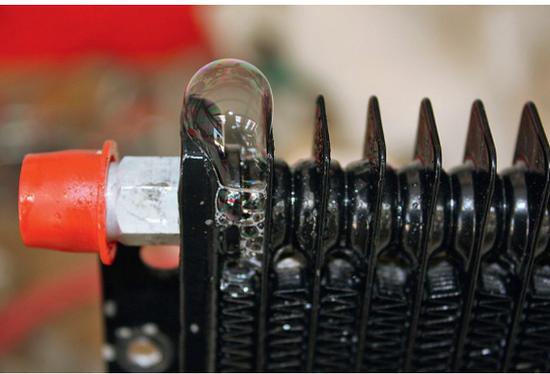
I'm forever blowing bubbles. This is a picture of the 'soap test' on the replacement oil cooler; initially it was thought that the inlet pipe had been over tightened, cracking the thin material in the cooler's structure, but the engineer that fitted the second cooler was sure that this was not the case. When Toby called to ask what we thought might be going on, it was suggested that the pipework leading to the cooler was quite long and appeared, looking at the photo supplied, not to be very well supported. Toby has repositioned the pipework and given it more support and we hope this will solve the problem. (Photo: Toby Wilcox)
