Annabelle Burroughes has enjoyed the delights of her Jungsmann for eight years but a tricky crosswind caught her out. *Light Aviation* will be following her rebuild of the aeroplane over the coming months as she sets out to have it flying again by next spring.

JUNGMANN REBUILD

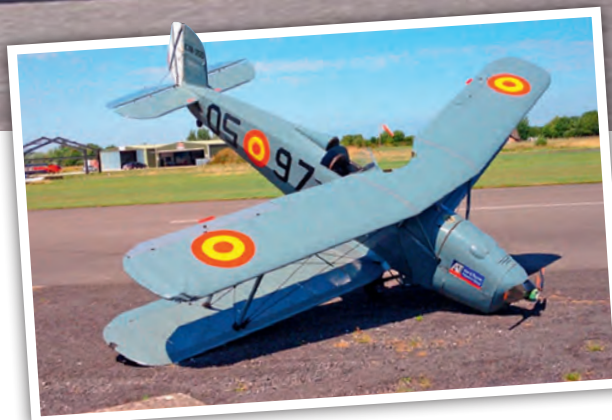
Justin walked around and around deep in thought. The problem was the right undercarriage had bent under the aeroplane and the rear of the leg fairing was through the floor. The worry was that if we just pulled the tail down, the right leg might collapse completely and damage her wing even more.

Oh dear! The result of an awkward crosswind that swung round to a quartering tailwind and caused the Jungsmann to tip onto its nose.

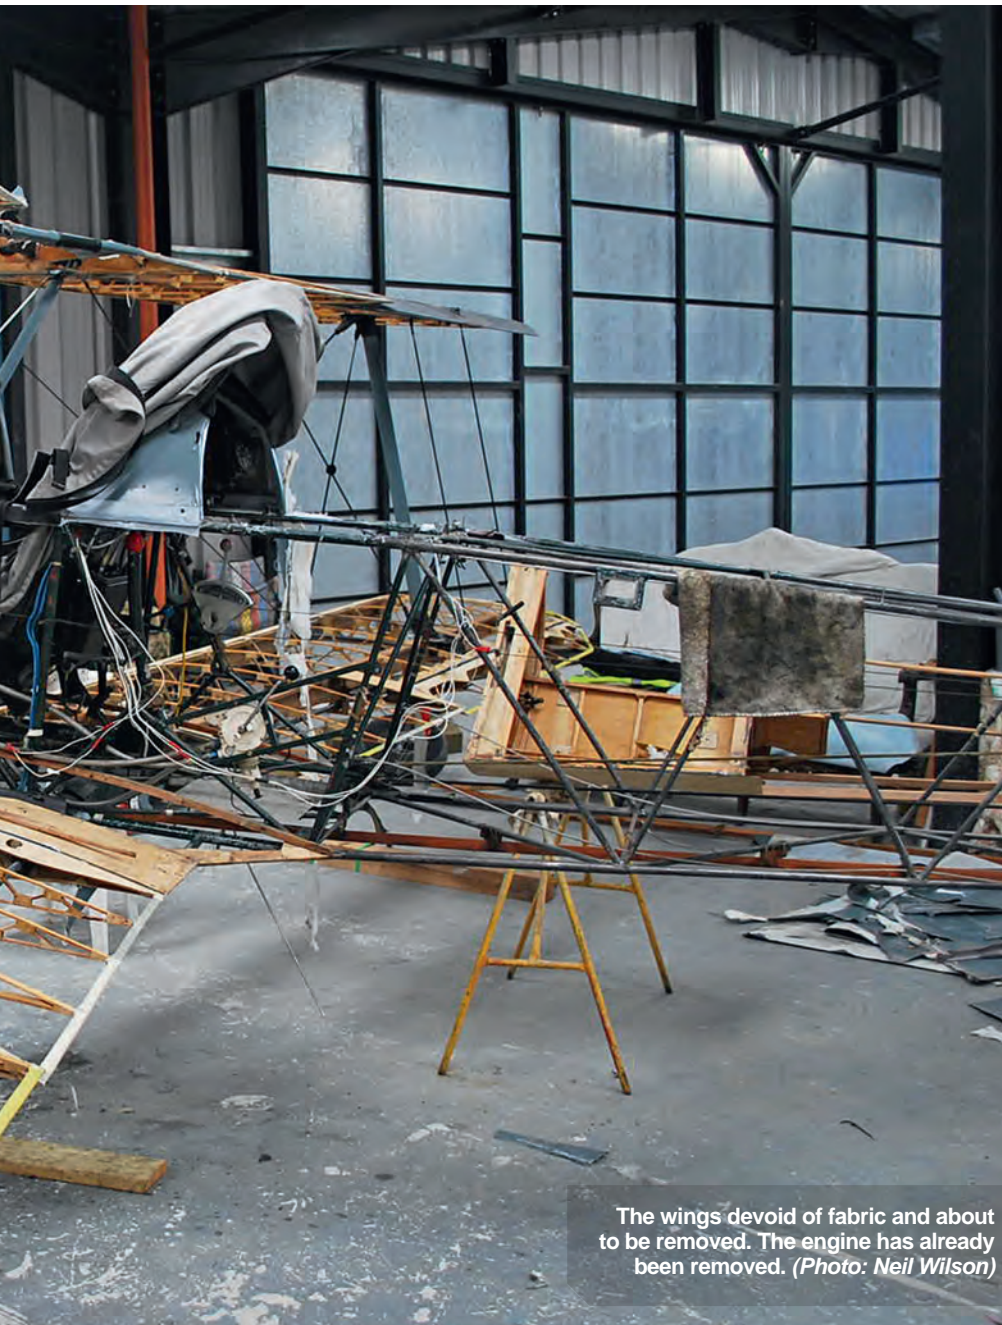
It was quite exciting seeing the delicate ribs, the beautifully crafted spars and the dainty wood moulding where the leading edge of the aileron connects. It was a shame that the wing tip was so deformed. The aluminium tube was worn away on the underside where the wing had scraped along the runway and buckled where it had hit the ground. The ribs were in very good condition. The two nearest the wing tip had a few fractures and joints that need gluing but the spar, on first inspection seemed perfect.

The wings devoid of fabric and about to be removed. The engine has already been removed. (Photo: Neil Wilson)

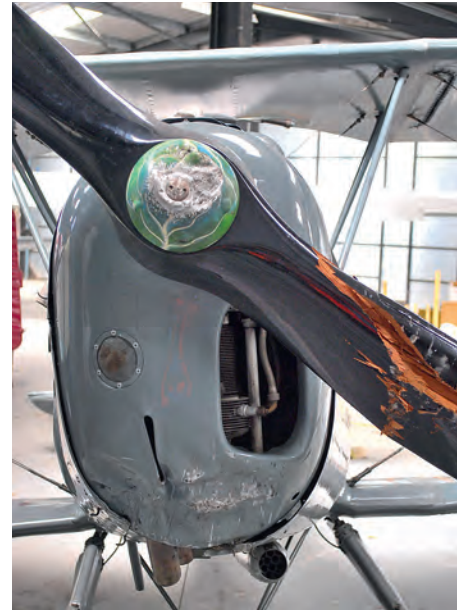
I was beginning to get an idea of what was going to be needed and the range of people I was going to need to give me quotes to get everything sorted. The list was getting longer. My favourite has been an offer to overhaul the prop – I suggested that they might need a lot of araldite. I was told that they never glued propellers, they were always done properly to which I replied that that might be tricky as mine was little more than a pile of matchsticks! They did laugh, luckily.

The damaged prop and 'gravel-rashed' nosebowl. Note cabbage paint scheme on crushed spinner.

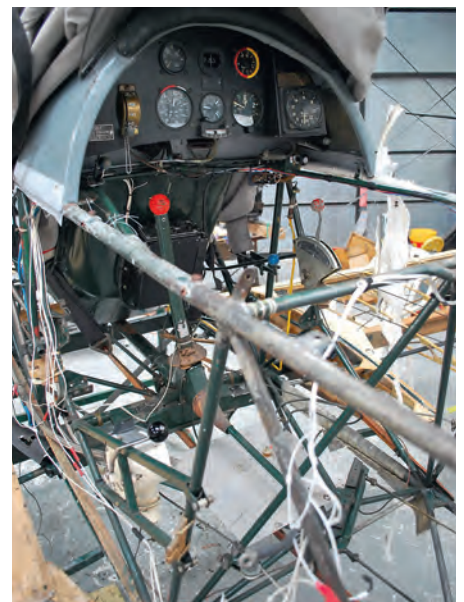
The fabric took no time to remove and it was the first time I have been horrified by the task ahead of me as she sat bare and seemingly vulnerable. It didn't take long to spot fractures in the forward fin lugs and a bent tube where the back of the undercarriage faring had come up through the floor and knocked off the wooden foot plate. This was just on a first casual inspection. The dark green paint on the tubes had cracked and lifted in places and flaked off with a light scrape – more old protective layers to remove before she can be put back together. I used the best paint stripper but I think they must have changed

The fuselage tubing will need all the paint stripping from it and a new dope-proof anti-corrosion finish applied.

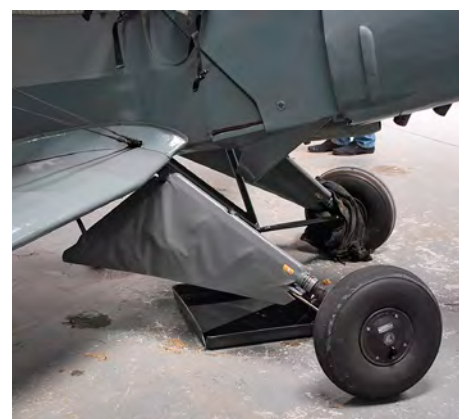
The only obviously broken part of the airframe was the undercarriage. The rear tube on the left had snapped through and the ribs of the fairing were very broken and the trailing metal edge was bent in half. It was much harder to remove than usual because a couple of the bolts were bent. The central leg brace attachment was torn from its mounting on the right hand side of the tripod and the phosphor bronze bush had pulled clean

through. Once the wheels were off I stripped the legs to check for fractures but thankfully with the paint stripped, the weld lines – where cracks are known to form – seemed perfect. I am not yet sure where to start mending the fairing ribs; they are attached with a type of jubilee clip, a thin metal band that wraps round and round and is fastened with a bolt that is turned to tighten the fastening. I am not sure where to get more, or if it is necessary to remove them. The oil filled legs have been emptied, cleaned and wiped with oil so that there will be no corrosion by the time they need to be assembled.

The offending starboard undercarriage leg that gave up in protest.
