SAFETY SPOT

WE LIVE AND LEARN... SOMETIMES

SILENCE TWISTER – TAILPLANE ATTACHMENT FAILURE

AUSTER J5G – IN-FLIGHT AILERON CABLE FAILURE

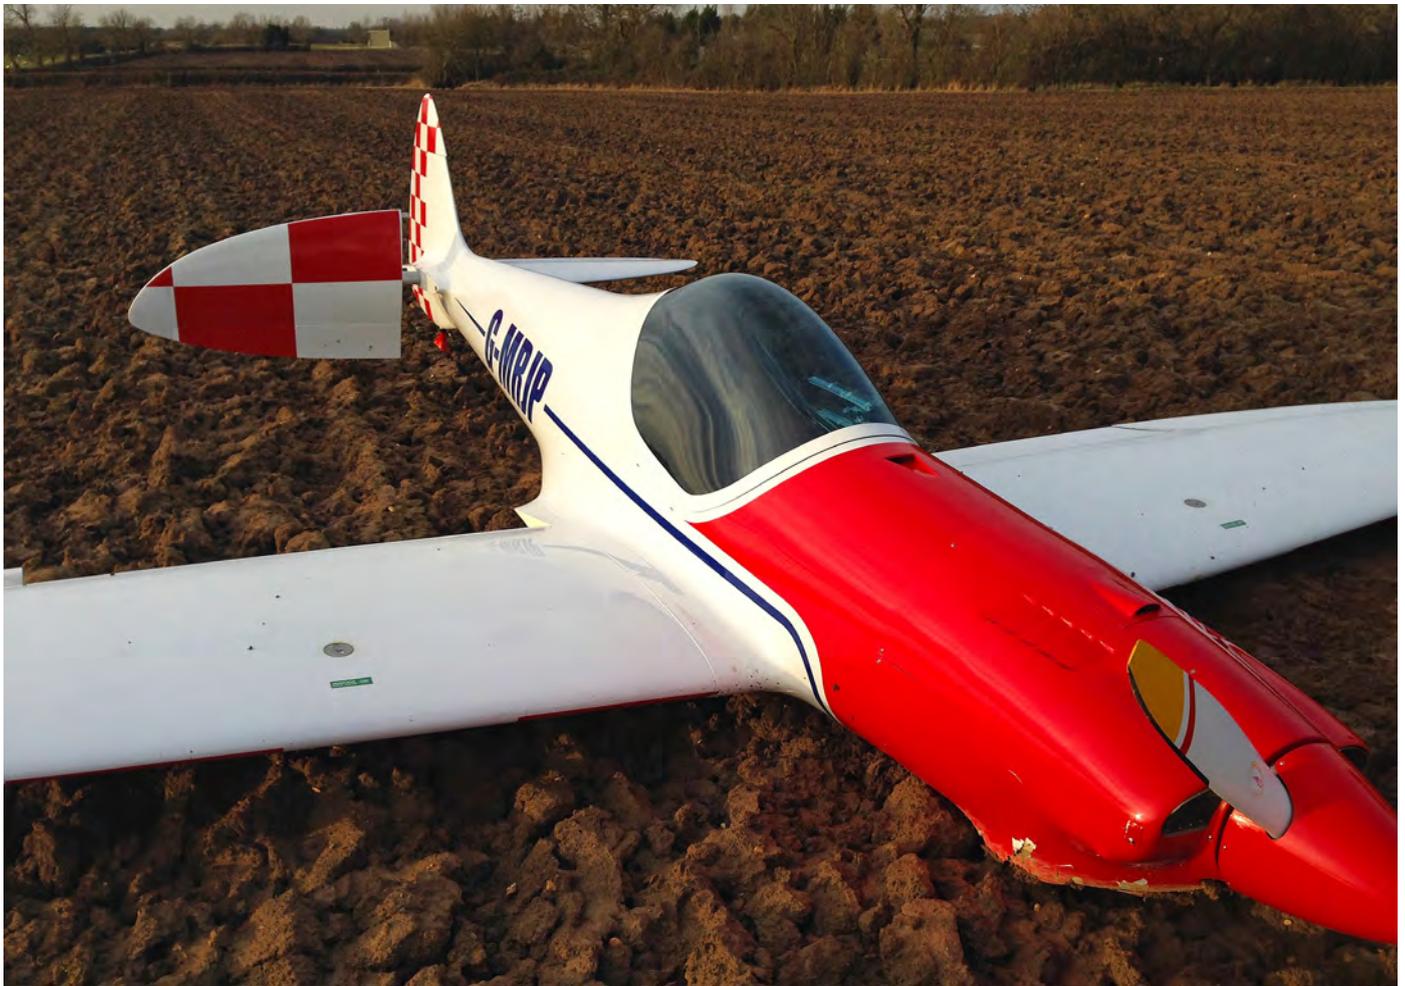
Here's a sorry sight and, although it seems impossible, that's the position that the tailplane, complete with the elevator, ended up after the tailplane securing pin failed on this Silence Twister. It's a pretty big airbrake... so big in fact that the pilot was only just able to maintain directional control and maintaining height was impossible even at full power. As you can see, the undercarriage has failed and although it cannot be seen in this picture, there was a fair amount of damage to the underside of the fuselage. (Photo: John Marriott)

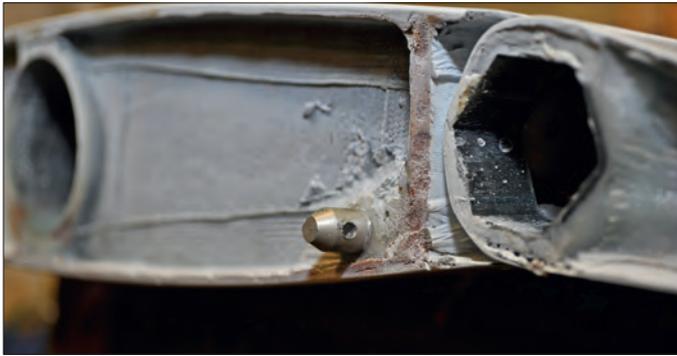
(Left) A picture of the other half of the equation, the female side of the elevator drive is clearly visible and the tailplane rigging spigot takes centre stage. (Photo: Malcolm McBride)

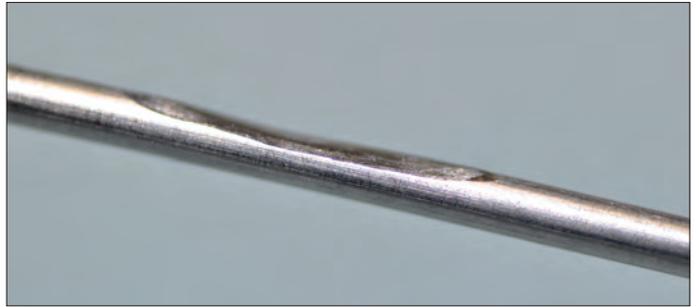
Above is another view of the tailplane rigging pin, and another clue as to what went wrong with the rigging operation that led to an in-flight control failure. This wear has been caused because the guide tube has been fitted too close to the elevator drive tube. What looks to have happened is that the guide tube has worn through and this has allowed the pin to leave through the side of the tube. (Photo: Malcolm McBride)

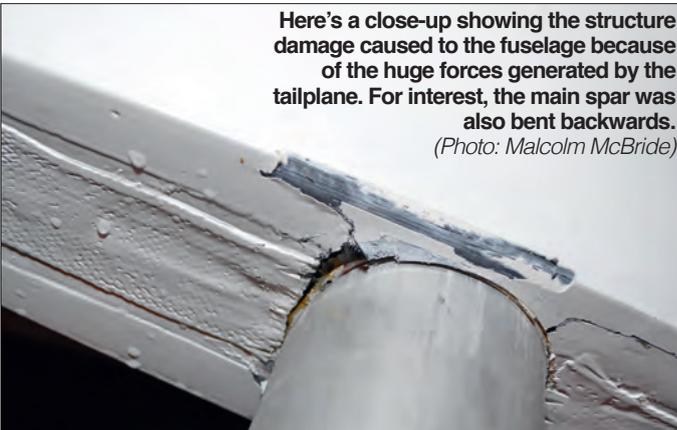
Here's a close-up showing the structure damage caused to the fuselage because of the huge forces generated by the tailplane. For interest, the main spar was also bent backwards. (Photo: Malcolm McBride)

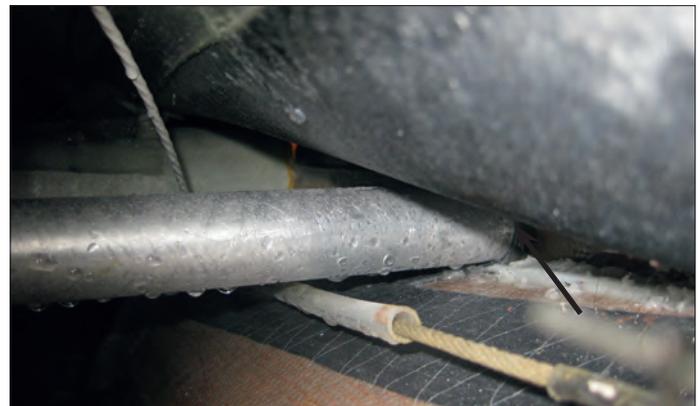
Above is a picture of the elevator drive tube of the Silence Twister that nearly lost its tailplane. You're looking from the rudder-end of the fuselage, the rudder cable is visible (from centre to bottom right). You can see that the rigging pin's guide tube (arrowed) is rubbing on the elevator drive. (Photo: Malcolm McBride)

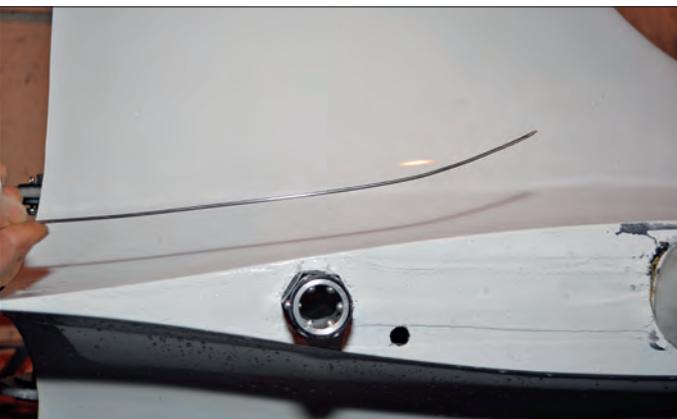
Above is a view of the rear fuselage section of the Silence Twister; note that the rudder has been removed. The locking pin is inserted through a hole at the rear of the fuselage and has to pass under the elevator drive (that's the clever hexagonal fitting slightly left of centre), hence the bend in the pin. You can just see the edge of the tailplane's main spar. It is not necessary to remove the pin completely as the pin really only needs to clear the tailplane locking spigot, but complete pin removal appears to be the precursor for this type of location issue. (Photo: Malcolm McBride)

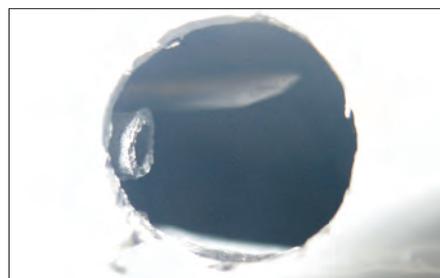
(Left) This picture shows why the locking pin failed to go through the tailplane spigot... and how the fact that it had done this was so easily missed by two experienced LAA flyers. (Photo: Malcolm McBride)

The aircraft was recovered back to its operating base by road and, on inspection, it was found that the wire securing pin (4800115) had left the side of the plastic guide tube before the end of the tube and hadn't, therefore, been in a correct position to direct the pin into the securing spigot (4800053), thus the tailplane was not mechanically secured to the fuselage before flight.

It is highly recommended that before you next fly your aircraft, you ensure that the tailplanes are securely locked in place; this can be done by firmly trying to remove the tailplane by pulling them sideways (as you would normally do when de-rigging). It would be appropriate, to be absolutely sure, to engage the services of an assistant to hold the fuselage in place during this process. One owner has commented that he always checks that the pin is actually passing through its plastic guide correctly before finally fitting the tailplane... this sounds like good advice.

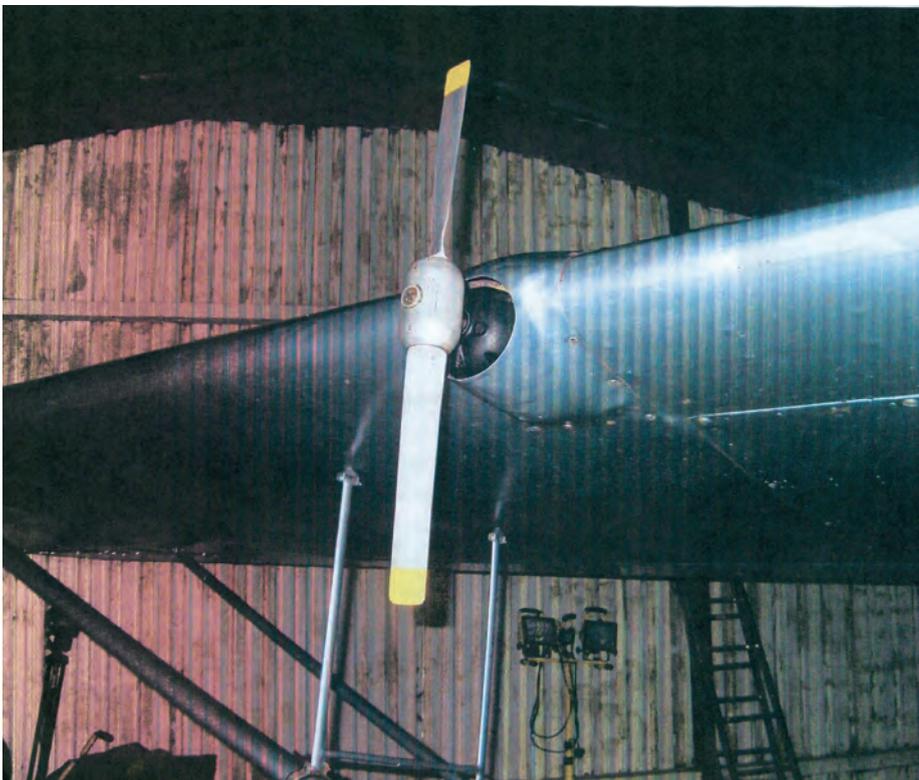
The picture above shows the wing-mounted, wing-driven generator as fitted to Arthur Boon's Auster J5G. Once these devices were commonplace but wind-driven generators are rarely used these days (except as emergency back-ups!). Read about what happened when this generator slowly crept backwards in its mountings in the accompanying article. (Photo: Malcolm McBride)

When the generator moved backwards, the positive pole made contact with the aileron cable which is earthed to the airframe and the resulting dead-short burnt the cable! After close inspection of the broken cable ends when you placed them together, the short looks to have burnt 99% of the way through the cable and the few strands that were left failed under the load of the turn.

The generator is now refitted correctly with a new cork gasket, rotated round 180° which puts the live pole below the aileron cable and all the electric cables have had heat shrink insulation covering fitted with rubber boots.

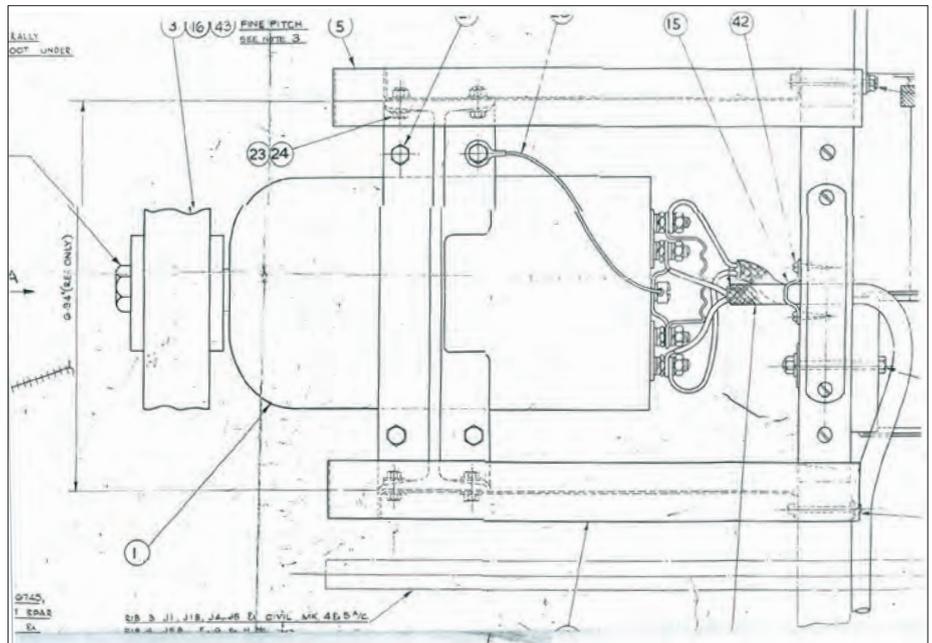
Harold Hall, an LAA Inspector and an Auster Specialist for very many years, checked his archive of Auster drawings for any information relating to the Rotax Generator. He came up trumps, above is a picture of the early type as fitted to Arthur's machine. In this drawing, even though the aileron cables are not drawn in, the issue can be clearly seen. (Photo: Auster Aircraft)

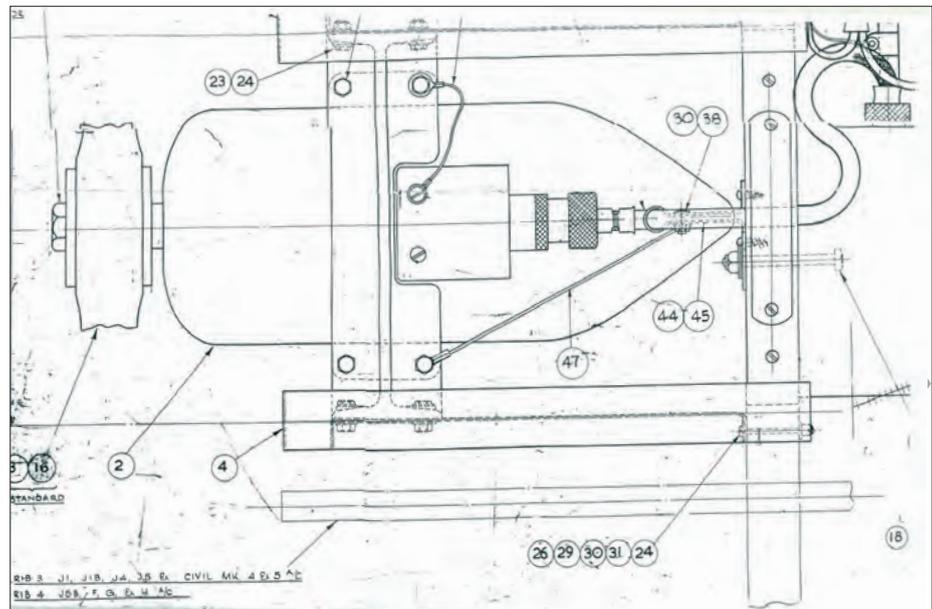
Seek and ye shall find. Above is a drawing showing the more common version of this wind-driven generator installation. You can see that the electrical energy is now taken from the top of the unit, far away from the flight control cables. The rear of the generator has been re-designed into a taper effectively halting any rearward creep. (Photo: Auster Aircraft)

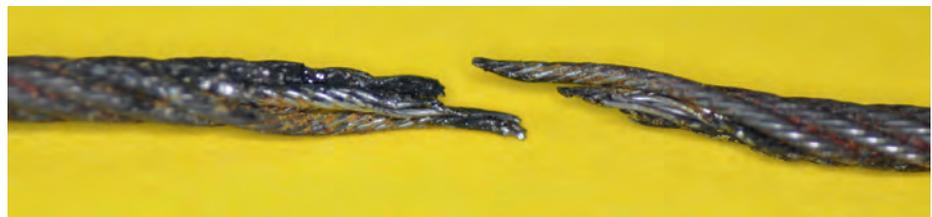
When Arthur removed the failed aileron cable from his Auster he could immediately see what had happened; if you look closely at this picture you can see clear evidence that the cable itself has melted. Initially, it was thought that the generator had moved back into the cable in one movement, allowing a charge to pass through the cable melting it immediately. Because this failure has a clear taper I wasn't so sure, so Arthur set up a test to see what would happen if a similar cable was asked to conduct the generator output.

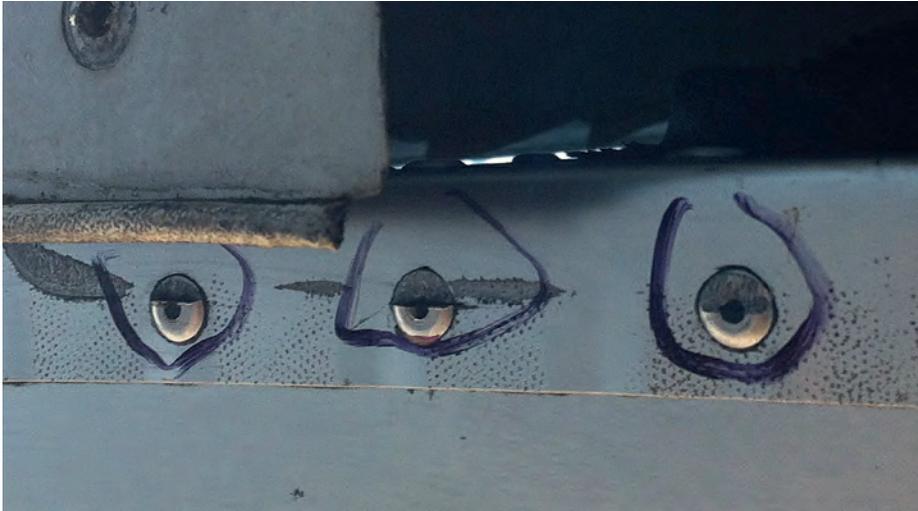
(Above) The real reason for my visit to Booker was to see first hand why Light Sport Aviation had issued a Bulletin requiring the removal of the wing/fuselage fairing within the next ten hours. Surely this would be something that would be automatically removed at each 100 hour or Annual check? As you can see from the 1,400 hour example above, this panel appears not to have been taken off for quite some time and, because the fibreglass has been rubbing against the rivets, the rivet heads have all but disappeared. There are two clear reasons why aircraft panels should come off regularly. The first is inspection; the owner of this aircraft was trusting to luck when it came to the security of the wing/fuselage connection, although he or she signed that all was all OK at every annual. The second is to gain access for essential servicing. I wonder how it would have been possible to lubricate the control mechanisms? Perhaps it wasn't felt necessary in this modern 'plug and play' world. (Photo: Auster Aircraft)
