With Malcolm McBride
Airworthiness Engineer

FORCED LANDINGS & DEPARTING DOORS

Piper PA18 Super Cub – In-flight Engine Failure

Europa XS – Door Torn off In Flight

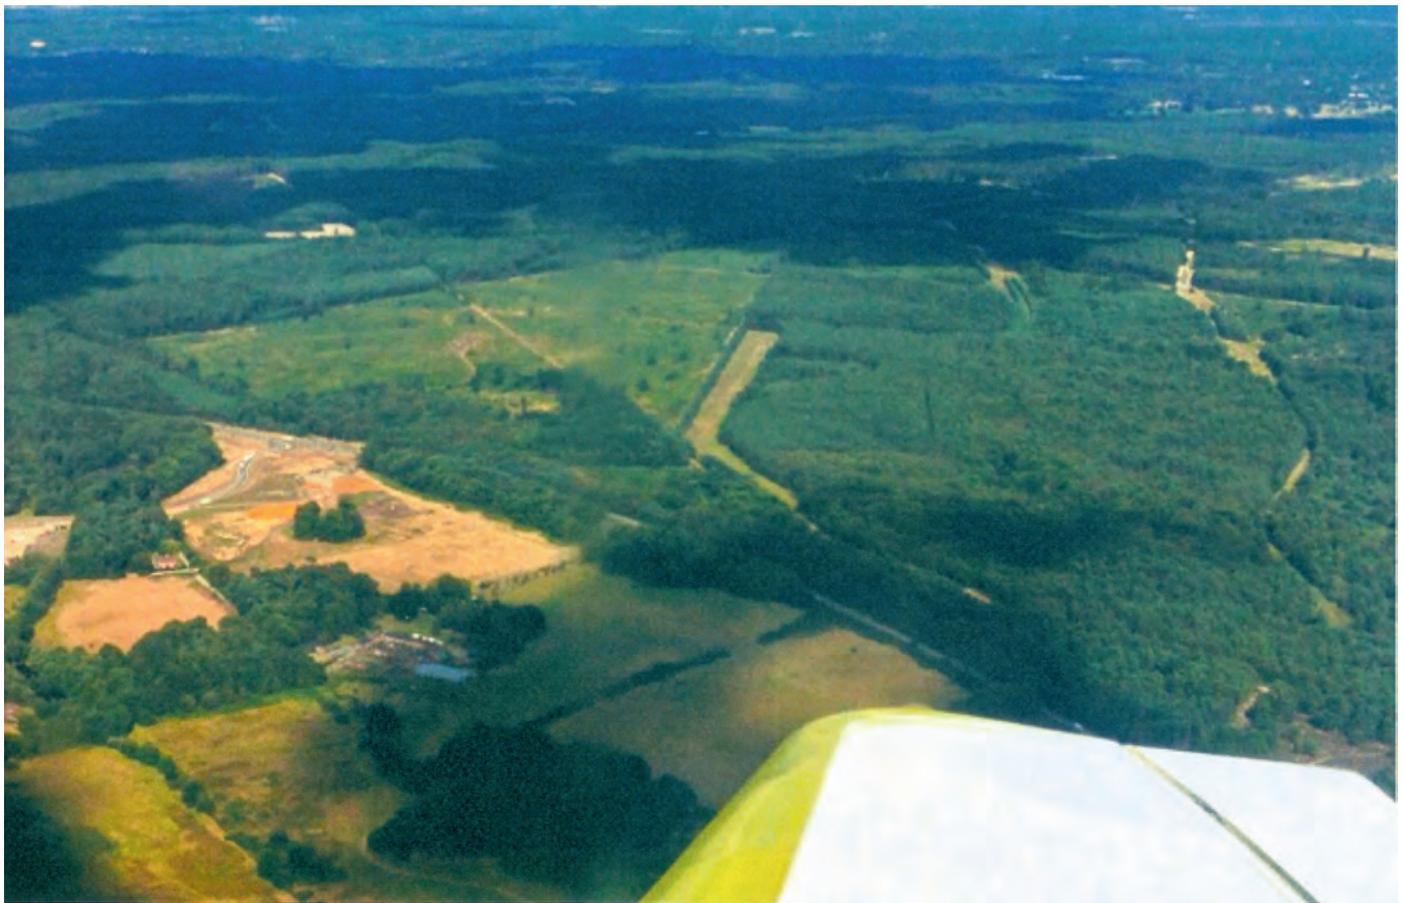
Here's a picture taken by a friend of Jonathan on another flight showing the field (strip) that ended up being used as a landing site when the engine started to misbehave on his Super Cub on the way back from a trip to the Isle of Wight. You can see that landing sites are a bit thin on the ground in this area and good judgement is required to pull off a safe landing. (Photo: Jonathan Morton)

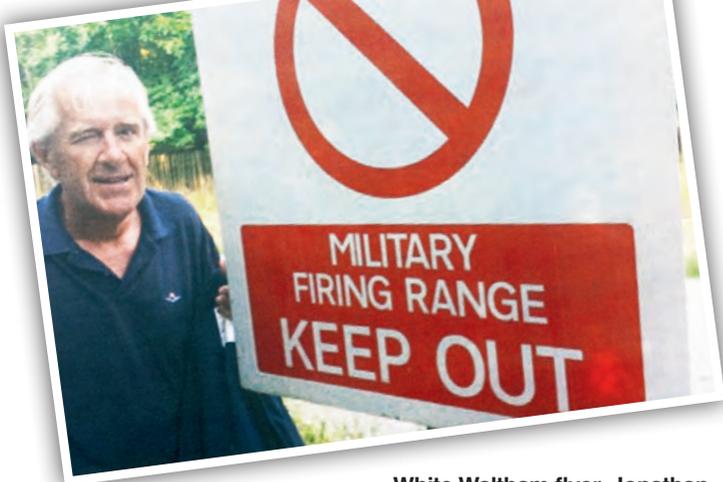
White Waltham flyer, Jonathan Morton, looking pleased with himself after pulling off a good emergency landing into a difficult field. In fact, the strip was part of the live firing ranges around Sandhurst, and Jonathan and his passenger found themselves stuck inside a barbed wire perimeter fence, but commented that both the MPs and the Surrey civvies were very kind and understanding. The aircraft was later de-rigged and trailered back to base by road. (Photo: Jonathan Morton)

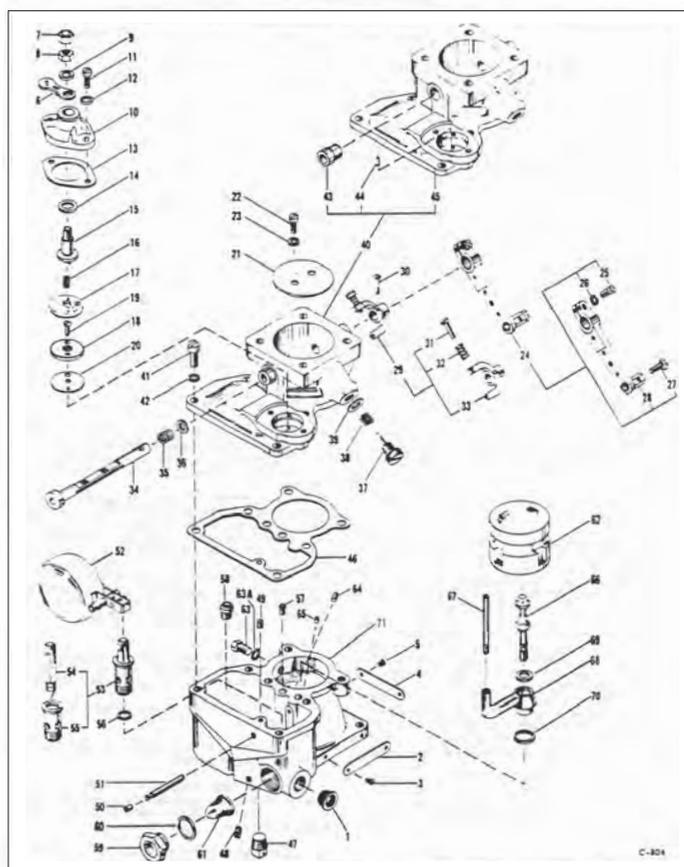
Figure 2-4. Exploded View of Stromberg NA-33A1 Float Carburettor

Carburettors are essentially devices for mixing fuel with air in the correct proportions to ensure complete combustion in the cylinder during the firing stroke. I hope that you can see from this exploded view of a Stromberg carburettor that this, on the surface quite simple job, takes quite a few components to achieve. The first part of the metering process is very much affected by the fuel level in the carburettor's internal store of fuel, the float chamber (bottom of the diagram). You can see the components that keep the fuel level correct in this chamber. Item 52 is the float which sits on top of the fuel, opening and closing the valve (54) against its seat (55). The valve seat is first set in its correct position using shims then, when correct, the seat is torqued down and then wire-locked. It was found, during the later investigation, that the overhauling engineer hadn't wire-locked the seat into place and vibration had caused it to come undone, blocking off the fuel supply. (Illustration: Stromberg Parts Manual)

Oh, and what caused the engine stoppage? Well, I mentioned earlier that, as part of Jonathan's ongoing maintenance plan, the carburettor had been sent off to a CAA approved workshop about 200 hours previous to the stoppage. The LAA Inspector, Alan Turney, who's known this aircraft for many years, soon realised that the engine had stopped because it wasn't getting any fuel. The carburettor was removed and the fault was soon discovered. When it was overhauled, the person who re-assembled it clearly didn't wire-lock an internal component so, after a couple of hundred flying hours of continuous vibration, it unwound (probably quite quickly once it became loose), essentially shutting off the fuel supply and stopping the engine. There could have been no sign of this externally so both the aircraft's day-to-day management and the age of its engine were exonerated.

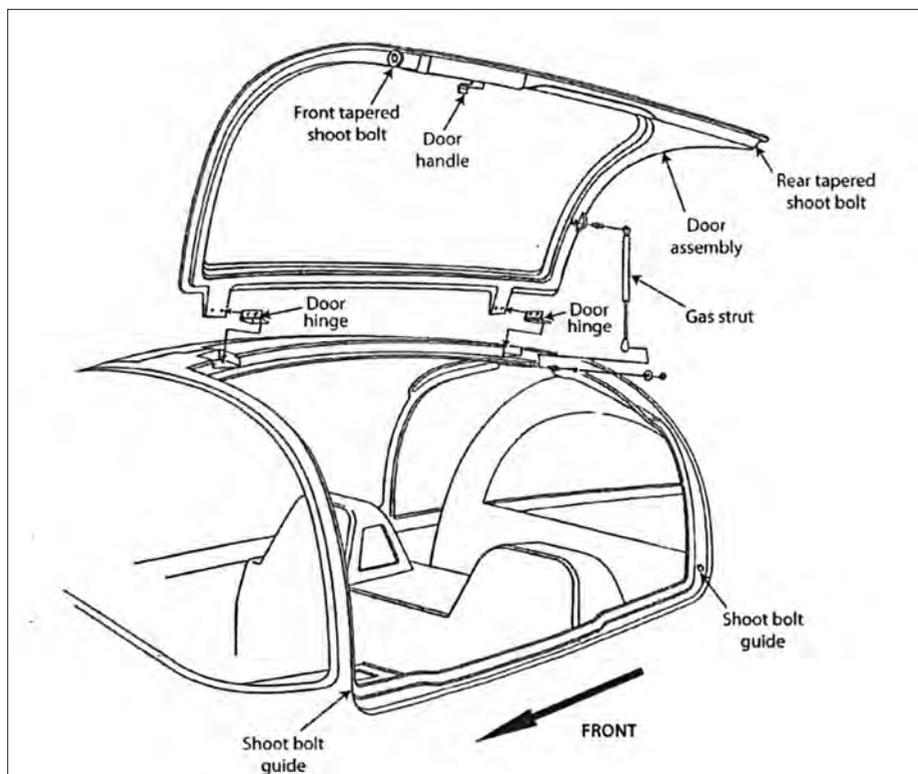
This sketch showing the general arrangement of the gull wing doors as fitted to the Europa. Note that there are two shoot bolt guides, one at the front and one at the back. After closing, it's easy to see whether the front pin has entered the guide but the rear guide sits behind the pilot's shoulders and is more difficult to see. Because the door is actually quite stiff, pushing on it during the normal 'Hatches and Harnesses' pre-take-off checks are clearly not a reliable way of determining whether the rear pin has engaged in its matching recess or not.

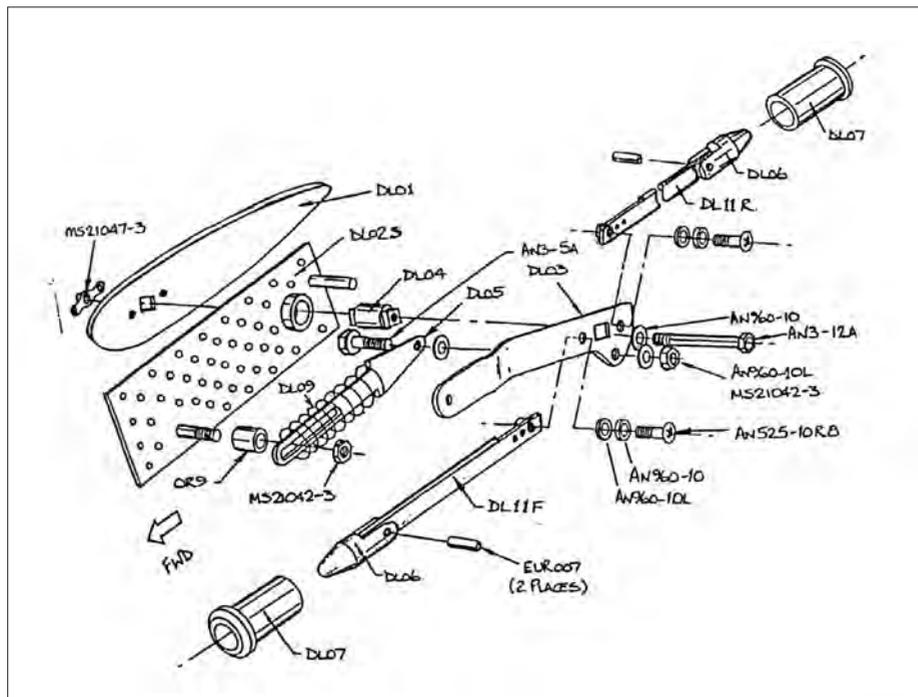
If you are a regular follower of Safety Spot you will know that we've seen Europa doors fail before. This picture shows the relatively complex mechanism involved in pushing the locking pins (shoot bolts) into their guides. Because in the event described in the text the pilot was sure he had shut the door fully, at first we thought that the wear in the mechanism might be preventing the bolts from going fully home.

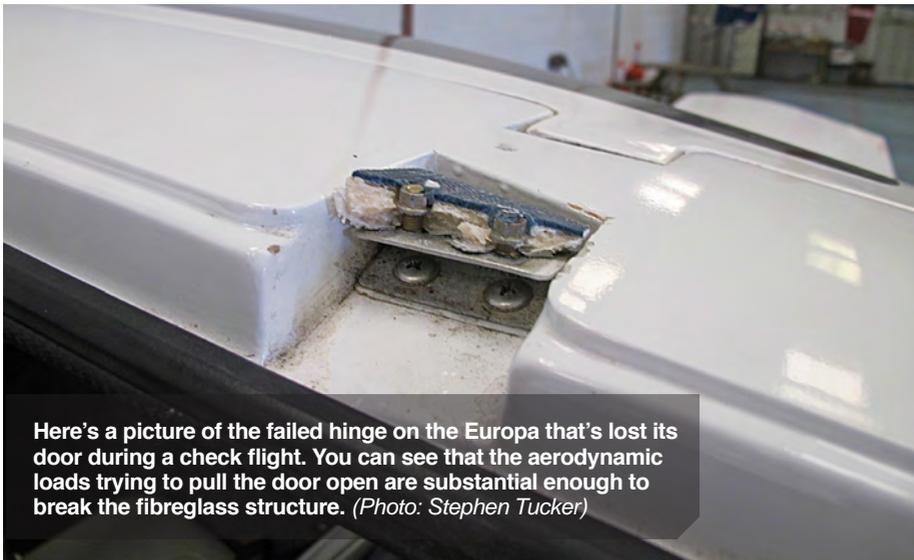
Here's a picture of the failed hinge on the Europa that's lost its door during a check flight. You can see that the aerodynamic loads trying to pull the door open are substantial enough to break the fibreglass structure. (Photo: Stephen Tucker)

With legal boxes ticked, the check-crew took-off to fly the LAA schedule. All was going well until, whilst flying at about 100kt, the port door ripped itself off the hinges and disappeared rearwards. Naturally, the check flight was abandoned and the aircraft returned home for a precautionary landing. After the incident both the pilot and the observer were adamant that they had checked that the doors were closed before departure and the observer, whose door had departed, added that there was no flapping or draught to suggest that the door had not been properly closed.

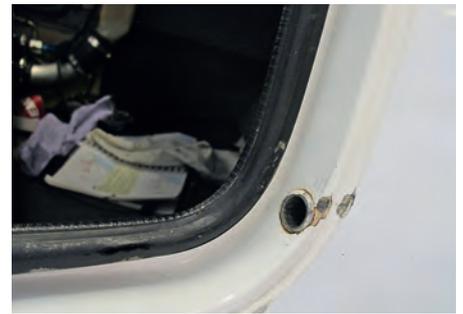
This picture, showing the rear shoot bolt guide, shows clearly from the witness/wear mark left behind that when the aircraft took off the rear shoot bolt wasn't engaged. The fact that the door wasn't closed properly wouldn't necessarily be noticed by the crew until the airspeed passed a critical point, in this case, 110kt. (Photo: Stephen Tucker)

March 2013). Certainly it's very easy to think the Europa door is closed without the rear shoot-bolt having gone home and, as many will know, a quick push on the door won't establish whether this has happened or not. As you can see from the photos, this crew may have been very lucky. The departing door hit the tailplane, causing substantial damage, which has added impetus to the ongoing search for a solution to this re-occurring issue. It has also opened up another discussion point: why, in the view of an insurance company, should a minimum qualification to fly an aircraft, if you're not the owner, be a flying instructor's rating? Surely experience on type is more important?

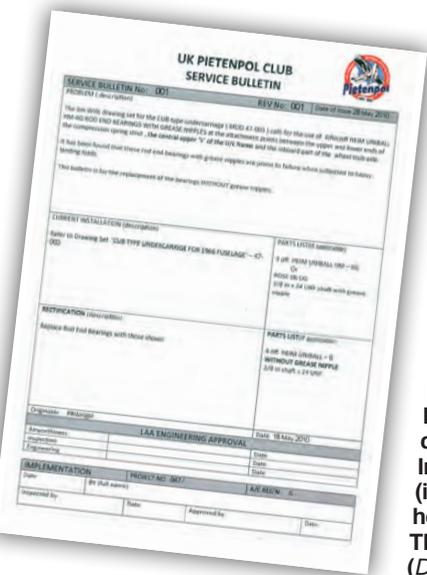
After the last Pietenpol rod end failure, The Pietenpol Club issued a Service Bulletin advising owners to replace any in-service rod ends with a stronger type of rod ends without nipples, which was a change endorsed by LAA. At the time, it was thought that the hole for the grease nipple was creating a stress raiser which was leading to failure. It's likely that this was the case but, now we've had a failure of a non-grease nipples bearing, albeit one of questionable quality, LAA Engineering is looking at requiring fitment of stronger bearings altogether and the introduction of a component life.

Interestingly, in this recent failure, the safety strap mod (info available from the Pietenpol club) wouldn't have helped as the undercarriage folded inwards when it failed. The strap only prevents collapse in an outward direction. (Diagram: Pietenpol Club)

As it turned out, the two-man team landed the aircraft without incident and very little damage, a good job very well done. You can review what failed in the attached pictures, and yes, we've seen this type of failure before, back in 2010. Suffice to say that LAA Engineering will shortly be issuing further advice to Pietenpol owners about the inspection and replacement requirements of the rod end bearings used in this type of undercarriage.

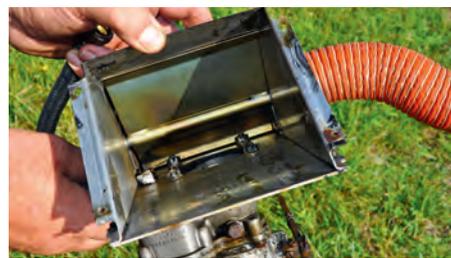
It is absolutely essential when a part fails in an engine that all the 'remains' are found before the engine is put back into service. Alan found part of the broken valve in the induction air-box – it must have passed backwards through the induction system, just don't ask me how!

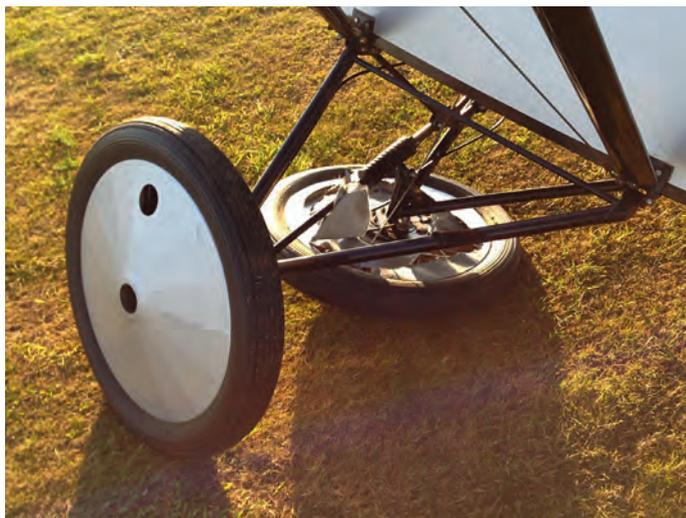
Have you seen this picture before? I know that you won't have done because this picture showing a failed Pietenpol undercarriage is hot off the press. The last time a rod end failed on a Pietenpol, back in 2010, we featured a very similar shot. You know what they say, 'What goes around, comes around'. (Photo: Neil Constantine)

"My pal, also an experienced taildragger pilot, and I were enjoying a flight in good weather around the local area. After about 20 minutes we decided to fly a few touch-and-go landings. I think we'd done about three, maybe four... anyway, just as we touched down I noticed, rather felt, something 'go' in the undercarriage. I applied full power and converted the landing into another touch-and-go. Looking over the starboard side it was clear that there was something wrong as the undercarriage leg was swinging about in the breeze".

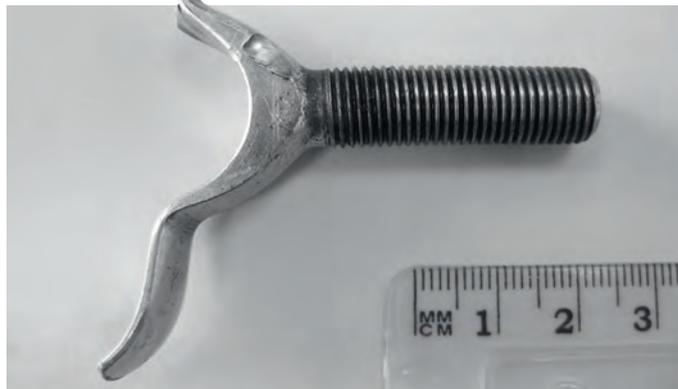
This rod end bearing has failed in tension, as you can no doubt see. We know from the aircraft's maintenance records that the rod end was replaced in 2010 after a similar failure during taxiing. At the time of replacement the aircraft had accumulated 162 hours. This replacement rod end failed at 230 hours so, by deduction, we can assume that it has been in service for just 68 hours. The current owner has logged 57 hours and 209 landings. We're not sure of the number of landings before this. We do note, however, that this Aurora MM6 bearing is not a part designed for heavy duty operation and the Heim heavy duty bearings are showing better service. (Photo: Malcolm McBride)

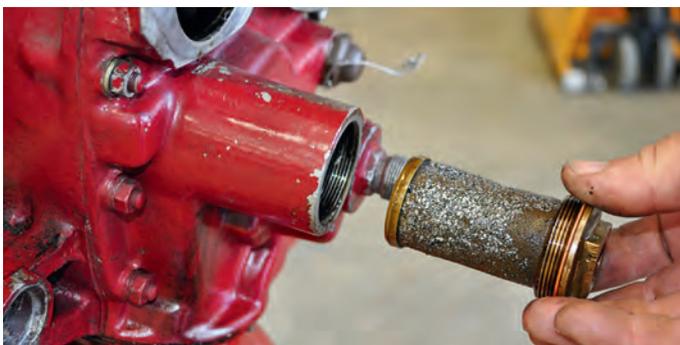
(Left) This picture shows some of the piston in the oil filter screen.

(Right) As it turned out, Adrian was able to source another engine, in fact, whilst I was on my lunchtime walk yesterday, I watched him take-off and cautiously fly a circuit. Everything looked (and sounded) fine, and I saw him depart after final engine checks later in the afternoon. This picture shows one of the exhaust valves from one of the other cylinders of the duff engine. The area shown is where most valve failures actually occur, this is because it's the area that takes the most punishment. Note the transition from a smooth surface, under the mushroomed head, to a pitted surface in the shank. This engine had completed about 650 hours after an LAA rebuild, but the records weren't concise enough to work out how old the valves were. *(Photo: Malcolm McBride)*

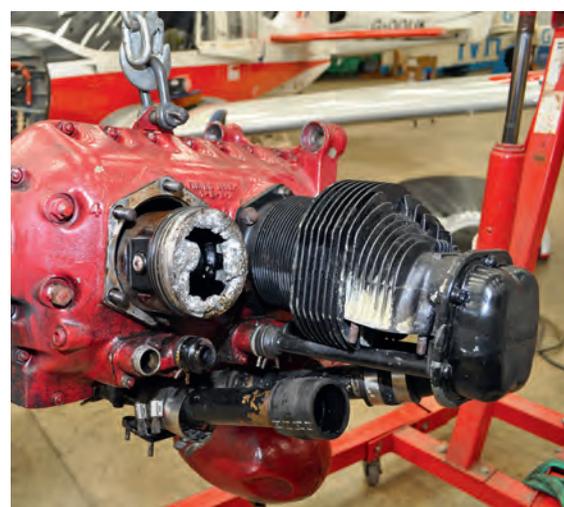
(Above) LAA'er Adrian Lines was flying his Aeronca 7AC back to Leicester after a great day out at Popham when, as he was passing between Fimmere and Turweston his engine lost most of its power. Given the choice of landing spots he opted for Turweston. Well done to Adrian for getting his lovely aircraft back on the ground safely. Here's the engine as it was removed from the airframe under the watchful eye of LAA inspector, Alan Turney. I expect that you can see what's happened... yes, an exhaust valve has failed. Because the detritus from this failure was sent around the engine, most of the compression was lost in the remaining cylinders, hence the virtually complete loss of power.
