With Malcolm McBride  
Airworthiness Engineer

# EXTRA CARE AS THE NEW SEASON STARTS

In a real mixed bag this month, we look at the crucial role of a decent pre-flight check, seat-belt brackets and control systems

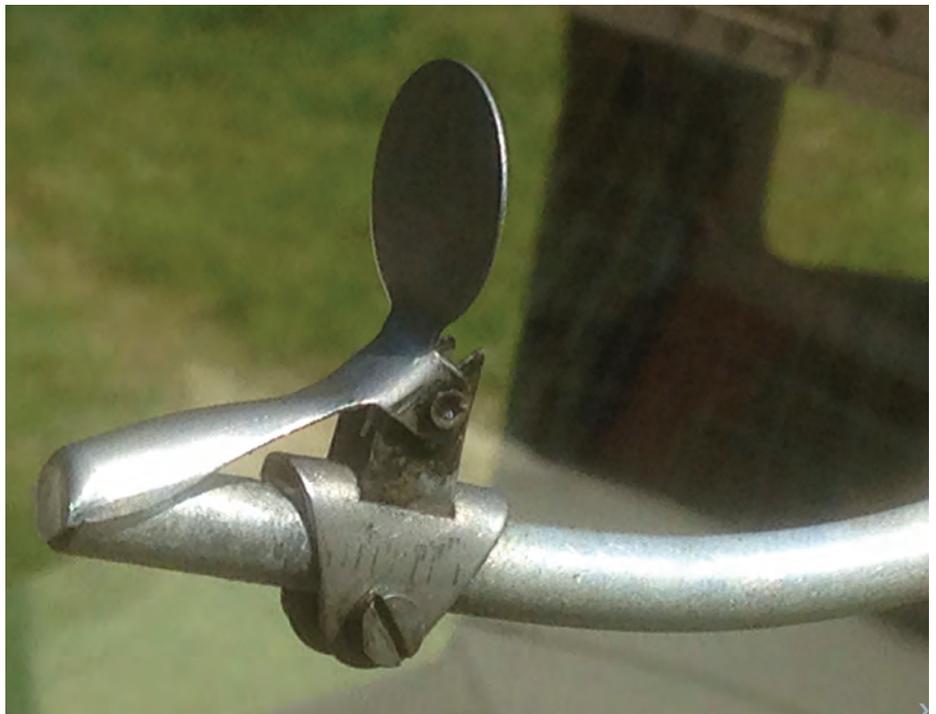
**Many of you will have seen a device just like this; the idea, of course, is to prevent bugs from entering the pitot system and making it their home. As the aircraft accelerates, the air pressure on the plate at the top opens the pitot to oncoming airflow. Pitot pressure, and therefore airspeed information is then available to the pilot. It's a good idea to check instruments as soon as you're able to, preferably before flight. For example, you can check a turn and slip as you're taxiing... 'turn right, indicating right, ball left, compass increasing'. Early on during the take-off run it's worth checking that you're getting full power and that your airspeed is increasing.**

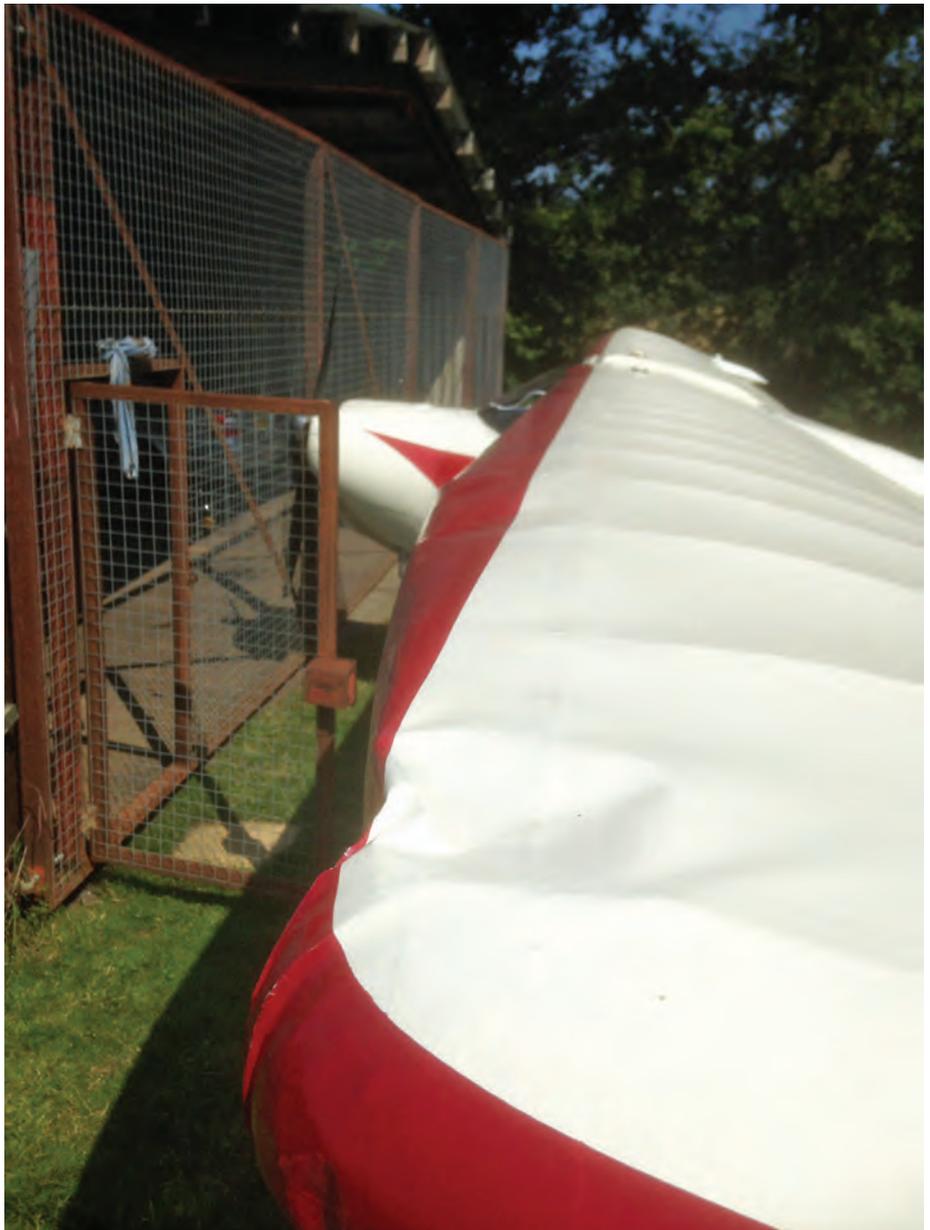
The pilot of this Luscombe didn't quite have enough distance to stop his aircraft after his passenger noticed that the bug-protector pitot cover had got stuck closed. Fortunately, he ran into the hangar at the end of the runway very slowly indeed and the damage was minor. (Photo: Duncan Campbell)

*During the take-off a hinged cover on the aircraft's pitot probe, designed to deflect under air loads, did not operate correctly, giving erroneous airspeed indications. The pilot abandoned the take-off but the aircraft overran the grass strip and collided at very low speed with a hangar.*

Duncan explained, *"We always check that this pitot cover flap is free to move during every pre-flight inspection, and I'm sure that I did this on this occasion. I have no idea why the flap should have failed to open during this particular take-off. I think that we failed to stop because the grass had just been cut and braking efficiency was significantly reduced. As it turned out, we only hit the hangar at a very slow speed so the damage seemed limited to a new propeller and a replacement leading edge skin but, serving perhaps as a warning, when the aircraft went to a professional repair outfit to deal with the damage, they discovered that the minor impact on the wing tip had, in fact, buckled the roof quite badly. The whole group is really looking forward to getting our 'girl' back."*

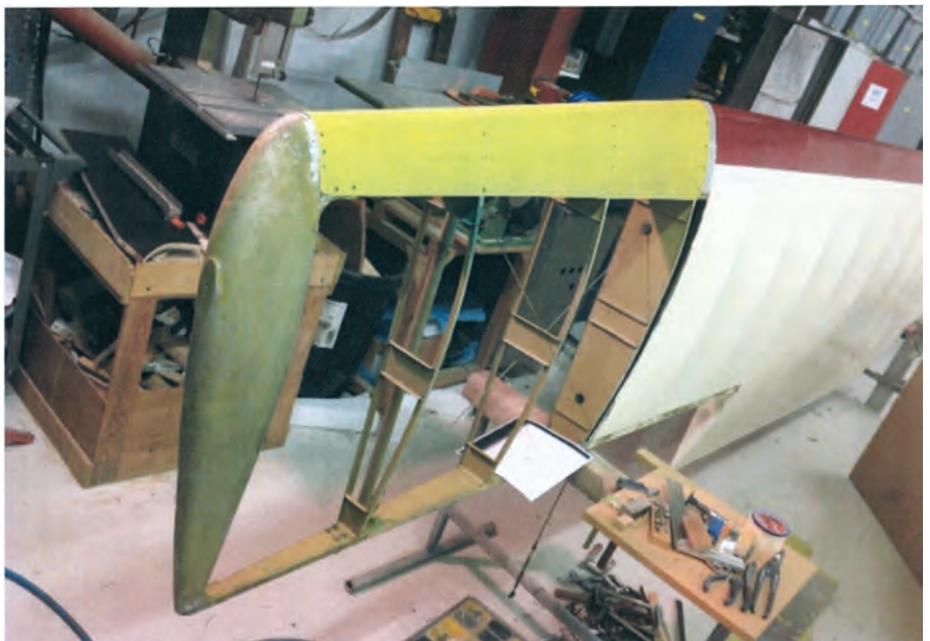
The Luscombe being repaired; I've included it so that you can see the structure inside the wing – it's a bit like an atom, mostly space! (Photo: Roger Targett)

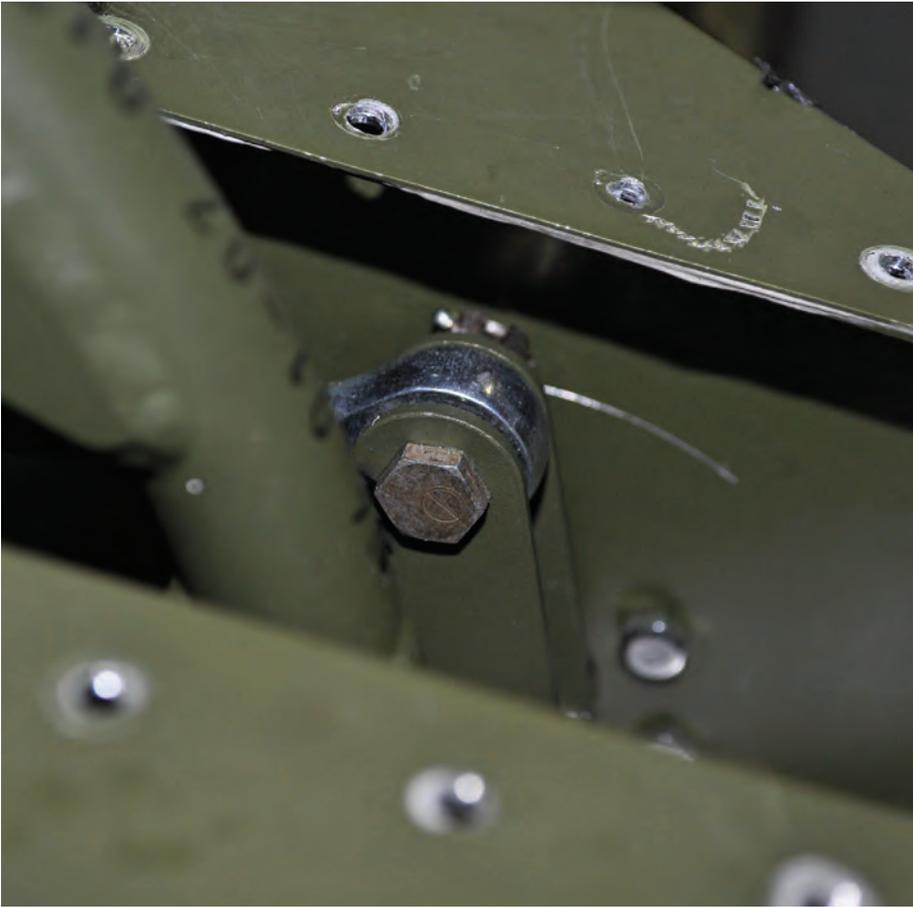
**This is a picture showing the connection to the flap drive to the torque tube in an EV-97 Eurostar and is an example where a close system inspection is warranted: notice the scoring made by the edge of the bolt as it rubs alongside the fuselage structure – of course this scoring shouldn't be there; it is a clue that all is not well in the system and must not be ignored. (Photo: Malcolm McBride)**

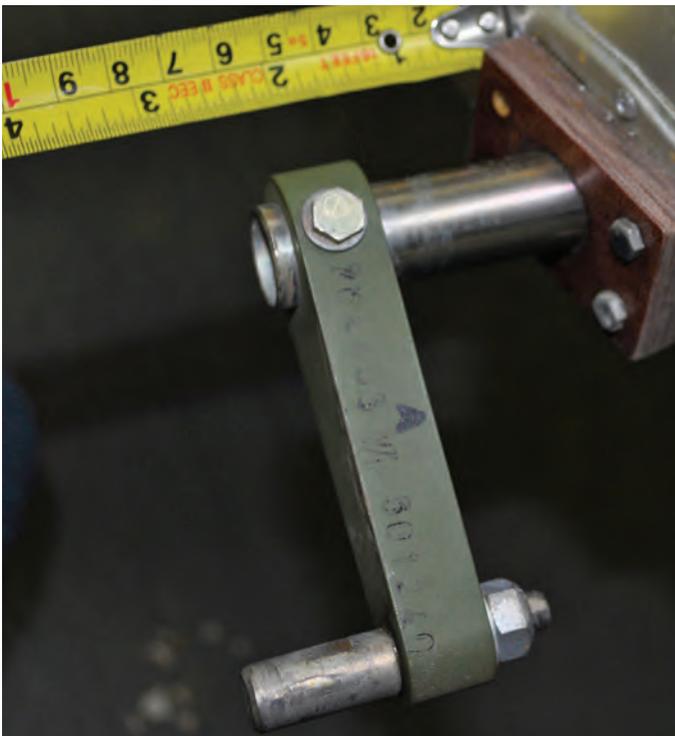
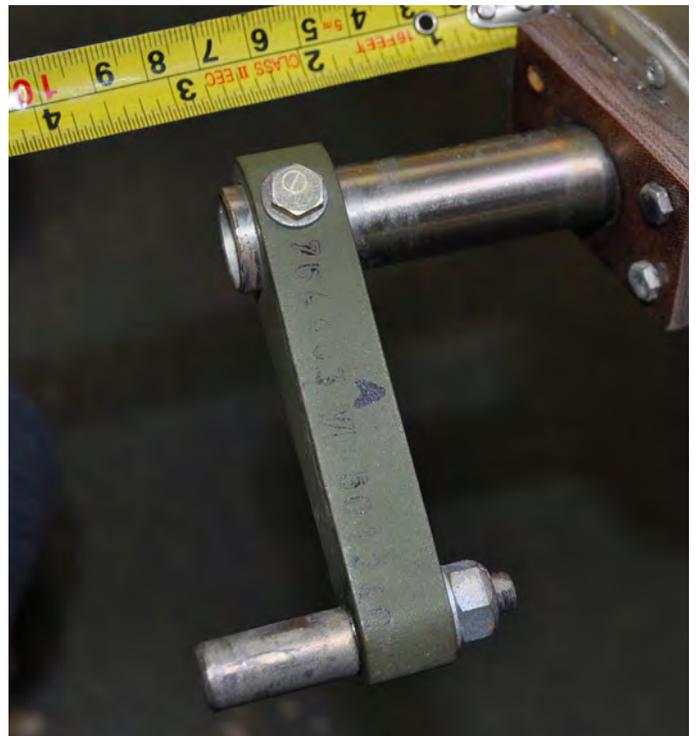
**As it turns out, an unnoticed dimensional error during the drilling of the flap's torque tube led to side-to-side movement in the torque tube on final assembly, something that wasn't spotted by the inspector who cleared the aircraft for flight. The pictures aim to provide a measurement of the side-to-side movement; the first picture measures 33mm and the second 40mm, that's a sideways movement of 7mm, easily enough to allow the pin to escape from the flap during normal operation. (Photos: Malcolm McBride)**

I agreed with Chris that many of the things he pointed out were indeed troubling and made a note to write-up Chris' points in a report to the Chief Inspector about poor quality inspection and work on this particular machine. All the individual issues pointed out by Chris were important in terms of overall quality of build but none of them in my view would have caused a catastrophe. Chris, however, had saved the best (or perhaps more appropriately, the worst), until last. In a jaw-dropping moment, he proceeded to demonstrate that he could push the flap torque tube from side to side quite freely. It was clear that at one extreme the flap mechanism itself was fouling the fuselage structure which was, naturally, totally unacceptable, but the full possible consequences of the lateral movement at the other extreme didn't, I confess, immediately dawn on me. However, with the torque tube pushed hard that way, the flap's drive pin could have at any time become disengaged from the flap itself! >

We now have to wind the clock forward to 2014. I received a telephone call from Dr Edmund Otun, Light Sport Aviation Ltd's Technical Director, asking if I'd seen the Mandatory Bulletin issued by Evektor-Aerotechnik, the EV-97's Czech manufacturer, about checks it requires on the flap drive pin engagement. I was, on reading the Bulletin, immediately reminded that this is a critical inspection point on this type and set about creating an Airworthiness Information Leaflet to promulgate Evektor's obvious concerns and required measurement checks to ensure full engagement of this Flap Drive Pin.

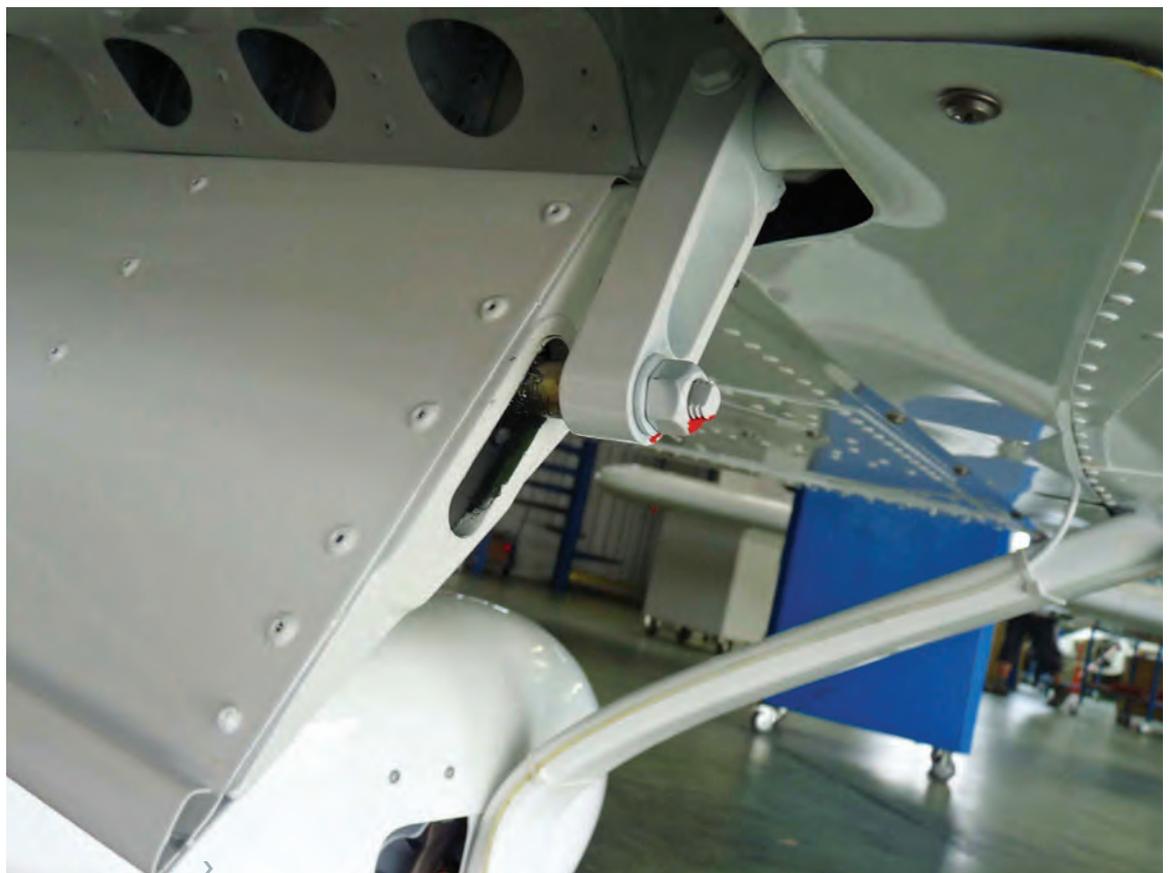
**The connection method used between the flap drive and the flap on an EV-97 Eurostar. It's a very neat idea and allows for a simple de-rig. A recent problem occurring on a foreign aircraft has led to Evektor, the aircraft's manufacturers, issuing a Bulletin requiring checks to ensure that the flap drive pin cannot inadvertently come out. (Photo: Evektor)**

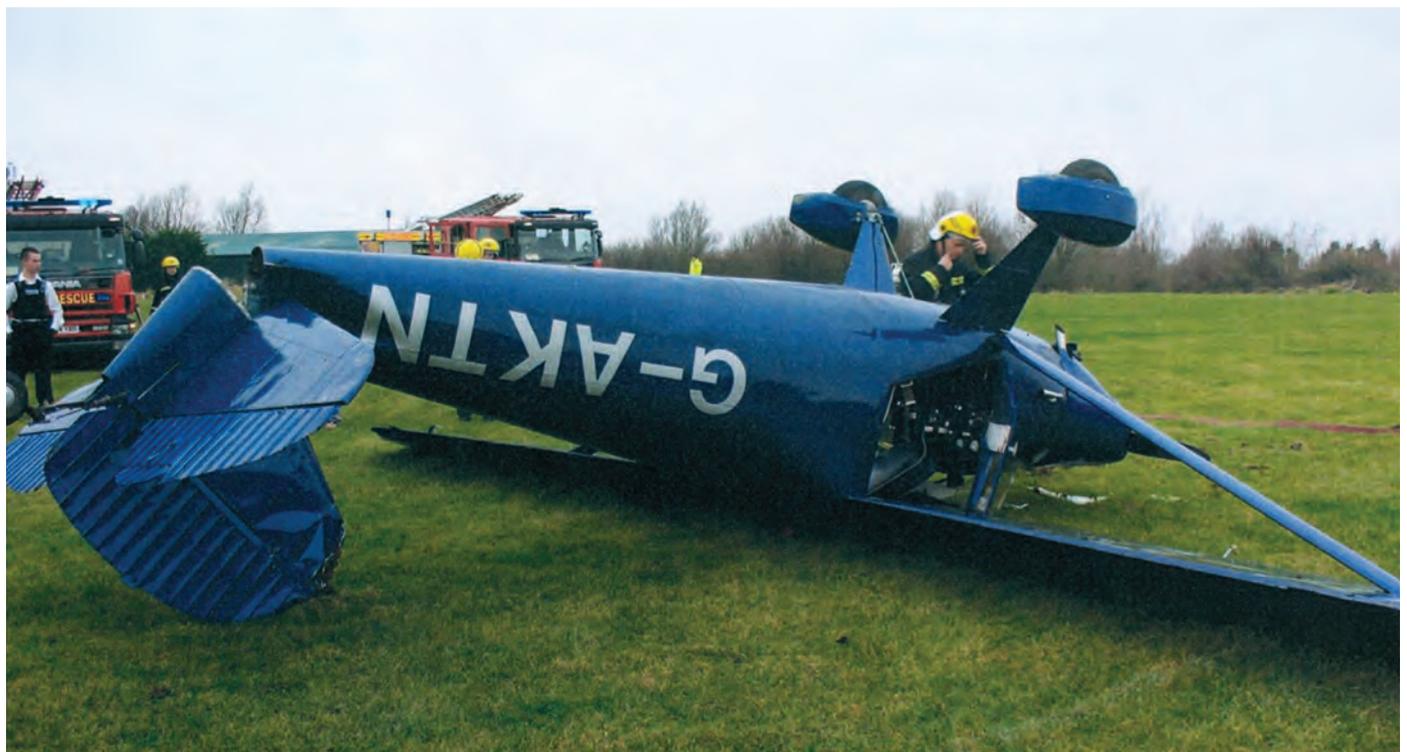
The pilot of this Luscombe, who had approximately 60 hours experience on tailwheel aircraft but only two hours on type, had completed a check flight on the Luscombe 8A a few weeks earlier. He reported that on this landing the aircraft had floated much longer than he had previously experienced and did not slow down as quickly as expected. He applied the brakes towards the end of the landing roll, at an estimated speed of about 20mph. Initially there was no response, then the brakes locked up, pitching the aircraft over onto its back. The pilot considered that the long float prior to touchdown and his inexperience on this type, which is not equipped with flaps, were contributory factors. I show this picture to remind pilots why seat belts are so important. (Photo: LAA library)

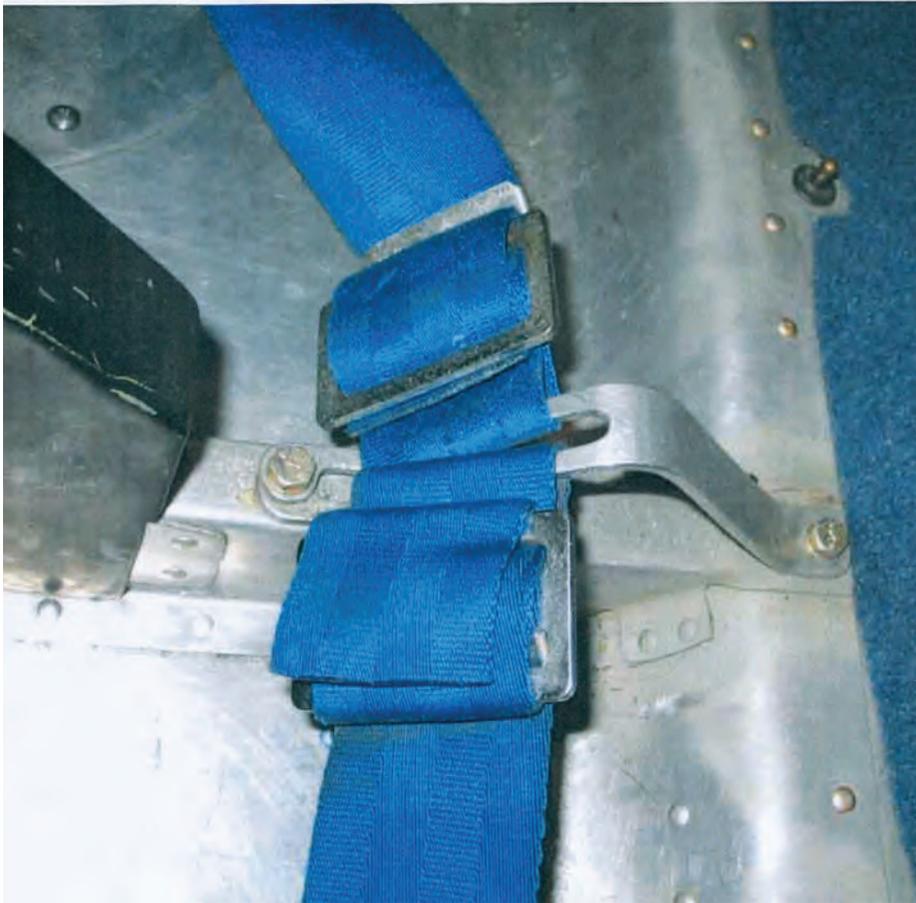
(Above) The seat belt attachment on a Cessna 120; note, it's not that big a component when you consider that it might have to take the combined weight of two hefty pilots! Cessna has recently issued a Bulletin suggesting that these early aluminium brackets should be changed for far stronger steel replacements. We agree with Cessna and are issuing an AIL requiring the upgrade. (Photo: Cessna Web Forum)

This type of Service Bulletin is rarely, if ever, published without good cause and, after looking online, it was clear that the failure of at least one of these brackets was being implicated as a possible component in the cause of death of a pilot in the US. The possibility of a lawsuit may have contributed to the lack of narrative in the Cessna SB.

I received a telephone call from one of our LAA Inspectors, Michael Powell, who asked whether I'd seen the recent Service Bulletin issued by the Cessna Aircraft Company. I explained that I hadn't and asked what it was about. Mike explained that the mandatory Bulletin required all seat belt attachment brackets to be checked at, or before, the next 100 hour inspection (or at the next annual). He explained that the Bulletin itself was a bit thin on explanation but, in essence, looked as if it was going to require that most of the brackets in service would need to be replaced.

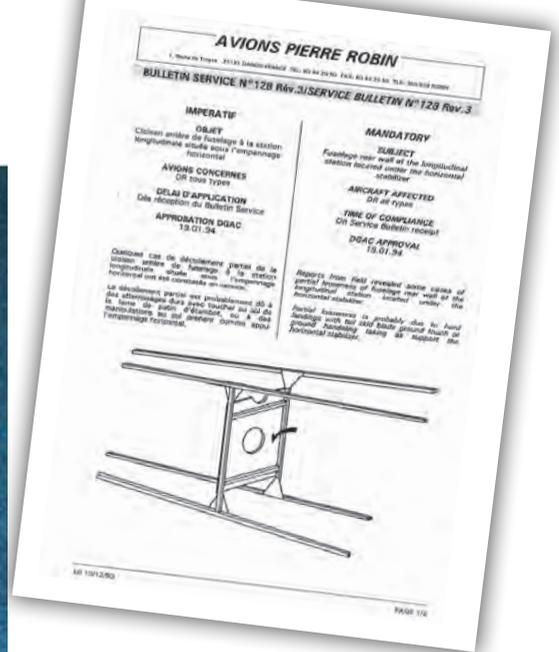
(Above) We discussed, in last month's Safety Spot, the runway excursion suffered by LAA flyer Chris Jolly at Lee-on-Solent in November 2014. This feature has generated quite a bit of interest and some debate, something that can only be a good thing. Interestingly, there have clearly been problems involving the rear fuselage area before and thanks to LAA Inspector Mike King for reminding me of this. This is a picture of the front page of a 1994 Service Bulletin suggesting checks in this area of the fuselage every 100 hours, after a heavy landing or, and I quote, 'after a flight under high load factor or in hard turbulence'. I've amended the LAA's recent Airworthiness Alert LAA/AWA/15/02 to include a link to this rediscovered SB (Avions Pierre Robin SB No. 128 Rev 3) should you want to download it for your records. (Photo: Mike King)

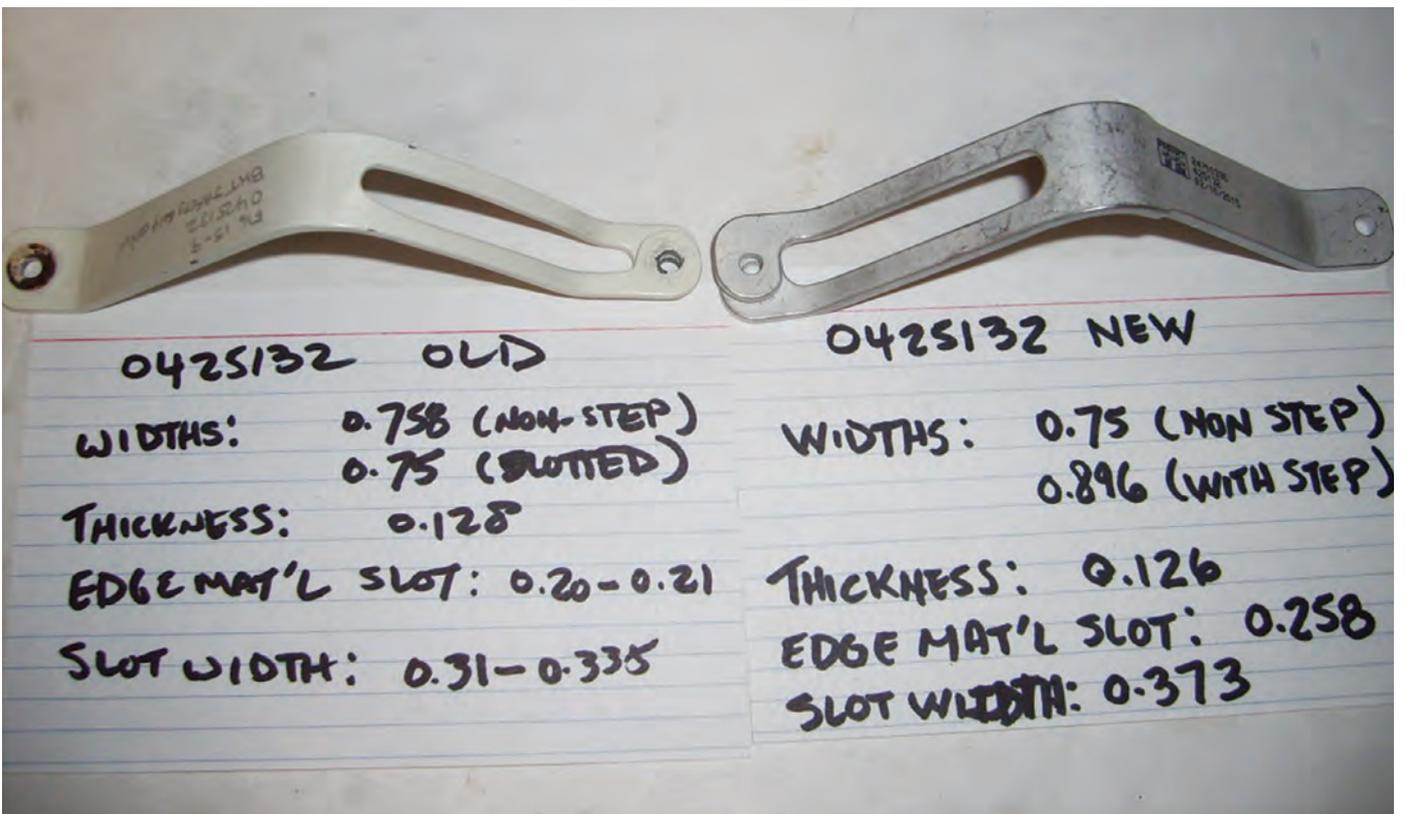
This photo shows the small difference between the aluminium original bracket and the newer steel replacement. (Photo: Cessna Web Forum)

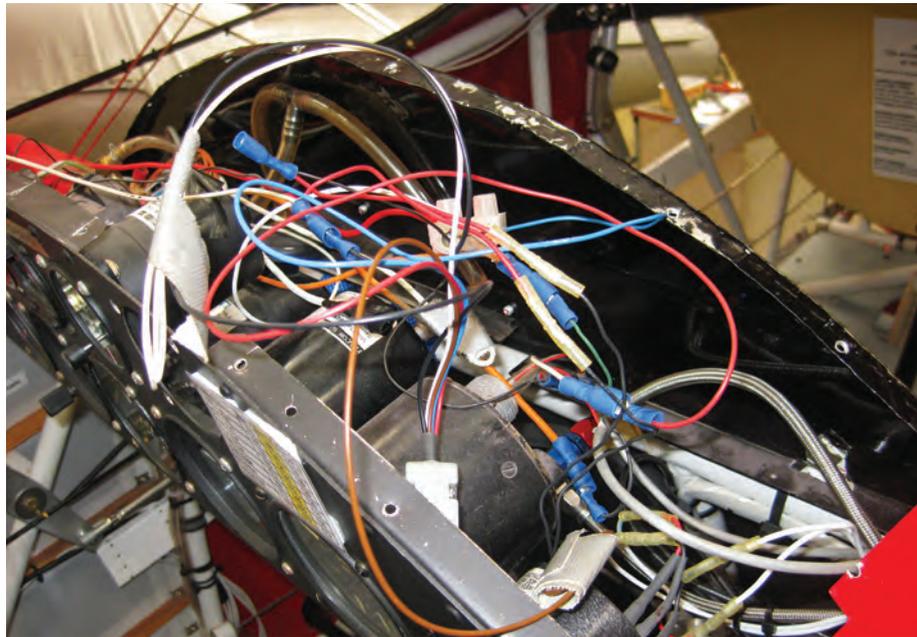
*(Left) Carrying on with our theme of acceptable/unacceptable standard of work, I'll show you what one inspector recently called me into the hangar to look at. I hope that you'll agree that, whilst it might all work, it's very gash workmanship and not anything like what's acceptable on an aircraft. Whilst we're talking about airspeed indicator failures, notice the pitot tubes top left... (Photo: Malcolm McBride)*

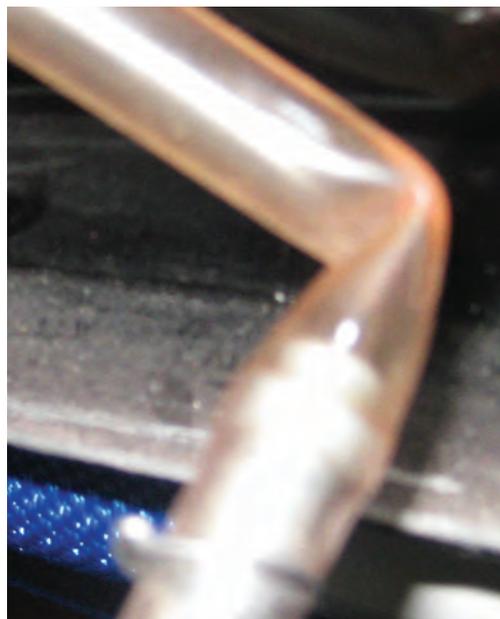
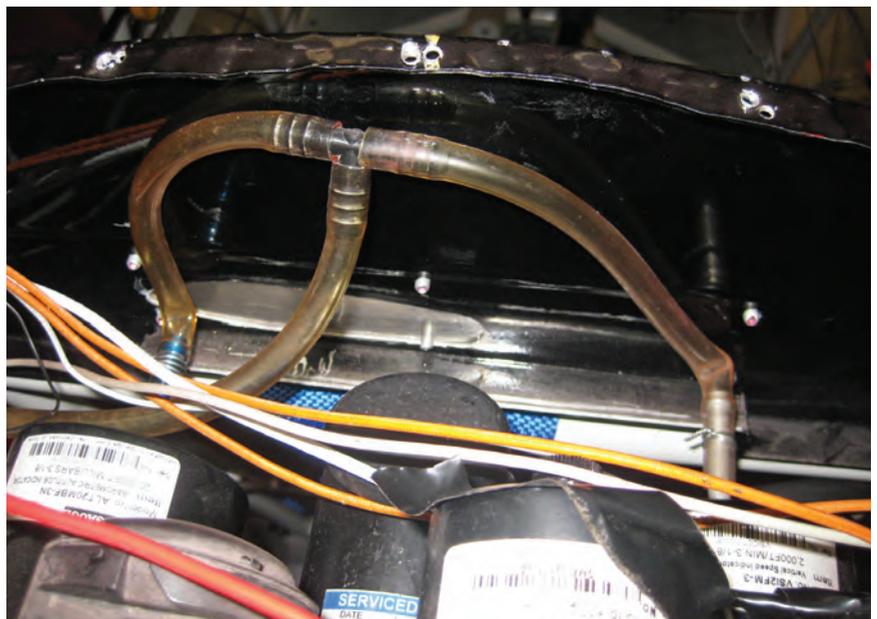
*(Below two) These two pictures are a good example of 'the picture tells the whole story'. (Photo: Malcolm McBride)*

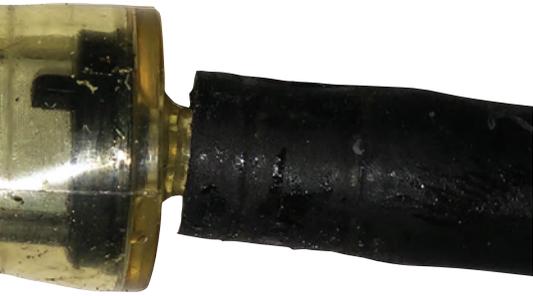
(Above) Thanks to North Country LAA Inspector, Nick Stone, for sending in this picture of a 'just about to fail' fuel filter. You can see, I hope, that this plastic filter has got hot at some point in its life and, although at a glance, the filter only looked a little discoloured, removal of one of the pipes shows that the outlet from the filter had nearly melted closed. A good aircraft inspector will never take anything for granted so if your inspector asks you to dismantle something for a closer look, do it with a fair heart. He might just find a problem that will have caused you trouble sometime in the future.

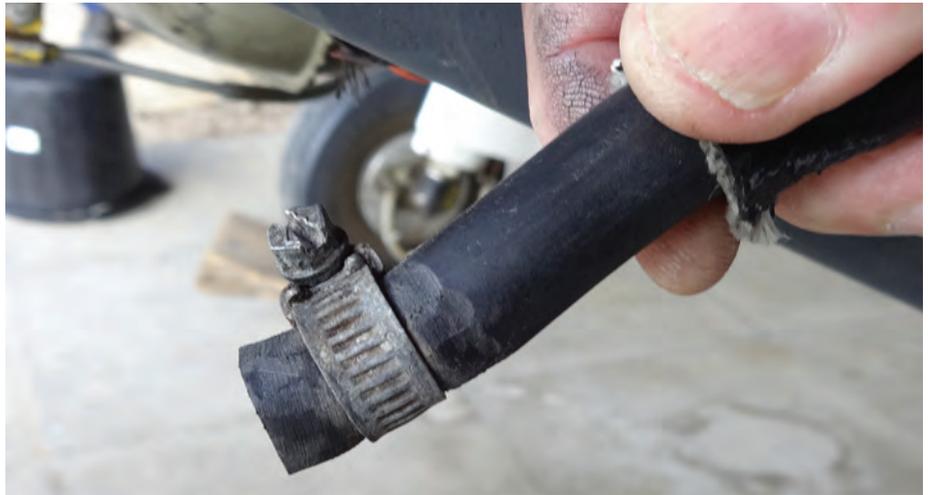
This problem, picked-up by a glider inspector, could have led to an in-flight fire, not a happy prospect... Clearly at some point in the past, the correctly sized Jubilee clip couldn't be found so 'the engineer' refitting the pipe decided to do a bit of whittling; the inspector who sent in this picture explained that the pipe itself ended up being 'very thin in places'. (Photo: LAA library)

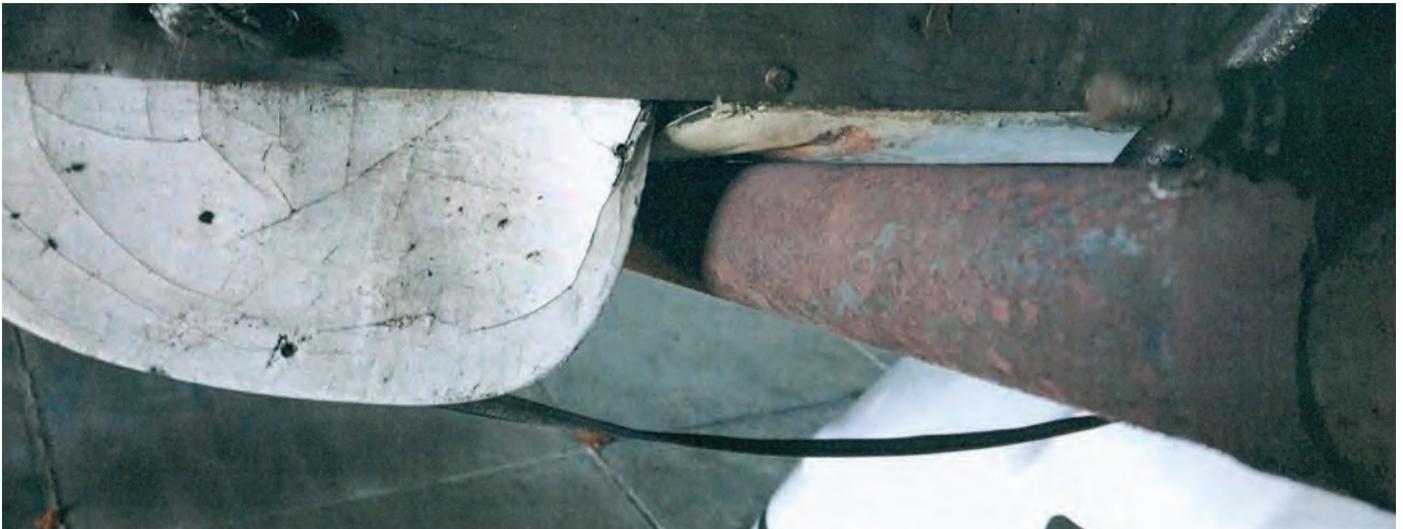
What drew our BGA man to the aircraft were concerns about the apparent 'closeness' of the exhaust system to the fuselage; you can see that this exhaust has actually worn a groove into the bottom of the fuselage structure, clearly a massive fire risk. This is the sort of problem that can have all sorts of unexpected consequences: think, just for example, if a small hole in the exhaust system appeared and this forced exhausted gas into the cockpit... Experience shows that carbon monoxide poisoning is insidious and deadly.
