With Malcolm McBride  
Airworthiness Engineer

# PROP SWINGING, ENGINE FAILURES AND CORROSION

Advice and anecdotes including hand-swinging, 14 engine failures and corroded and malformed cable swages, to a split propeller blade and rodent-damage behind an instrument panel

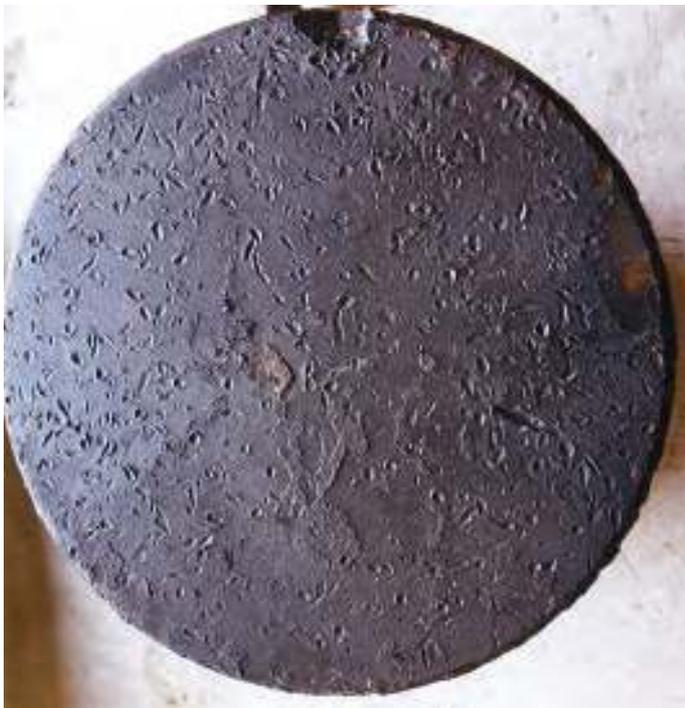
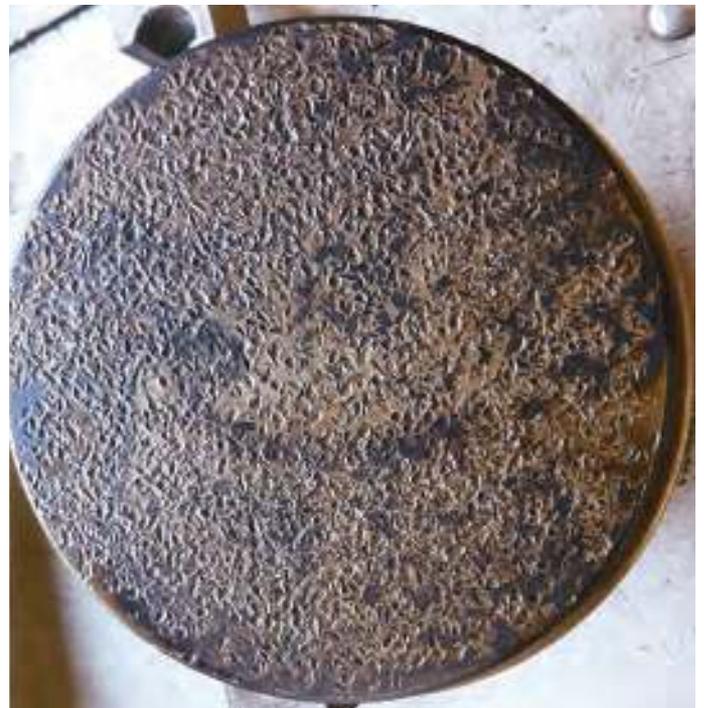
**Here you can see the damaged caused to David Hurn's Lycoming O-320 engine because a small part of a broken valve was left in the engine after a 'top-end' rebuild. The photo on the left shows the piston from cylinder number two (front left on the Lycoming) and the picture on the right shows the piston crown from cylinder number four (back left). To understand how one piece of exhaust valve could damage two pistons, you'll need to read the accompanying text. (Photo: Tony Baron)**

the remains of the original valve (and now an expensive key-ring) had been moving around the induction side of the engine. Very occasionally I think that the metal fragment lodged itself under a valve and this is what was causing the occasional misfire. Then, once the fragment had been 'forged' small enough by the actions of the piston, it entered one cylinder under the valve, probably number four, and started to cause the damage you can see in the attached pictures. Then, still smaller, it passed through the system, into number two cylinder where it eventually jammed a valve

*Said piece is approximately 1/3 of the exhaust valve. I have now replaced the two damaged cylinders with two new cylinders. The engine is all up and running and is as sweet as nut. Total of forced landings 14 in two weeks (must be a record).*

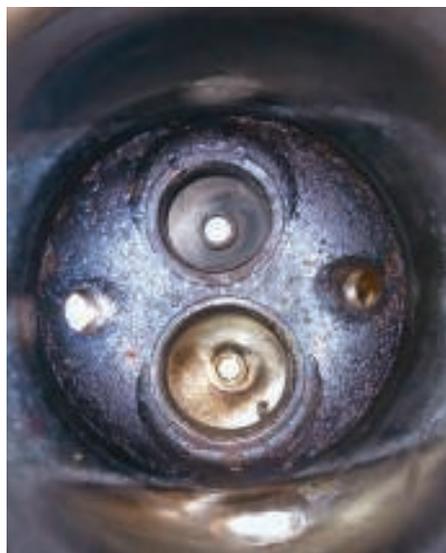
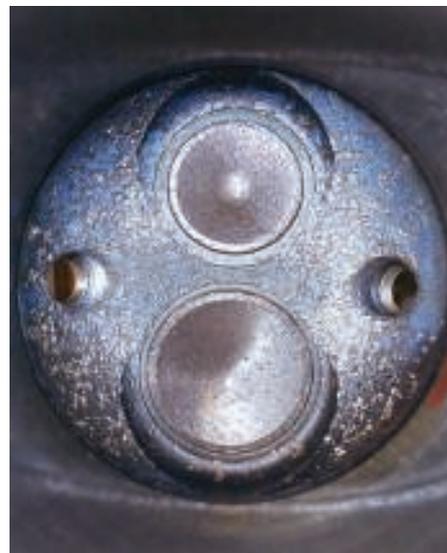
These two pictures show the corresponding damage to the brand new cylinders (replaced because of a partial engine failure on a flight between Sandown on the Isle of Wight and Popham). Unfortunately, the engineers involved weren't qualified to do this work on an LAA aircraft and cleared the aircraft for flight without ensuring that all the debris of a broken valve, the reason for the partial engine failure, had been removed from the engine. (Photo: Tony Baron)

*Said company replaced number four cylinder but did not locate the missing piece of valve; they believed it had passed through the exhaust pipe, but it had not. The pressure from the exhaust forced the piece of valve back down into the air intake tube of number four cylinder; I found the piece in number four cylinder air intake tube when I removed the cylinder. I also found that the piece of valve had damaged number two cylinder.*

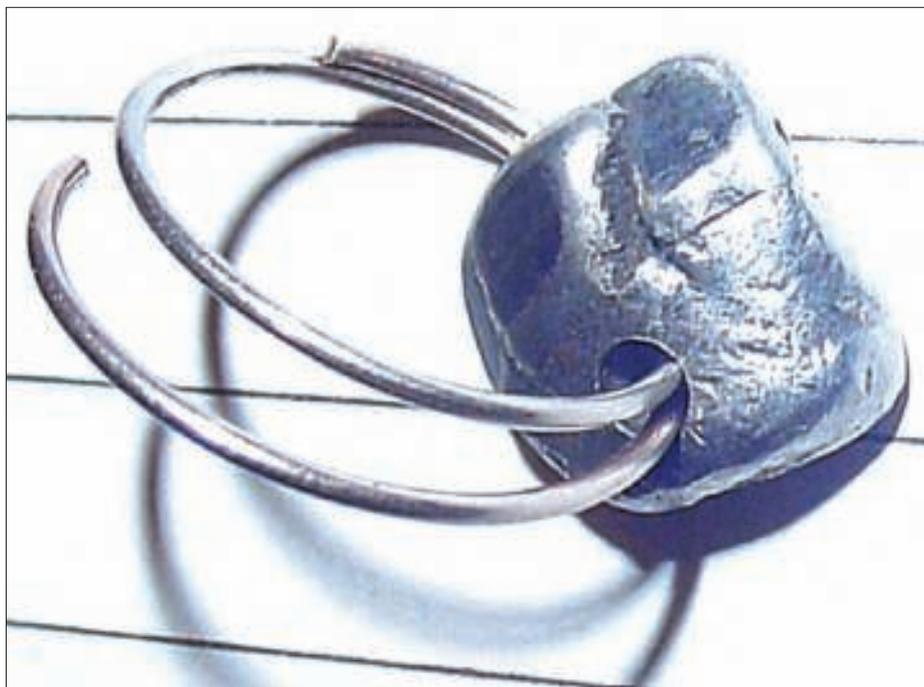
As it turns out, this very expensive key ring, made from the pulverised remains of a Lycoming exhaust valve, could have ended up costing even far more than it did. We think that the remains of the exhaust valve, hidden in the induction chambers feeding the left-hand bank of cylinders on the Wassmer's Lycoming engine, eventually found its way into the cylinders, perhaps passing freely between number two and number four. Eventually, the remains stuck under a valve and the pilot suffered a complete loss of power, fortunately he was able to make it back to Sandown rather than ditching in the Solent. (Photo: Tony Baron)

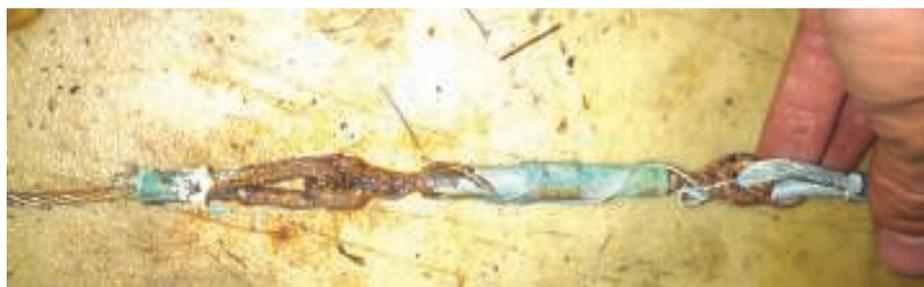
When LAA Inspector Peter Montgomery took a look inside the rear fuselage of a Europa Classic for its annual inspection he was amazed to find that both left and right rudder cables had corroded to the point where at least one of them was on the point of failure. The aircraft itself received its first Permit to Fly in 2002 and has been inspected annually ever since. A detailed investigation into the aircraft inspection history by the LAA's Chief Inspector, Ken Craigie, revealed that it is likely that this corrosion had occurred in the previous year. You'll need to read the full text on page 50 to find out what most likely happened. (Photo: Peter Montgomery)

I thought you might be interested in these pictures of some rudder cables/turnbuckles as found on a recent Permit inspection. The offending aircraft is a Europa Classic. As you probably are well aware, the Europa has a FSB (LAA 247 FSB-005) which calls for inspection of the entire length of the rudder cables on Europas (or is the plural Europi?) at every Permit inspection. These turnbuckle sections are the easiest part to see being in plain sight in the fuselage just aft of the cockpit.

The owner recalls the aircraft getting very wet returning from a flight one time, being left outside and standing for a few days before 'drying out'. This could well have been the catalyst for this corrosion to start but I think you would agree that this kind of degradation takes some considerable time.

Needless to say, we have replaced the entire turnbuckle assemblies and the rotten sections of cable. On attempting to undo one of the turnbuckle ends it actually sheared and did not take much force to do so. I have included a picture as close up as I could get of the sheared end (p49) and you clearly see that there is a corrosion crack propagating 1/3 of the way through this vital stressed part! A classic Europa with a rudder cable snap on landing or take-off would be somewhat of a mess. I have all the bits here, just shout if you would like them for closer inspection yourself.

there is already an FSB covering this very issue to be complied with at every Permit inspection so that should really have covered it. Regardless of that, any control cable in any aircraft is vital and should be inspected with diligence at least at every Permit inspection.

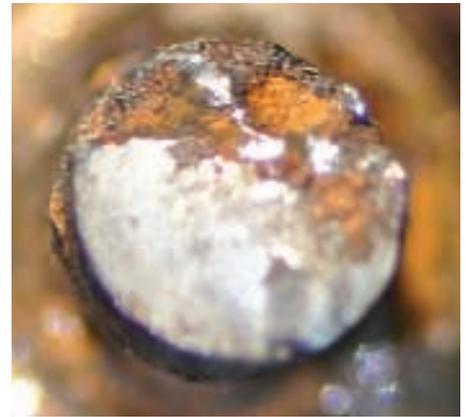
When the LAA Inspector tried to undo the turnbuckles on this Europa rudder cable so that it could be replaced the shaft of the 'eye' of the turnbuckle failed in overload, the left hand picture shows the state of the removed cable and the picture on the right shows the extent of the corrosion within the shaft; it can be clearly seen that nearly 50% of the effective diameter of the material has been lost to oxidation.

There are many reasons for corrosion; some of the specific reasons in this case, where a cable has been found in service in a very dangerous condition, is discussed in the text. This picture, showing the control 'runs' in the Europa aircraft, shows how difficult it can be to ensure that a cable is inspected fully throughout its whole length. Of course, corrosion and wear are much more likely at connections or where the cable direction changes around a fairlead or pulley, so these are the areas that need inspecting on an annual basis, but it is essential that your Tailored Maintenance Schedule includes, at the three or six yearly 'node', a complete inspection of the control cables. This inspection can, if possible, be done in-situ or, if this is not possible, the cables must be removed and the inspection carried out outside the airframe.

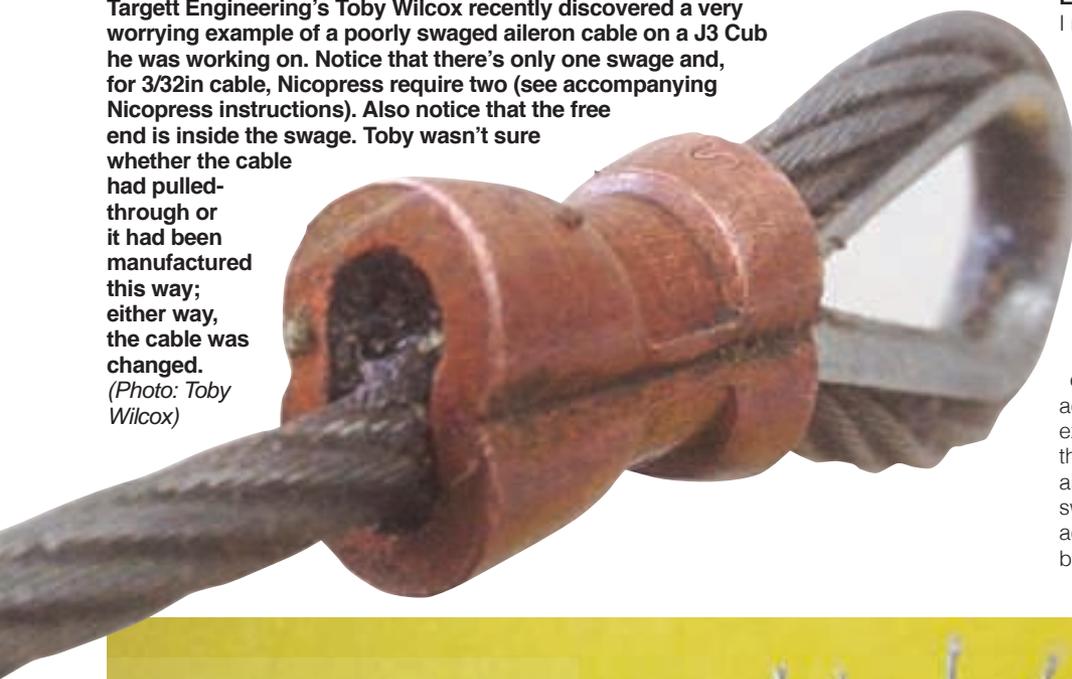
**Targett Engineering's Toby Wilcox recently discovered a very worrying example of a poorly swaged aileron cable on a J3 Cub he was working on. Notice that there's only one swage and, for 3/32in cable, Nicopress require two (see accompanying Nicopress instructions). Also notice that the free end is inside the swage. Toby wasn't sure**

**whether the cable had pulled-through or it had been manufactured this way; either way, the cable was changed.**

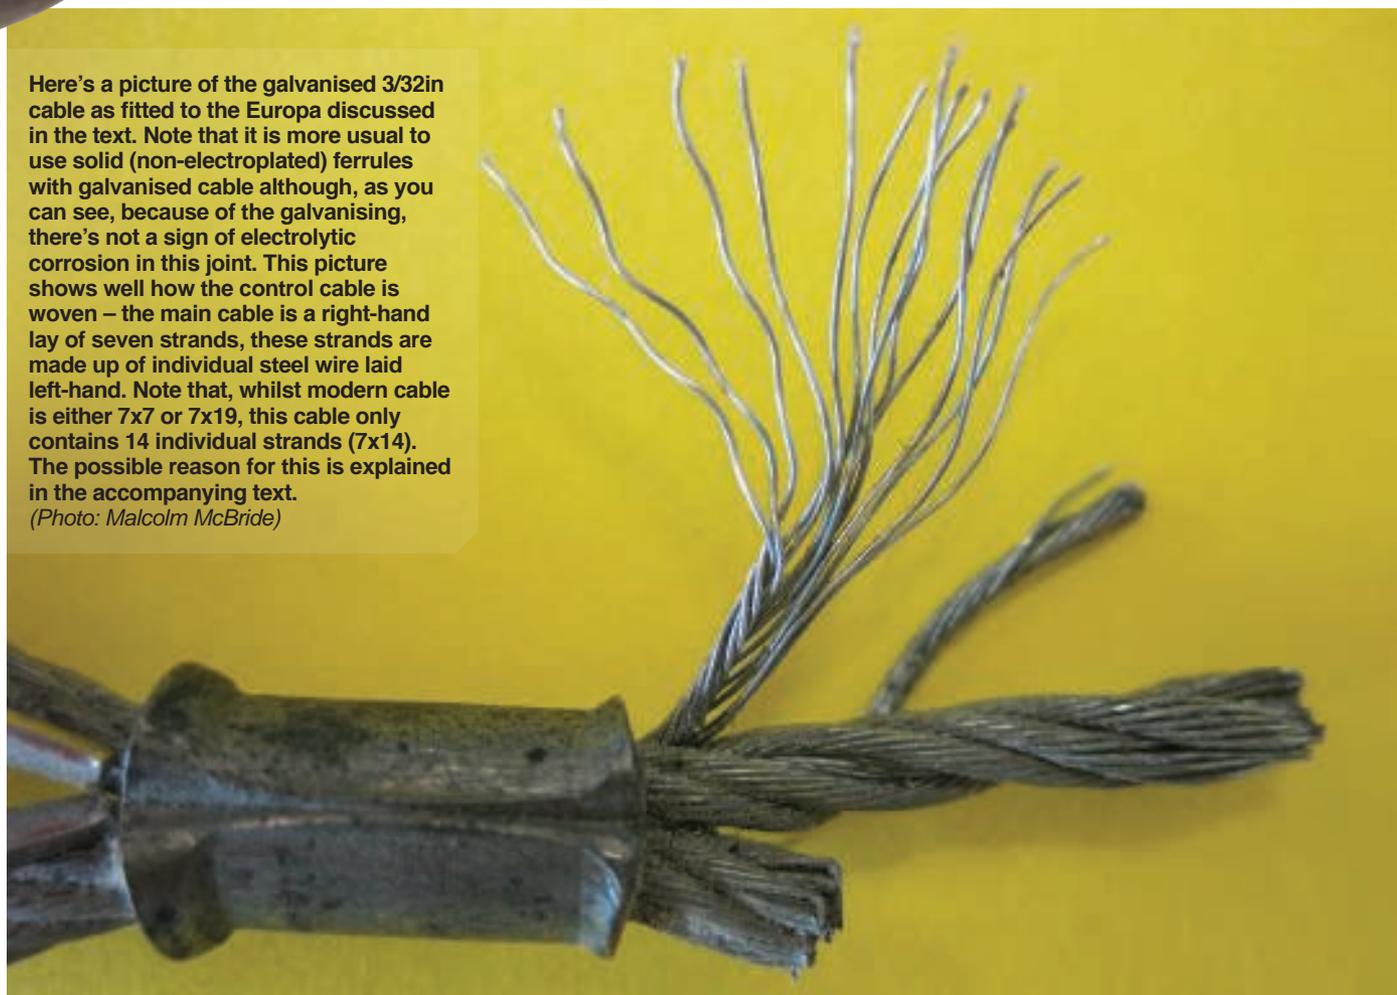
Here's a picture of the galvanised 3/32in cable as fitted to the Europa discussed in the text. Note that it is more usual to use solid (non-electroplated) ferrules with galvanised cable although, as you can see, because of the galvanising, there's not a sign of electrolytic corrosion in this joint. This picture shows well how the control cable is woven – the main cable is a right-hand lay of seven strands, these strands are made up of individual steel wire laid left-hand. Note that, whilst modern cable is either 7x7 or 7x19, this cable only contains 14 individual strands (7x14). The possible reason for this is explained in the accompanying text.

Also of note with these specific cables is that the wrong Nicopress swages were used at manufacture. Oddly the forward cable sections were found to be stainless and the aft sections galvanised. Galvanised cable should use plain copper swages whereas stainless cables have tin-plated swages to prevent dissimilar metal corrosion. Unless the tin plating has all been completely dissolved, the swages on the stainless steel cables are clearly plain copper and there is lots of corrosion evident between the swage and the cable. The cable ends on the rudder (galvanised cable) were made using tin-plated swages (plating still completely covering them) and these are in very good condition with no sign of corrosion. I have read somewhere (but cannot find it now) that tin-plated swages can be used on galvanised cable as well as stainless, and this does make sense as I believe zinc (ie galvanised) does not have dissimilar metal issues with tin. I might have made that up though... Like I say, there was no corrosion at all evident on the tin swages on the galvanised cables. They have

Incidentally, the reason for the fitment of the unusual galvanised cable appears to go back to the aircraft's first build. I checked and at that time (2002) only stainless steel cables were supplied with the Europa Kits. A close look at the cable end showed that the galvanised cable was actually W series cable, a type withdrawn from use on aircraft shortly after the second war. This type of cable was (and may be still) in service on many early gliders and, yes you've guessed it, this particular Europa was built in a shed alongside a glider repairer. It looks like there may have been a bit of component migration during the build.

With regard to tin-plated swages on galvanised cable, I will make the following comment: when assembling anything it's best to stick to the manufacturer's instructions. I think that the pull tests done at the time of the swaging systems approval would have been done with plain copper ferrules, so these must be used to stay within the manufacturer's rules. It may be that tin-plated ferrules, whilst fine when it comes to their electrolytic corrosion protection function, may not have the same grip during testing. Remember, one of the important properties of galvanised cable is that it is far more flexible than its stainless equivalent because the galvanising actually add lubricity to the strands. It may be this very lubricity would change the frictional characteristics of the ferrule. Thanks Peter for your report.

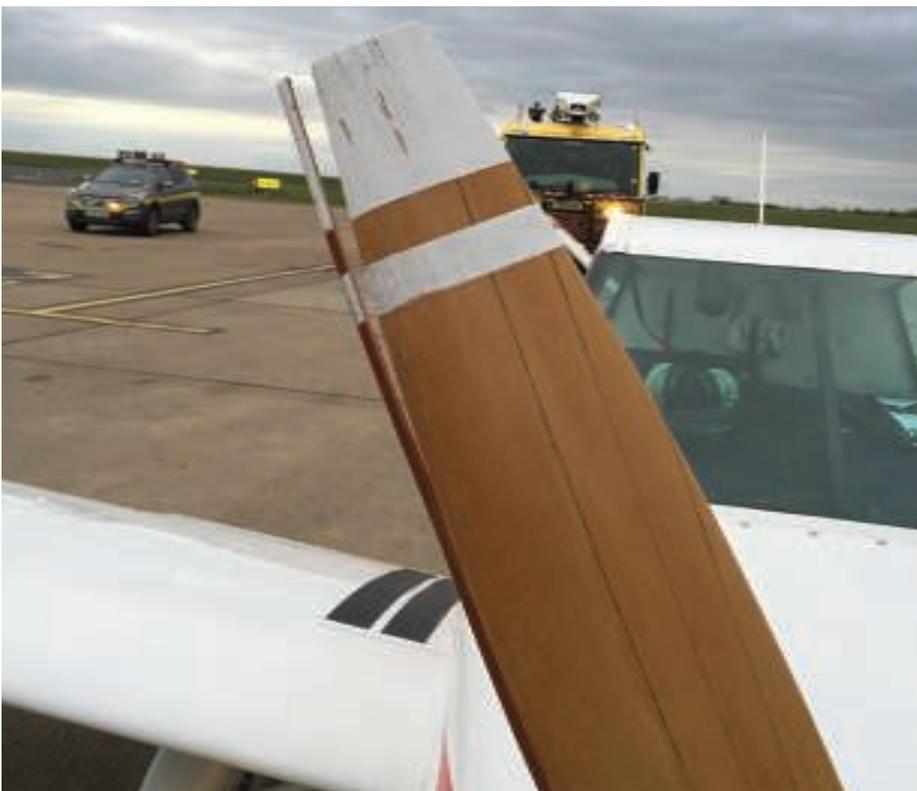
LAA'er, Flt Lt Peter Barker, uses his Davis DA-2 occasionally to commute from his operational base here in the south of England to his home near Huddersfield. During a recent trip back to work one Sunday afternoon, he had to make an emergency landing at East Midlands because the aircraft suddenly started to vibrate and the engine developed a noticeable 'buzz'. When he landed, the reason for the change in engine timbre was rather obvious, as you can see; the leading edge protection strip, bonded to the wooden propeller, had become partially detached. (Photo: Peter Barker)

On inspection of the aircraft I was able to identify the problem immediately; approximately 20cm of the composite-material leading edge had detached itself from the main body of one of the wooden propeller blades. This caused both flutter and significant drag to the propeller which would explain the engine vibrations and reduced availability of rpm.

**Most likely explanation:** Moisture entering the wood causing the joint to weaken.

**Contributing factors:** Degradation of the varnish exposing small areas of bare wood and

lack of prop covers exposing wood to the rain over the weekend.

**Lessons learned:** Thoroughly check all areas of the propeller for nicks and potential signs of failure, especially after being exposed to moisture.

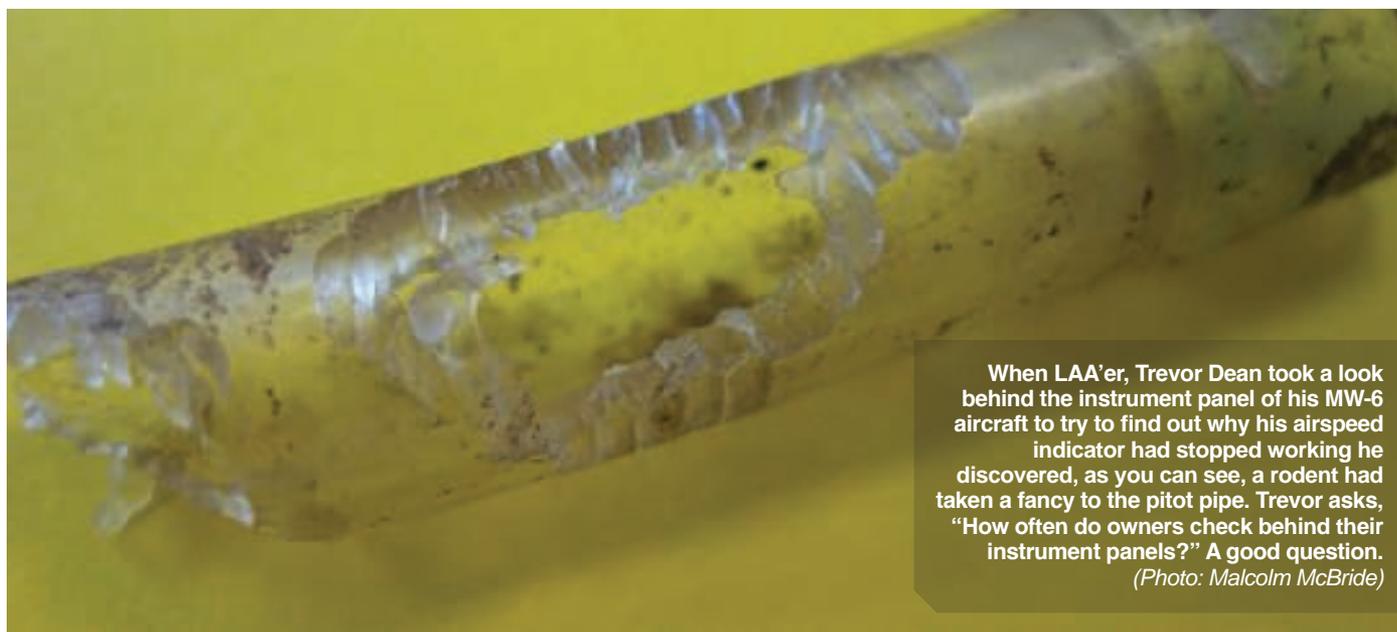
When LAA'er, Trevor Dean took a look behind the instrument panel of his MW-6 aircraft to try to find out why his airspeed indicator had stopped working he discovered, as you can see, a rodent had taken a fancy to the pitot pipe. Trevor asks, “How often do owners check behind their instrument panels?” A good question. (Photo: Malcolm McBride)
