With Malcolm McBride  
Airworthiness Engineer

# LOSSES, RESTRICTIONS AND FAILURES

A selection of incidents and accidents that demonstrate the importance of knowing and looking after your aircraft

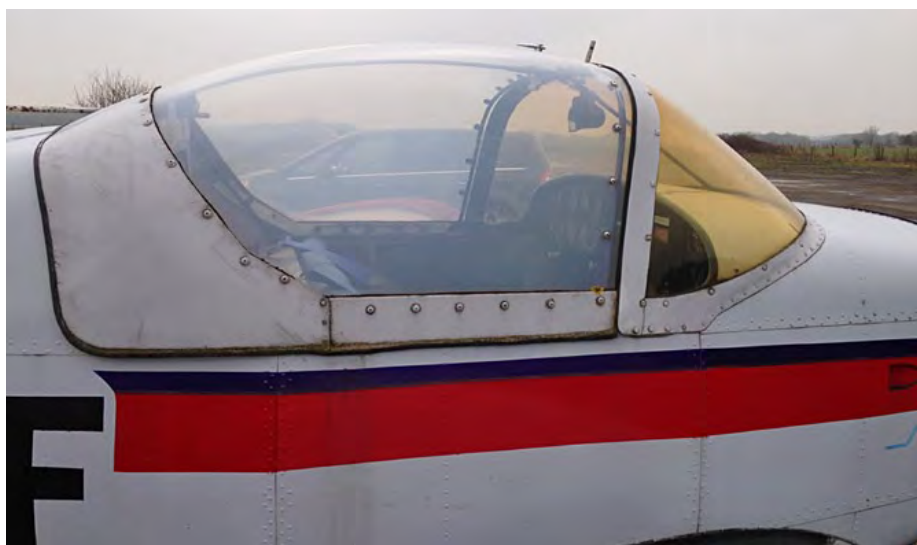
This picture shows the Practavia Sprite canopy in place before the fateful flight where the canopy was lost. This type of canopy was never designed to be opened in flight, with the curved shape producing significant lifting forces peaking just behind the locking handle. When this canopy is closed and latched, the canopy itself sits under the top of the windscreen frame holding it in place. When it's opened, there's not much holding it down. (Photo: Tony Barber)

Around Hinkley, the portable carbon monoxide (CO) detector I had brought along started alarming: I still had about seven miles to run to Bruntingthorpe so I decided to slide back the canopy slightly to allow some fresh air in. As I went to close the canopy (it was only open a few inches), it detached and flew off.

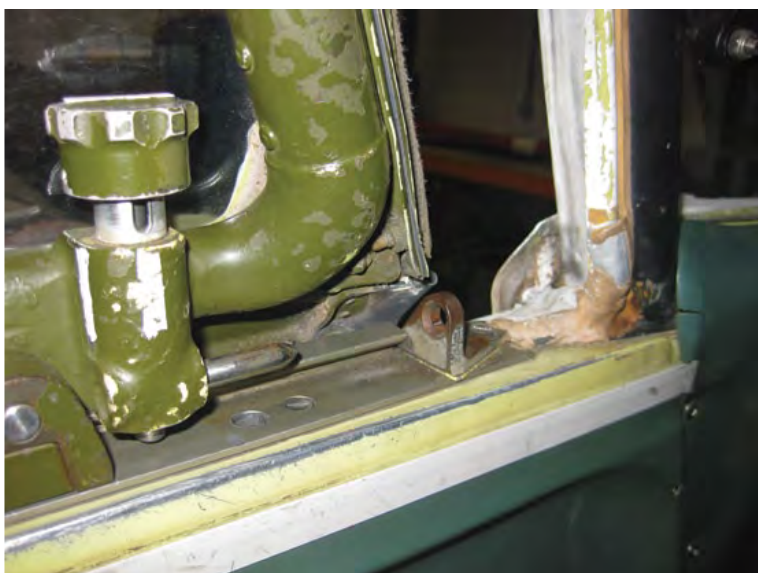
(Left) The simple mechanism that holds down the Bulldog canopy; clearly, if the canopy was opened in flight (by sliding it backwards), the securing pin would cease to hold the canopy down and it would leave the airframe because of the lifting forces generated by its shape. In actual fact, because of the RAF requirement for easy exit in case of emergency, the Bulldog canopy contains quick release mechanisms making it a quite complex assembly, but that's another story. The picture below is G-BZME, owned by LAA'ers Terry Spandley and Hugh Tyrell.

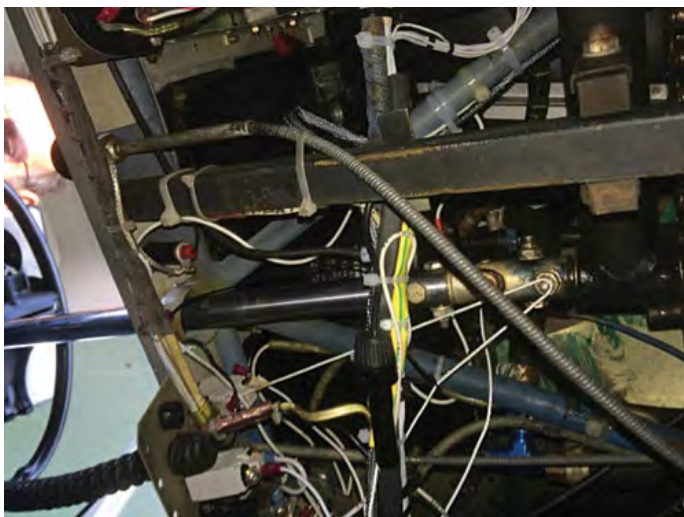
(Above) Anybody who is used to working with rope will tell you, if it can snag, it will snag. Sometimes a snag is just plain annoying but, as in this case where the pitch control was severely restricted, snags could prove to be very dangerous. Notice that the wire loom top-centre in the picture is neat and well secured, unlike the spaghetti-like wiring bottom-centre. (Photo: Roger Gillett)

If you check the photo, it can clearly be seen that a nut on the universal joint for the control column has fouled an electrical cable in the wiring loom. This cable feeds a circuit breaker for the intercom, which had also popped. As you can see the wires had been routed very close to the column and this was an incident waiting to happen.

The snag had chafed the insulation exposing the wire's core, which created a short-circuit and caused the circuit breaker to pop. One would not have automatically associated one fault with the other.

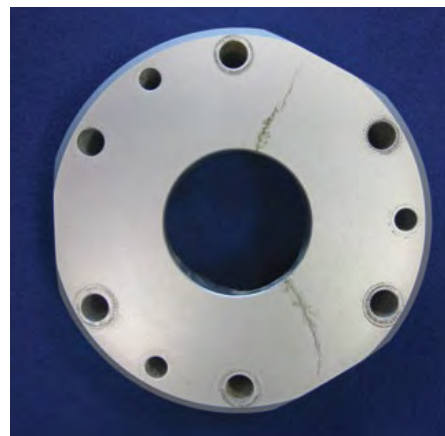
(Right) LAA Inspector Phil Trangmar sent this Neuform propeller hub to us, it came off a BMAA Ikarus C-42. Notice the two radial cracks running outwards from the centre of the hub; they would be difficult to miss even with the most cursory of inspections. This is the first time that we've seen cracking like this on this type of propeller design and we were so worried about it that we immediately wrote to all LAA Neuform users (all on Ikarus C-42 aircraft). So far no other cracks have been reported. At the time of writing this, we're waiting on comments from the German manufacturers to see what they think about this serious failure. You can see that the top quarter of this hub is about to let go and, if it did, it's quite possible that a blade would have been lost, possibly quickly followed by the engine. (Photo: Malcolm McBride)

Worryingly, the radial cracks that could be seen on the front face of the hub went right through the hub itself; one crack is so extensive that the hub was close to letting go. Phil noticed that there was another C42 on site which was also fitted with a Neuform propeller and decided, after checking with the owner, to take a closer look. This second propeller hub was also cracked so he let us and the BMAA Engineering Department know that he may have stumbled upon a serious defect that might affect the whole fleet. A logbook check revealed that this second machine had completed just over 600 hours.

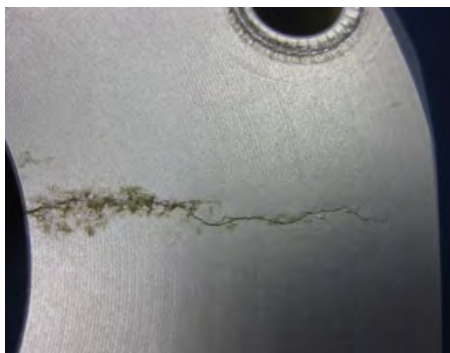
(Above) Here's a close-up of the crack found on the Neuform; notice the corrosion products on the surface, particularly near the crack's origin (left in this picture). I suspect that this crack has been growing for some time. Clearly, as part of any sensible Tailored Maintenance Schedule, the annual check should include the removal of all panels, spats and, pertinent to this failure, the spinner; with the spinner removed, this crack would have been easily seen.

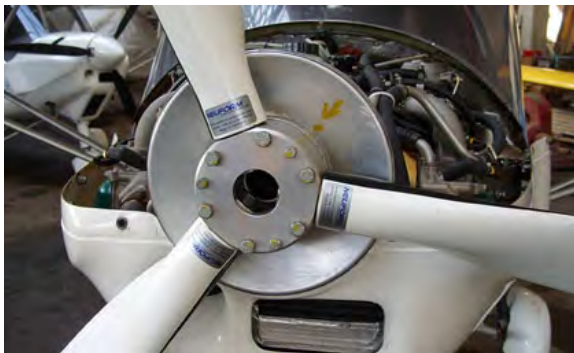
(Left) We asked the LAA's Neuform Propeller owners to remove their spinners to check for hub cracking before further flight; so far, all the responders (six from eight) haven't found cracks. This example, sent in by Keith Meridith, is from 2002, and over the last 13 years, has accumulated over 1,600 hours of trouble-free service. (Photo: Keith Meridith)

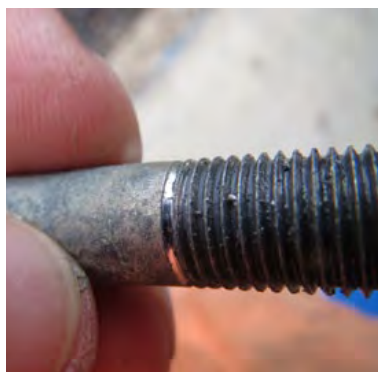
(Left) Van's RV-3 owner and keen LAA'er, Rob Hatwell, was worried about a slight vibration from his powerplant during an air test to check-out a newly-fitted Hercules propeller; the vibration was most noticeable at about 1,700rpm. Back on the ground he decided to check torque the propeller's attachment bolts - they torqued-up fine. Still not satisfied, he decided to pull the attachment bolts and, to his great surprise, noticed that the bolts, whilst they appeared to be doing their job, had actually bottomed out in their threaded fittings. This picture shows the evidence of the thread bottoming before the bolt has reached its correct tension.

On removing the bolts that held the spacer to the crankshaft, I found that the bolts had become thread-bound, i.e. the bolts had run out of thread, therefore the spacer was not torqued properly to the crankshaft. On inspection it was found that the thread in the top hat bushes was 3/32in further forward on the new crankshaft compared with the old.

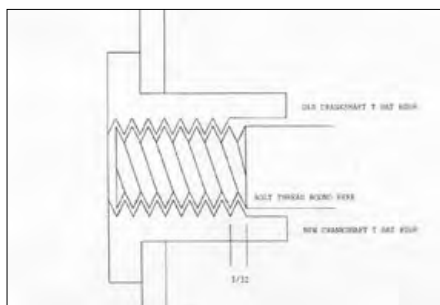
(Left) This sketch shows better how the bolt has become thread-bound

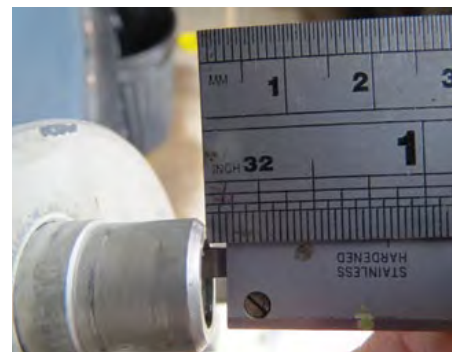
(Right) This close-up shows the threaded ferrule that both attaches the propeller to the spacer and provides a path for the torsional power from the engine to the propeller. The new ferrules, supplied with the new crankshaft, were subtly different in that the thread started 3/32in further forward in the ferrule which allowed the bolt to become thread-bound.

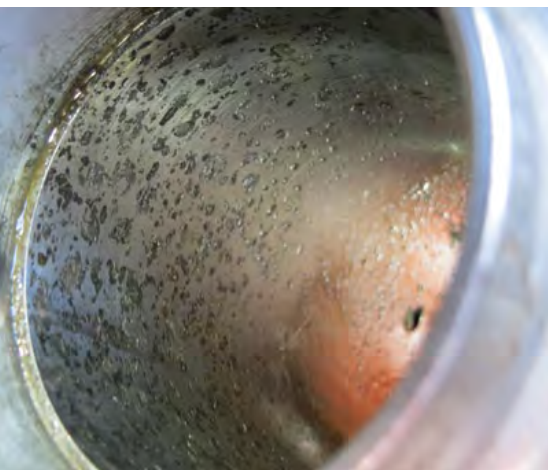
(Above) This picture shows the extent of the corrosion still remaining after cleaning and polishing the internal bore of the crankshaft on Rob Hatwell's RV-3 engine. Clearly, this crank isn't serviceable.  
(Photo: Rob Hatwell)

'If you're not sure - check' won the day and the propeller was removed and the oil retaining plug removed. The level of corrosion they encountered was quite a shock and, after discussing the state of the crank with engine expert Richard Isenberg, they decided to scrap it. Here's Rob's letter explaining the other issue he's dealing with:

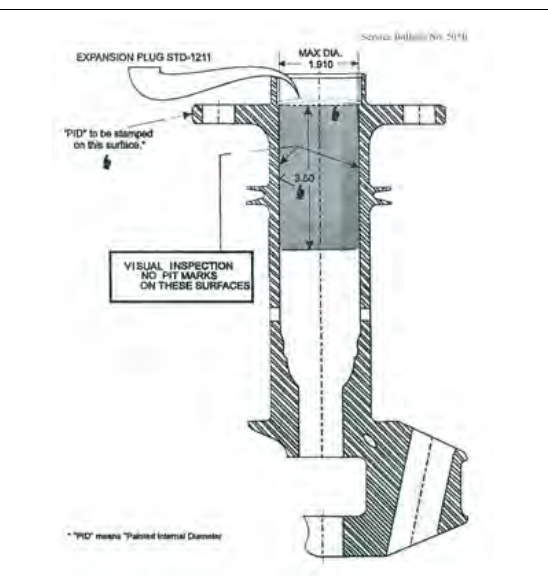
(Left) This cutaway shows the front end of a hollow Lycoming crankshaft (the propeller attachment flange is at the top of the picture). Because this crank is the primary oilway for main and big-end bearing lubrication, any water in the oil will cause corrosion in the inner face. There are a number of Airworthiness Directives around concerning this problem of crankshaft corrosion, the main one to look out for is FAA AD 92-02-08. This requires inspection of hollow crankshafts on certain O-320 and O-360 models, although a later Bulletin issued by Lycoming in 2004 which suggests the application of an anti-corrosion coating, includes the O-235. The main problem with corrosion in this highly stressed area is the formation of corrosion pits that extend into the structure of the component; these act as stress-raisers and will lead to eventual crankshaft failure.  
(Photo: Textron Lycoming)

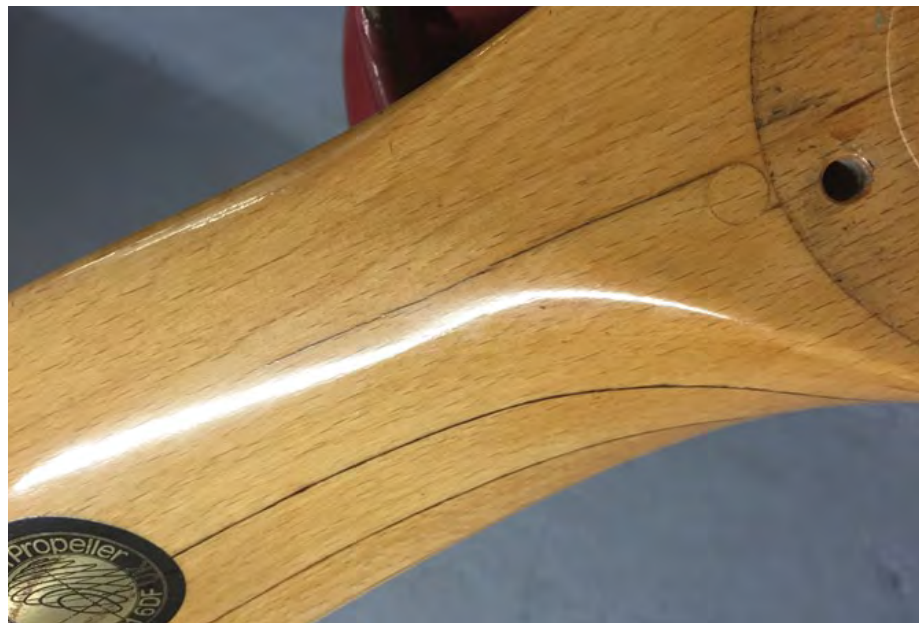
(Above) During a pre-flight inspection, LAA Inspector Matt Pettit noticed this deep crack emanating from the plugged balance weight on this Newton 54in propeller, as fitted to a Jodel D9. Records indicate that this propeller had completed about 400 hours and in all other respects appeared in first-class condition. Sadly, this propeller was effectively scrap, although I expect it will end up as a barometer mount affixed to a study wall. Well done to Matt for picking this up; remember that the pre-flight inspection is, from a pilot's perspective, most probably the most important inspection he or she will do, and it's certainly worth the extra effort required to do the job properly. (Photo: Matt Pettit)

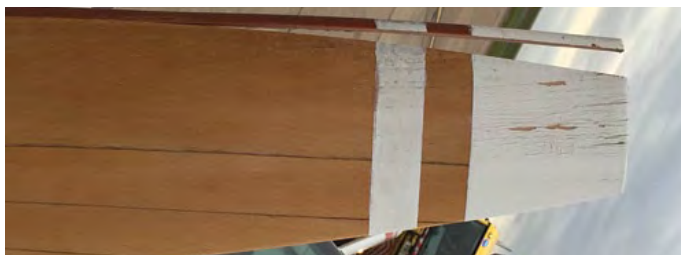
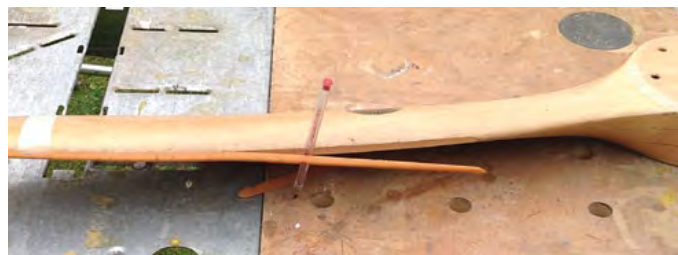
(Above) These two pictures show the partial detachment of the resin leading edge from the wooden body of two separate Newton Propellers. Two separate failure events like this are worrisome and it may be something going on in the moulding process. We think though, bearing in mind the vast numbers in LAA and BMAA service of this design of propeller, that the occurrence of two failures in one season might be coincidental. The left failure was featured in the August Safety Spot, where we felt that water ingestion had led to the joint separation; the right failure occurred in flight on LAA'er David Lawry's Jabiru SK, the propeller having completed about 130 hours. (Photos: Top Peter Barker, Bottom David Lawry)
