With Malcolm McBride
Airworthiness Engineer

ACCIDENT STATS AND DEEP MAINTENANCE

Some interesting corrosion issues this month plus Europa doors, missassembled Foxbat harnesses and EFATOs

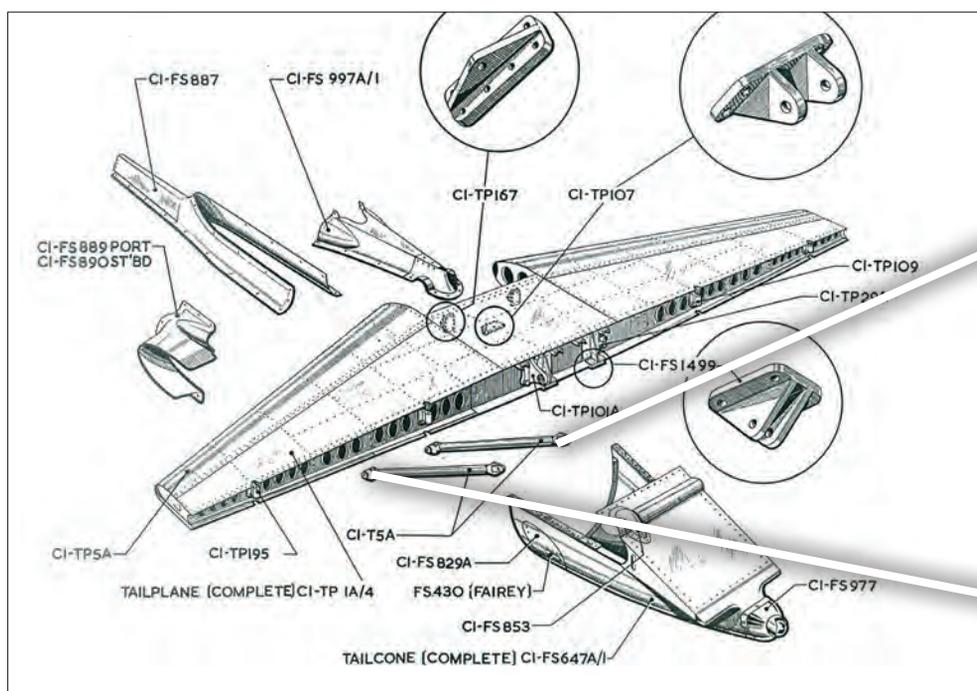
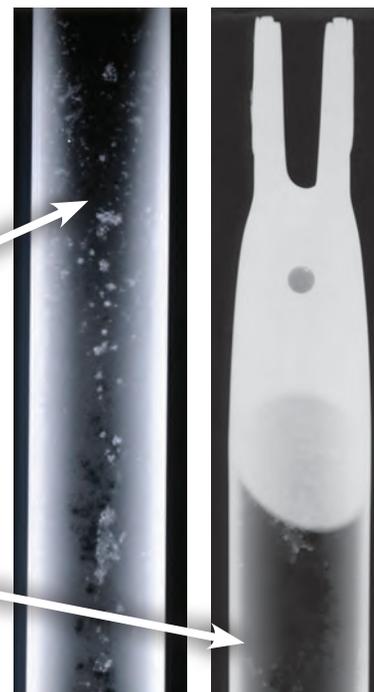
These pictures show why it's important to include, as part of the aircraft's Tailored Maintenance Schedule, checks for problems found in the past. The schematic shows a number of components where history has demonstrated that a close look is warranted at regular intervals. For the Chipmunk aircraft, information about the empennage area is covered in a number of Technical News Sheets and engineers consider that these checks are so important that they're actually backed-up by CAA Airworthiness Directives so they become 'must do' jobs. The Chipmunk tail is effectively held on by brackets and steel tubes, you can see the tubes in the schematic, marked CI-T5A. History has shown that these steel tubes are prone to corrosion and because of their structural importance, they need to be X-rayed every seven years. The X-ray pictures I've shown offer guidance as to the maximum acceptable limit of corrosion before the parts are scrapped. The method to be used and the period between checks is laid out in *TNS 186*.

Some owners have been asking the LAA whether the period between checks, currently seven years, could be increased to, say 12 years, bringing them into line with other Chipmunk X-ray checks. I asked Bill Taylor, De Havilland Support's knowledgeable boss, whether these requests could be considered. He explained, "Certainly, we could consider extending the distance between checks but we'd need some evidence before we could explore this possibility. If LAA members can provide us with evidence that the safety of the aircraft wouldn't be compromised, then we'd be happy to re-visit the issue." So, if you've got radiological evidence that, in service, weakening corrosion isn't forming then send it to Bill. He's already got a 'file', so he tells me! Incidentally, the part circled (CI-FS1499) is subject to another TNS, *TNS 209*... but that's another story!

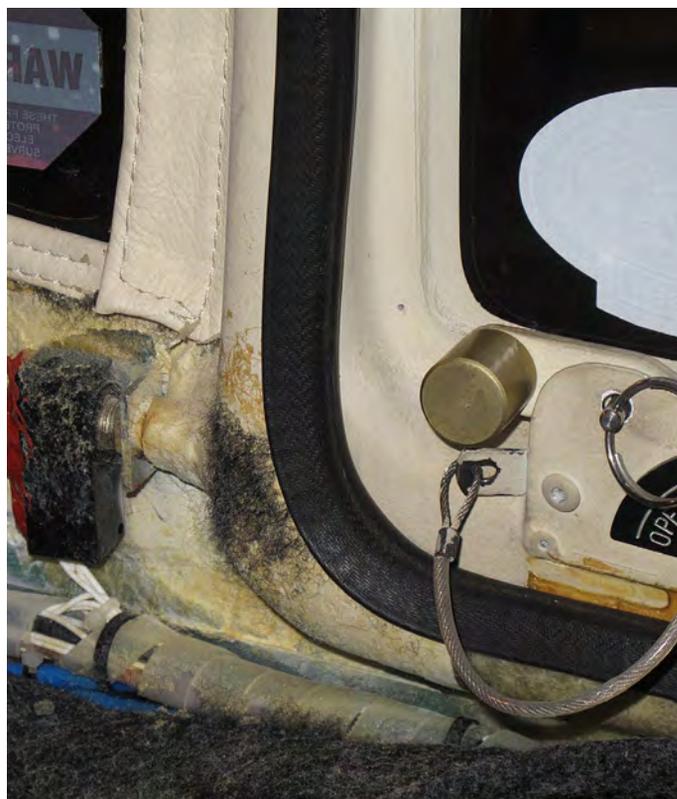
When built correctly, the Europa's doors are easily closable. When Europa is operated correctly, they are surely and safely closed before take-off. But, because of slight variations in the build and a human error in the pre-flight inspections, a door is easily not-correctly closed and will open unintentionally. That action is dangerous, make hassle and is frightening, and demands an awful much work, time and money to repair that error. That's possible, if you are even alive to do that work. When building, I wanted to prevent this situation so I planned and built a mod involving microswitches and panel-mounted warning lights. If port or/and starboard side door is incorrectly closed (i.e. one or even two shooting bolts are not engaged deep enough in the tunnel) I have red lights. If I add some power, as I do usually during take-off, because of a throttle switch, I get also a loud buzzer. I get two greens when closed. To get this simple system I needed couple of hours, five microswitches, four LEDs, a buzzer and some wire. The weight penalty is only around 100gr.

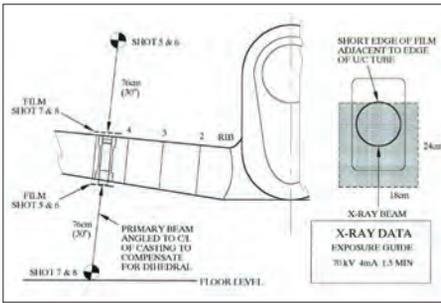
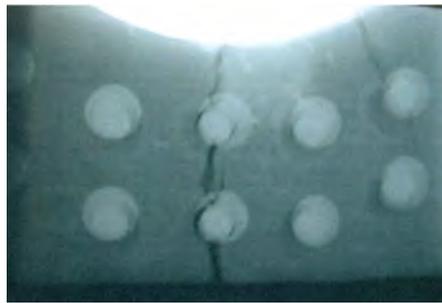
(Left) X-ray beams travel in straight lines so there are a number of different angles used to check the undercarriage casting on the Chipmunk aircraft. This is the angle that found the crack. I've included the X-ray picture for your interest, the crack is clearly visible. Remember, this crack would normally be hidden by the top wing skin and casting so, without actually removing the casting, X-rays are the only way of inspecting the part. (Photo: DHSL)

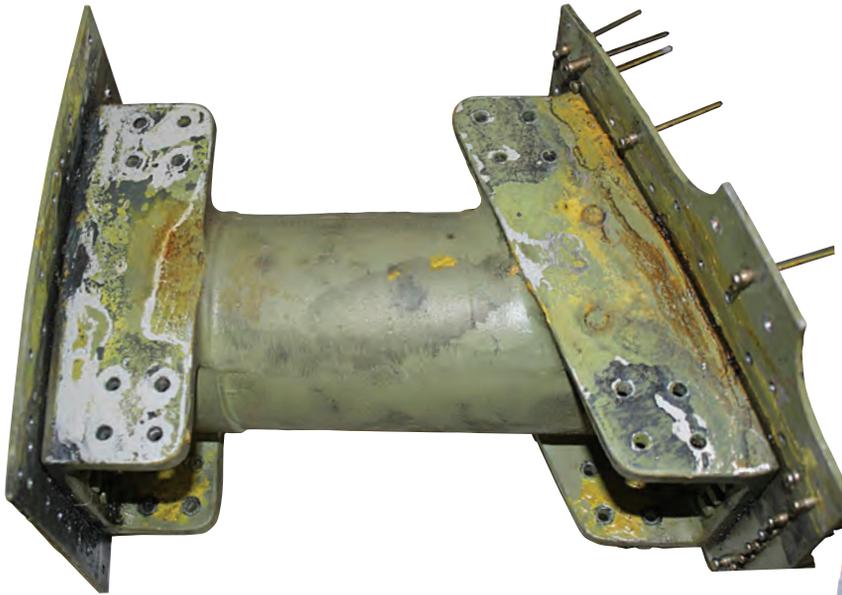
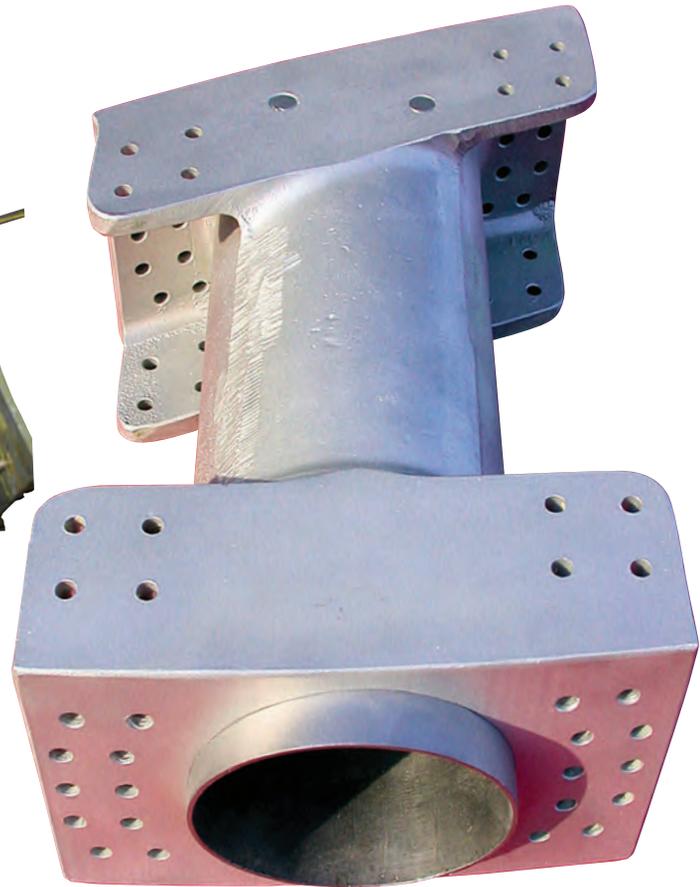
(Above) The right-hand picture shows a new 'straight out of the stores' part; the part on the left, according to LAA Inspector Richard Kilham, who is responsible for the repair, has completed in excess of 140,000 take-offs and landings. Shouldn't complain really! (Photo: DHSL/Richard Kilham)

(Below) Once removed, the cracks can be easily seen although, in situ it would be virtually impossible. Clearly this part has seen better days and needs replacing. (Photo: Richard Kilham)

So, what of the crack found in a fairly high-hour Chipmunk? Well, I've included it in this month's Safety Spot because it's an interesting example of how continuing airworthiness is managed on an aircraft with known 'problem' components. In this case, because of the material specification and manufacturing method used in the main undercarriage attachment housing, they have been known to crack. In actual fact, materials experts have worked out that the cracking is primarily due to stress corrosion cracking and not because of locally applied overloads. That means, in short, that crack propagation is a function of time and not operational effects.

to avoid complete failure, a Technical News Sheet (DHSL TNS 165 issue 7) was issued laying out the rules engineers must follow both in the frequency of checks and the limits of acceptable cracking. Notice that this TNS has reached issue seven, this is because, as more experience has been gained through the years, the rules have been tweaked to become more appropriate to the problem. The only way to check these components in situ is using X-Ray technology and this can be very expensive. I've discussed this particular 'Spot' in a more focussed way under the pictures. This narrative, stressing the importance of creating and adhering to a Tailored Maintenance Schedule, wouldn't be complete without reminding owners of the importance of including engineering advice gained over the years. This information, in the aircraft engineering world, comes in many forms which include Airworthiness Directives (ADs), Service Bulletins (SBs), Airworthiness Information Leaflets (AILs) and, as in this case, Technical News Sheets (TNSs). We try to maintain an accurate record of all this information in the aircraft's Type Acceptance Data Sheet (TADS) which, for many types, can be downloaded from the technical section of our website. The diligent owner would be wise to explore all this technical information and, where appropriate, add these requirements into their Tailored Maintenance Schedule.

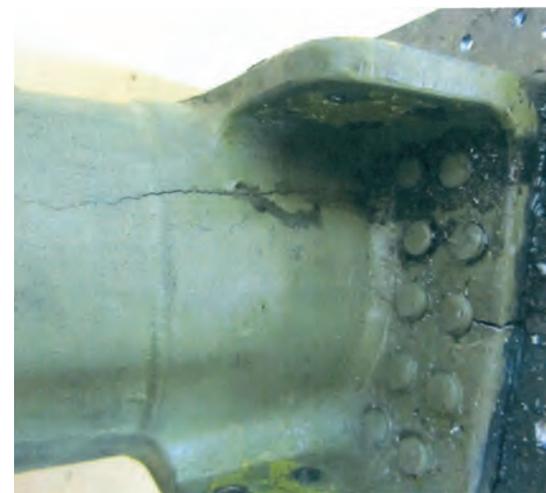
The series of pictures above and right clearly show the good use of X-ray inspection to look inside hollow structures. This picture of the Chipmunk wing shows just how much of the surrounding structure, which completely masked visual inspection, had to be removed to gain access to the component. (Photo: Richard Kilham)

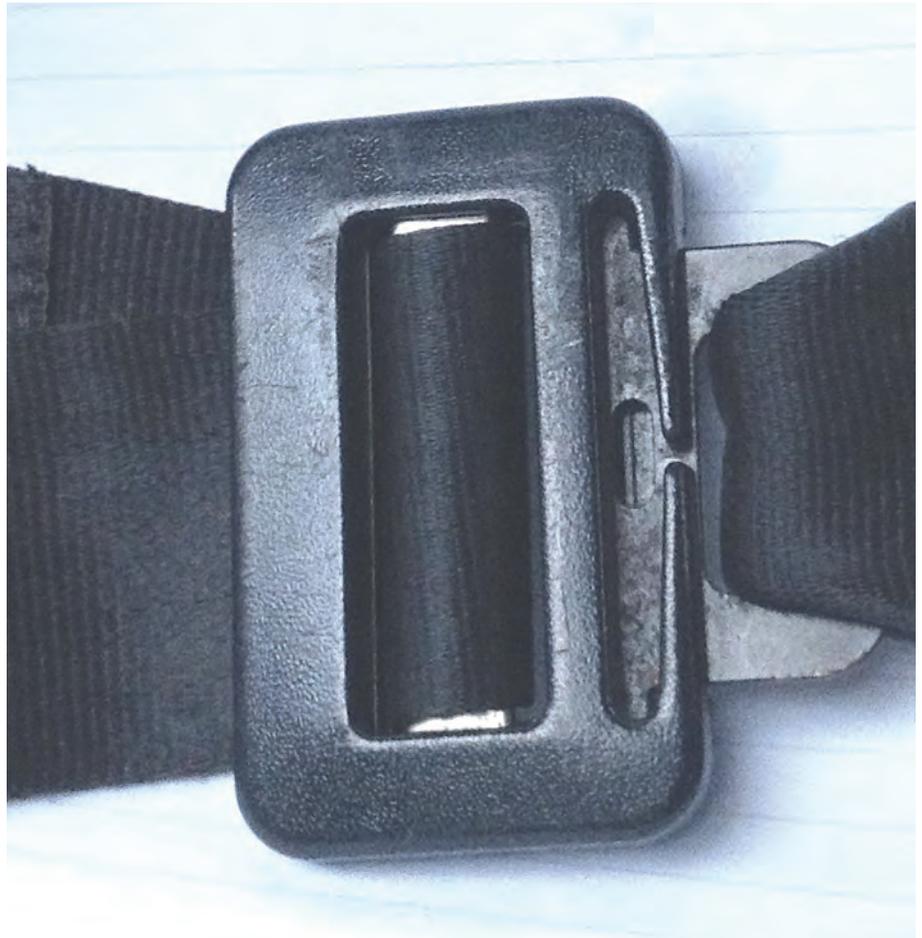
It was a little while before I realised the true significance and how dangerous to my health this situation was. The way the belt had been assembled meant that the webbing would have parted company with the adjuster in a crash because only the plastic frame was holding the two parts together! I think that this error was made by the belt manufacturer and has gone undetected since new.

This picture shows a shoulder strap adjustment buckle from a Foxbat aircraft. From the surface, the strap looks perfectly normal but, because the webbing was incorrectly looped against the restraint, forces imposed were only reacting against the plastic cover and this device would have undoubtedly failed when called upon to restrain a pilot in an emergency. (Photo: Graham Elvis)

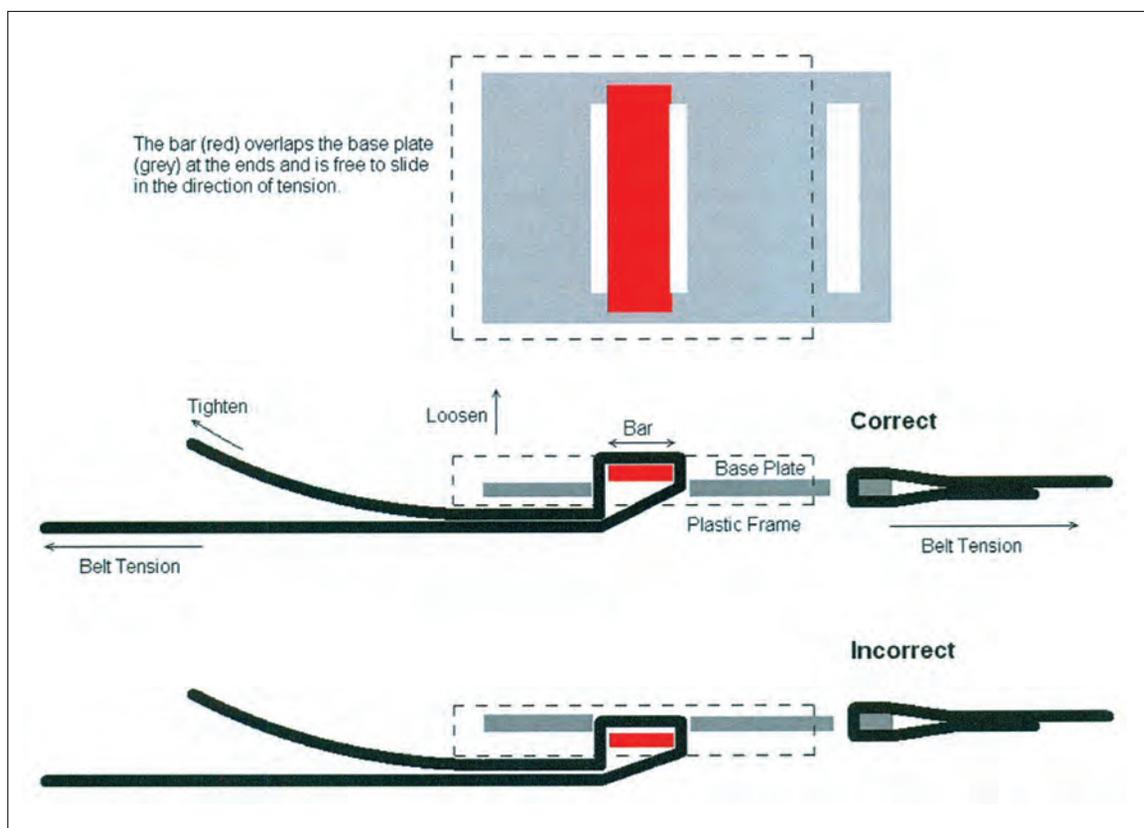
This sketch, created by Foxbat owner Graham Elvis, shows what was wrong with the assembly. We think that there are three engineering points where this error may have been introduced: the first is that it was a manufacturer defect; the second possibility is that the harness was misassembled during initial build; and the third is that at some point during maintenance or repair the straps were removed and incorrectly re-fitted. In any event, checking the function of the straps is an annual requirement so this error should have been picked up earlier. (Diagram: Graham Elvis)

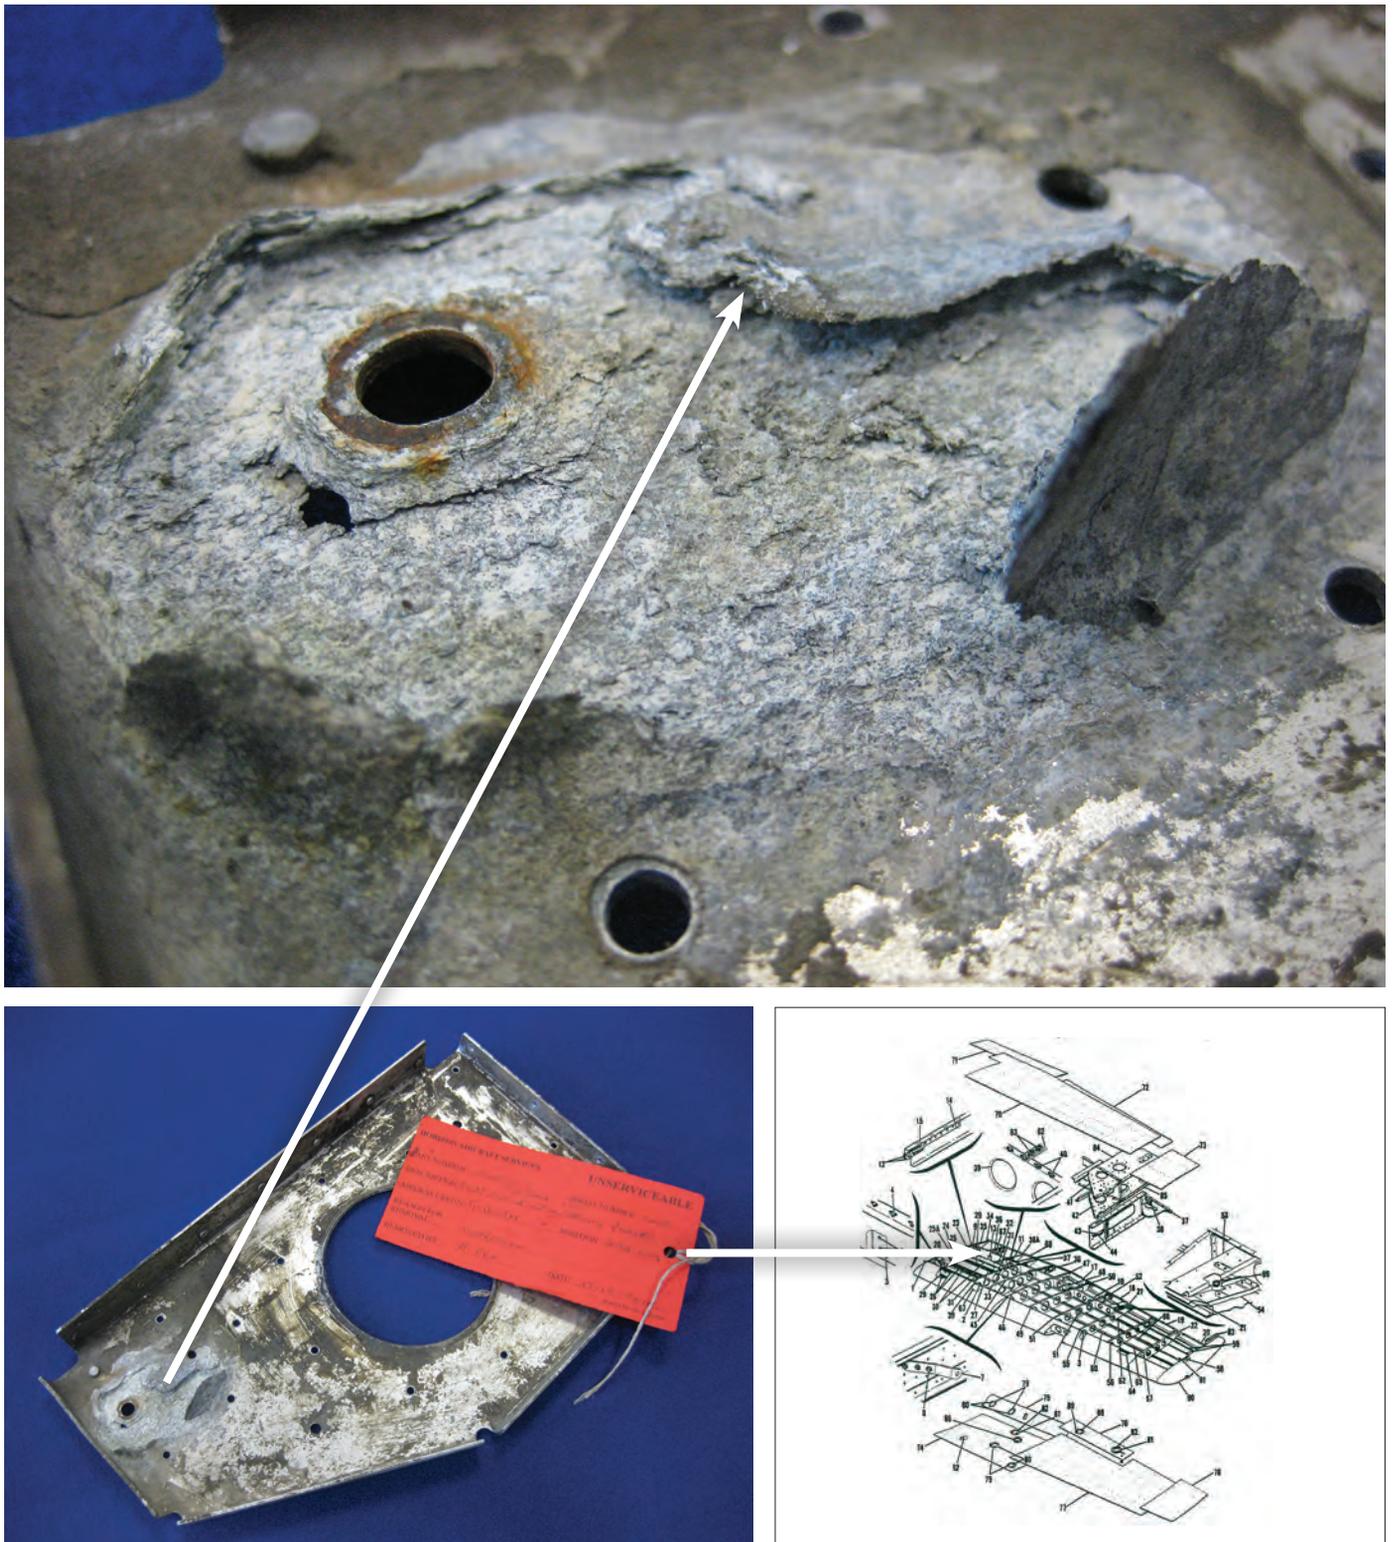
Here's a picture of a part that Ken Craigie, our Chief Inspector, gave me the other day. The part was provided by St Athan-based LAA Inspector John Sparks after a site visit which is part of the LAA's audit programme. I gave John a call, both to thank him for the gift and to find out a little more about its origin. John explained that he had purchased the aircraft, a Cessna 150A, with a view to refurbishing the machine. The aircraft itself needed a new firewall because of serious cracking; this, as you will imagine, is a job not for the faint-hearted!

When the old firewall was finally removed, John was shocked at the level of corrosion he found and so decided to carry out a deep inspection of the whole aircraft. This particular machine first went into service as a training machine in 1968, nearly half a century ago, and has, in this time, accumulated nearly 7,000 flying hours. The actual rib shown in the picture is the one that holds the electric motor that drives the flap. You can see that this rib appears to have corroded from the inside out; from the surface this type of corrosion is easily missed and, as you can see, this attachment wasn't that far away from failure.

What I think has happened is that the flap motor has probably been changed at some time in the past and the mechanic doing the job refitted the new part without including some corrosion protection (for example, chromate paste) in the joints, especially the joint between the attaching steel bolts and the aluminium alloy of the rib. In this case the bolt has acted as a cathode and the rib the anode. The small, but continuous current created in this little battery has led to this intergranular corrosion which was only discovered after John called for a 'finger-tip' inspection of the whole aircraft. Certainly, had this structural weakness not have been found then there would have always been the possibility of a flap failure which would have certainly spoil somebody's day.

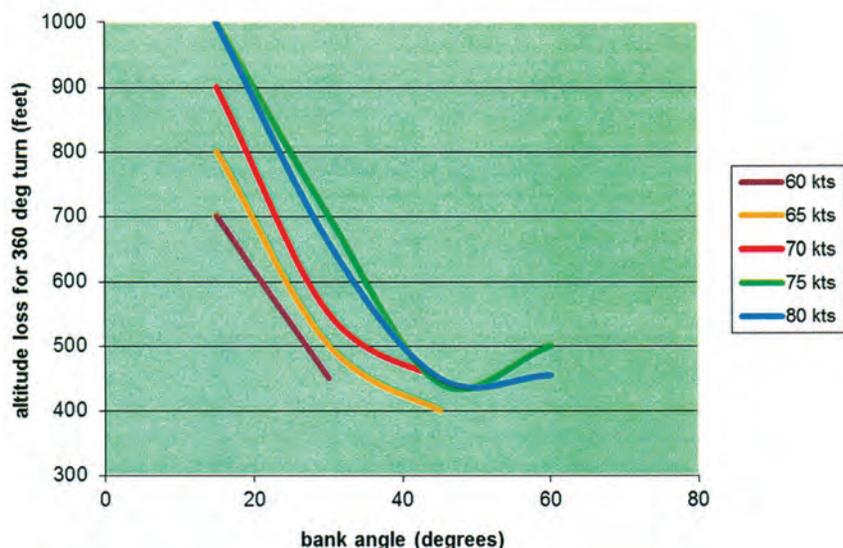
RV-6: approx altitude loss from 360° turn

Clearly, in some circumstances, it might be possible to turn-back with relative safety. Peter's graph is useful albeit a bit optimistic in my view, in that it shows that, up to a point, quite a steep turn appears to be the option that equates to the least height loss: in some cases, it might be possible to turn back straight into the down-wind leg of a circuit pattern and land normally. If this is an option, a sensible rate turn would be, as the graph suggests, the most sensible plan. The reason why the ‘Never Turn Back’ concept was introduced, I think, between the first and second European wars, was that people were getting killed regularly attempting it.
