# RECORDING AND AVOIDING ACCIDENTS

Among Malcolm's investigations this month is a visit to the AIB's accident investigation workshop and cases of canopy failure

### ZENAIR 601 (UL) – CANOPY FAILURE

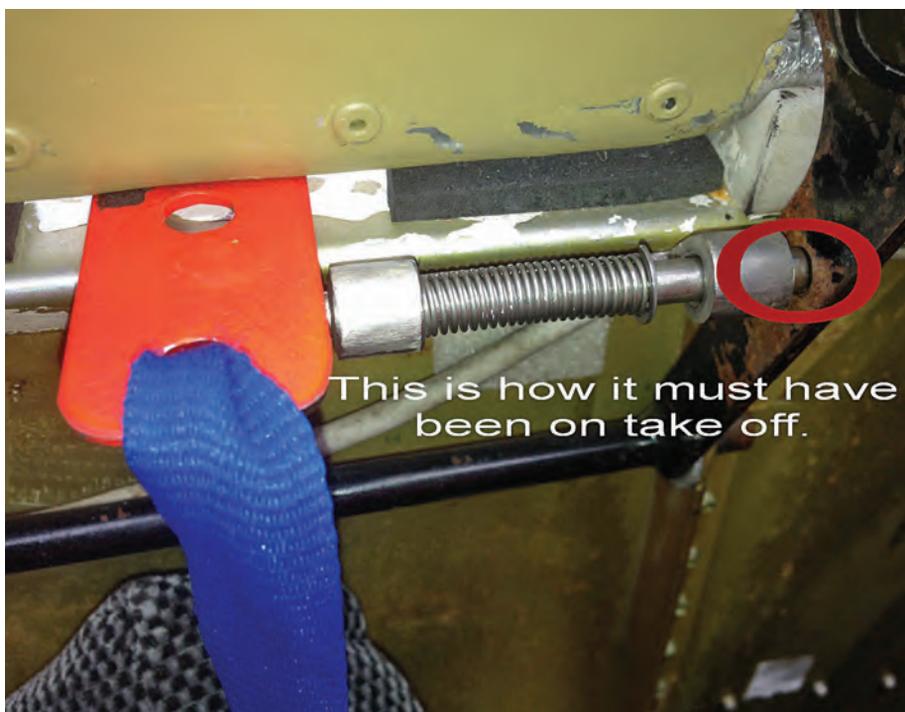
(Right) The canopy of the featured CH 601 UL aircraft after a canopy failure; I have underlined the a because, in truth, this picture was taken after a subsequent failure – it just goes to show that lightning can strike in the same place twice! In this second failure the cause was absolutely established as an incorrectly latched canopy before take-off. (Photo: LAA Library)

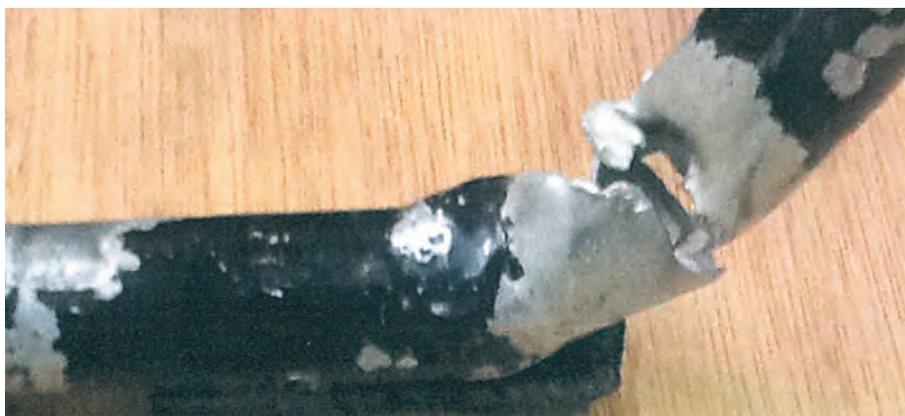
*(Above)* By far the main cause of in-flight canopy failures is that they're not secured correctly before flight – in this case the pilot sent us a picture of what he thought must have happened. Fortunately, no bones were broken. Normally, the last two items on a light aircraft pre-take-off checklist are Hatches – Secure, Harnesses – Tight. Just chanting the checklist doesn't work, you have to actually check to make sure the job's been done! *(Photo: LAA Library)*

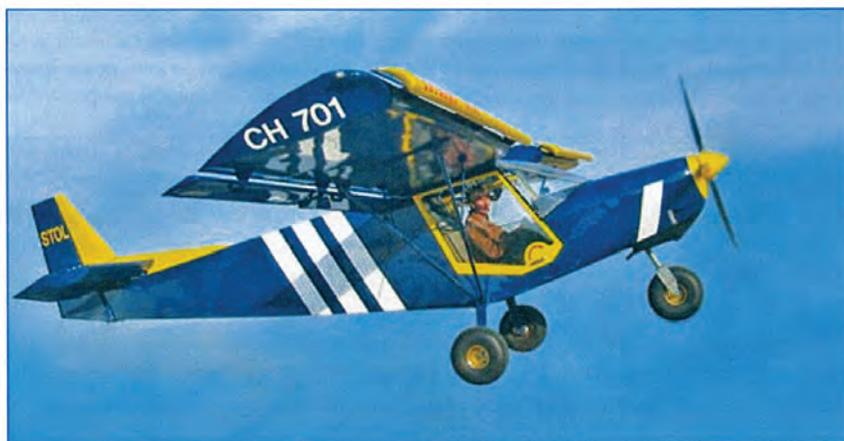
(Above) Manufacturer's options can be very beguiling; fitting these 'bubble doors' to his 701 certainly was for a recent LAA builder. The problem was that these doors hadn't been checked out as suitable for LAA-built machines. The consequence of this was that they weren't properly tested and it was found during service that, above a certain speed, the extra 'pull' afforded by the curved screen (remember Bernoulli?) overcame the canopy latch and the door was ripped off. (Photo: Zenith Aircraft)

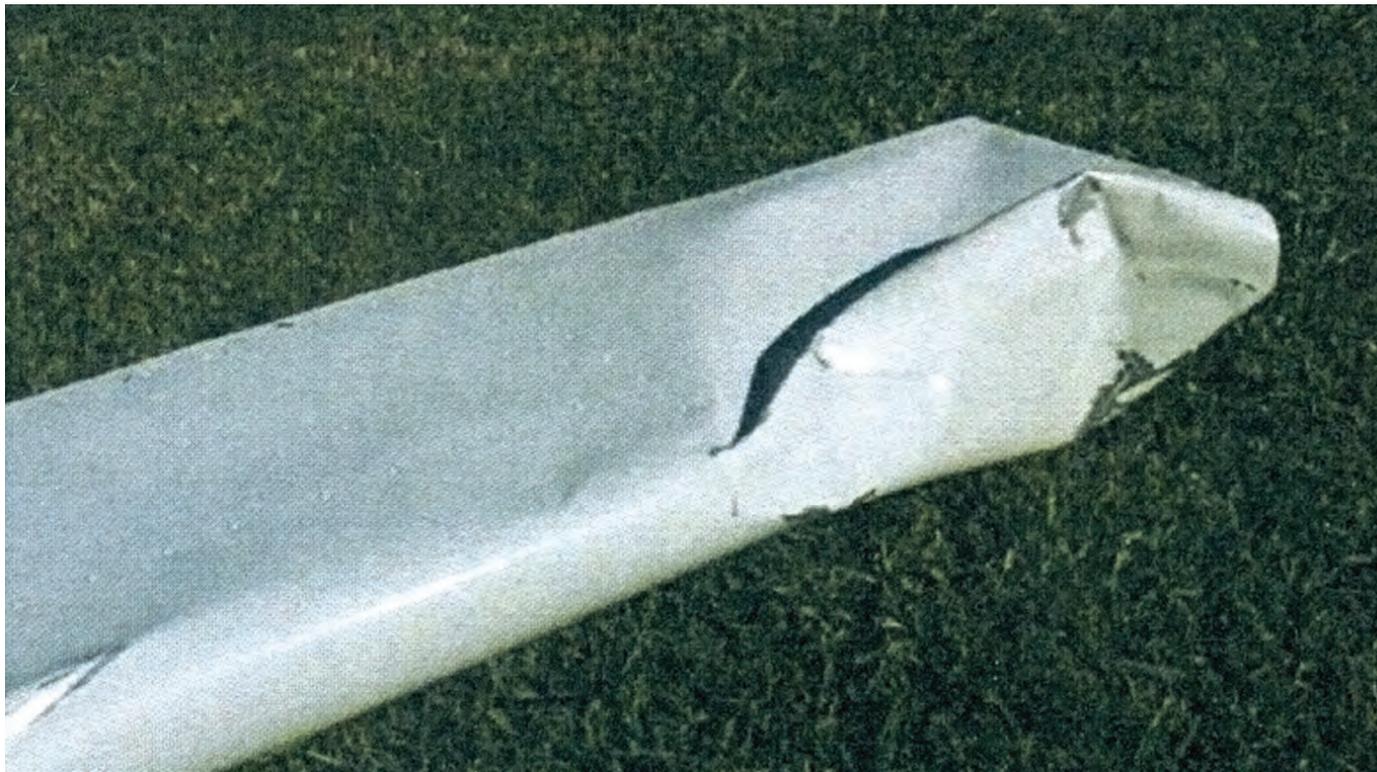
*(Above)* Another canopy failure, this one happening to a US owner who swapped his CH 701 doors without checking that the door catch was strong enough. This is his tailplane after the impact from the door as it left the fuselage. The reality of the bubble doors on the 701 is that they're very successful and do improve the internal cockpit dimension (for a wide-shouldered chap); however, any change needs to be checked out by a design engineer before it is incorporated to guard against unintended consequences... which is what the LAA mods system has been designed to do.

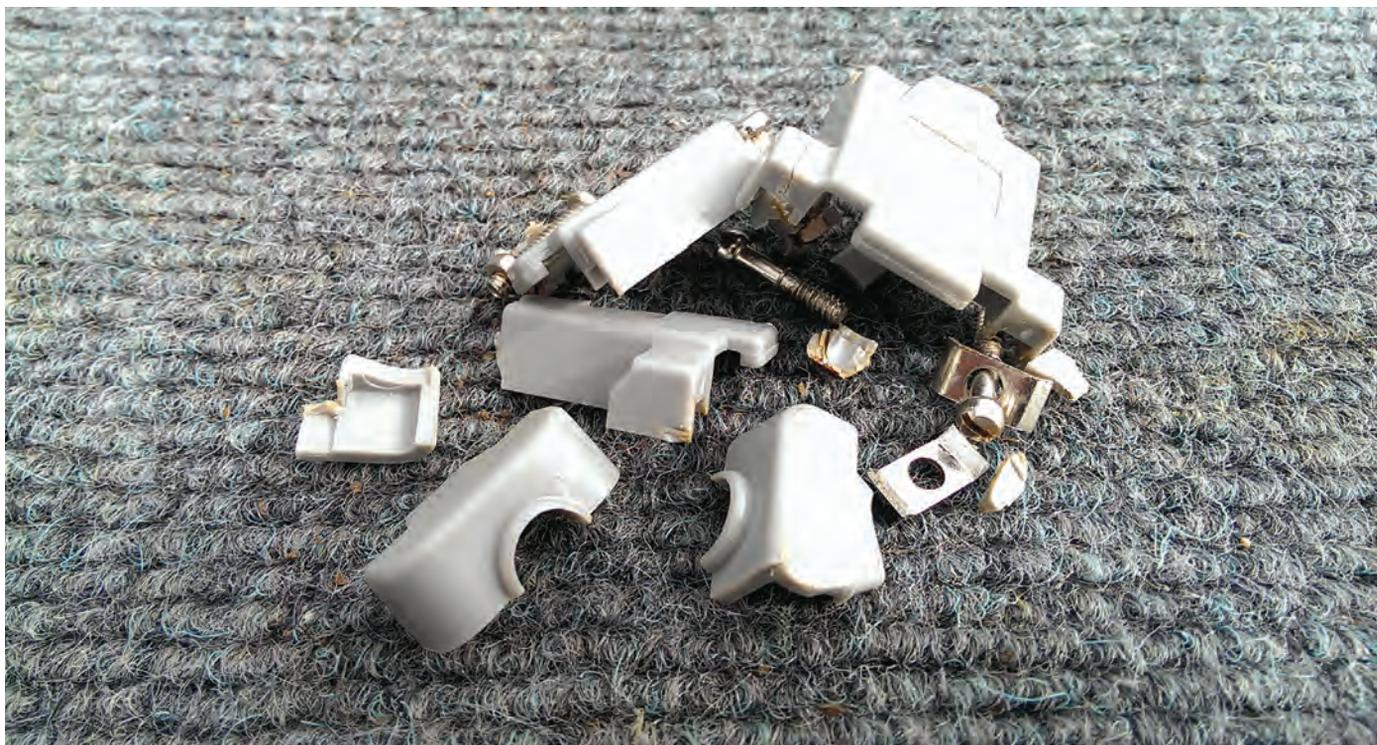
*(Above)* LAA'er (and RV-6 owner) Tim Gibbs sent us this picture; he entitled the accompanying email 'An Interesting One'. Tim explains, "I was inspecting internals as part of my LAMS 150 hour check today and noticed some debris in the bottom of the fuselage. As the pics show, the plastic nine-pin D connector shell for my AFS magnetometer had failed. When I touched it, it just crumbled away. No 'biggy' in itself, as the metal D plug is held into the socket with retaining screws, BUT this unit is above my elevator bellcrank - and I don't like the thought of bits dropping onto that. I mention it as there are probably a few RVs set up like this.

"I wonder whether the vapour from the ACF50 anti-corrosion fluid I've been using has reacted with the plastic. I'll find myself a metal shell for the connector." I agree that this is a bit worrisome and it's the first time I've heard of ACF50 being 'in the frame' as a possible reactant. Naturally if you, dear reader, have other experiences or have another explanation for this unusual materials failure, please let me know. For your information, Tim's RV is six years old. *(Photo: Tim Gibbs)*

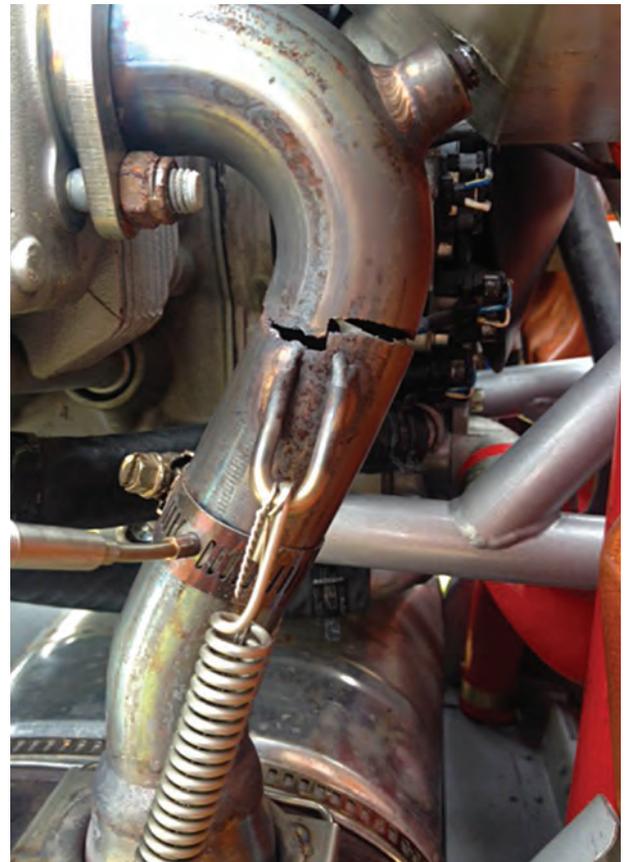
Thanks to Oban based LAA'er Donald Cameron for sending us this picture of the failed exhaust on his Europa XS. Donald explains, "Whilst on a flight earlier today, I was flying along and, all of a sudden, there was a sudden change in engine sound. No engine vibrations felt, it just got very noisy. Ts and Ps were within range and everything was performing as it should. I therefore presumed there was a problem with the exhaust system somewhere. Noting this wasn't normal, I performed a quick turn around and headed straight back towards my departure airfield."

You can see that this exhaust system, specially made by CKT Exhausts for the Europa, is actually quite a complicated piece of engineering. Naturally we've seen examples of exhaust cracking before, but I think that this sort of failure, after only 30 hours of running, is unusual. The failure appears to have emanated from the welded spring attachment tang and it's possible that the material has become thinned, or perhaps embrittled. I would imagine that the precursor crack would have been spotable some time before the complete failure and, perhaps, that's the lesson that should be drawn from this failure.

Whatever the cause of this particular failure turns out to be, hats-off to CKT who exchanged the damage part FOC without quibble.
