FOD FOR THOUGHT & WHEELS-UP LANDINGS

A new collection of cautionary tales that highlight importance of foreign object debris and faulty components. Would you know how to react if it happened to you?

Christen Eagle – Jammed Elevator Control

Spitfire Mk. 26 – Undercarriage Failure

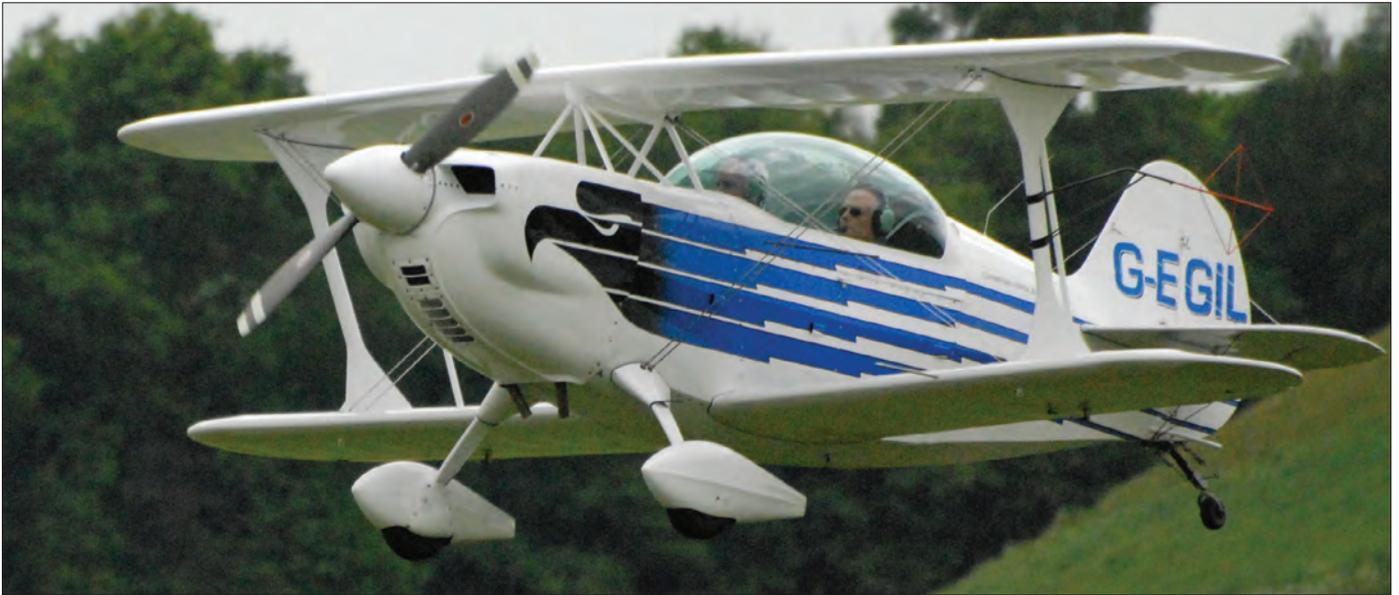
All except one of the UK's Christen Eagle IIs transferred as soon as they were able to an LAA administered Permit to Fly. This aircraft, originally constructed in 1980, joined the LAA fleet in 2007 and has been quite recently completely refurbished. After a period of inverted flight, it suffered an elevator control restriction which meant that the pilot couldn't slow the aircraft below about 85mph. The pilot handled the emergency well and the aircraft, after a couple of attempts, was landed safely; a little less movement in the elevator travel may have led to a different outcome. Never be complacent where FOD is concerned. (Photo Dennis Maddocks)

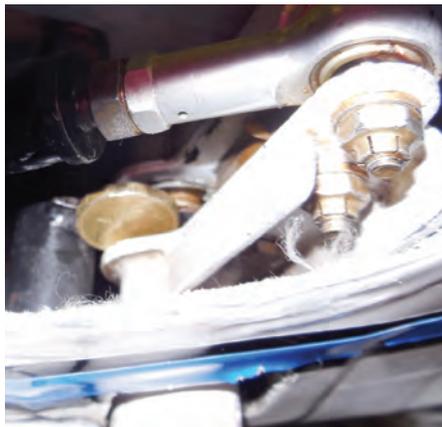
After taking the panels off, the reason for the control restriction could easily be seen – a £1 coin had jammed itself in the elevator bellcrank, severely limiting the up movement.

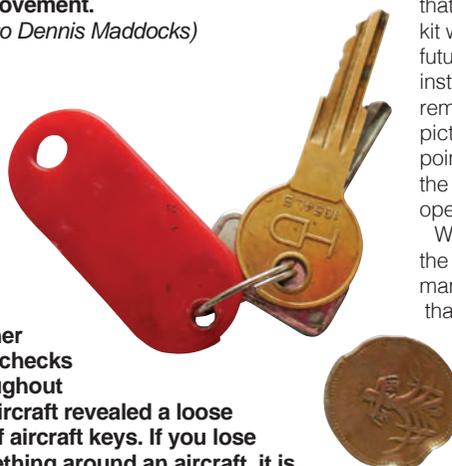
Further FOD checks throughout the aircraft revealed a loose set of aircraft keys. If you lose something around an aircraft, it is very likely that it's hiding somewhere in the airframe. Don't rest until you can be absolutely sure that it isn't waiting to cause you trouble at some time in the future. (Photo Dennis Maddocks)

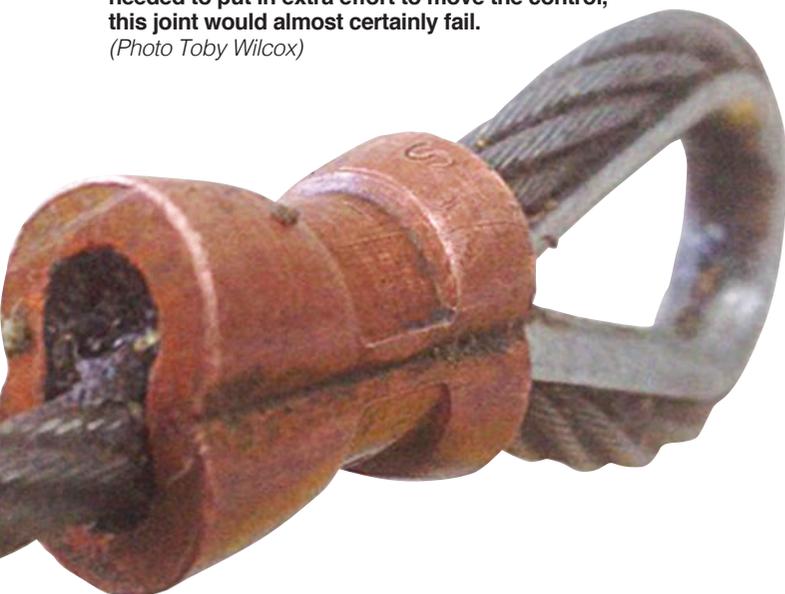
We put this image of an incorrectly swaged cable-end in last month's mag but because space became tight we weren't able to show the graphic of the correct swage number and swaging order; thanks to those of you that noticed the missing graphic. The problem was discovered in a routine inspection of the aileron system on a Piper Cub carried out by Targett Aviation's engineer, Toby Wilcox – good spot Toby. You can see that, whilst the ferrule is holding everything in place under normal circumstances, if for any reason there was a jam in the aileron circuit and the pilot needed to put in extra effort to move the control, this joint would almost certainly fail.

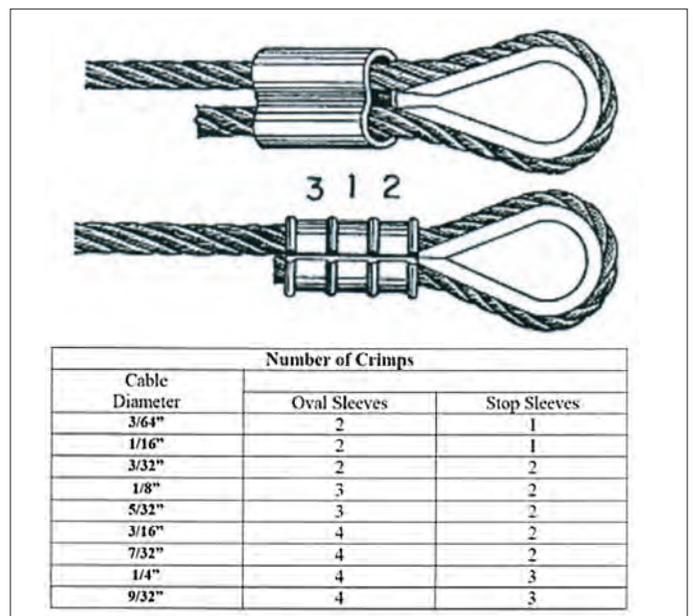
This graphic shows the correct swage order and the number of swages per ferrule, which increases with cable size. Note that the 'dead-end' reduces in size as the cable is crimped; experienced technicians often do a test cable end before making a final part. The material used in the manufacture of these ferrules has been especially chosen for its initial malleability and rapid work hardening, in other words, they are easy to form but, once formed, create a very stable connection. (Diagram Nicopress)

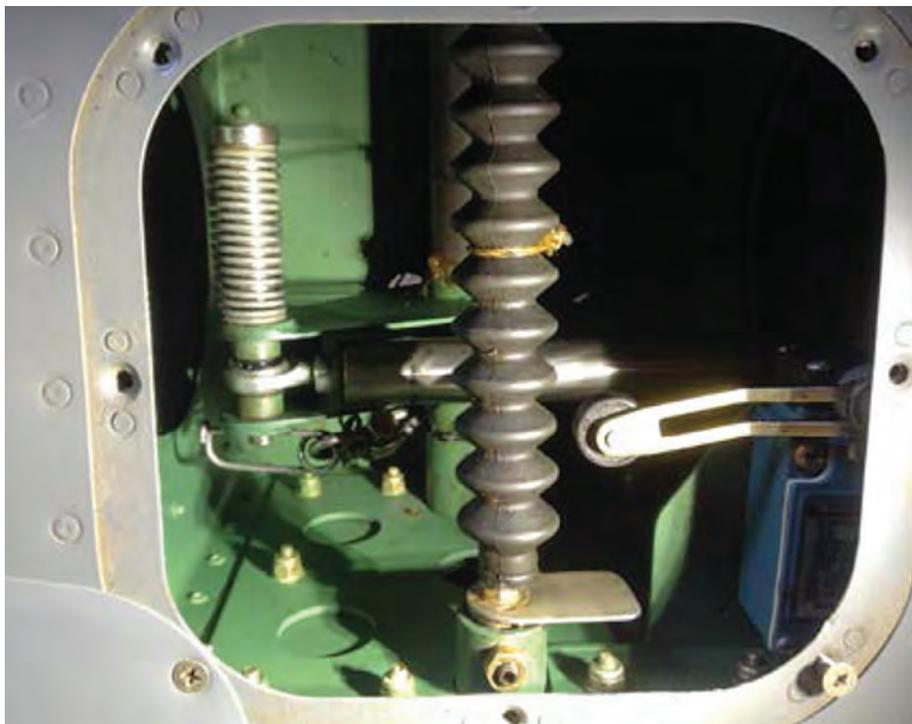
(Below) This picture shows the up and down microswitches which are used to control both the undercarriage operating motor and the undercarriage's position lights. The LAA is looking closely at the circuitry involved to see whether the system needs improvement.
(Photo Gary Cotterell)

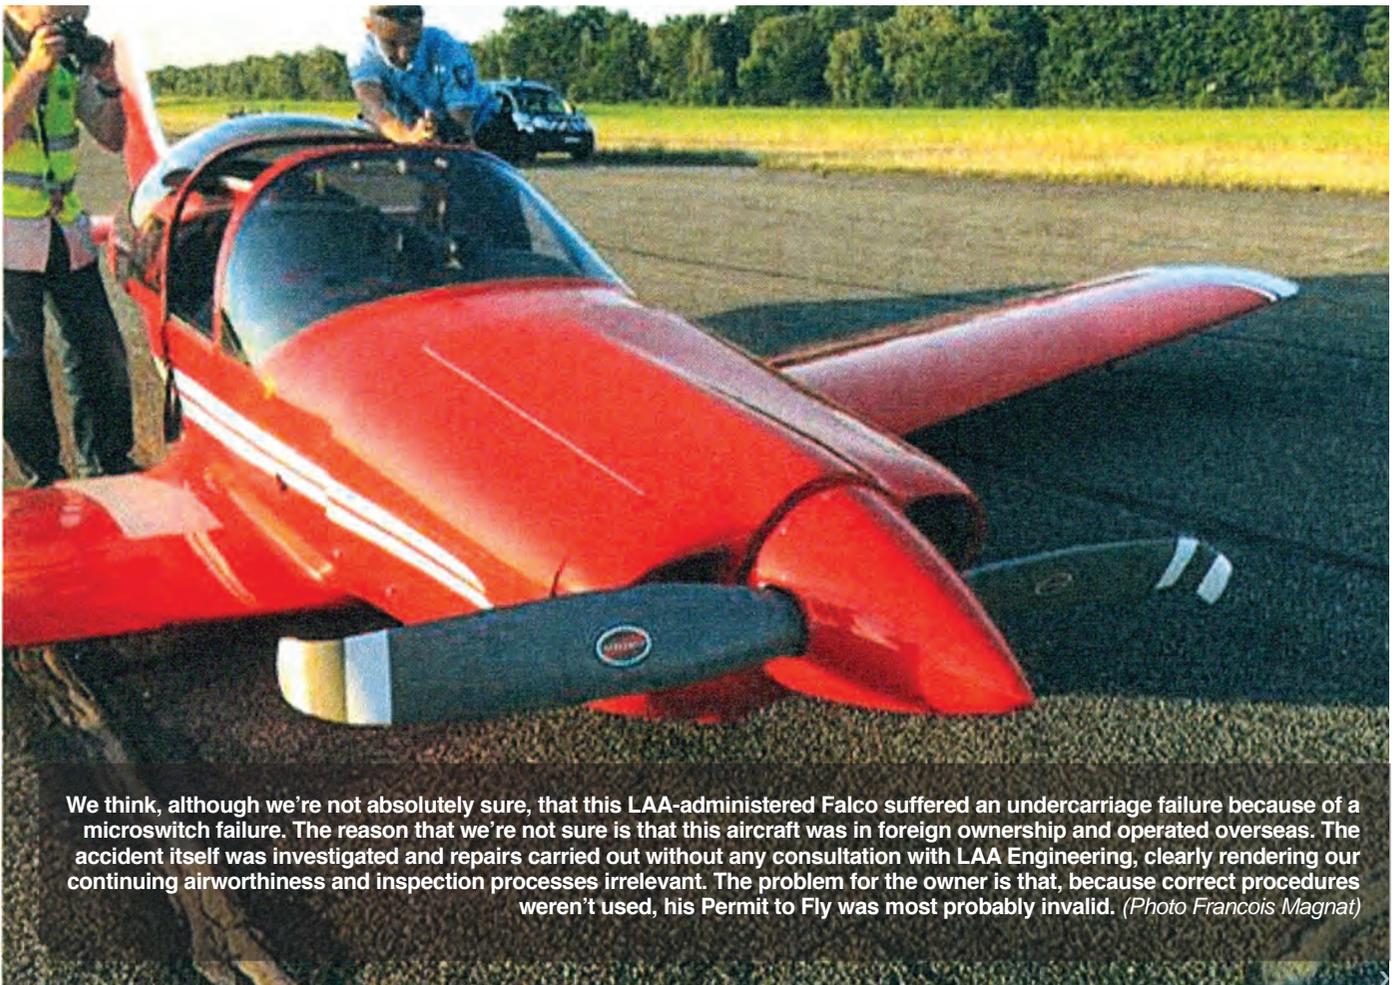
We think, although we're not absolutely sure, that this LAA-administered Falco suffered an undercarriage failure because of a microswitch failure. The reason that we're not sure is that this aircraft was in foreign ownership and operated overseas. The accident itself was investigated and repairs carried out without any consultation with LAA Engineering, clearly rendering our continuing airworthiness and inspection processes irrelevant. The problem for the owner is that, because correct procedures weren't used, his Permit to Fly was most probably invalid. (Photo Francois Magnat)

... found the cause of the accident when it dismantled the aircraft: broken electrical cables in the nose landing gear. When the two bare wires touched, the contact indicated that the landing gear was down. On completion of the repairs, we took several test flights and noticed that in turns involving g+ and in turbulence,

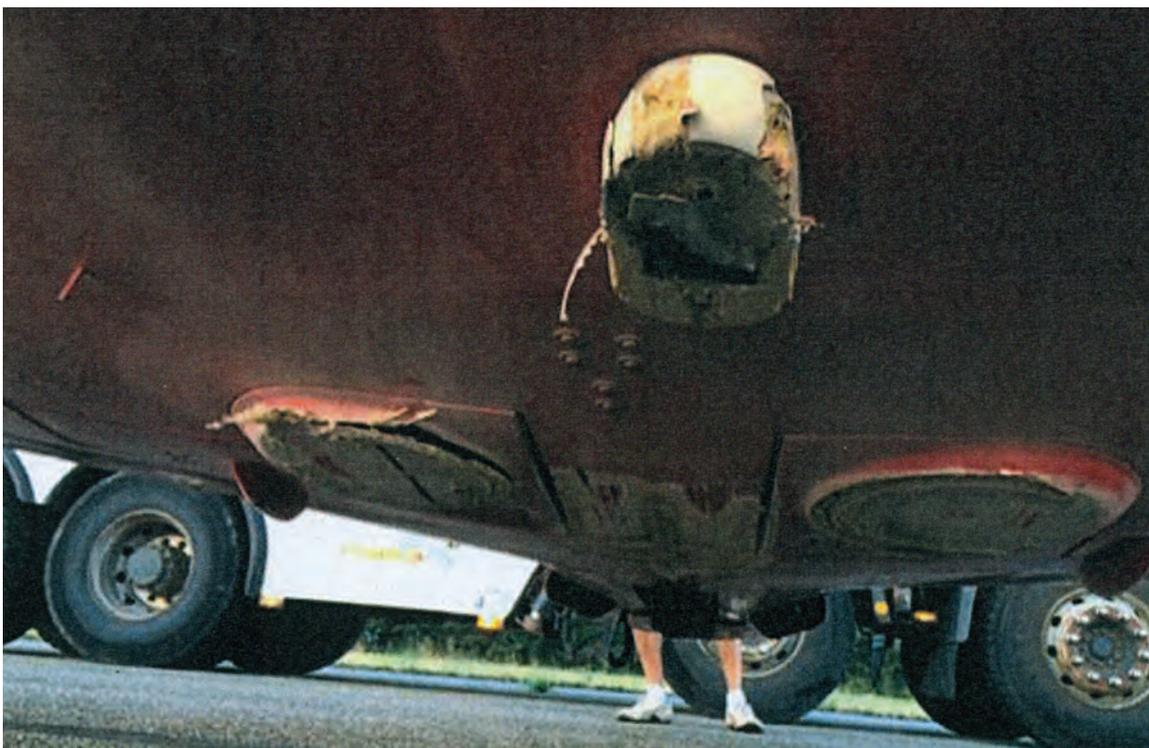
Once the Falco was lifted, the extent of the damage to the underside of the fuselage can be seen. In actual fact, the repairs themselves, when completed, appeared to have been done to a very high standard but, because they weren't done under LAA supervision, a Permit Maintenance Release couldn't be signed and the aircraft couldn't be released back to service. This aircraft is now being transferred to the French register. (Photo Francois Magnat)
