With Malcolm McBride
Airworthiness Engineer

IS IT TIME TO CONSIDER A 'DEEP INSPECTION'?

Problems with iPads, but that's not the real theme this month. It's the underlying issues which call for an occasional major inspection

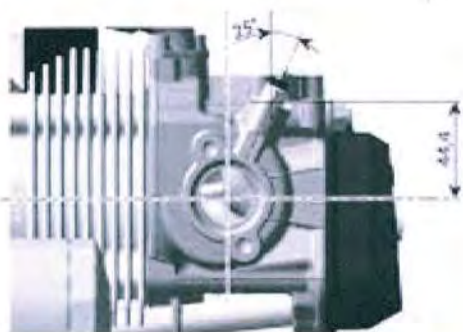
(Above and right) This drawing and picture show the positions of the temperature sender units on later (post 2013) Rotax 912 and 914 cylinder heads. These units extend into the water jacket and are therefore measuring the coolant temperature (CT) at this point in the circuit; as you can see, the units face upwards.

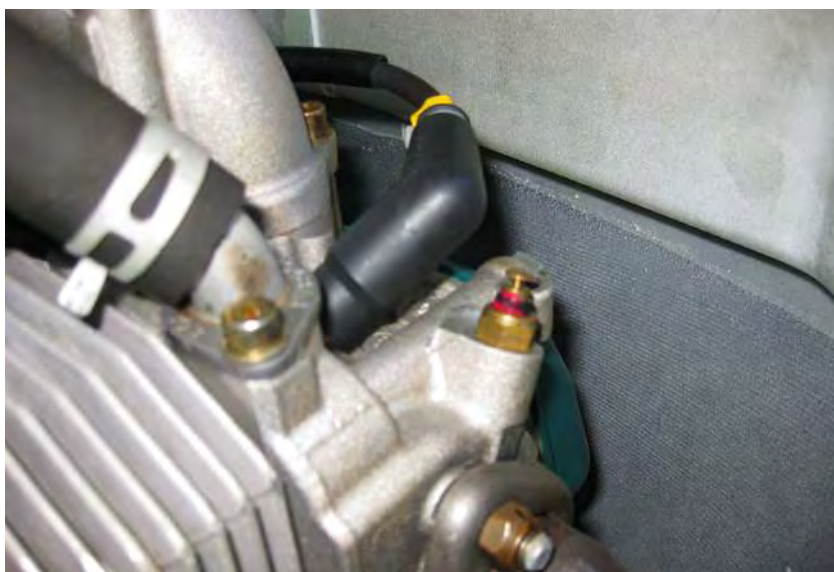
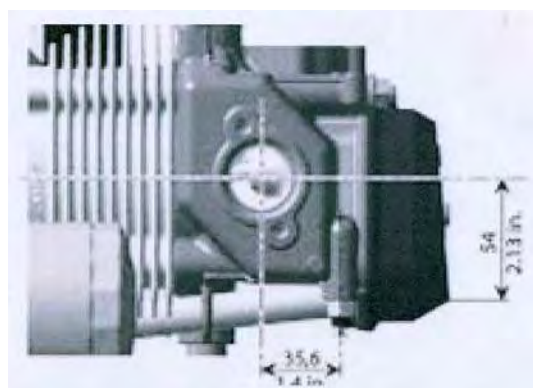
(Above and right) In this drawing and picture the older type of 912 and 914 cylinder head (roughly pre 2013) is shown; these units, facing down, are screwed into the aluminium head itself and are therefore measuring cylinder head temperature (CHT) (Photo BRP Powertrain/Malcolm McBride)

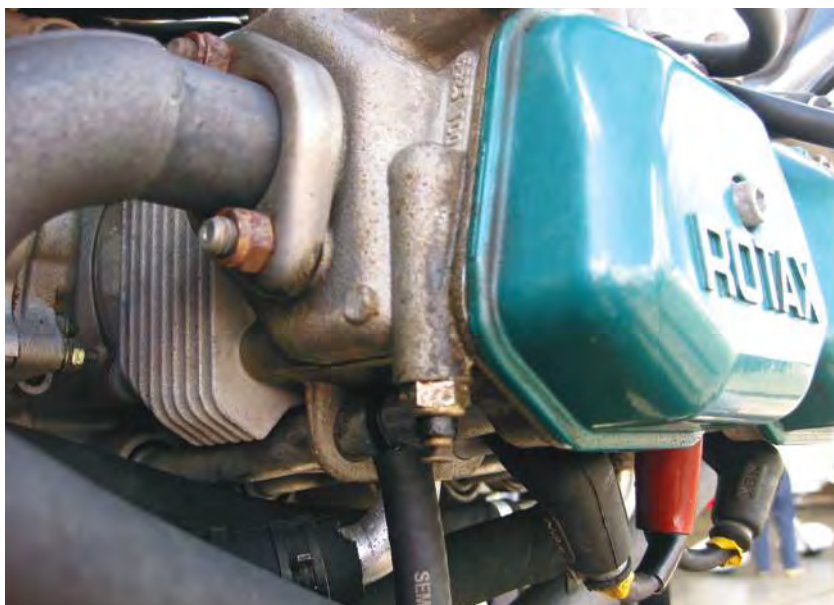
(Above and right) It is essential that a pilot is presented with appropriate and accurate information about the engines performance and, most importantly, its temperature relative to its operating maximums. We've come across examples in our fleet where a sender is measuring water temperature but the gauge fitted was marked-up as a CHT gauge.

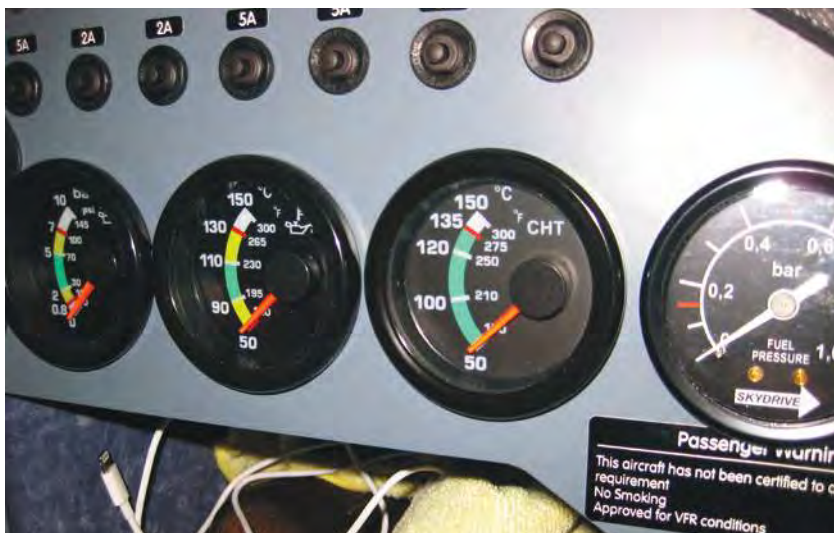
(Left) EASA has issued an Airworthiness Directive requiring owners and operators of 912 and 914 engines to check that their engine temperature gauges are marked-up correctly. The AD requires that, if the engine is fitted with the newer types of cylinder head, then an 01 mark must be added to the engines designator. This, in some cases, would mean that the engine would need to be removed to get access to the plate. The UK CAA is, at the time of writing, just about to issue an MPD requiring similar checks; however, the LAA and the BMAA have negotiated that the plate mark-up, when needed, can be deferred until the engine needs to come out for other reasons. (Photo BRP-Powertrain McBride)

shocked. Our AIL requires all 912 and 914 owners to check their systems, it isn't rocket science and the pictures attached pretty much say it all. Just in case a cylinder is changed on a machine after this has been checked, which may introduce an error, we've asked that this check be carried out at each annual inspection. If, when you check your installation, you do find anything amiss, may I ask that you let us know about it, this type of feedback is often very useful.

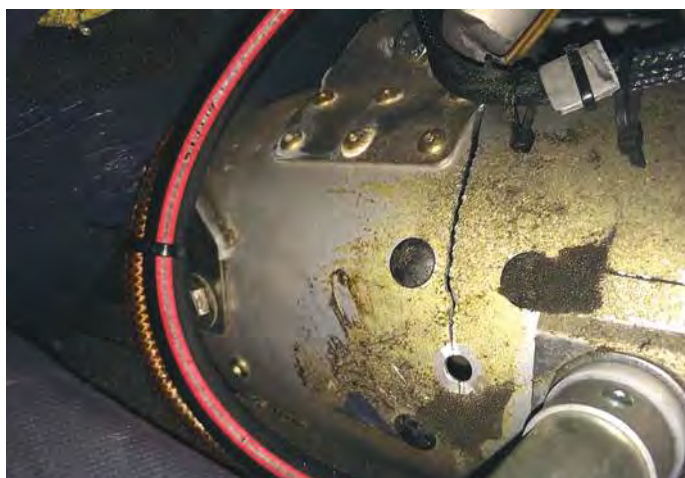
(Left This worrying crack wasn't spotted during the aircraft's regular maintenance checks because at this point the boom is covered with a glued-on insulating foam covering. This area of the fuselage structure is working hard because it has to resist the loads from the nose undercarriage and thrust forces from the engine. Picture: (Photo Red Aviation)

The airframe with the far more serious cracking shown in the accompanying pictures has flown something like 4,500 hours in a training role, and most of this has been flying off a grass strip, so we're cautiously optimistic that with an LAA fleet all being relatively low hours (our fleet average is nevertheless a

That said, this dangerous cracking hasn't happened overnight and without doubt this aircraft has been flying around for some time in a very dangerous state. This area of the main boom not only resists engine loads but also acts as an anchor for the leading edge of the mainplane via the forward strut. If the boom let go suddenly, goodness knows what might

The CAA has issued an emergency MPD requiring inspections in this area and, naturally, we've let all our C42 owners know directly that there's been a specific problem with this airframe type. In our view, this is exactly the type of problem that would have been spotted had the operators adopted a maintenance and inspection regime that requires, through the life of the aircraft, regular 'deep' inspections of the whole airframe, not just the parts that are easy to see.

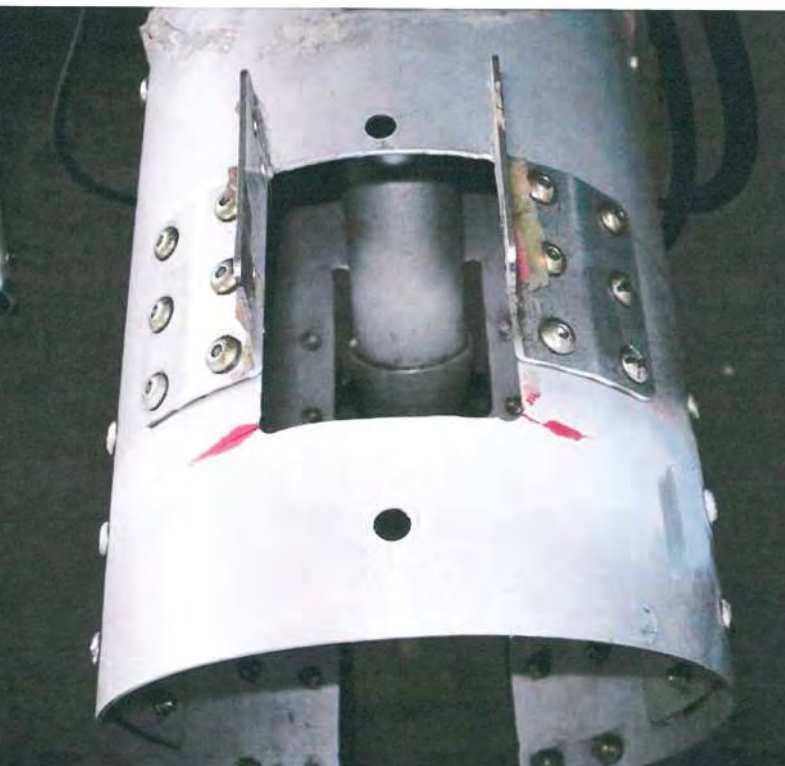
Over the years, inspectors and owners have noticed that the main boom on the C42 is prone to cracking at the corners of a cut out for the forward strut connection. Red Aviation, the aircraft's importers, have added a doubler inside the tube to strengthen the area though, as no LAA aircraft have been affected, this BMAA mod has not yet been cleared through the LAA system. (Photo Red Aviation)

Rob explained that, in some of the earlier airframes, small cracks had been seen emanating from the corners of the cut-outs in the main boom, particularly around the area of the nose undercarriage. The BMAA, along with the aircraft's importer, has developed a mod which strengthens up this area of the structure. We've no record of problems like this on LAA administered machines thus far but we've issued an Airworthiness Information Leaflet (AIL) asking owners to conduct checks on their airframes.

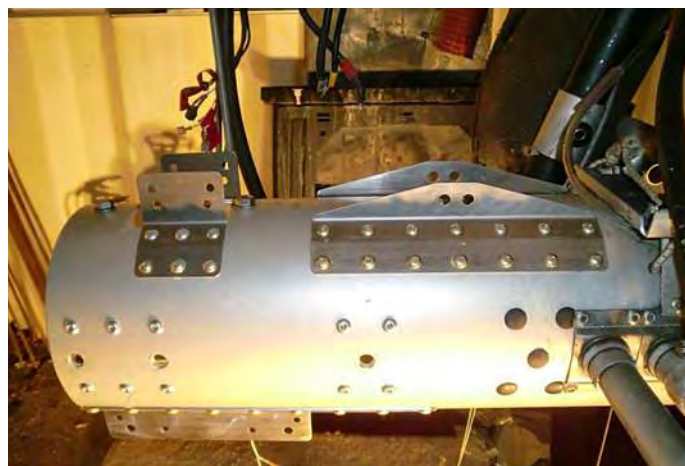
This is the forward end of the main boom on a later version of the C42 without the main engine mounting assembly fitted; notice that, in this example, the top rear bracket has been enlarged considerably, as you can see. There's a lot going on in this area of the fuselage structure but much of it is hidden and difficult to inspect; that's why it is essential, from time to time during the life of any aircraft, to carry out in strip inspections so that every part of the aircraft's structure can be thoroughly checked. (Photo Red Aviation)

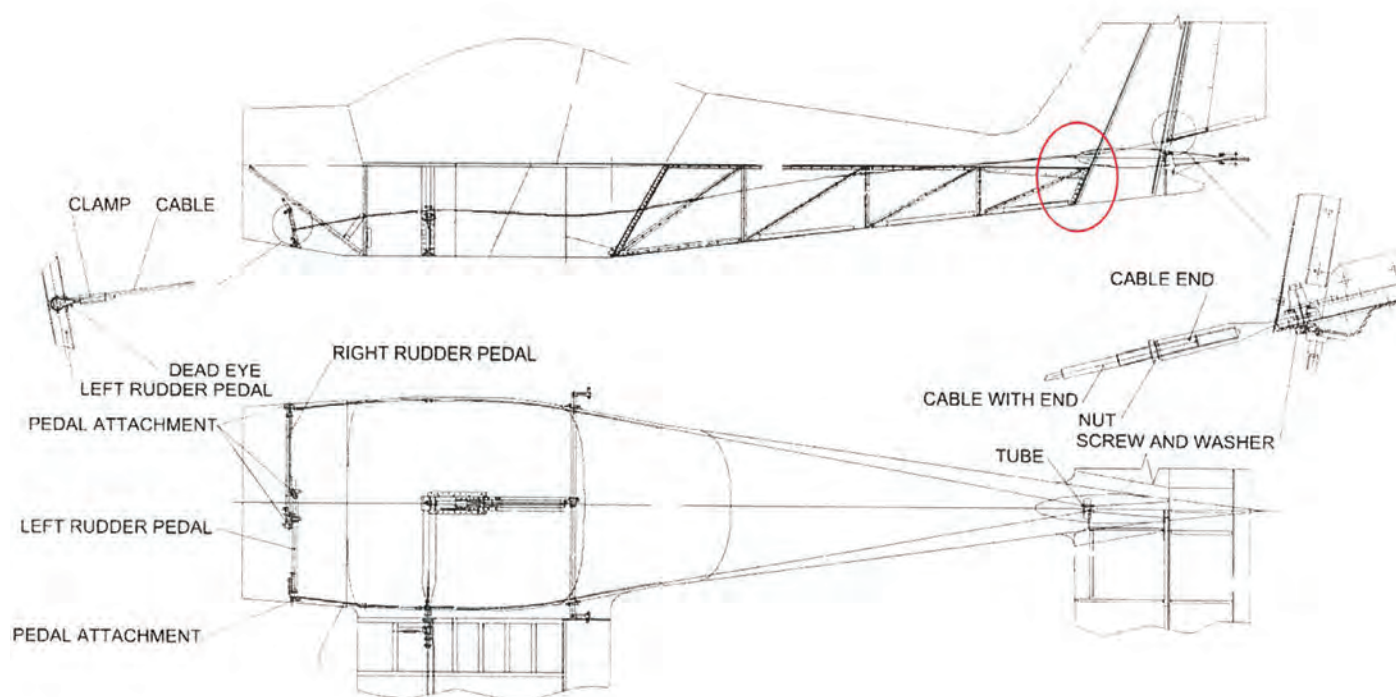
(Above) The recent Light Sports Aviation Service Bulletin requiring checks of the rear fuselage and the CAA's Emergency Mandatory Permit Directive enforcing it was written after a serious crack in the rear bulkhead of a relatively high hour example of an Evektor EV97 Eurostar. Like the recent problem affecting the C42, this area is very difficult to inspect properly without dismantling the airframe; the drawing above shows the general arrangement of the aluminium structure, the red ring highlights the area of particular concern. (Photo LAA Library)

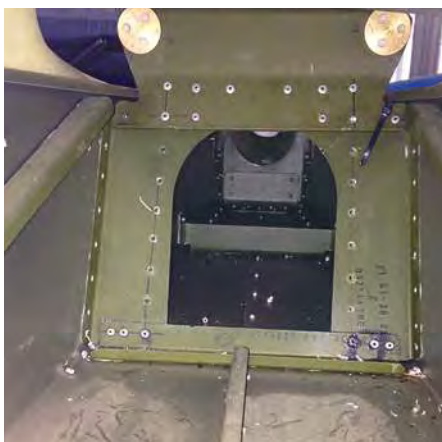
LAA Inspector Chris Theakstone has specialised in the maintenance and repair of EV97 aircraft took this picture of another example of this aircraft in his workshop. To gain sensible access, he's removed the 'turtle' deck and the tailplane and elevator completely. The two round discs at the top of the photo are the forward tailplane attachment points so, as the CAA's emergency MPD points out, 'Cracks and sheared rivets [in this area] may result in the failure of the integrity of the tailplane and/or loss of control in flight'.
(Photo Chris Theakstone)

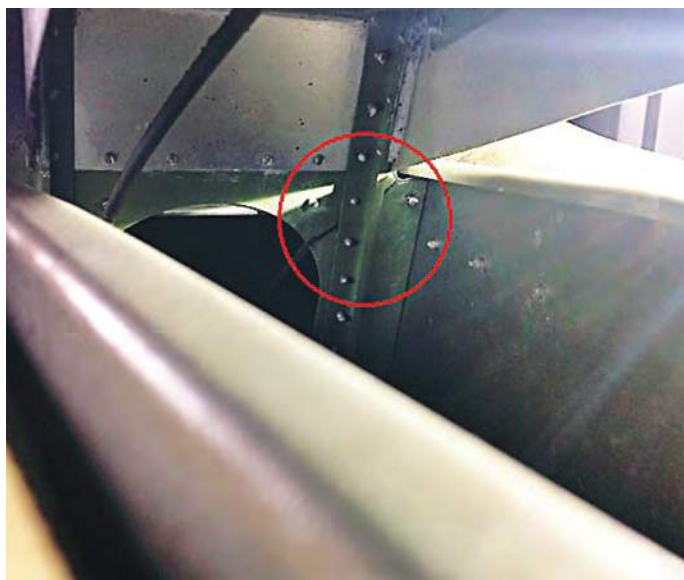
At the time of writing we've just become aware that a relatively high hour EV-97 microlight aircraft has been found with a serious crack to the structure that compromises the physical attachment of the tailplane. Unfortunately, due to a number of summer holiday related communication breakdowns, we didn't hear about this serious event until we were sent a draft of the local importer's Service Bulletin requiring checks. This SB was shortly followed up by a CAA Mandatory Permit Directive effectively mandating checks on high-hour aircraft.

This picture shows the cracked bulkhead on a 4,000+ hrs EV97 training aircraft as spotted using a small camera. Certainly, boroscopes, cameras and even mobile phone technology can be very useful for looking into areas of a structure that have limited access. It's always better though to do a close visual inspection, if necessary by removing flight control surfaces, seats, panels, tanks or other assemblies, to gain access.
(Photo Chris Theakstone)

The UK importer of the Eurostar, which holds type responsibility for the factory-built examples, considers that immediate visual checks to this rear bulkhead are necessary before further flight on aircraft that have more than 1,000 hours flight time. For aircraft that

haven't reached this hours total, the check can be carried out at the next service interval.

At the time of writing, LAA Engineering hadn't decided on its response but I feel sure that we will be looking at a scheduled inspection sooner than this (500 hours has been discussed) and the recommendation from our inspection team is that the tailplane will have to be removed (a simple job) to carry out this inspection properly.

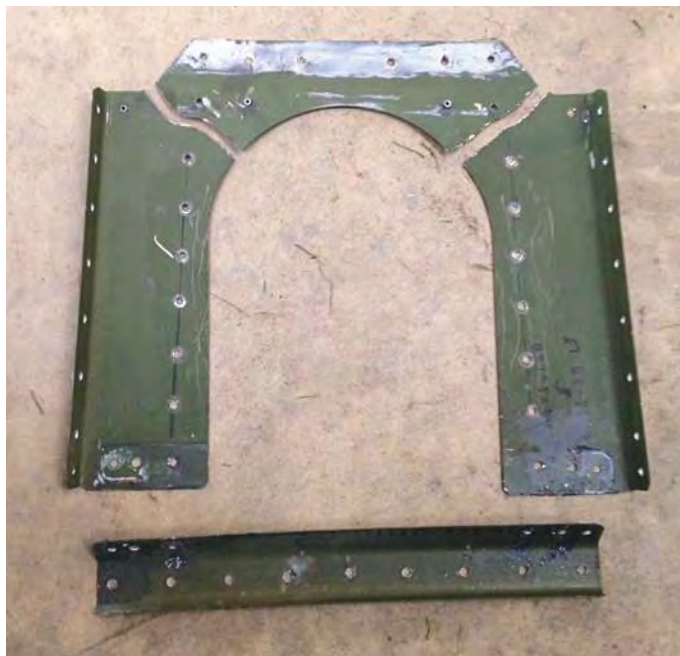
Though just a small crack could be seen during an initial close inspection, this is what was found when the frame was completely removed. As you can see, the structural integrity of the main connecting structure to the forward tailplane attachment has been completely lost. (Photo Chris Theakstone)

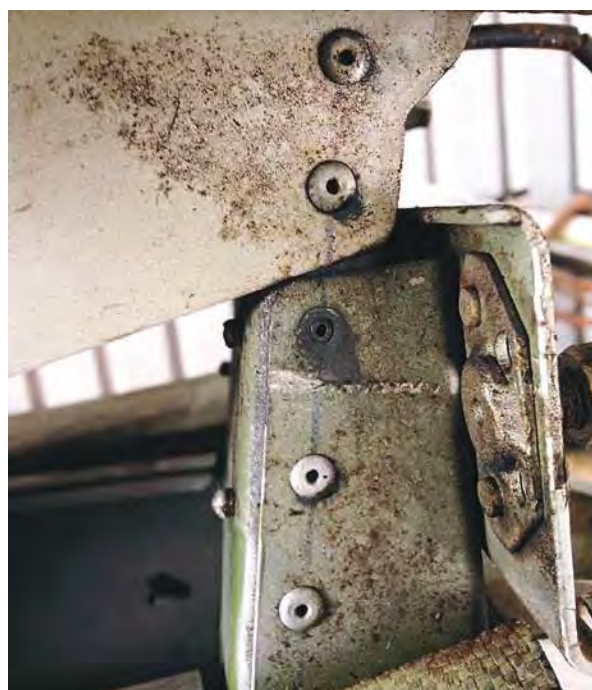
(Above) Recently, during the inspection of an EV97, the rudder was moved from side to side to check for freedom of movement. The engineer was surprised to find that the rudder, quite literally, came off in his hands. The EV97's bottom rudder hinge uses a fixed pin (right above) through a bearing (left above). The pin is threaded to take a washer and a nut which are intended to locate the rudder and prevent any end-wise movement. As you can see, the bearing is so worn that the inner ball has been able to slide out of the outer race and, because the washer behind the securing nut was smaller than the race's inner diameter there was nothing to hold the rudder in place after the bearing came to pieces. Evektor, the aircraft manufacturers, specify checks specifically for excess rudder end float so that any excess wear can be picked up before it becomes critical.
