With Malcolm McBride
Airworthiness Engineer

WET, WET, WET AND CAN WE LEARN FROM ACCIDENT STATS

Malcolm warns about the risks involved in storing an aircraft for a protracted period in damp conditions and considers the 2015 LAA accident statistics

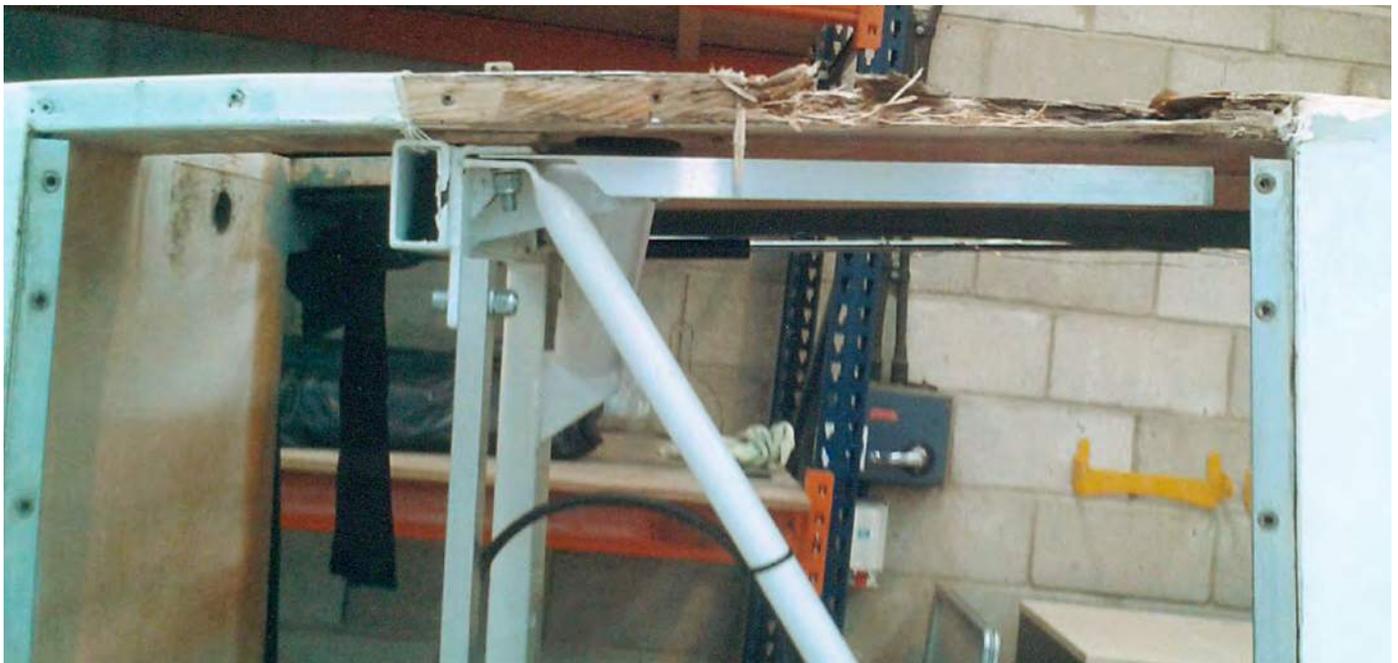
Wood is especially vulnerable to water damage – this picture shows the result of fairly long term exposure to standing water. For your interest, this is the fuselage side from a Pioneer 200 microlight aircraft that was never hangered.

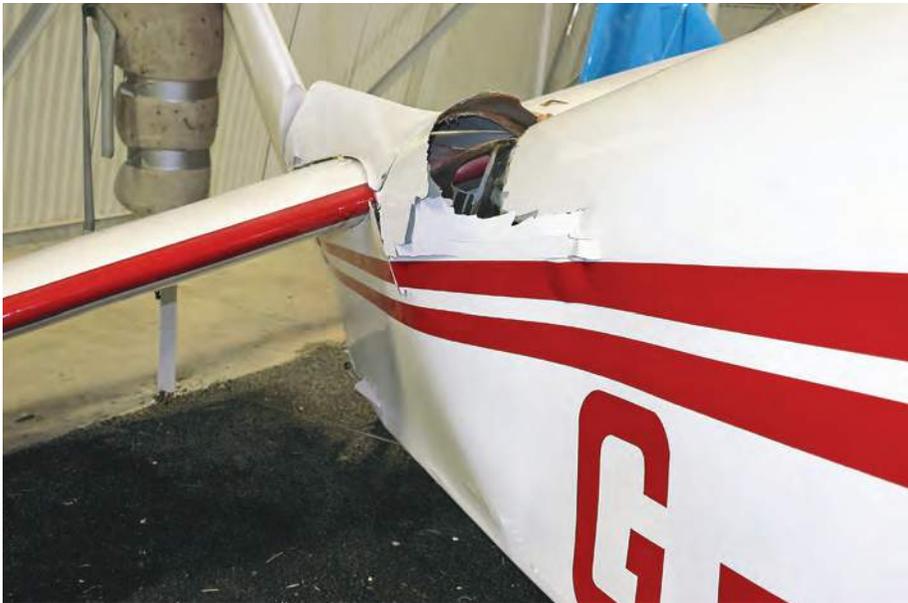
(Left) We've featured this picture of a Jodel fuselage failure before in Safety Spot (March 2015); following a groundloop incident, damage could clearly be seen. During the incident, the tail was seen to have impacted a concrete post and much of the damage seen may have occurred at this point. Both LAA inspectors and the engineer from the insurance company weren't so sure though and felt that the original cause of the runway departure may have been because part of the structure, weakened by water damage, broke shortly after landing. Looking at the evidence I have to say that I'm minded to agree. (Photo Al Greensmith)

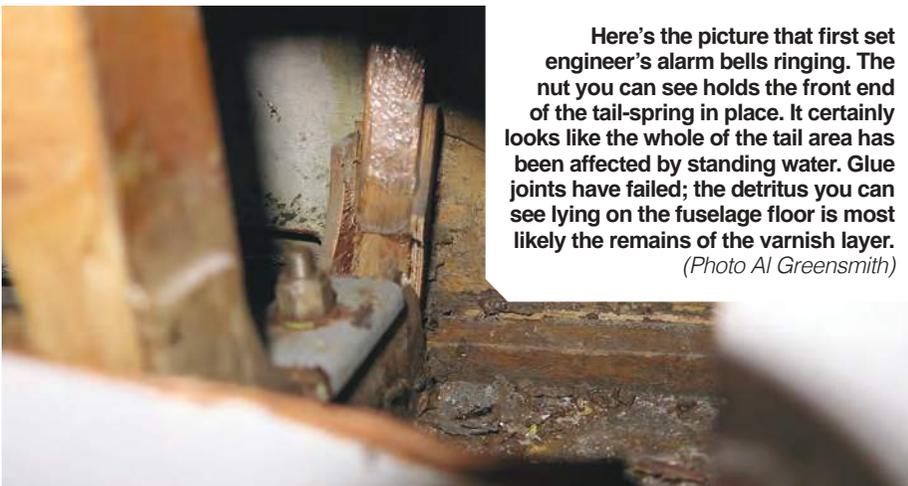
Here's the picture that first set engineer's alarm bells ringing. The nut you can see holds the front end of the tail-spring in place. It certainly looks like the whole of the tail area has been affected by standing water. Glue joints have failed; the detritus you can see lying on the fuselage floor is most likely the remains of the varnish layer. (Photo Al Greensmith)

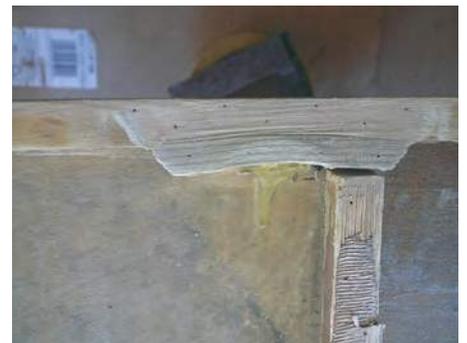
(Above) The water-damaged Jodel is now being rebuilt from the bottom up. LAA'er Alan Shipp has taken on the challenge and we're keeping an eye on progress here at LAA HQ. This picture shows a typical example of the type of damage that is having to be fixed – the joint between the upright and the longeron has completely failed, note the 'crush' damage to the tailplane attachment block. As wood absorbs water it grows, then metal fittings bolted to the wood structure crush the wood as it tries to swell. When the wood dries out, it shrinks again leaving the fitting loose. Naturally, for the maintainer finding the loose fitting, the temptation is just to tighten up the bolts but come the next drenching the cycle will repeat itself, leading to an ever more crushed and distorted structure. Naturally, the cure is to keep the water out in the first place. (Photo Alan Shipp)

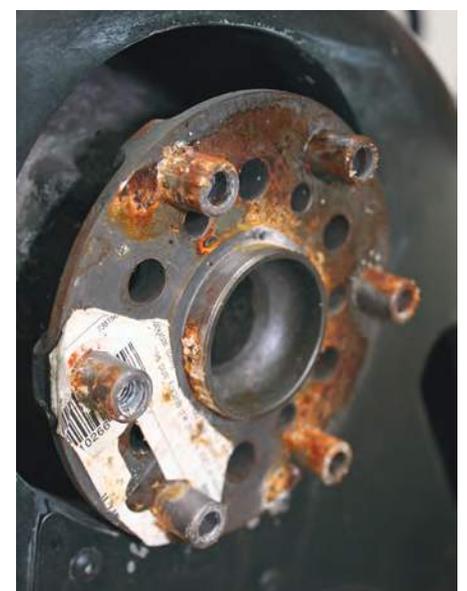
(Right) If water is allowed to get in, it will. LAA Inspector, Roger Targett, sent me this picture with the following note: Thought you might like to see a couple of pictures of the prop shaft on an aircraft we're working on at the moment. We had a shock load inspection carried out yesterday, the prop bolt safety wiring left a lot to be desired, but then, on removing the prop, we found paper/cardboard packing on one side to shim the hub over to improve the tracking, leaving a gap allowing corrosion to set up! (Photo Roger Targett)

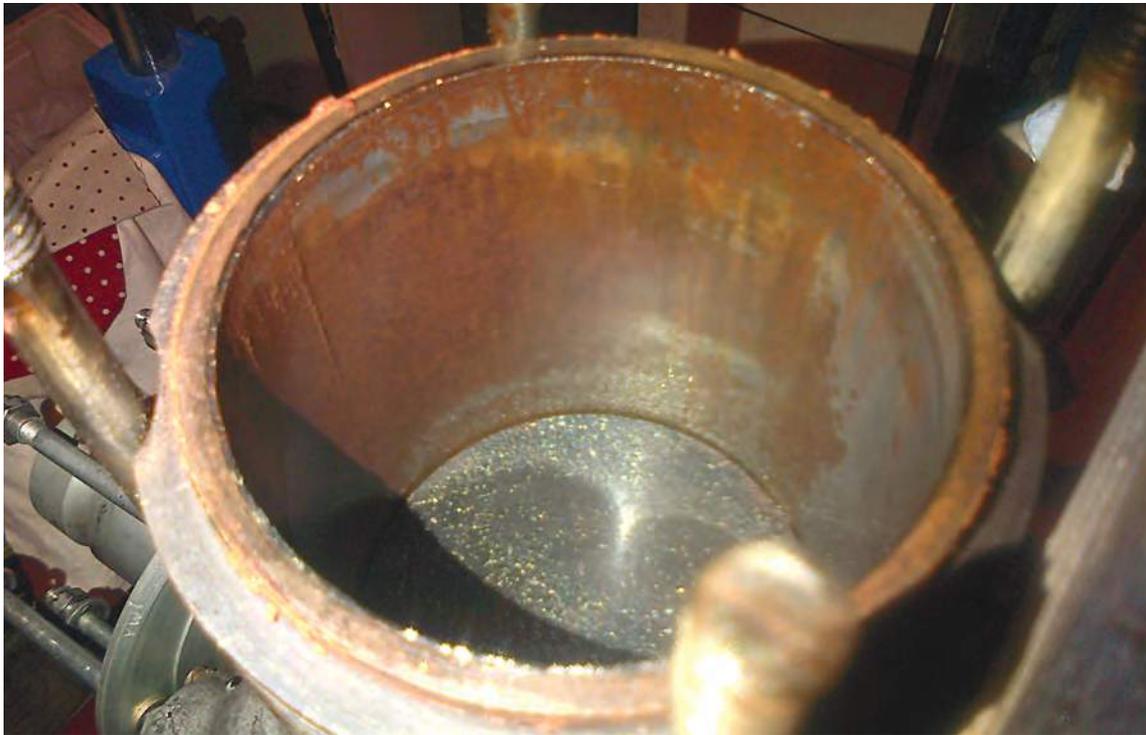
In the text I discussed the very great importance of ensuring that your aircraft hasn't been negatively affected by its prolonged winter stand-down. This cylinder barrel, as you can see, has been badly affected by corrosion and it will be an expensive operation bringing the component back to full serviceability. It's a bit of a conundrum working out the best way of preventing this type of problem but LAA Inspector, David Beale, offers some useful tips which I've shared in the text.

Hi Malcolm, I had a recent new owner of a Taylor Mono with a VW ask me for help over the weekend when it would not start. I diagnosed immediately that the problem was no compression, so a quick squirt of oil in cylinders, wind over, plugs back and it then fired-up almost immediately and ran perfectly thereafter (VW valve seats rust ever so easily). I suggested that he puts some oil in the fuel and seals the exhausts with bags (or tennis balls) as I do on my Mew. Another thing that I do is put an

oily (or WD40) soaked rag in the inlet and pull it through one blade every few weeks when it's not being used... but do not do short ground runs as that will lead to internal corrosion.

Another tip you might pass on for those laying-up their aeroplanes over the winter is to put some two-stroke oil in the fuel tank before the final flight of the season; this would help lubricate the fuel system and leave oil film in the engine to help stop corrosion. Two-stroke oil is probably much better than engine oil as is designed to mix with fuel, not separate out, plus it's very low ash and burns without causing deposits (like upper cylinder lubricant).

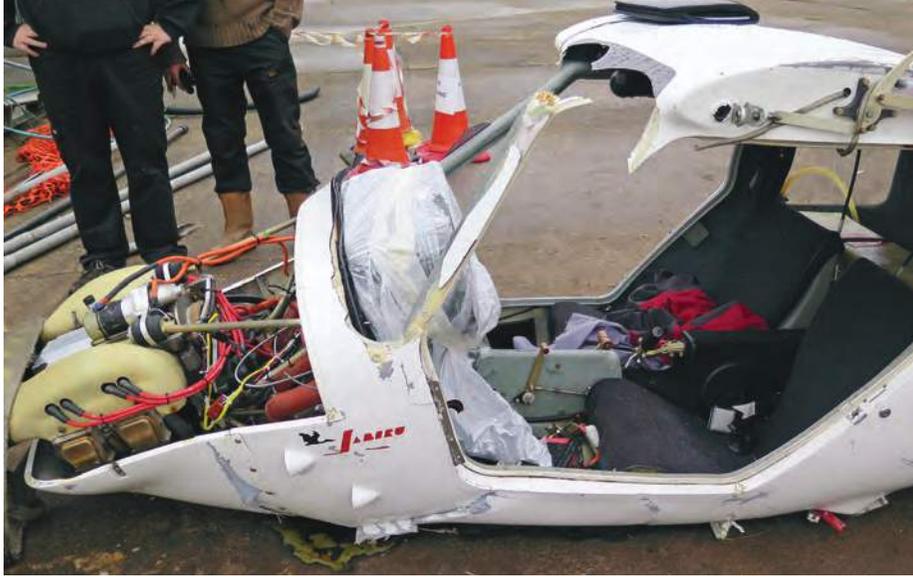
The pilot of this Jabiru inadvertently caught a mainwheel on a lamp post during the final stages of an approach to an unfamiliar airfield. As you can see, the aircraft was very badly damaged but both occupants, whilst suffering quite serious back injuries, survived the experience and are now both well on the way to a full recovery. Considering the nature of the accident, this Jabiru fuselage has remained pretty intact, perhaps a testament to good design. I briefly discuss this accident in the text and I feature it as an accident that would be listed as purely operational. (Photo AAIB)

runway was displaced into the field some distance because of some tall street lamps surrounding a small factory unit and had set up an approach to the original position of the runway. He didn't see the 23ft high street lamp that contacted the undercarriage and doesn't remember much else about the incident.

Whilst this incident is operational, so almost by default, pilot error, I do hope that you see that there are other components to this accident. I've taken a look at the plates for this airfield and they're not brilliant, for example, whilst they're marked, there's no specific warning about the obstacles on the approach, even though this is not the first accident at this site. I only say this to remind readers that it's a very rare accident that only has one cause.

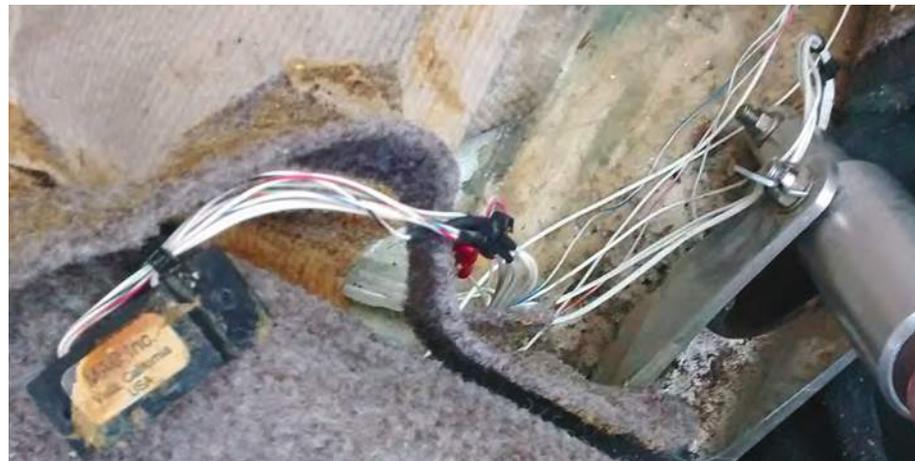
After a lot of searching, a likely cause of the uncommanded trim action was the very poor wiring to the pitch trim relay – wiggling the wires shorted the circuit. Once this was discovered, the owner took the decision to re-wire the aircraft. (Photo David Joyce)

The fourth possible reason is that, for some reason, the servo fired-up on its own. That's definitely a technical cause. As it turned out, a fault was found in the aircraft's wiring which may have been the culprit. So, should we categorise this as an operational incident now we know that there was an electrical fault? Well, that's what we've done, although it has to be said that the aircraft should be able to be flown with a jammed trimmer; part of a pilot's conversion training to type should include an exercise where a completely out of trim situation is rehearsed. This pilot had not had this experience, so when it happened in real life he didn't immediately recognise what was going on.

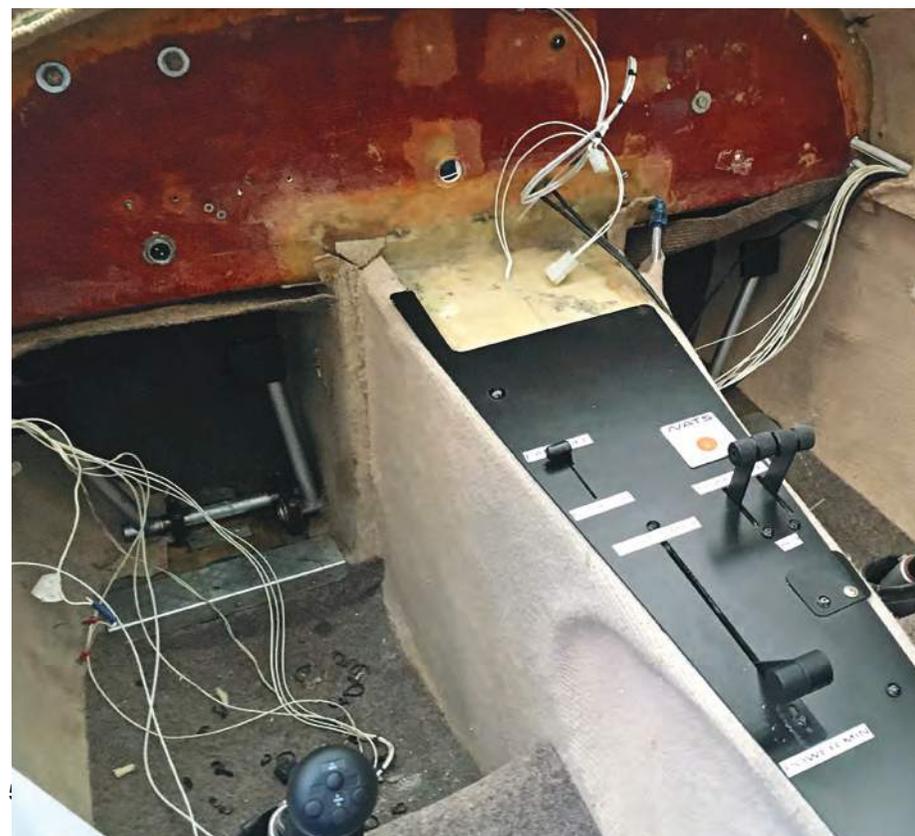
This picture shows a Europa that's being completely re-wired, it's also having a complete instrument upgrade. This is a good example of an operation incident with a technical initiator. Notice the stick-grip contains unprotected switches, these operate the radio's press-to-talk facility and, relevant here, the pitch trim. The aircraft suffered what the pilot thought was a complete control failure during an otherwise normal take-off. He aborted the take-off fairly promptly but ran out of runway damaging the undercarriage and the propeller. (Photo David Joyce)

The third option here is that the pitch trim was accidentally operated during the beginning of the take-off roll. Notice that this aircraft had stick-mounted pitch trim actuation buttons; could it be that, gripping the control stick, the pilot accidentally activated the pitch trim servo? Again, this scenario is possible and would fit into the operational folder. But are

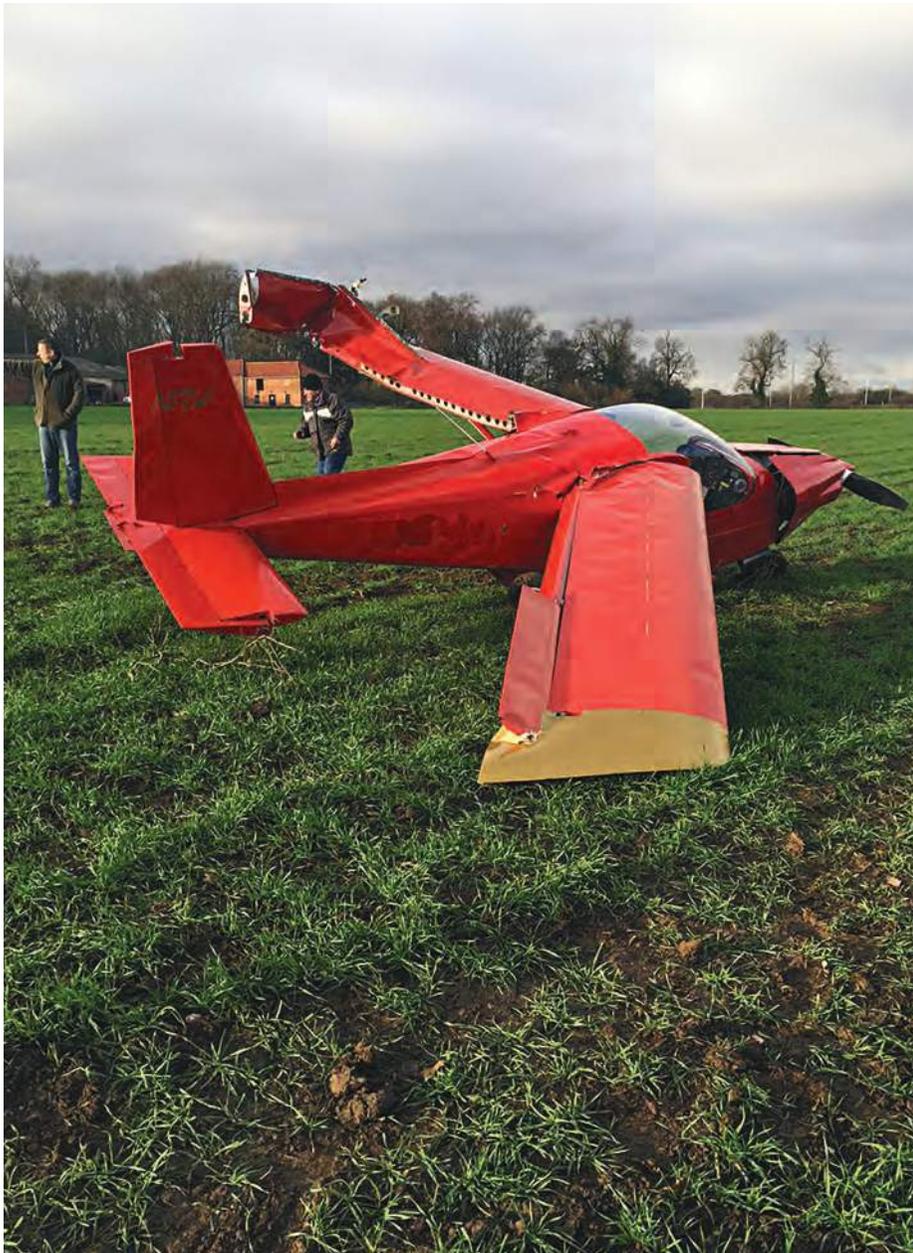
This picture shows the aftermath of a failed field landing after an engine failure shortly after take-off. It's unlikely, very sadly, that this ARV Super II will ever fly again. I feature this accident because it is primarily a technical failure in the final stage of an otherwise textbook forced landing where the pilot hit an unseen tree stump. (Photo Andrew Barley)

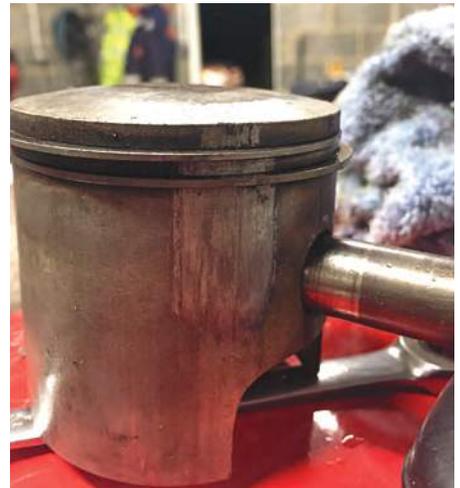
Like in the last couple of examples, this pilot was new to this type of aircraft; in fact he'd never operated a two-stroke engine before. Now, if you take a look at the scuff marks on the piston (pictured) you'll probably guess that lubrication and temperature probably played a role in this engine failure. History tells us that two-strokes do not like being throttled back quickly after a long climb, this is because the engine gets pretty hot during the climb, >

probably fairly close to its limit and, if you pull back the throttle quickly, you stop fuel getting to the engine. Because the lubrication oil is carried around the engine by the fuel in this type of engine, closing the throttle effectively starves the engine of oil. Also, as with many engines, the mixture strength with most two strokes is automatically richened at full throttle, for extra cooling, coming back a bit on the throttle weakens the mixture.

(Above) The Hewland-powered ARV's engine stopped because the piston 'picked-up' against the barrel wall; two-stroke engines can be prone to this type of failure as I discuss in the accompanying text. (Photo Andrew Barley)
