With Malcolm McBride
Airworthiness Engineer

DE HAVILLAND DH82A TIGER MOTH – IN-FLIGHT BREAK UP

MINICAB (JB01 STANDARD) – PROPELLER STRIKE ON START-UP

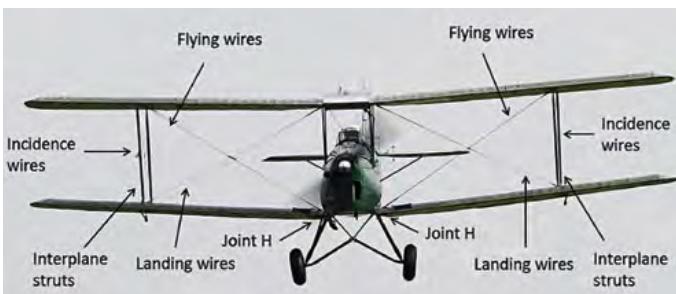
The Tiger Moth has two tie rods which form a tension couple between the wings (effectively between the two Joint Hs marked). This picture allows the observer to picture the forces through Joint Hs during flight. Remember that a lateral lifting force will act perpendicular to the wing's surface and that, if the structure is to hold together, all the forces must resolve themselves! (Photo de Havilland Support Ltd. Modified by ATSB)

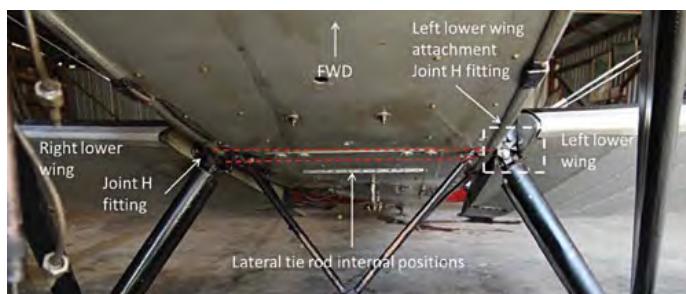
Here the position of the two Lateral Tie Rods, which sit inside the fuselage, is shown by the dotted red line; ground loads, which place this part of the structure in compression, are resolved through a tubular strut (shown in another picture). Note that much of the force generated by the undercarriage into the fuselage is distributed through the Joint H fitting though the lower lower landing gear attachment. (Photo ATSB)

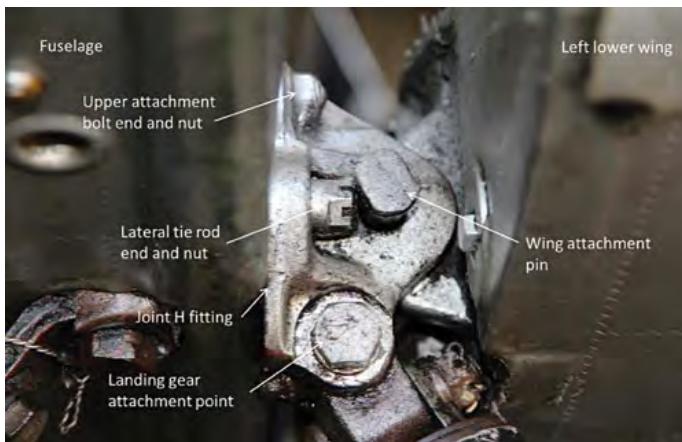
This picture shows a close-up of the Joint H fitting itself. During the investigation it was found this assembly had been assembled using incorrect bolts which could have affected the way the connection behaved during normal operation. (Photo: ATSB)

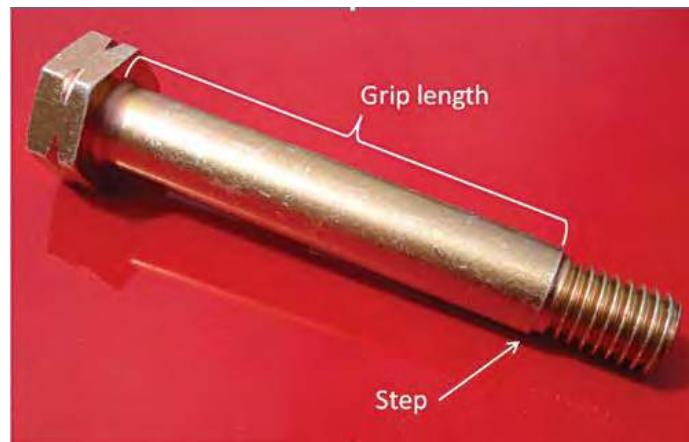
This picture shows a genuine Joint H attachment bolt. Note the grip length and step down to a smaller-diameter thread. The step in the bolts is necessary for correct assembly. Substitution of bolts with a reduced grip length may cause excessive shear loads to be reacted by the tie rods.

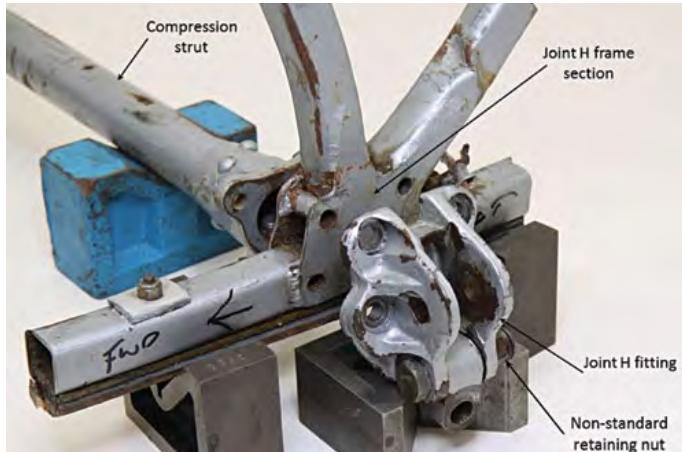
(Left) This picture shows the 'working parts' of Joint H, note the substantial compression strut and the non-standard retaining nut holding the undercarriage attachment swivel. (Photo: ATSB)

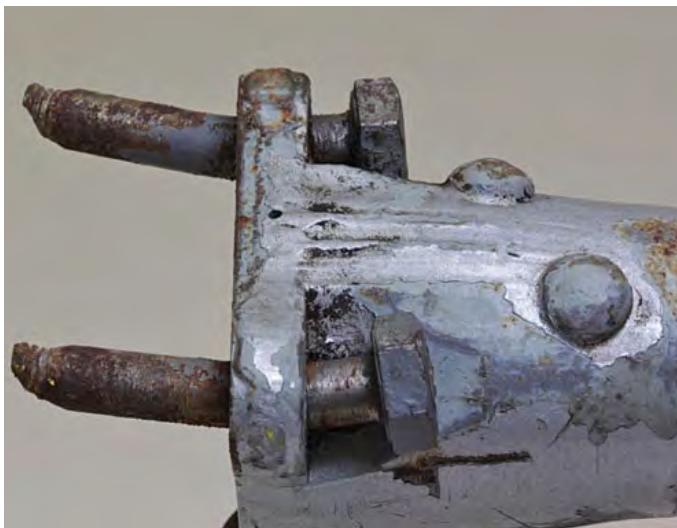
(Left) This picture shows the failed Joint H upper attachment bolts still attached to the compression strut. The DH82a should be fitted with four special upper attachment bolts (de Havilland part number H37868). Three of the four bolts were recovered from the accident site, the fourth bolt, from the left side, forward position, was not recovered. It was not determined if the missing bolt was present at the time of the accident. The three recovered bolts had all fractured through the threaded area in a manner consistent with ductile overstress. The H37868 drawing specified a high-tensile steel, shouldered bolt with a 0.28 inch grip diameter and a step down to a 0.25 inch BSF (British Standard Fine) thread. The grip length of the bolt was specified as 1.45 inches (36.8 mm), with an overall bolt length of 1.8 inches (45.7 mm).

The recovered bolts were non-standard and their origin was not recorded in the aircraft logbooks.

The hardness of the bolt material was consistent with high tensile steel and in line with the original design part drawing specification. However it was evident that the bolts had been machined down from larger bolt stock and re-threaded to suit the application. The bolts displayed non-standard bolt head markings and had one flank ground down to fit against the compression strut. During investigations in Australia two other aircraft were discovered to be flying with 'home-made' joint H attachment bolts and, subsequently, checks in the UK have revealed three more examples. (Photo: ATSB)

The unquestionable connection, with regard to the fatigue issue, is that the Joint H top attachment bolts were not of the correct design. The top attachment bolts are special stepped bolts sized to provide a reliable shear connection between the fittings and the fuselage sides. Instead, bolts had been fitted which had the incorrect shank length, preventing these bolts carrying shear effectively. This meant that punishing vertical

shear forces from the landing gear were almost certainly transferred to the lateral tie rods, which are not designed to fulfil this function. You can see the importance of this connection, which has to resolve aerodynamic lifting loads, wing weight and a variety of forces generated by the undercarriage, in the attached pictures. I hope I'm not being disrespectful to the original de Havilland design team when I say that I don't think a designer would configure this connection in this way now!

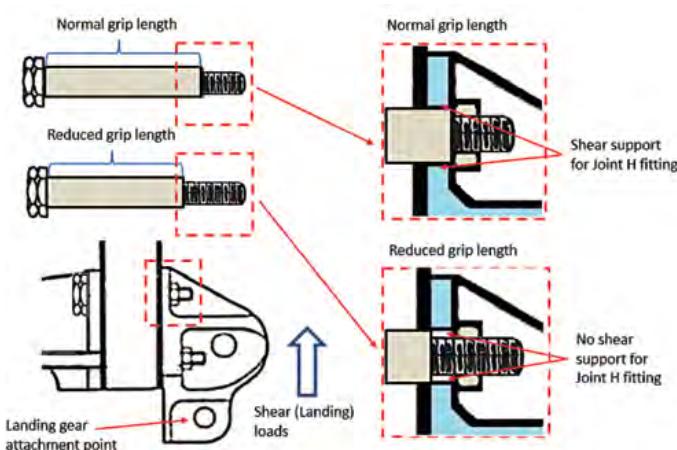
(Left) This graphic, supplied by the ATSB, shows the importance of fitting the correct components in critical assemblies. You can see here that, because of the reduced shear support to the joint H fitting itself, the joint wouldn't have been working 'as designed'. Debate continues about the relative consequences of this major assembly defect and I wouldn't want to be the person that has to make a decision about this in the inevitable court case following the accident. (Photo: de Havilland Support Ltd. Modified by ATSB)

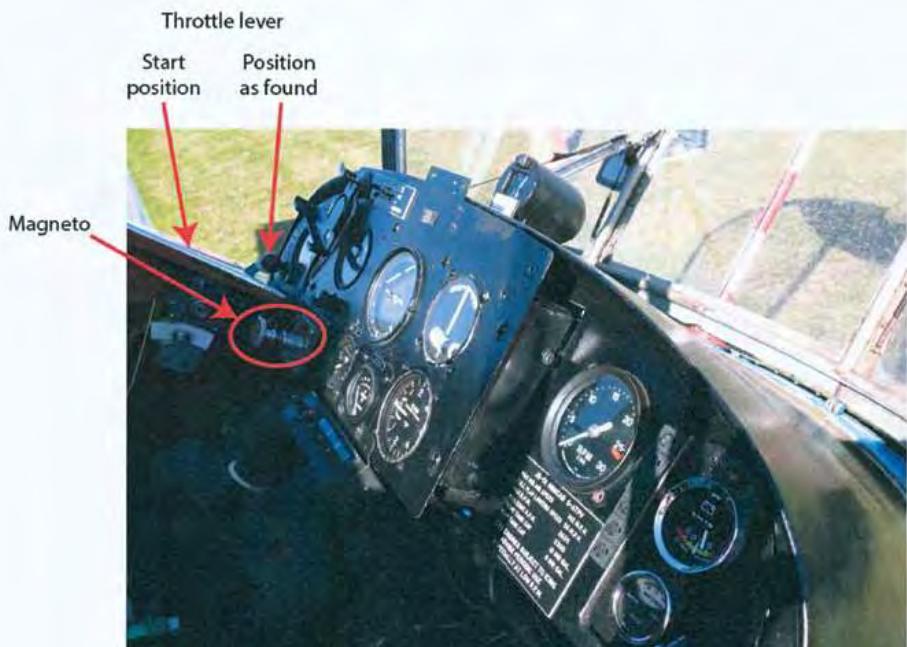
He considered it most likely that, immediately before the accident, he had omitted to retard the throttle from the fully open position before attempting to swing the propeller.

This picture shows the position of the Gardan Minicab's throttle after the incident so there can be no question that it hadn't been correctly set before the hand start. Most aspects of aircraft operation require drills and checklists. Naturally, if a task is on a checklist then it must be important but, when it comes to checking mag switches before touching a propeller, or ensuring that everything is set correctly before hand-starting an engine, I'm in the habit of checking twice. (Photo: Fenland Aero Club. Courtesy of AAIB)

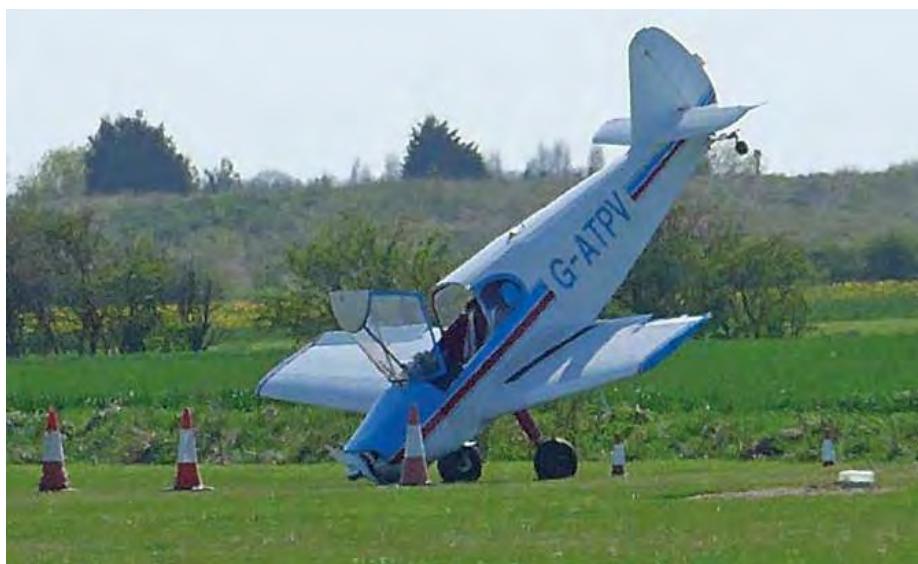
This picture of the Gardan Minicab, taken by LAA'er Richard Keech using a long lens, shows what can happen if an engine is hand-started with the throttle set to maximum power. Naturally, the propeller is a write-off and the engine, a Continental C90 will be lucky if it passes the shock-load inspection: both these issues pale into insignificance when you consider that the pilot lost the lower part of his left arm when it was struck by the propeller as the aircraft nosed-over. (Photo: Richard Keech)
