JABIRU 2200 ENGINE – STARTER RING ATTACHMENT

Safety Spot

MK.26 SPITFIRE – UNDERCARRIAGE RETRACTION ISSUES

EUROFOX – UNDERCARRIAGE FAILURE

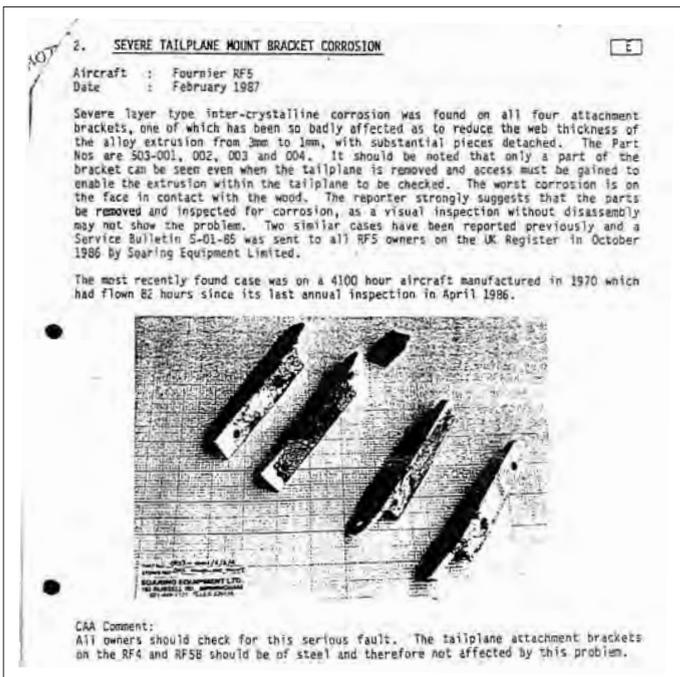
(Above) Because aircraft have very long lives and, often, many owners, important safety information can get mislaid. Here is a good example of a technical issue highlighted in February 1987 by GASCo concerning corrosion worries in the tailplane mounting brackets of some Fournier RF-5 aircraft. This rather unofficial alert mentions a Service Bulletin (S-01-85) which was mandated by an Airworthiness Directive from the CAA (AD85-207). Because the LAA enjoys the company of 10 RF-5s on its books, though only four are currently flying, we're actively collating all historical technical information on this type. (Photo GASCo)

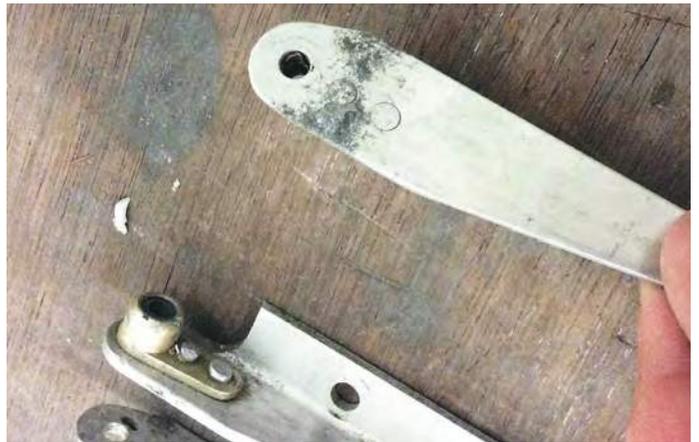
(Above) LAA Inspector David Bland sent us this picture showing a tailplane bracket he's recently removed from an RF-5 under repair in his workshop. I hope that you can see just how relevant the earlier (1985) safety bulletins were. Corrosion like this on any aircraft fitting is totally unacceptable not just because of the strength reduction due to material loss but also that corrosion pits formed act as 'stress concentrators' which will lead to cracking. (Photo David Bland)

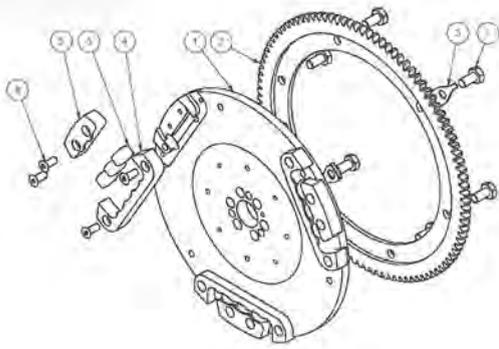
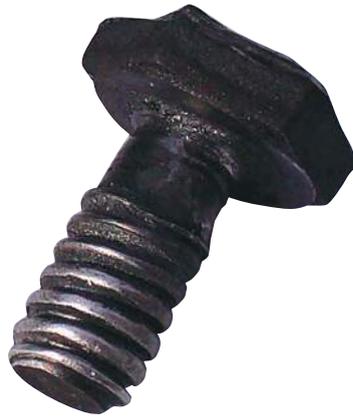
(Above) A good example of a problem discovered during a 50-hour inspection on his Jabiru SP 430 microlight aircraft that would, had the component failed, most likely caused an in-flight emergency. You can see that connection between the starter ring gear and the flywheel has become loose and, because it's been moving about, has worn the connecting bolts nearly to the point of failure. Naturally the owner, LAAer Chris Pratt, pulled the assembly and replaced all the bolts. This is the first time we've had this problem reported to us. Chris noted that there was no sign of a thread locking compound having been used, though the Jabiru agent tells us that this component should have been locked using Loctite 620. (Photo Jabiru/Chris Pratt)

I was very impressed when I spoke to LAA member and Jabiru microlight owner Chris Pratt the other day. Chris emailed me a couple of photos of a bolt that he'd just removed from the starter ring gear of his 2200 Jabiru engine. It was obvious that Chris had picked up a problem that was rapidly moving towards a complete failure of a structural element in his engine. Namely, the starter ring gear was very close to falling off the flywheel because the attachment bolts had all worked loose. It wasn't a completely obvious spot but it was found because he put his inspector's hat on and looked carefully at every connection and component on his engine – whether or not a specific inspection had been called up in the maintenance manual. I don't think that I've seen this failure previously, so I gave the Jabiru specialists a call to see whether they'd heard of this disconnect happening before. They

It looks like this failure occurred because the original assembler of the engine didn't use a thread-lock when fitting the bolts and that, not surprisingly as this failing would be very difficult to spot, this omission wasn't spotted by an inspector before the engine was released to service. If you own a Jabiru engine then next time you have the cowls off, get your inspector's hat on and take a close look at your flywheel/starter ring gear bolts, just in case. Whilst you're at it, test yourself and have a good look around the rest of the engine; see if you can find a problem. I bet you do!

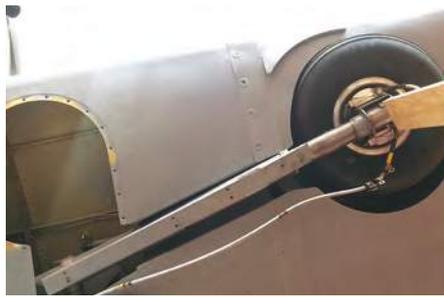
(Left) A worm's eye view of the post ground loop Mk.26 undercarriage leg in the fully retracted position; note the different clearance between the tyre and the wheel cut-out front and rear. (Photo Dave Bishop)

Once I'd got out of the cockpit I found that the radial tread groove in the tyre had caught on the wheel-well skin at the forward edge of the undercarriage bay and the wing skin had "pinged" into the tyre groove. Selecting U/C Down and resetting the breaker didn't work, selection simply popped the breaker again. In fact, to free both legs I needed the assistance of a couple of friends.

Clearly, the ground-loop that Chris and David suffered had bent both the undercarriage legs. David is right, had he flown the aircraft like this he would have ended up having to land his machine wheels-up: not the sort of end to a first flight you'd really wish on anybody. I think that everybody agrees that these early Mk.26 legs are marginal strength-wise, so David has set about designing a modified leg from stronger material. I noticed that his Mod application came in just a couple of days ago so, well done to him.

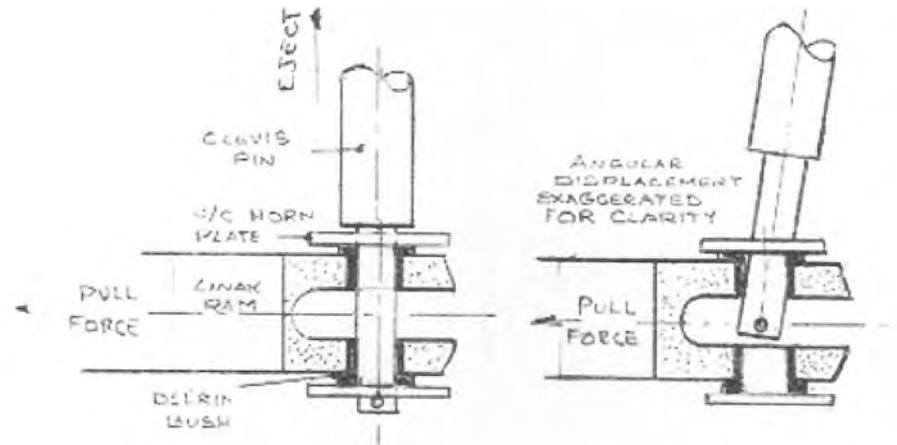
(Above) Dave, a very competent detail engineer, noticed that the undercarriage emergency drop mechanism wasn't working well and decided to investigate why. Here is a sketch showing one of the reasons why the release pin, which connects the electrical motor drive unit to the leg itself, became jammed halfway out during an emergency drop test: the material in the bush (which Dave thinks is Delrin) isn't strong enough to resist the side loads in the pin created when the pin is halfway out. Dave discussed this with our Design department and it was agreed that the Delrin bush could be replaced with a stiffer bush made from phosphor bronze. (Photo Dave Bishop)

The third reason, found by David, was that the nylon bush, fitted to some but not all the UK machines, was distorting when the

pin was half out; the pictures show David's fix.

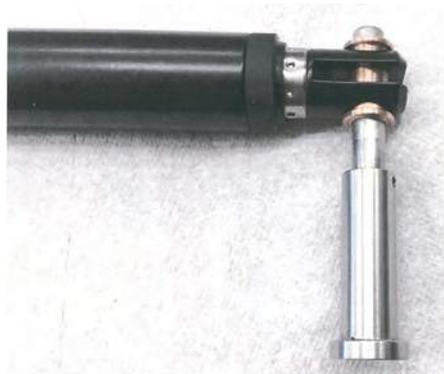
(Left) Dave's new bush as fitted to the actuator with the connection pin in place. (Photo Dave Bishop)

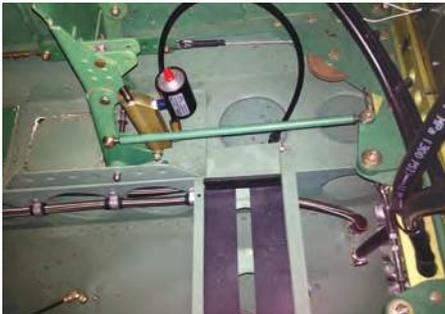
(Left) The modified position for the brake actuator and the new connection rod on the port rudder pedal. You can see that the connection to the rudder pedal has been moved much closer to the pedal which, though reducing 'throw' increased the relative force transmitted to the actuator itself. This is a very neat solution to the issues of poor braking and system overstress during braking, but it does have the disadvantage that the ability to easily adjust the rudder pedals has been lost ... though it would be easy to change the length of the drive rods to suit an individual leg length. (Photo Gary Cotterell)

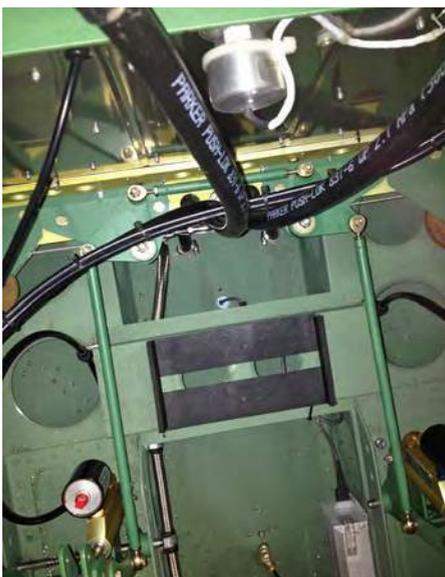
(Left) One problem that has been noted by Mk. 26 Spitfire owners is that the differential brake control is not brilliant. Inspectors have noticed that during toe brake operation the cables to the rudder are being stretched giving the system a sloppy feel. Also, the loads in the rudder cables, increased because of braking force, has caused damage, in some cases, to the rudder and attaching structure. LAA inspector and Mk. 26 owner Gary Cotterell has been working with us to improve the directional control aspects of this brilliant aircraft. Here's part of the mod which is in the final stages of the LAA's approval process. You can see that the rudder's control loop has been closed by the introduction of a mechanical link between the rudder pedals. Other small changes have included the strengthening of the rudder attachment itself and some geometry changes to the brake pedals. (Photo Gary Cotterell)

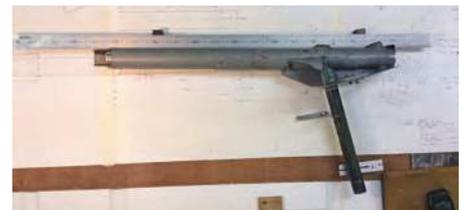
(Above) Dave's Mk. 26 was an early kit and contained the original undercarriage leg design. Because of subsequent weight increases and, it has to be said, problems with these early legs due to bending, Dave is drawing up an improved (strengthened) design. As well as some local reinforcement the new leg will be made from a stronger steel that has a better resistance to creep than the original stainless material used. Dave is working with our Design Department through the LAA's Mod system to get this change approved. (Photo Dave Bishop)

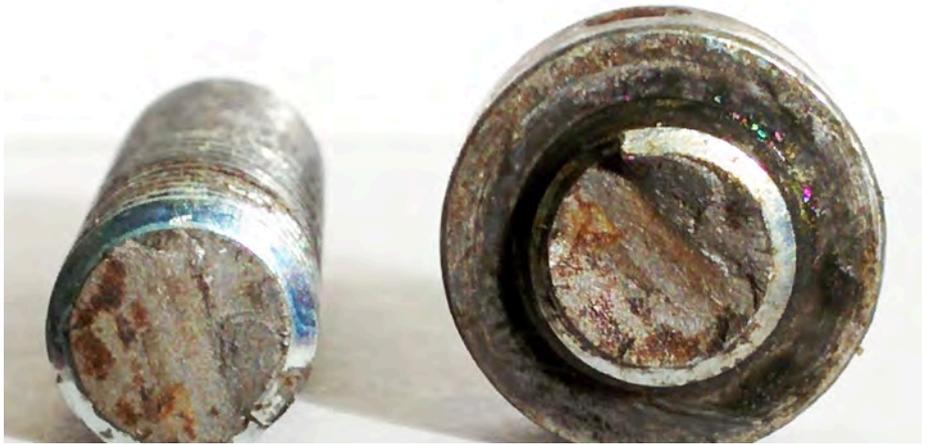
The undercarriage leg itself is a composite construction which, as you can see from the attached photos, is attached to the fuselage via a bracket at the centre of the fuselage and a rubber filled clamp. The bolt that failed, as you can see, primarily due to fatigue, was the forward clamping bolt.

(Above) The fracture face of the failed bolt that led to the undercarriage failure on the Dorset Gliding Club's Eurofox tug. The corrosion, which clearly shows that this bolt has been failing over time, follows the beach lines indicative of a failure due to fatigue. To allow for movement of the leg during normal operation the leg is held in a rubber plate held within a clamp. We think that, especially when the aircraft is operating on rough ground, that the fore and aft loads are causing the leg to twist slightly; this in-turn, loads-up then unloads the forward locator bolt causing fatigue and eventual failure. (Photo Dave Piercy)

At that time, it was felt that the reason for the failure of the bolt was due to over-tightening. The manufacturer had designed the attachment such that this clamp bolt should only just be nipped-up. We've had a bit of a re-think about this and, along with the manufacturer, are in the process of designing a change that should improve the fatigue characteristics of this connection. The bulletin, which should be published towards the end of October 2016, will also life these bolts.

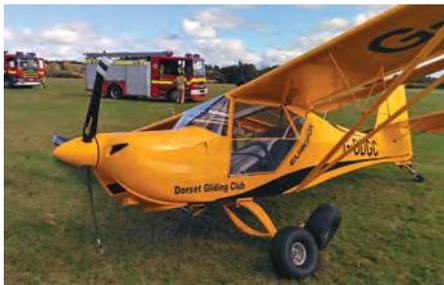
So, as we very nearly reach our *Safety Spot* word limit, I just have to let you know about a rather well-publicised incident a couple of weekends ago at the Dorset Gliding Club's site near Wareham. Essentially what happened was that, during a normal take-off, towing a glider, the starboard undercarriage leg, after hitting a small bump, became partially disconnected from the airframe, ending up hanging vertically downwards from its centre-fuselage connection. The pilot was not aware that the outer leg attachment had failed until alerted by radio by the rather surprised pilot of the glider he was aero-towing.

(Left) Here's a picture taken by LAAer Dave Piercy of the Dorset Gliding Club's 'tug' after a landing with only one serviceable undercarriage leg. Though Dave is the tug-master at DGC he wasn't actually flying the aircraft at the time, that honour went to tug pilot Tim Ambler and well done to him for getting the aircraft back down on the ground without damage and, most importantly, without injury. (Photo Dave Piercy)

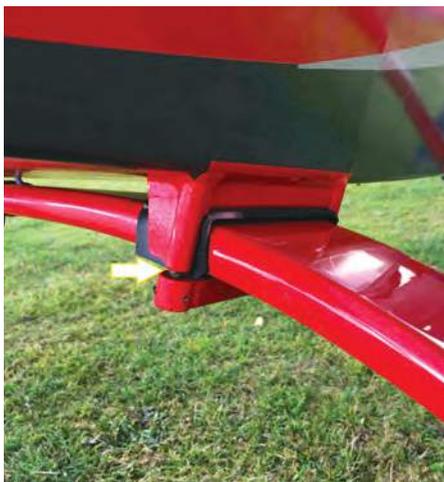
(Left) How the main undercarriage is attached to the fuselage on the Eurofox aircraft. You can see that if the bolt (arrowed) fails, freeing the clamping strip, the leg is then free to rotate around the centre fuselage connection bolt and will hang down vertically. Previous failures of this bolt have been noted after landing or during maintenance checks and it's a pre-flight inspection requirement to check this bolt before flight. The LAA is, at the time of writing, working-up a Bulletin with the aircraft's manufacturer requiring this connection to have a bush fitted so that the bolt can be pre-tensioned. This will mean that it will be less prone to fatigue failures; added to this these bolts will be lifed. (Photo Roger Cornwell)
