With Malcolm McBride
Airworthiness Engineer

FUEL PUMPS, CARB RUBBERS AND FILTERS

Disparate issues this month, though they are all related to the tricky subject of inspections and maintenance

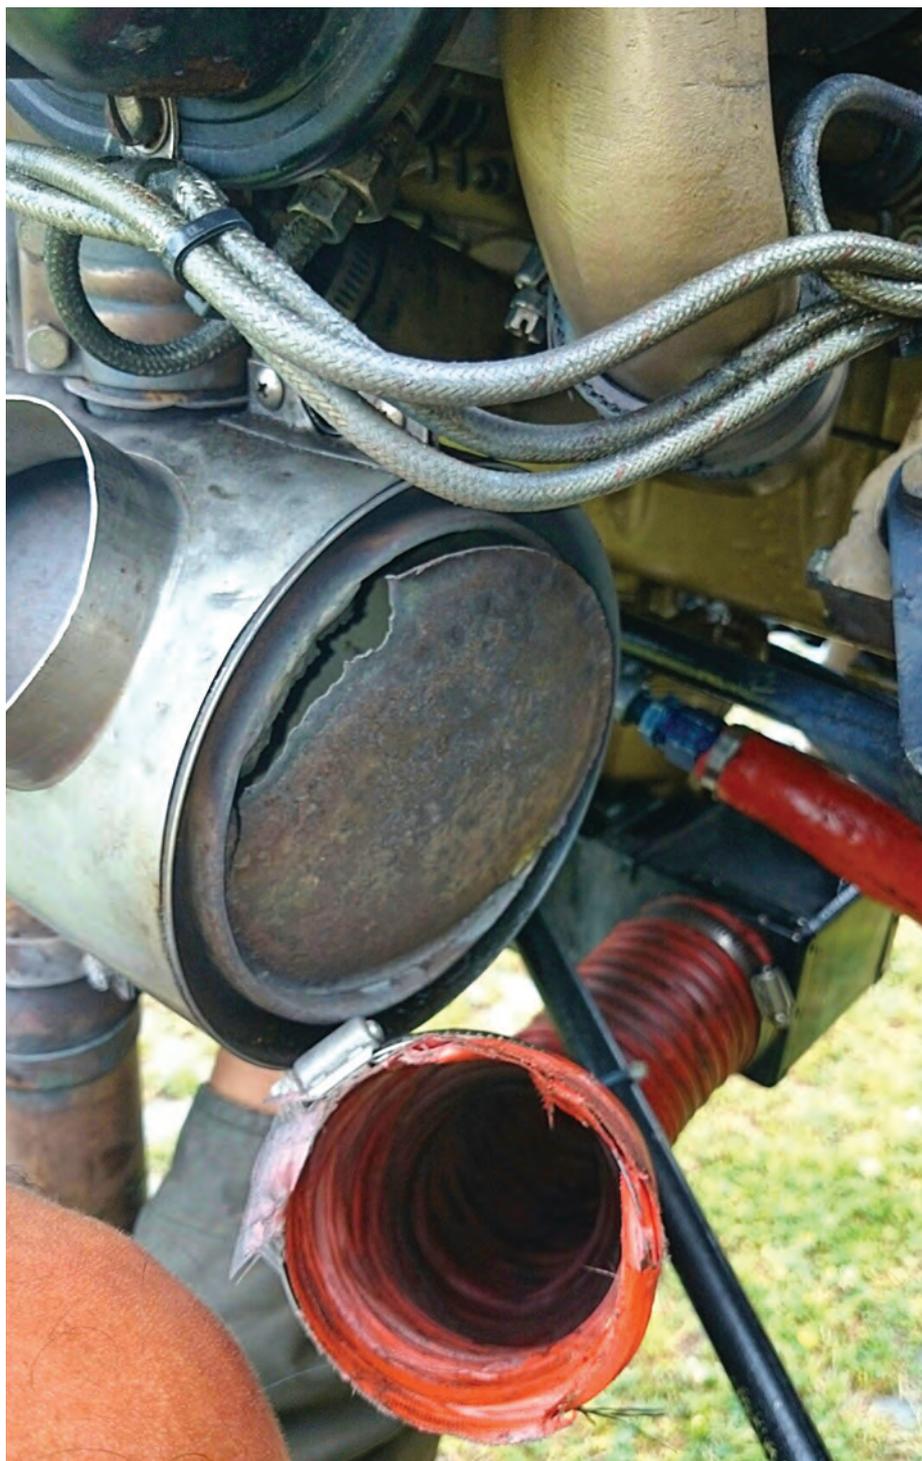
"Dear Malcolm, I think that the important requirement to inspect induction system should emphasise that to inspect them properly you have to take the rubber fitting off the engine.

"To inspect the rubber you need to bend it to make sure it's still flexible; only then can you see cracks in the rubber. I would not have thought about doing this, had this not been pointed out to me by Roger up in Norfolk during an engine service!"

Tecnam P92 Echo flyer, Leo Collier, sent us this picture of a carburettor attachment rubber that has failed. Leo's P92 is powered by a Jabiru 2200 engine and a hole in the rubber like this is very difficult to spot without removing the rubber itself. Because of the reduced manifold pressure at this point in the induction system, fresh air can enter the manifold through the hole, weakening the mixture and causing loss of power and, under some circumstances, higher than normal running temperatures. Had this been on a two-stroke engine it would probably have caused an engine seizure. A tell-tale symptom for this kind of problem that's worth remembering is an increased idle rpm. (Photo Leo Collier)

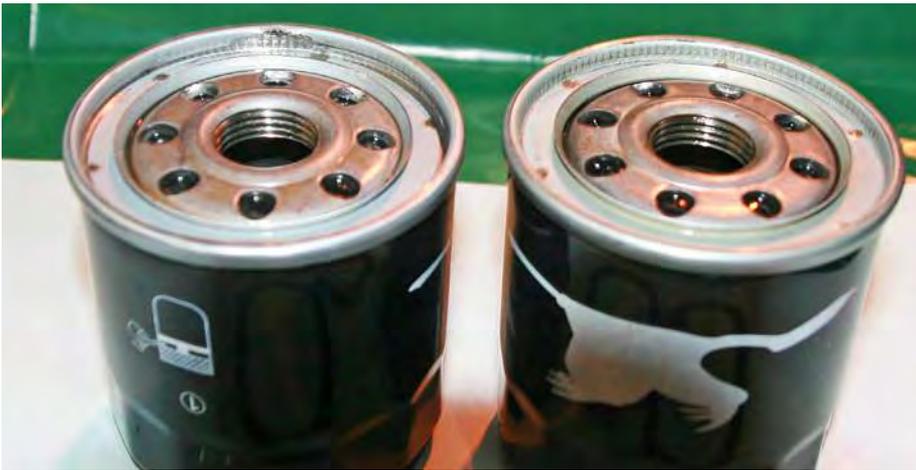
Cumbrian Jabiru J400 flyer, Tom Pullin, sent us this picture showing a 'good' oil filter (on the right) and a bad filter (shown left). Tom explained that his aircraft got covered with oil during a post-maintenance ground run because the oil filter wasn't sealing correctly. Initially he thought that the threads had been cut at an incorrect angle and the filter wasn't seating as it should but, on further inspection, he saw that the flange which connects the base to the bowl was faulty. (Photo: Thomas Pullin)

Take a look at Tom Pullin's picture of a badly-made oil filter. After doing an oil and filter change, Tom did a ground run, brought the engine up to operating temperature and then removed the engine cowls of his Jabiru J400 to check all was well within. Because he took the trouble to do this he spotted the oil leak. Had he gone flying without doing this it is very likely that the engine would have run out of oil and seized. Tom was pretty annoyed that he'd been sent a duff oil filter but, because of good engineering practice, the actual cost, a bit of time cleaning up and a few litres of oil, was relatively low.

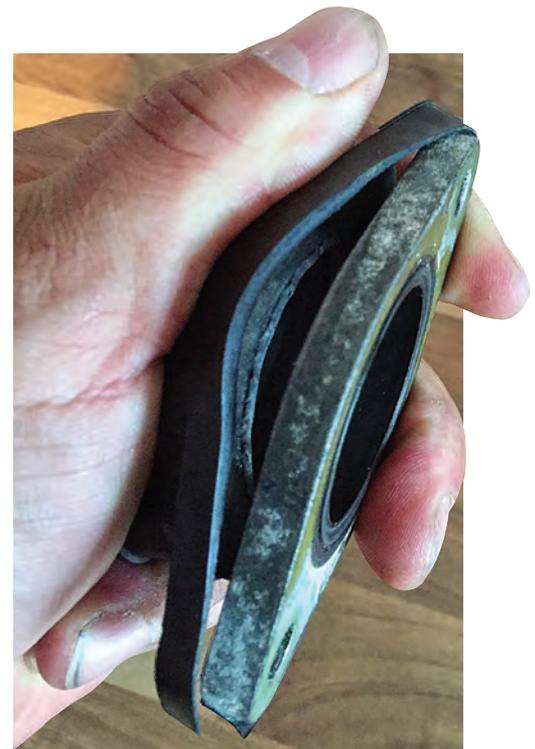
Thinking that the rough running might be because a jet was blocked, he started to remove the carburettor and set about undoing the attachments. Low and behold, halfway through this exercise, the carburettor fell off. "Honest guv,

Having established the fault, he set about replacing the attachment rubbers. Nick commented that he'd replaced these rubbers two years ago and that they've only flown 65 hours. The UK Rotax agent, CFS, agreed and replaced these obviously defective mountings free of charge, so well done to them.

BMAA Flyer, Nick Brownlow, kindly sent us these pictures of a failed Rotax 912 carburettor attachment fitting. As you can see, the metal attaching plate is, or at least should be, bonded onto the formed rubber sleeve that attaches the carburettor; as evidenced from the corrosion on the metal plate, this fitting has been failed for some time. This type of failure has occurred before on 912 engine installations and Rotax have had several goes at improving the component over the years.

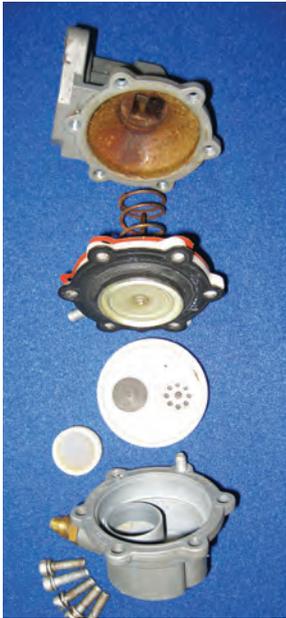
"Oil leaked from the pump flange on the first engine run – one of the two screws was not clamping the flange due to "bottoming out". We cleaned out the female thread in the block and all was well."

This may be important as the pump may have been operating at an incorrect angle to the push rod, perhaps dislodging or disturbing the mechanism within the pump.

"A sudden loss of power was experienced at rotation, resulting in an aborted take-off. After extensive trouble shooting it was found that the fuel pump had failed."

"We could not reproduce the effect consistently on the ground until we raised the nosewheel approximately 10 inches to simulate the climb attitude. The engine would then run

(Right) LAA flyer Graham Elvis sent us an excellent report into the causes of a serious loss of power incident he suffered in a Rans S6 back in 2015. In the end he established that the problem was a malfunctioning fuel pump... another unusual failure mode. In this case the rocker arm 'jumped' out of the slot in the diaphragm pull-rod leaving this tell-tale witness mark. (Photo Graham Elvis)

happily at 2600rpm but at 2900rpm (flat out) it would lose power after about 10 seconds. It ran perfectly with the fuel pump bypassed (gravity only) so the pump contributed significant resistance to the flow in its failed state."

Naturally the non-functioning pump was changed, fuel flow checks carried out and the aircraft returned to service. Graham commented that when he examined the failed pump he found a number of things he wasn't happy with, notably the screws holding the two halves of the pump together were barely tight – 'finger-tip on a screwdriver' – though no fuel was leaking from the joint.

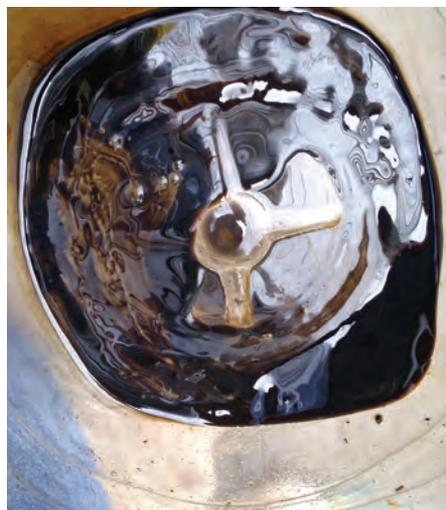
Eventually, after searching every imaginable possibility as to the cause of the engine surging, Robin found the problem – a blocked crankcase breather bottle. Robin explained, when I asked him to send me a picture of the blocked bottle. He said:

"Unfortunately, we cleaned it all up before I took the attached picture of the sludge. However, the picture of the emulsified sludge in the container is as it came out, albeit with a little avgas to help its removal.

"I managed, finally, to clear the sludge using 120psi from my compressor. It's conjecture just how long it takes for a near as dammit solid mass of emulsified oil to build up but I can assure you it was very solid, certainly solid enough to block the breather at the top of the catch tank and the main breather. It really did release its first pressure pulse in one great glop to the underside of the fuselage - it was almost comedic.

What appears to have happened here, primarily to lack of maintenance in the past, is that the crankcase breather has blocked which results in a steadily increasing crankcase

Here's an unusual picture. This tar-like substance was, after rather a lot of persuading, removed from the crankcase breather bottle of a Jabiru SK. It was clear that this bottle hadn't been cleaned out for quite some time and this lack of maintenance ended up with the pilot force landing into a field. The owner did a good job in getting the aircraft down without damaging anything, especially as this was the first time he had flown the type. We think that there are lots of wider lessons to learn from this incident. (Photo Robin King)

pressure. This increased pressure is due to what engine fitters describe as 'piston blow-by'. That's when some of the combustion gas from the top of the cylinder pushes past the piston rings into the engine's crankcase, or sump. That's why the system is vented, to release the gas, and the bottle is there to catch the minute particles of oil contained in the gas.

Now, an increased pressure in the crankcase will increase the pressure acting on the fuel pump diaphragm and the fuel delivery pressure will increase. Take a look at the accompanying pictures and you'll see what I mean. Remember that the fuel pressure from this type of pump is related to the spring pressure, flow is a function of the frequency of operation.

In Robert's case, the pressure built up so much that the fuel pressure reached a point where fuel was forced past the float valve in the carburettor. Regular readers will remember that we've seen this before on some Rotax installations fitted with incorrect return line restrictors. Naturally, once the float valve become inoperative the engine will essentially flood with excess fuel and stop.

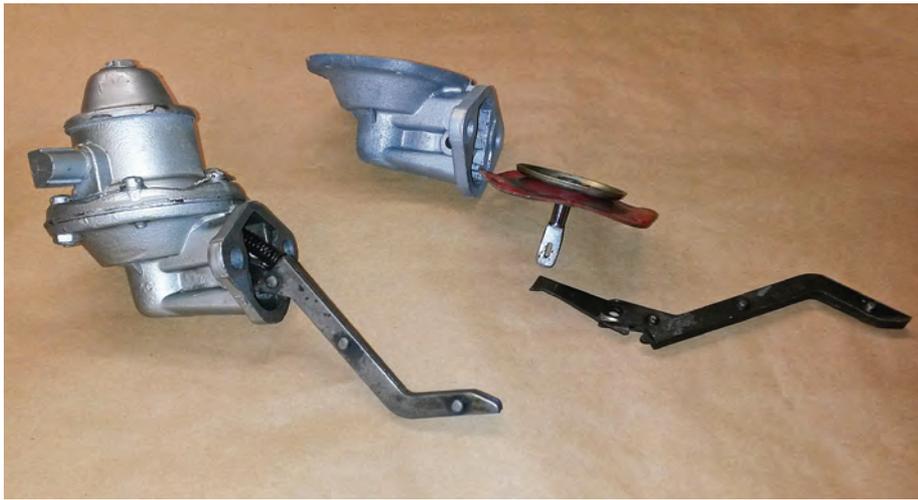
A couple of days later Dave rang and explained what had gone wrong. It seems that the root cause of the problem was that the hook that attaches the pump's drive arm to the diaphragm pull-rod had broken off, rendering the pump inoperative. Fortunately, the aircraft is equipped with an electrical back-up fuel pump for this eventuality, though this had also stopped working.

(Above) LAA Inspector David Bonsall sent this picture showing an unusual failure mode of a fuel pump. The pump on the left is a perfectly serviceable item and he's included this to show what the removed pump should look like. The dismantled pump on the right, showing the diaphragm and the rocker arm, stopped working because the connection between the inner arm and the diaphragm failed. (Photo Dave Bonsall)

What seems to have happened here is that the pilot had got into the habit of starting his engine with the electrical stand-by pump switched on and, for some reason, of leaving the electric pump on for the whole flight. Whilst, with this type of installation, there's no immediate harm done to the other fuel system components by leaving this pump on, it does mean that, if the main mechanical fuel pump fails, as it had in this case, the pilot wouldn't be aware that the engine is only running on the (essentially) emergency stand-by fuel pump.

Dave, naturally, replaced both pumps >

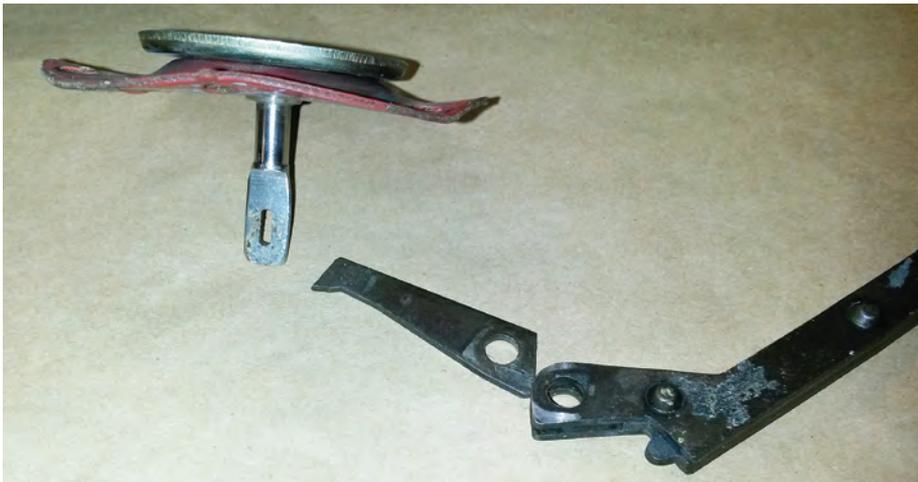
(Above) Here's a close-up showing the failed AC pump's inner arm/diaphragm failure; the broken end of the rocker-arm hasn't yet been found. (Photo Dave Bonsall)

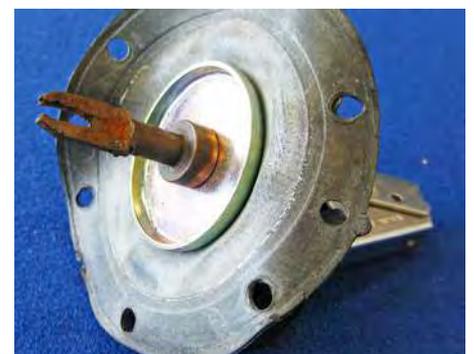
Here we show another failure mode of an AC mechanical fuel pump; you can see clearly that the slot in the diaphragm pull-rod – remembering that it's the spring on this type of pump that does the pushing – has failed, most likely because of the abrasive effect of iron oxide between the moving surfaces. (Photo Malcolm McBride)

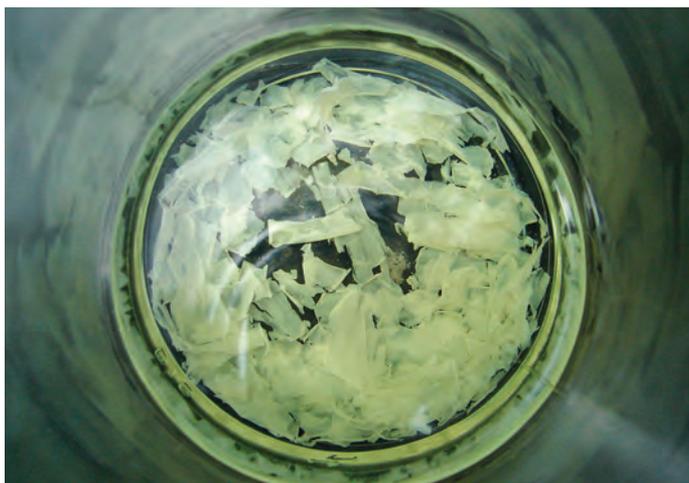
(Left) I almost guarantee that you couldn't guess what this picture shows. No, it's not a petri dish full of the latest horror bug or a creature from the depths of the mid-Atlantic ridge, though it does rather look like it might be! Thanks to Kitfox flyer, Milt Turner for sending us this picture of debris he found in his 'Mr Funnel fuel filter' after a recent re-fuel of his Kitfox. I think that we can be fairly sure that the fuel system would have been compromised had this muck found its way into the tank. First lesson, always use a filter when refuelling from a can. (Photo: Milt Turner)
