# SAFETY SPOT: LESSONS LEARNT FROM OTHERS' MISTAKES

## Another 'runaway' after a hand start – a costly blunder

### DHC-1 CHIPMUNK – RUNAWAY AFTER ENGINE START

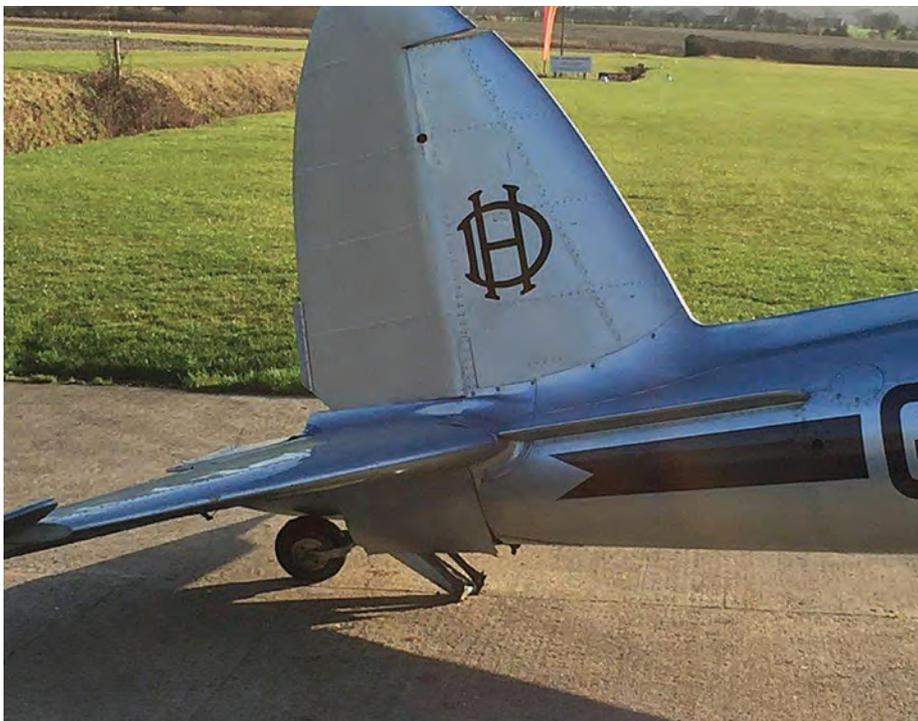
Naturally, all this happened very quickly indeed and it took a few moments for the onlookers to realise what was going on and begin to react. The aircraft, still accelerating, described a number of ellipses over the apron, eventually reaching the edge of the smooth surface. Unfortunately there was quite a step between the grass of the airfield and the concrete hard standing, and during the course of these pirouettes, the tailwheel got swiped, causing quite serious damage to the tailwheel assembly and possibly structural damage elsewhere..

(Above) The tailwheel on this DHC-1 was damaged when it struck the edge of the concrete apron sideways after control was lost during a hand start. You'll need to read the text to understand what happened. (Photo: Supplied)

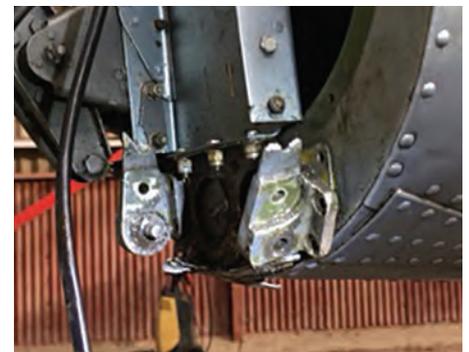
(Above) When the owner removed the tail cone, the damage to the lower and, though not shown, the upper bulkhead attachments became clear. Though it's early days in the inspection process, we're hoping that the damage is limited to the rear brackets and doesn't involve the fuselage or tailplane structure.

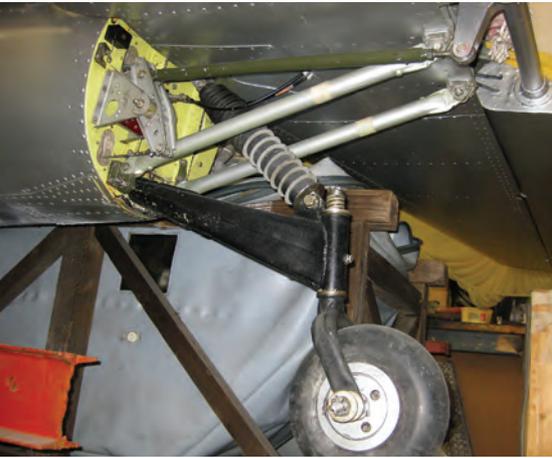
(Above) I took this picture of the tailwheel/ tailplane support structure of an 'under-rebuild' Chipmunk here at Turweston. As you can see, there's a lot going on and this rear bulkhead is being asked to do a lot of work during normal operation. You will also note that the basic geometry doesn't lend itself well to excessive side-loads. This bulkhead and associated bracketry needs regular inspection.

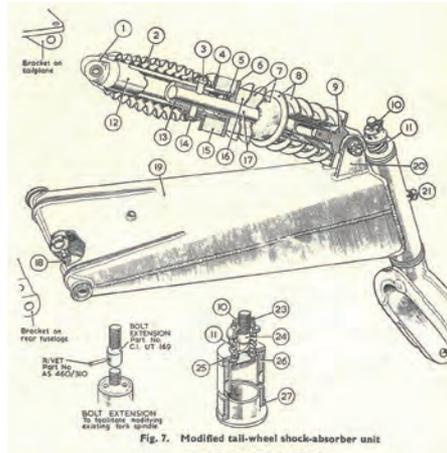
(Above) This picture, taken from the DHC-1's repair manual, shows how complicated the tail-wheel assembly really is. The main support arm is fixed to the rear fuselage bulkhead by cast brackets, these brackets resist the primary side to side loads during normal operation. The shock absorber is connected to a bracket mounted on the tailplane.

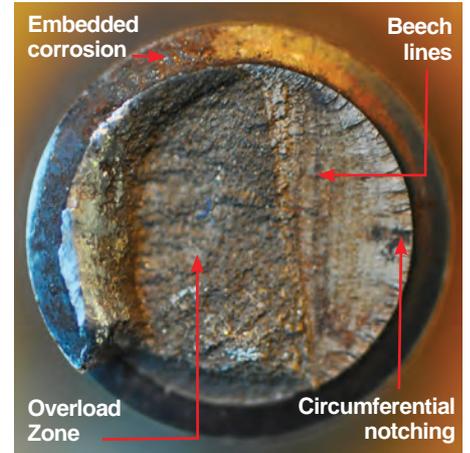
(Above) Roger sent us the remains of the failed port top engine mounting bolt from his Europa Monowheel. Note the clear evidence of high-cycle low-stress fatigue in this fracture face, also note the corrosion in the rolled thread which may have led to corrosion pits in the thread itself which, when established, would have caused local stress concentrations. Notice also the multiple failure origins around the circumference (notching between 360° and c. 170°). (Photo: Malcolm McBride)

In the end, Roger got his inspector to come and have a look; he could see that the engine wasn't firmly 'in' the airframe and found, by looking a little closer, that two of the four attachment bolts were broken – worse still, when the engine was removed from the engine mounting frame, a large crack was found in the frame – effectively the engine was being held in place by just one attachment bolt.

We'll never know for certain if it was the rough start-ups that caused the bolts to break, or the broken bolts that caused the rough starts, but we're issuing an Airworthiness Information Leaflet requiring Europa owners to check tighten the engine mount frame to engine connections on their aircraft as soon as possible. It's clear, from the corrosion present on the fracture faces of the failed bolts that these bolts had been failing for some time, but this hadn't been noticed.

Next time you carry out a walk round pre-flight check on your aircraft, open up the engine compartment and physically check that the engine is firmly held in place by giving it good heave in different directions, to see if there is undue movement or suspicious noises. If you can't see the attachment clearly, and some of the attaching bolts in some Rotax installations are difficult to see, then use a torch and a mirror. The last thing anybody wants when flying is for the engine to fall out, and the Europa we've just discussed was only one bolt and a thin section of 4130 tube away from that.

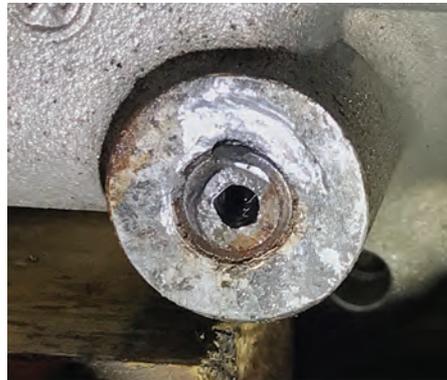
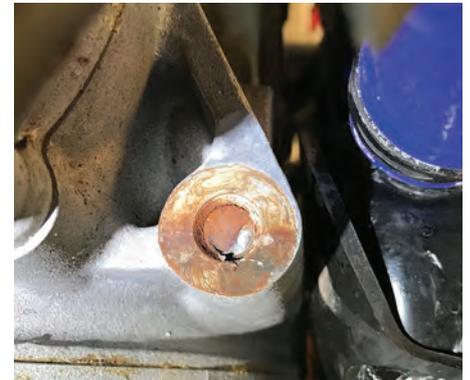
(Right) These pictures help to tell the failure sequence story in a recent event where the owner and LAA Inspector discovered that the Europa aircraft's engine was effectively being held in place by only one engine mount bolt. The picture on the left shows the in-situ port upper bolt, the oxide and fretting shows us that this bolt has been broken for some time. The right picture is of the port lower bolt (see that it's been drilled to accept an easy-out). You can see that there's clear fretting in the face and corrosion is present on the bolts fracture face. The failure sequence looks to be: port upper first, then port lower, then starboard lower engine mount frame... probably because it wasn't able to resist the side to side movement of the (now) only partially restrained engine. (Photo: Roger Sheridan)

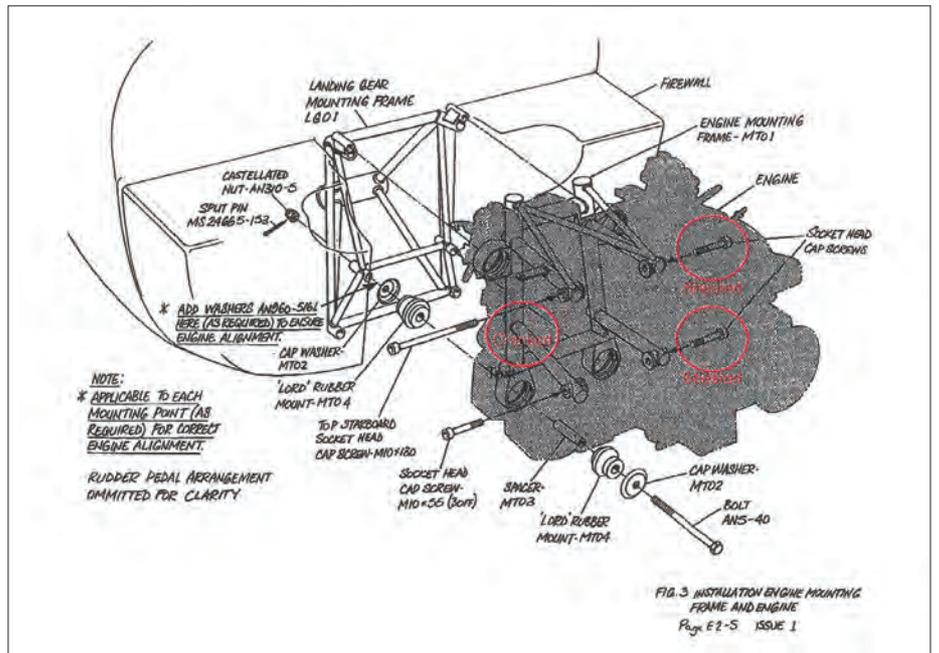
(Right) Europa owner Roger Sheridan, bought his aircraft from the original builder in March 2015 and operated the aircraft 'successfully' through the 2015 season. Through the spring of 2016, the aircraft was refurbished and brought up to 'top quality' status! Another successful year followed, and all was well until, in December 2016, the engine started misbehaving - misfiring, vibration, difficult to start - so Roger bought himself a soft-start module, hoping the problem was connected with the ignition timing. Unfortunately, the engine was still vibrating badly so he decided to bite-the-bullet and ask his inspector to take a look. On close inspection it was found the both the port engine mounting bolts had broken and the lower starboard engine mount frame support was badly cracked. In essence, the engine was being held into the airframe by one 10mm cap bolt. (Photo: Europa Aircraft)

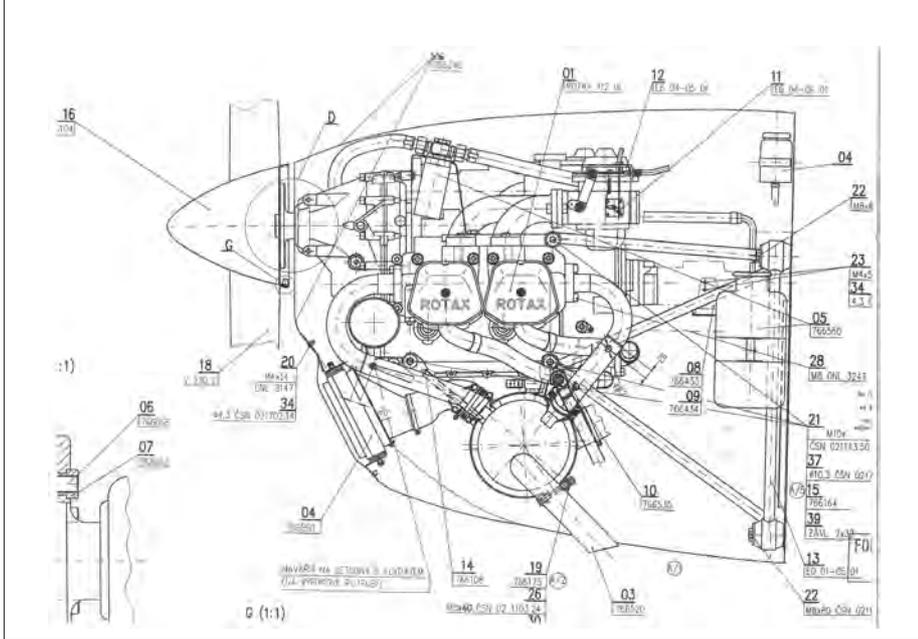
(Above) This drawing, reduced from an original manufacturers design drawing, shows a side-view of the Evezkor EV-97 Rotax engine installation. The installation is essentially similar to the installation seen in the Europa, where the engine mount frame is solidly mounted to the engine using four ten millimetre bolts and the frame is attached to the fuselage firewall through rubber vibration mounts. Clearly, with this type of engine installation are the key mechanical connections, and therefore key inspection points, are the engine mounting frame to engine connection and the engine frame mounting to firewall. Movement between the engine and the engine mounting frame and damaged rubber isolation mounts will end up causing fatigue failure. (Photo:Evezkor Aircraft)

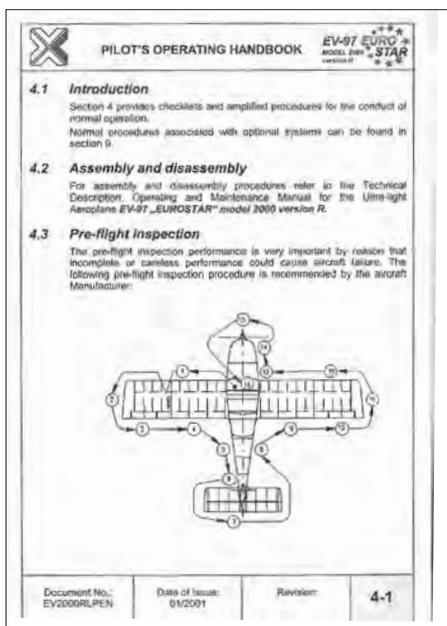
(Left) The EV-97 is an extremely well-supported type, especially here in the UK where there's an excellent agent (Light Sports Aviation at Booker Aerodrome) looking primarily after the factory-built machines, and the LAA which has primary responsibility for the amateur kit-built machines. Of course Evezkor themselves are still very much in business and very pro-active where continuing airworthiness safety is concerned. Hear, hear to that. This picture shows a page from the high-quality 'factory supplied' Pilots Operating Handbook, most of you will, I'm sure, recognise the pre-flight (walk-around) inspection plan. Personally I think that this picture would be better if the top engine cowl was off during the inspection, reminding us that the engine shouldn't be thought of as a 'file and forget' item only needed to be checked thoroughly at the 50 or 100 hr inspection point. (Photo: Evezkor Aircraft)

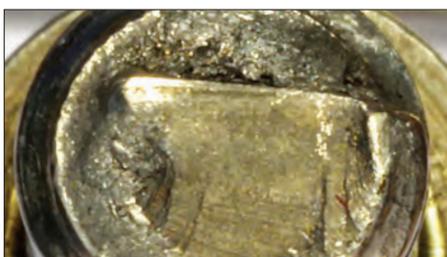
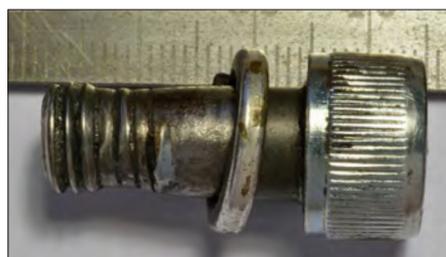
Hello Malcolm, we were prepping our aeroplane for its Permit inspection this afternoon when we found the attached. We'd noticed some vibration recently when flying and on inspection it appeared there was more movement in the engine/mount than there should be in one direction. Turned out the front lower port engine bolt had failed.

The aeroplane has just short of 1,500 hours on it now. The only thing keeping the broken bolt in place was the plastic cap on the engine mount. The other end of the bolt is still in the engine block. LAA Inspector Dave Bonsall (from Dukeries Aviation at Netherthorpe, his brother Mark is our LAA Inspector) happened to be passing the hanger and had a quick look. We intend removing the engine and taking it to the Bonsalls for them to remove the broken piece still in the engine and check the engine mount for any possible damage.

(Above) Just as I had finished creating a file on the Europa engine mount frame bolt failure, I received an email from EV-97 Eurostar part-owner, Gareth Horne. Gareth belongs to a group of five LAA flyers and a recent 'joiner' to the group felt some vibration through the rudder pedals during his check flight, and they decided to remove the engine cover – primarily thinking that the minor vibration was "just normal" but the new boy's concerns shouldn't be ignored! This picture of the lower port engine frame to engine attachment bolt shows what they found. As with the fracture face in the Europa bolt shown elsewhere, there is clear evidence of fatigue, though the origin appears to be rather more in the centre of the fracture face. This may be because of the unusual loads generated some distance from the failure point (note the waisting in the accompanying picture showing the shaft). (Photo:Gareth Horne)

Assuming they can get the broken piece out, and the engine mount is not damaged, we intend on replacing all the engine mount bolts. We'd welcome your thoughts on this

Thanks Gareth for the report and yes, we will be issuing an Airworthiness Information Leaflet to the LAA's EV-97 fleet offering some advice about this. I spoke with Dave Bonsall and asked him how he was going to remove the embedded bolt from the engine without damaging the engine's crankcase. I explained that removing the bolt from the Europa engine previously discussed was proving troublesome and that, after breaking off the easy-out they had resorted to taking the crankcase to a company specialising in spark erosion. As an aside, I spoke to one of the engineers at the spark erosion company and he's promised me a couple of pictures of the process. I'd never heard of this method for removing troublesome bolts before. I'll try to feature this in the March *Safety Spot*.

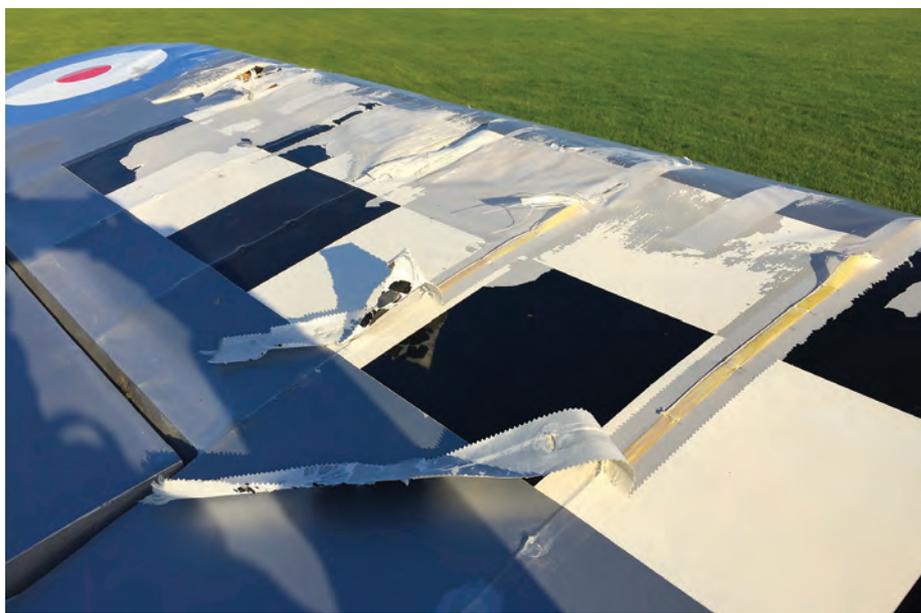
I've featured the picture Ed sent showing the fabric damage to the top of the port wing which, I'm sure you will agree, is quite extensive. My boss, Francis Donaldson, and I travelled over to Napps Field to take a look for ourselves and see what may have happened to cause this partial leading edge failure. We met the aircraft's inspector, Richard Kimberley, and Ed on a cold, wet and windy morning. Richard has been mentoring Ed and flies the aircraft himself regularly. Ed has owned the aircraft since the middle of 2015 and is an experienced flyer – his usual steed is a commuter aircraft out of London City airport.

*(Above)* This is a picture of the port top wing taken straight after the emergency landing; as you can see there is severe fabric damage, though the leading edge looks intact. Further inspection revealed that the forward section of the wing ribs (forward of the main spar) had almost completely failed, which allowed the leading edge member to be forced upwards an inch or two which, in turn, slackened the fabric causing an enormous amount of drag. Fortunately the leading edge member remained attached at both the inboard and outboard ends. *(Photo: Ed Styles)*

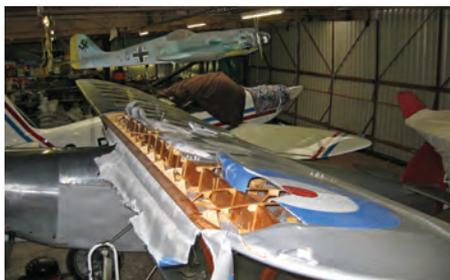
*(Above)* Though we cannot be completely sure, we think that it is possible that this Isaacs Fury suffered a bash to its leading edge, somewhere near the tip, at some point in the past: it is possible that this impact broke two or three of the leading edge ribs, weakening the wing's leading edge structure. It may be that inner ribs failed sequentially over time, perhaps because they were being overloaded taking the stress from their missing brothers, finally leading, whilst the aircraft was manoeuvring well within its design limits, to a complete failure of the leading edge. *(Photo Malcolm McBride)*

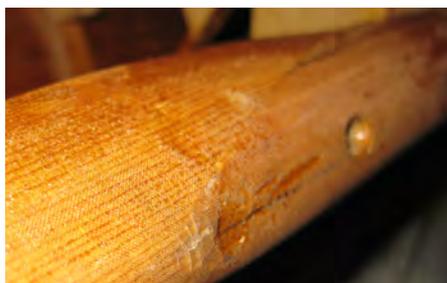
Because the loose fabric would no doubt have been thrashing about, most of the forward sections of the ribs are broken in multiple places but there is a clue to one possible reason for this failure in the few broken, but mostly intact, ribs near the leading edge. Once the fabric had been peeled off the leading edge, there was a clear sign that the leading edge itself was bruised, as if it had at some stage suffered some strike damage. After discussion, we all felt that the signs pointed to some previous hangar damage, possibly the leading edge being swung into a hangar steel support, and because the leading edge member is so thick, the fact that it had broken a few leading edge ribs was missed at the time.

*(Above)* Though we cannot be completely sure, we think this Isaacs Fury suffered a bash to its leading edge, somewhere near the tip. It is possible that this impact broke two or three of the leading edge ribs, weakening the wing's leading edge structure. It may be that inner ribs failed sequentially over time, perhaps because they were being overloaded taking the stress from their missing brothers. *(Photo: Malcolm McBride)*

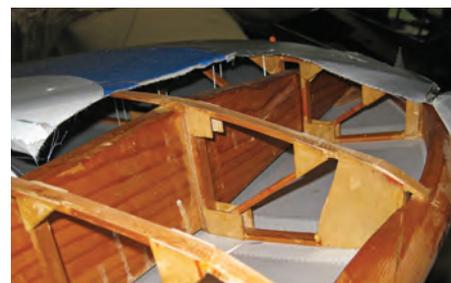
During our inspection, we removed the fabric from the top surface of the leading edge region. As you can see from the attached photographs, most of the ribs attaching the leading edge in place have broken, which has allowed the very beefy leading edge member to be forced upwards a couple of inches by the airflow. As the leading edge member moved, so it slackened the fabric covering between the main spar and the leading edge itself. The rest of the wing and its attachments were sound.

*(Above)* This is a close-up picture of the forward sections of the ribs at the outboard end of the port upper wing of the Isaacs Fury involved in the recent, and very unusual, wing structure failure. Look closely at the top member of the rib and you can see that it has broken, probably in compression. Notice that, just inboard of the leading edge member to tip hoop scarf joint, that the leading edge is bruised. *(Photo: Malcolm McBride)*
