The latest LAA Engineering topics and investigations

SCHROTH HARNESSSES: NO AERO'S WARNING FROM MANUFACTURER

VANS RV-6: ELECTRICAL FUEL PUMP FAILURE INCIDENT

ALPI PIONEER 300: UNDERCARRIAGE ISSUES INVESTIGATED

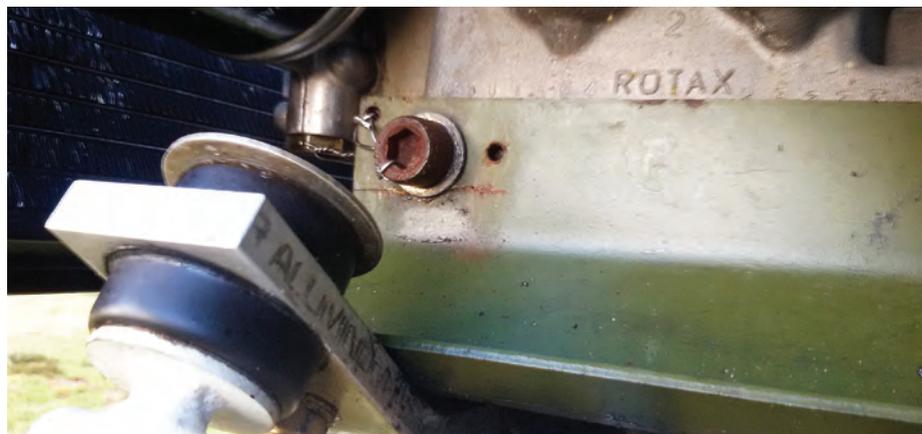
(Above) Last month's *Safety Spot* talked about Rotax 9 series engine-mounting bolts coming loose and failing through fatigue. That item generated a big response and it seems that this has long been a design issue. However, my take on this is that no design is perfect and there's much compromise in a lightweight aircraft structure, which is why close (and timely) regular inspections are so important. Here's a good example of a materials failure in a different kind of engine mounting. This 912 ULS is fitted to a Zenair 701 and, yes, both sides were cracked (below the the cap-headed bolt). Judging by the amount of corrosion around the crack, it had been there for a while. (Photo: Sandy Hutton)

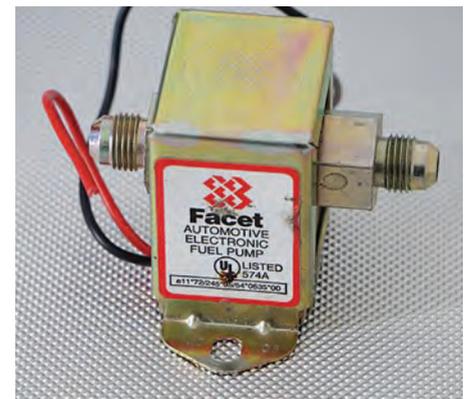
(Above) A consistent fuel pressure in an aircraft's fuel system has always been important, perhaps more so today for those using motor fuels which have a higher vapour pressure, to avoid the dreaded vapour lock. Many of you will recognise this relatively low-output Facet fuel pump – they were supplied as standard for Van's aircraft in the 1990s. These simple electrical piston pumps were designed to offer a back-up, just in case the engine-driven pump fails, and current advice suggests that these back-ups should be switched on during operations below 1,000ft. (Photo: Richard Parker)

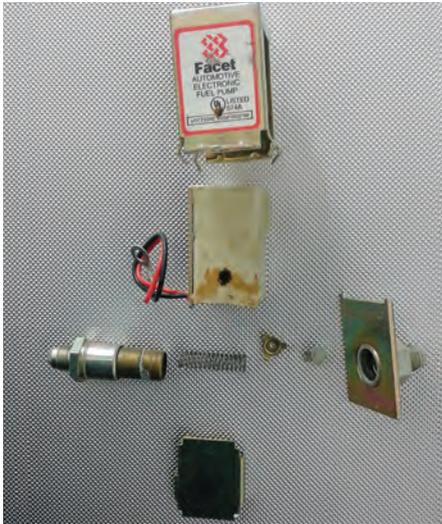
(Above) When aircraft electrical engineer and LAA'er Richard Parker switched on the electrical stand-by fuel pump fitted to his Van's RV-6, as part of his pre-take-off actions, he was surprised to find that he could soon no longer see anything, as the cockpit had filled with a "black, acrid smoke". Needless to say, he shut the aircraft down straight away and exited as quickly as possible. The reason for the smoke was tracked down to the expanded foam 'potting' compound getting too hot because of a PCB failure. This picture shows the bare bones of his failed pump and, as you can see, the shuttle piston, which contains a non-return-valve (NRV), is forced against a spring by an electro-magnet, while the inevitable electronic timing system is 'potted' in foam (at centre in the picture). (Photo: Richard

Richard is an aviation electrical specialist, though he didn't need to be in order to work out that the electrical fuel pump had failed in some sort of catastrophic way. He soon had the pump out of the aircraft and in bits on his workbench – you can see the pictures he took showing what has happened.

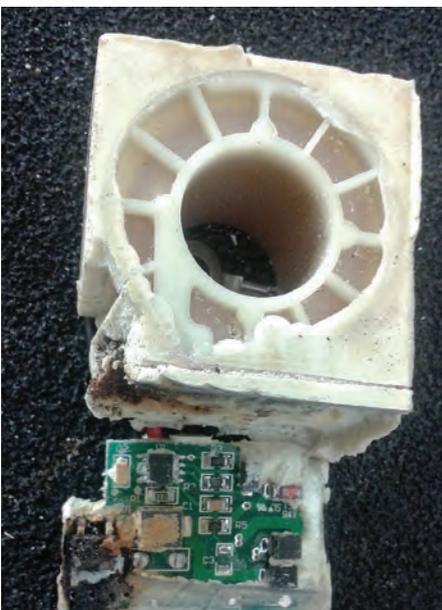
(Below) It's clear that the source of the heat which caused the fuel pump to change its role to a 'smoke generator' lay in the failure of the electronic timing mechanism. We're waiting to hear back from the manufacturers of the pump but aren't holding our breath for a response. During previous tests this pump had a running current of about 3.2 amps, while the identical replacement pump, supplied by Facet, draws only 1.2 amps so it may be that this failed pump has been living with a problem for some time.

Richard explained to us that the amount of smoke produced by the burning PCP components and the scorched foam appeared completely disproportionate to the volume of smoke evidenced. I wrote to the manufacturers of the pump asking them whether they had any idea what may have gone wrong but, as of writing, they haven't responded.

Richard pointed out that, during an earlier test, his pump was drawing 3.2 amps, which he thought rather a lot for such a low-power device. He's now received his new pump, which draws just over 1 amp. He came to the conclusion is that the old pump was in some way defective.

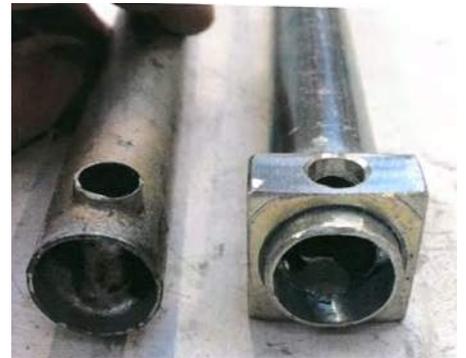
(Above) Correct adjustment of the length of the screw jack on the Alpi Pioneer operating rod is essential to ensure that the over-centre strut goes fully over-centre when the undercarriage is lowered. One problem is the adjustment of this rod has been rather too coarse. The length of the rod is changed by removing the attaching bolt and rotating the shaft through 180°, one way or another. This picture shows the original design, on the left, and the later improvement. Notice that the minimum adjustment is now afforded by turning the shaft through 90°, halving the length of the increase or decrease. *(Photo: Toby Wilcox)*

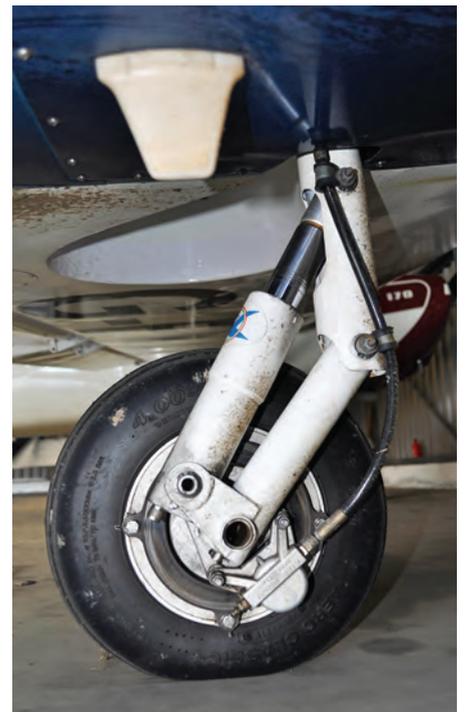
(Above) Here we show the general arrangement of the Pioneer P300 main undercarriage. This type of drag-link suspension is effective for absorbing impact loads applied roughly perpendicular to the lower swinging arm, but less so for those applied directly upwards. The geometry of this type of arrangement means it's especially important that the shock absorber is functioning correctly and not over-pressured. When we tested this leg, we found that shock-absorption wasn't that good during a drop test but was good with a fore and aft-loading case. Note the position of the brake disk attachment bolts, as discussed in the main feature. *(Photo: Malcolm McBride)*

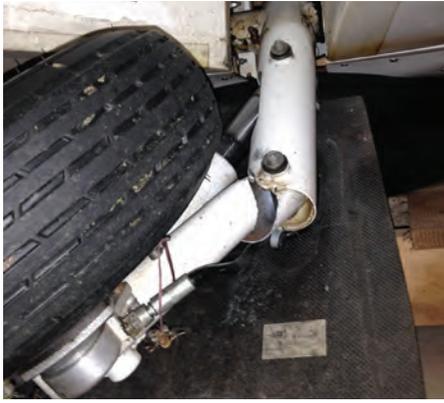
(Above) This picture shows the P300's undercarriage in its 'jammed' position. The pilot, LAA'er Roger Andrews, wrote up the tale for the February edition of *LA*. At the time of writing the story, Roger was convinced he'd hit an obstacle – perhaps just a big undulation in the ground – during the take-off run. However, further investigation has revealed other issues with this leg which may have contributed to the failure. *(Photo: Roger Andrews)*

As you can see from the pictures and accompanying text, there's some question over the reason for this undercarriage leg failure. Certainly, when it was inspected closely, the leg contained a pre-existing crack, which probably didn't help with the survival of the leg when it hit the bump. However, the big lesson here is that the undercarriage green lights were incorrectly wired, in so far as a failure in the gear motor circuit meant that undercarriage indication would also be lost.

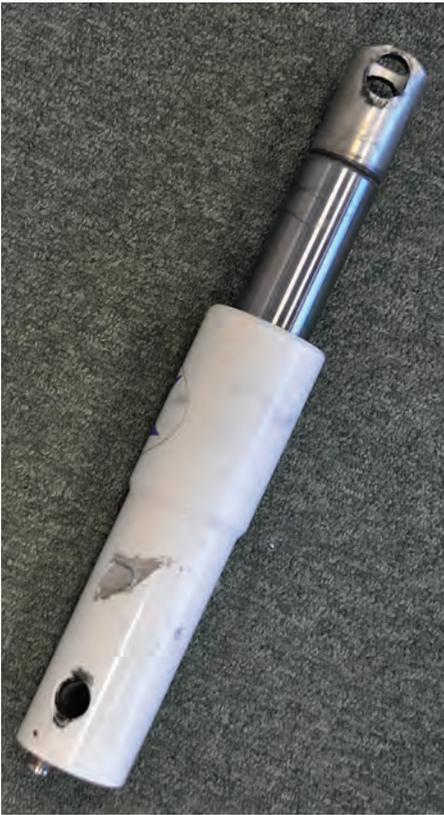
(Above) We showed this shock strut, from the P300 which suffered undercarriage impact damage during take-off, to Alpi Aviation's Corrado Rousillon. He immediately exclaimed that the reason for the wheel jamming – if it did – was that the head of the bolt attaching the brake disc had wound itself out and contacted the side of the shock-strut! Take a look at the tell-tale marks in the picture and you'll see what Corrado means. We may never know whether this undercarriage failed because of a structure failure of some sort or ground impact – perhaps it was a combination of both. *(Photo: Malcolm McBride)*

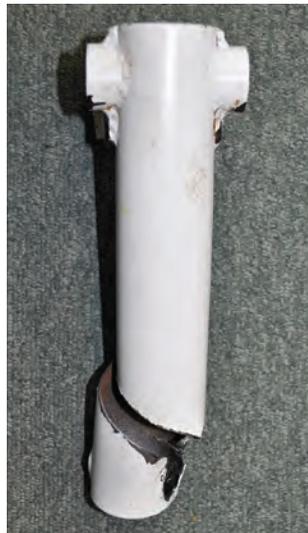
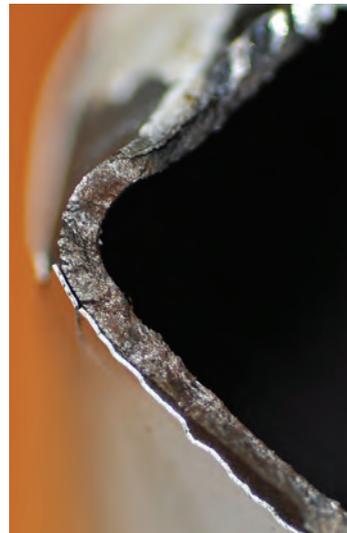
(Left) We stripped the undercarriage leg of the P300 which suffered a main undercarriage leg failure (shown far left). During a close check of the fracture face, we found that the leg appears to have been failed for some time, as can be seen by the embedded corrosion (shown in close-up, at right). *(Photo: Malcolm McBride)*
