Safety Spot
By Malcolm McBride

ROTAX PUSHRODS ALERT, SPORTCRUISER NOSE LEG ISSUE, TWISTER AIR SHOW ENGINE FAIL & PLACARDS

The latest LAA Engineering topics and investigations

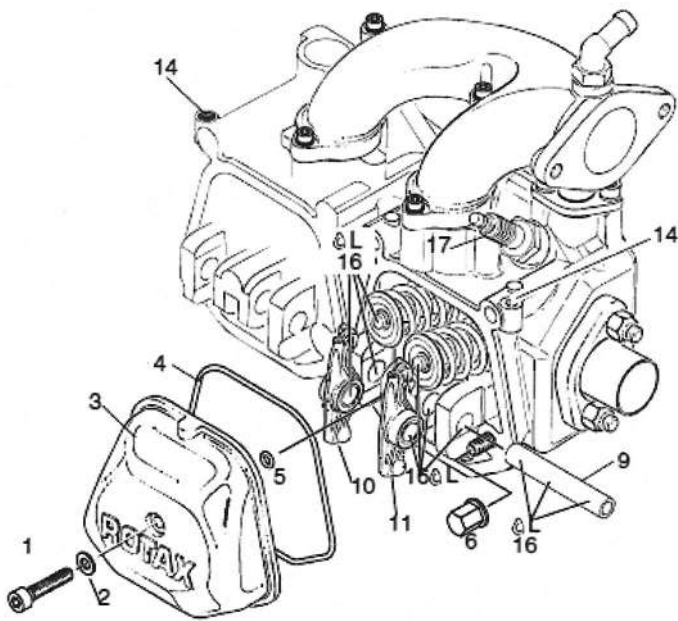
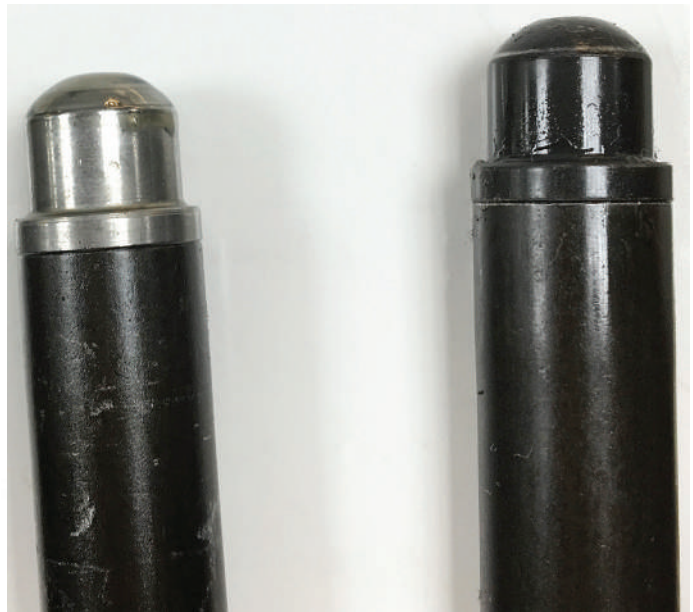
In this case, the hardening process on the rocker arm ball socket – that's the contact point between the rod itself and the rocker arm – went wrong and, in service, the sub-standard parts suffered accelerated wear. Though this isn't something that's likely to cause a catastrophe in the short term, wear will affect the operation of the engine's intake and exhaust valves and could, over time, lead to a gradual power loss. Eventually, of course, this ball-end could give way completely and that would very likely stop the engine.

(Above) Manufacturing errors occasionally occur, even in the best-run production workshop. When it comes to components which are going to be used on aircraft, it's especially important that potentially defective components which may have entered the supply chain can be traced and the affected owners notified. But this can be a difficult thing to achieve in the uncertified sports-aviation arena.

The UK CAA has recently issued a *Mandatory Permit Directive (MPD)* alerting owners to a potential problem with the surface-hardening treatment of some of the pushrod sets used on Rotax 912 and 914 engines. In this case, the defective pushrods can easily be spotted as they have a black finish, as opposed to the correct silver sheen. For further information, please visit the LAA website, head for the Engineering section and then look for 'Alerts'. (Photos: Rotax Engines/UK CAA)

purchased from an overseas source may have defective rods so, to be safe, check its serial number against the list in the *Rotax Service Bulletin* – there's a link in the *Alert*.

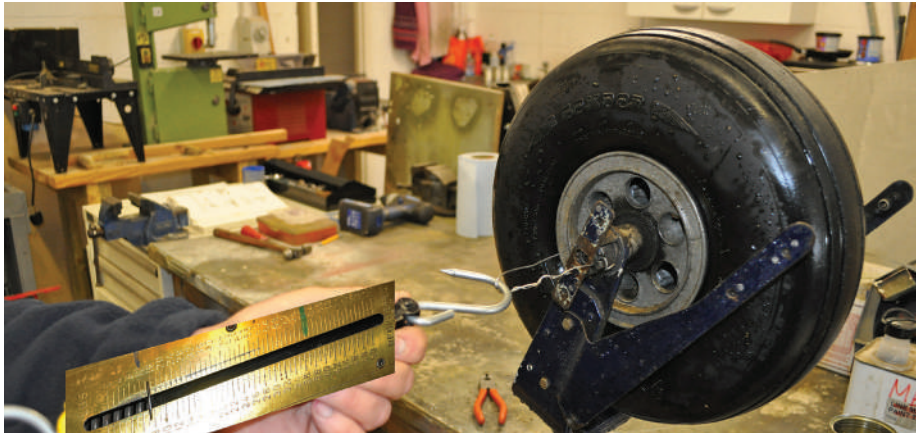
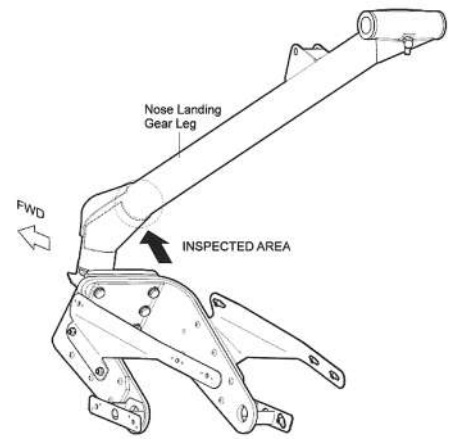
(Above & above right) Because of design limitations, nosewheels can have a tendency to shimmy – a reasonably stable dynamic oscillation around the spindle (side to side). Apart from being uncomfortable, shimmy can impose very high local loading on supporting structure, which may exacerbate the effects of both wear and material fatigue.

Some aircraft use hydraulic or friction-based dampers, fixed in parallel in the nosewheel steering, but the SportCruiser's system relies on the friction created between the fork assembly and the spindle itself. After receiving the broken undercarriage at our Turweston workshop, one of our first jobs was to establish whether the friction figure obtained was within the allowable limits – it was. The sketch shows the area of the leg that needs regular inspection – sensibly, before every flight.

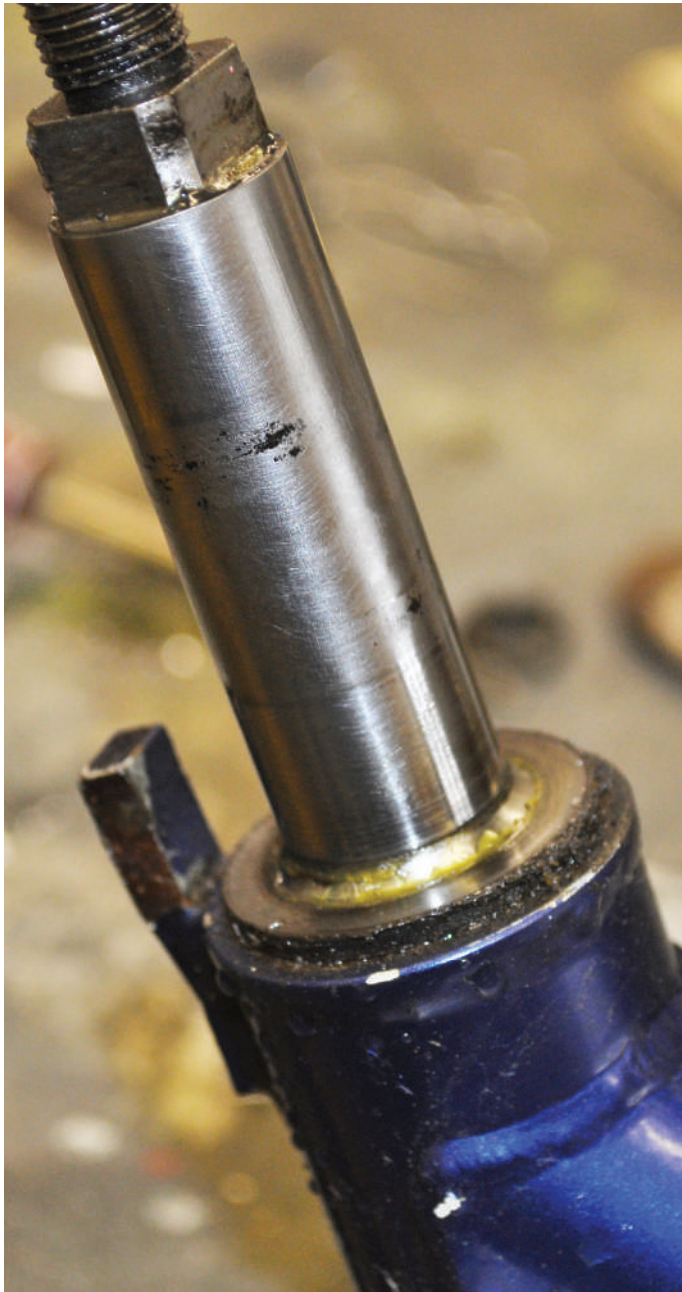
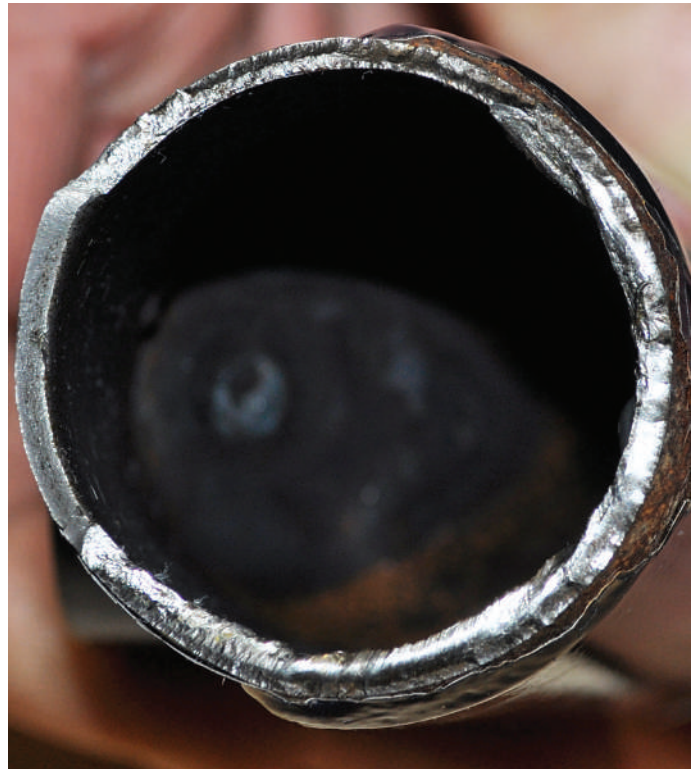
(Left & above) The early failures of the CZAW SportCruiser's nose undercarriage were due to two factors, firstly, poor maintenance – primarily incorrect friction loading and lack of lubrication – and design issues.

These pictures at left show the spindle from the failed Mk I leg. As you can see from the picture at left, apart from some corrosion in the centre of the shaft, it's in good order. The picture above, however, shows the fracture face of the tube itself – corrosion suggests that this part has been failing for some (unknown, of course) time. (Photos: Malcolm McBride)

This latest failure is different. The aircraft involved, a group-owned machine, is very well maintained – this was clear when the failed leg was dismantled here at our Turweston workshop, as the drag friction was spot on and the leg was well-lubricated. However, what was clear was that this leg had been failing for some time – in some ways it's a good thing because it means we can, just for a short time, keep them in service until they can be upgraded, either with the later PiperSport Mk II undercarriage system or the fully modified, original CZAW leg.

recent failure, and have backed this up with an *Airworthiness Information Leaflet (AIL)* requiring owners operating with the PiperSport Mk I legs to remove the nosewheel spat, carefully clean the area surrounding the spindle support and check that all's well before their next flight. We do know that some SportCruiser owners already operate without spats so that they can keep an eye on things between the 25-hour inspections. Further requirements will no doubt follow, and I suspect that I shall be able to describe the full 'fix' in next month's *Safety Spot*.

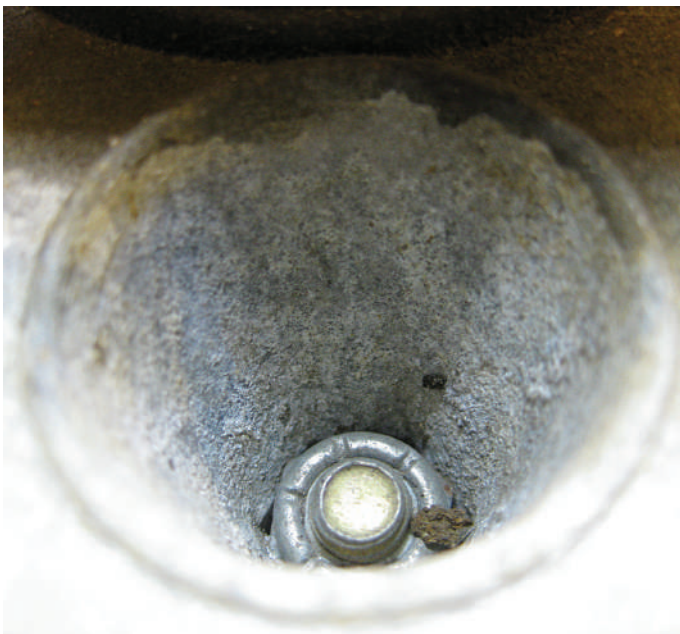
(Left above & left) These pictures show close-ups of the nosewheel fitted to the SportCruiser which suffered the leg failure. I include them to reinforce the point that spats can hide an unhappy engineering situation. This Matco wheel came with the original kit and was supplied without any surface protection. As you can see, after not that long in service, it's now very corroded. Remember, when you see the products of corrosion on any part of an aircraft, you're looking at material which is unable to participate in any further useful work and, perhaps worse still, may focus stress inappropriately through a component, which could lead to premature failure.

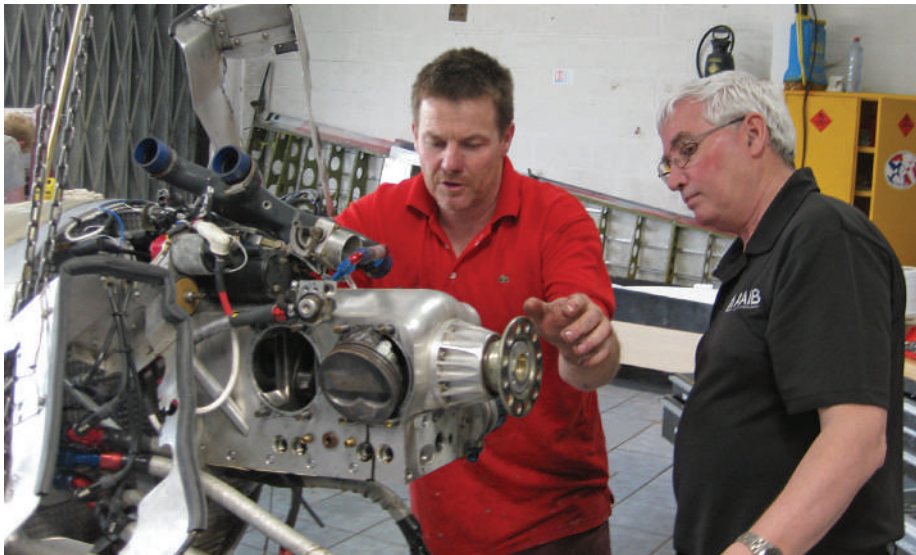
(Left) Under normal circumstances, an engine failure on a Permit aircraft wouldn't drive a full-field investigation by the UK Air Accident Investigation Branch (AAIB). However, when the failure occurs at an air show, there's a good deal more scrutiny. This picture shows AAIB Senior Investigator Brian McDermid, who's a keen pilot and has recently joined the LAA, in the process of stripping the ULPower engine with Twister expert and LAA Inspector, Pete Wells, to ascertain the likely reason for its failure. *(Photo: Malcolm McBride)*

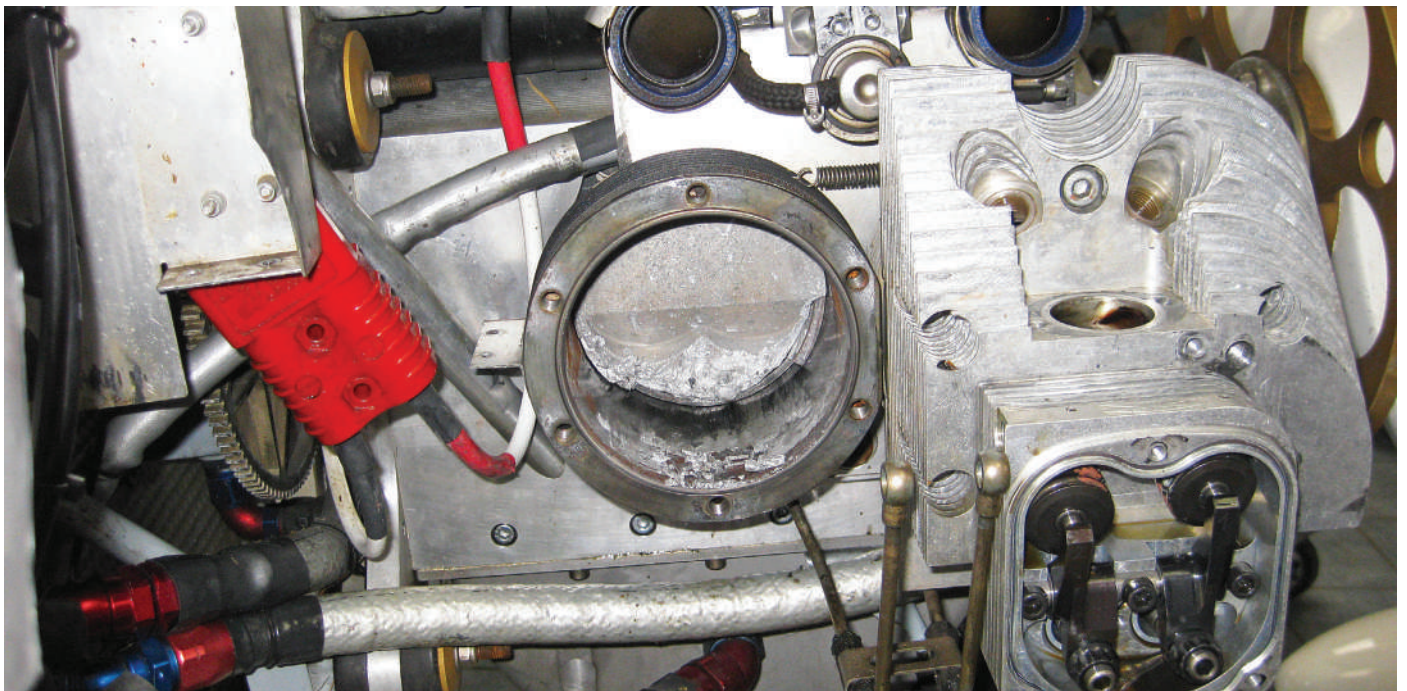
(Below) It didn't take too long to discover the cause of the engine stoppage – the piston in number three cylinder had effectively seized in the barrel. What seems strange was that there was no oil residue at all in the cylinder, piston skirt or rings. *(Photo: Malcolm McBride)*

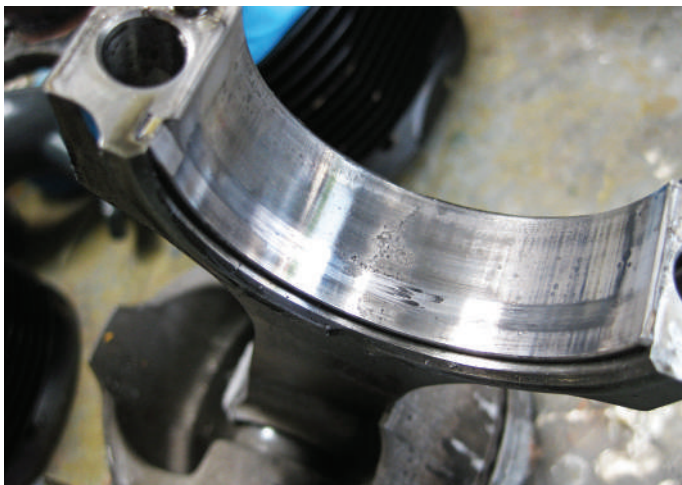
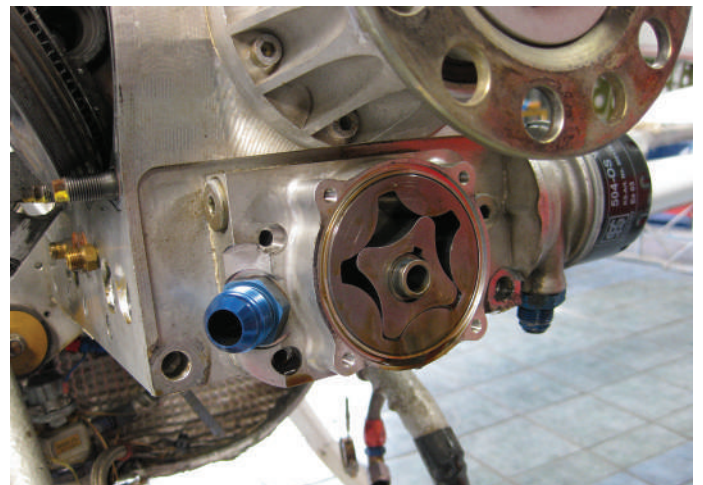
(Above left & right) The picture above left shows the main bearing shell from the ULPower engine which suffered a piston seizure. The result of the oil loss is clear in the material of the shell, though note that there's only limited local bluing (top left), which suggests this was a very rapid event and the bearing itself didn't actually seize. The picture above right shows the geared oil pump – note there's some residual oil in the pump and no evidence that it ran dry, except perhaps for a brief moment. The piston/cylinder lubrication on the ULPower engine, like most powerplants in its class, is provided by the mist of oil that's ejected from the main bearings. That's why, in this class of engine, a reasonable oil pressure is so important. Some engines increase this internal 'oiling' by allowing the crank to rotate in the oil contained in the sump. *(Photos: Malcolm McBride)*

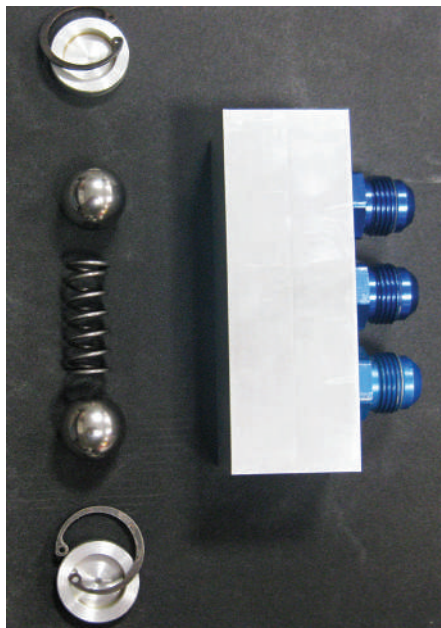
(Left) Though it was agreed that the cause of the engine stoppage was lack of oil at the cylinder walls, there was no obvious cause. One suggestion, and the general consensus, was that the oil supply inversion valve was the most likely culprit. This picture shows the valve dismantled – before it was taken apart, the sealing qualities were tested using air pressure and it worked well. However, the nature of this valve is that the slightest bit of detritus between the sealing ball and the socket would allow air into the system and stop oil reaching the pump. (Photo: Malcolm McBride)

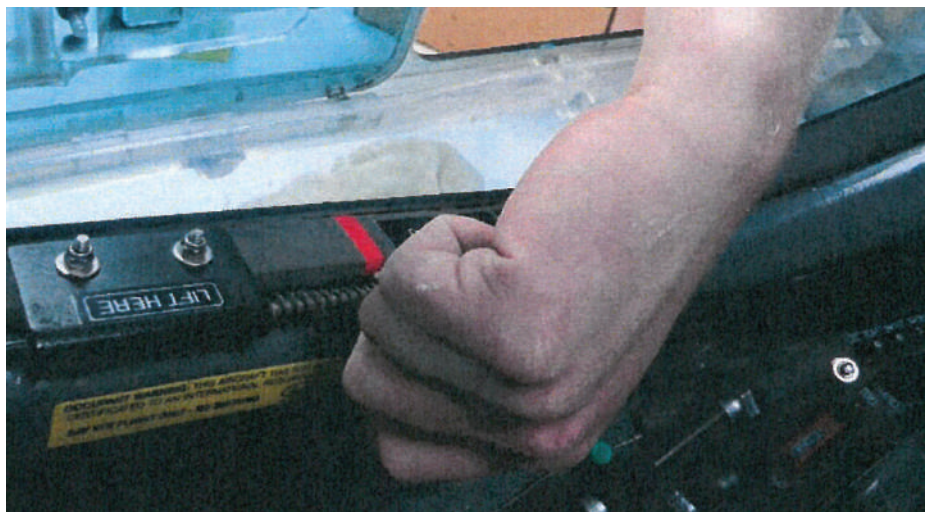
(Above) Although the method of getting into and out of an aircraft might seem obvious to the aviator, it'd be wrong to assume it's instinctive to non-flyers. I've taken this picture, originally supplied by LAA Inspector, Peter Wells, straight out of the AAIB *Bulletin*. If you've had any experience of gliding you will immediately recognise that, to lift the canopy, you must reach for the catch through the DV window. However, because there were no placards directing the first responders to this procedure, potentially valuable moments were lost during the pilot's rescue. (Photo: UK AAIB)

Much of the discussion regarding the possible reasons for the engine failure are dealt with in the associated picture captions. However, the accident also highlighted the need for clear instructions about how to get into the cockpit to reach the incapacitated pilot, in a language which can be quickly understood by non-flyers. In response, the LAA has updated *Technical Leaflet TL. 2.11* to include specific advice about the fitment and content of placards which describe how to get into a cockpit.
