With Malcolm McBride
Airworthiness Engineer

REPORTABLE INCIDENTS 2017, MORE HAND-STARTING AND MOGAS ISSUES, EV97 CANOPY & J430 UNDERCARRIAGE BOLT

The latest LAA Engineering topics and investigations

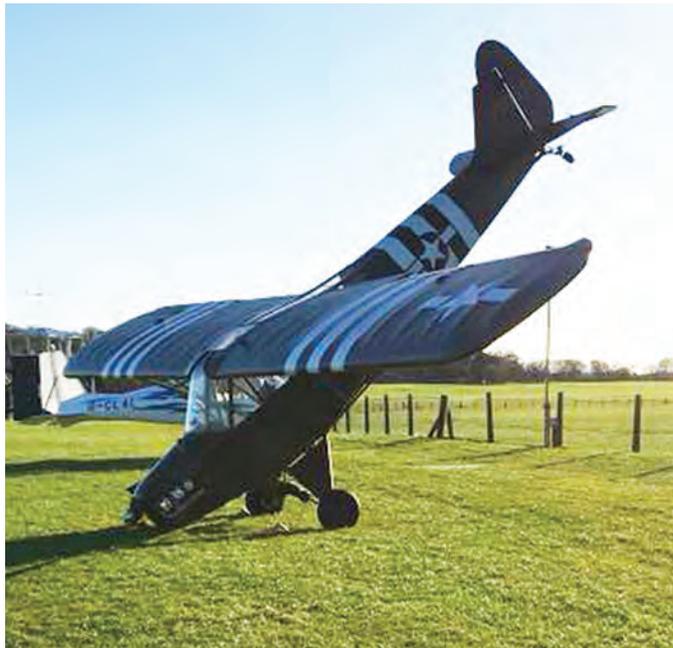
(Left) Another brief lapse in concentration, another hand-starting incident. Fortunately, the pilot of this excellent example of a 1943 Piper L4H didn't forget to chock the wheels. He did, however, have a narrow escape when the aircraft pitched forward after the engine 'fired-up' with the throttle incorrectly set. This engine will now need a full shock-load inspection and a new propeller – an expensive error.
(Photo: Stuart Gray)

Very fortunately, last year, nobody was injured in a hand-start incident, though this 'first of 2018' sounds to have been a close-shave for the pilot, almost literally!

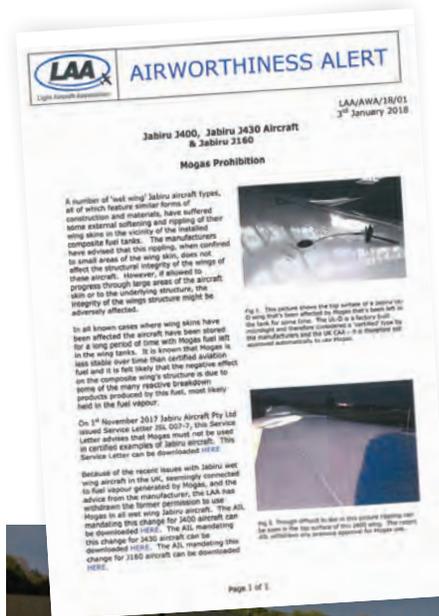
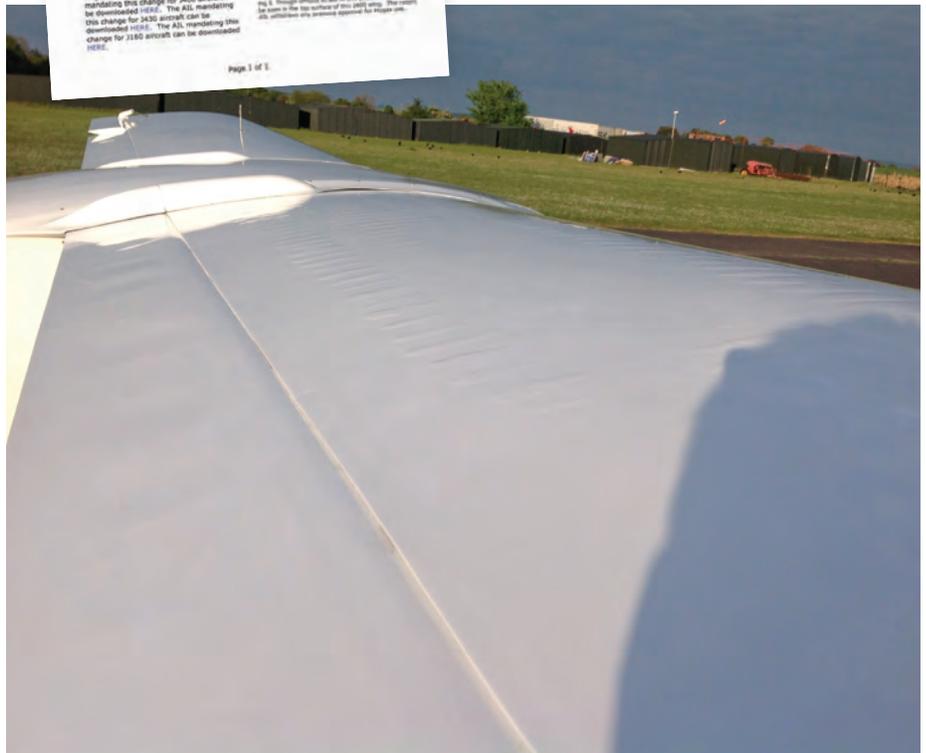
We have, of course, discussed some of the issues surrounding the use of mogas many times over the past months, and talked about the issue where rippling was seen on a Jabiru J400 wing skin back in the June 2017 edition of *LA*. Here I'll just remind all owners that there's an investigation and approval procedure to be followed before mogas is permitted to be used in suitable LAA aircraft and, if you want to read the recently published *AILs* concerning the wet-wing Jabirus, go to the 'Alerts' page in the Engineering section of the LAA website, www.laa.uk.com.

(Left & below) LAA Engineering has issued a number of *Airworthiness Information Leaflets (AILs)* prohibiting the use of mogas in all wet-wing Jabiru aircraft following problems. These include the rippling and softening of the wing skins on some aircraft which have been using mogas. This prohibition affects the four-seat J400-series aircraft, the Factory-Built Microlight version (UL-D), the J160 two-seaters and a few UL 430/450 two-seaters. Naturally, we've sent all the owners of these aircraft a copy of the relevant *AIL* directly, but access to them is available via links in the online version – look for 'Alerts' in the Engineering section of our website, www.laa.uk.com. (Photo: LAA Library)

The recent issues with Jabiru 'wet wings' has, as we've already discussed, led to the LAA prohibiting the use of mogas in Jabirus with fuel tanks mounted in the wings. The *AILs* which the LAA uses to pass information to owners of aircraft have three levels of urgency built in. They're listed on the bottom of the leaflet itself as:

Naturally, time pressures being what they are, most of the *AILs* that LAA Engineering produces are considered very important, and therefore carry Classification A, in other words 'must do'. The *AIL* prohibiting the use of mogas in wet-winged Jabs was just such a case.

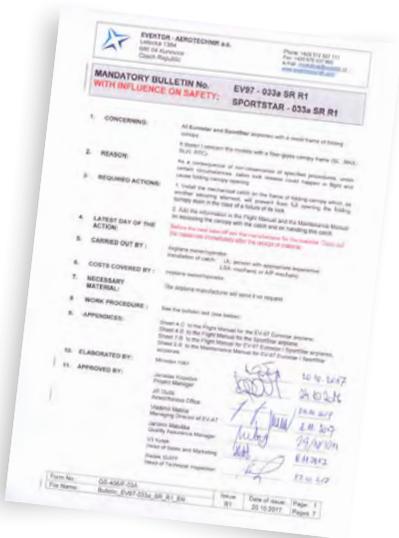
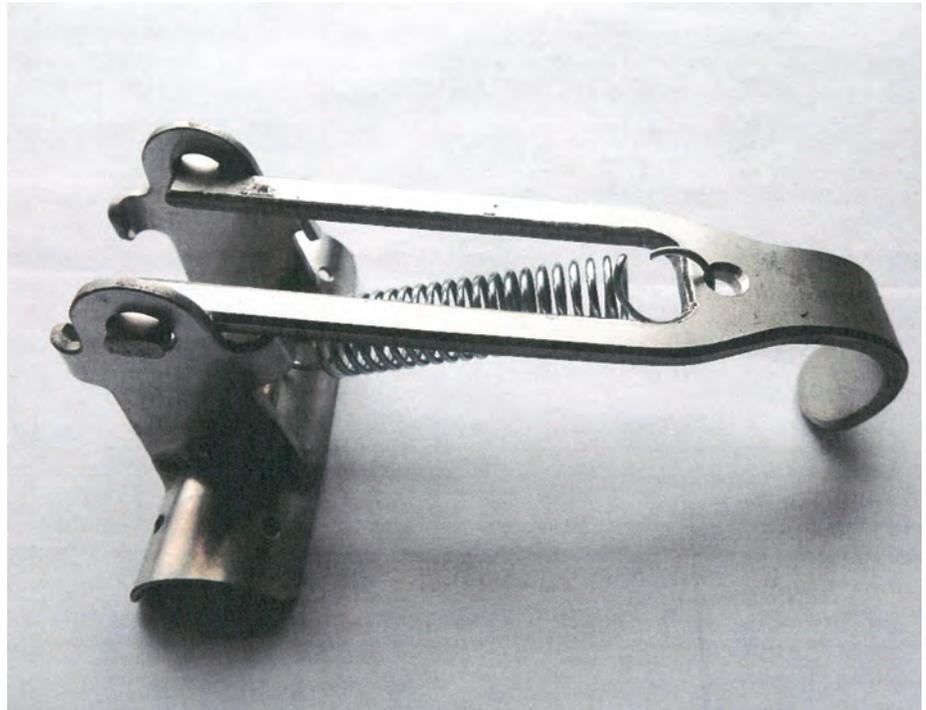
A good example of this is the recent *Bulletin* issued by Evector, introducing a second canopy catch (see photos opposite, top). In this case, LAA Engineering doesn't feel that the risk of a canopy coming undone poses a great threat on this particular aircraft type. That because early testing showed that when the canopy was opened in flight it only did so to about six inches and then stabilised. Flight control wasn't affected and the aircraft had sufficient power reserves to overcome the increased drag.

(Above & right) Sometimes a safety device doesn't really solve the root problem, though there may be some safety benefit. A recent *Service Bulletin* issued by Evekotor affecting the UK EV97 EuroStar fleet, seems to be a good case in point. This secondary canopy catch would stop it opening more than a few inches if a pilot forgets to secure the canopy before flight, but if he or she forgot the first catch, why would they remember the safety catch? (Photo: Dave Simpson)

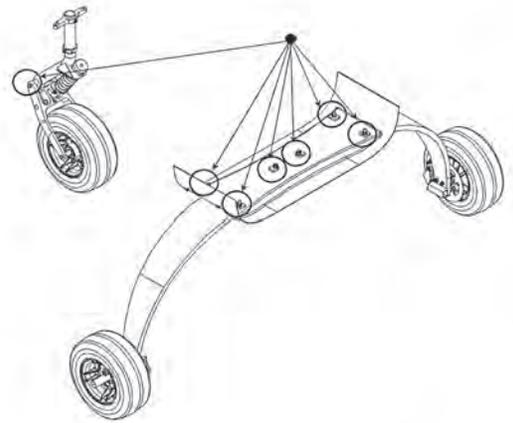
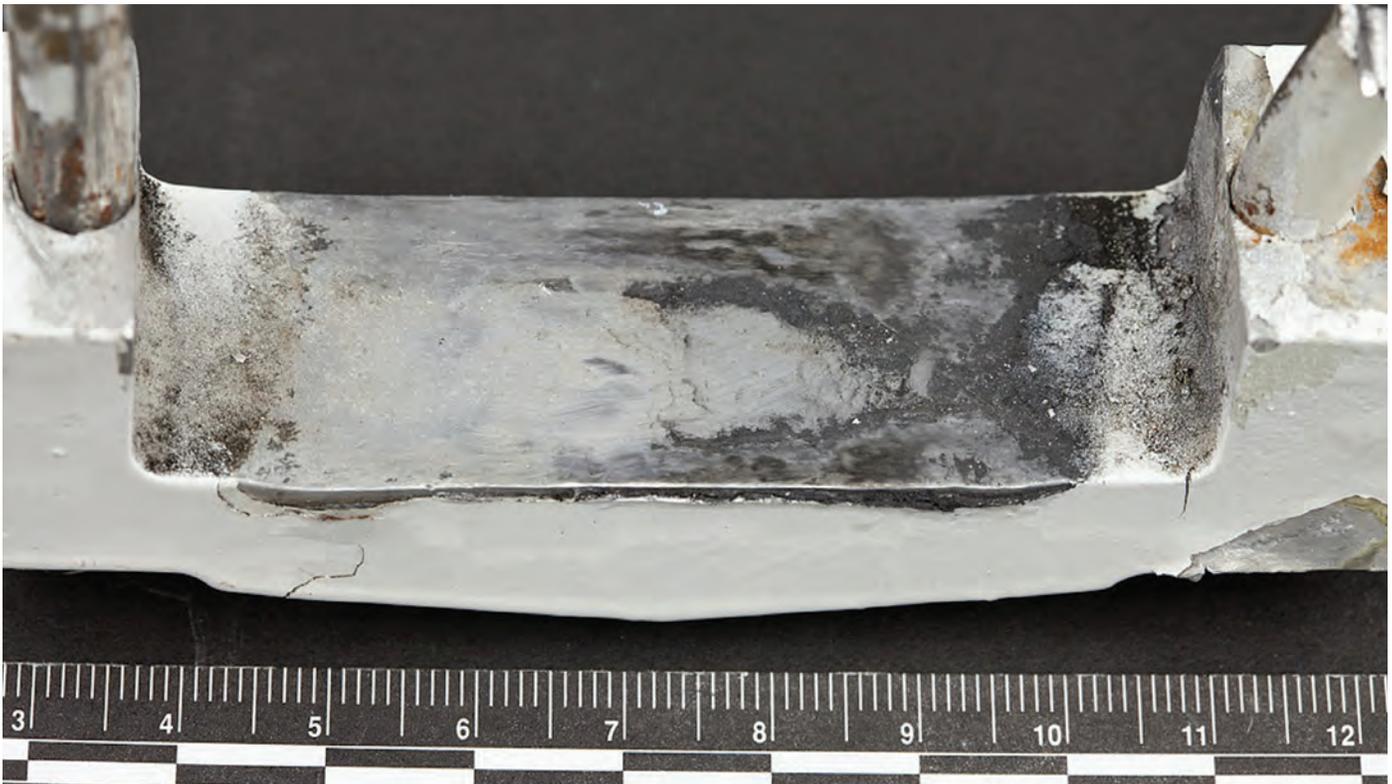
In 2005, Jabiru Aircraft issued a *Service Bulletin* (the company calls these *JSBs*) requiring that all the undercarriage attachment bolts on its J400 (four-seat) range of aircraft be upsized, from 5/16" to 3/8". Later, in 2009, Jabiru issued another *JSB*, which introduced a life of 500 hours into these bolts. Although it didn't say so directly, the *JSB* implied that all of its aircraft must be fitted with the bigger bolts and were included in this life limit.

At that time, we hadn't had any failures in our fleet so we didn't mandate this using our *AIL* system. Then, through 2013, we saw two undercarriage failures linked to these bolts, so we issued an *AIL* effectively mandating the *JSB*. The *AIL* required the fitment of the larger bolt, regular inspections for looseness and replacement at 500 hours. >

(Right & below) Regular readers of *Safety Spot* will remember that we featured this picture in the December 2012 edition. This was followed by the issuance of a number of type-specific *Airworthiness Information Leaflets (AILs)*, mandating a factory *Service Bulletin* limiting the life of the attachment bolts to 500 hours. The *AILs* also required a detailed inspection of the undercarriage. We're returning to this issue because a Jabiru 430 aircraft in our fleet has recently suffered an undercarriage failure, and the owner wasn't aware of the importance of maintaining a careful eye on this undercarriage attachment. The *AILs* offer advice about the best method for checking the tightness of the undercarriage bolts, something that hadn't been undertaken on the subject aircraft for some time. The pictures show the general arrangement of the Jabiru undercarriage system – the left and right legs are separate cantilever springs. You can see that each main undercarriage leg is secured by three bolts, the outer two being 3/8" (AN6) bolts fitted through a clamp (see close-up below) which holds the leg to the fuselage structure. The inner bolt on each leg is rubber-mounted which, along with the flexible nature of the composite leg itself, affords some flex. The main undercarriage leg is canted forward, which creates a loading asymmetry in the clamp itself and, as you can see from the picture of a clamp, if an attachment bolt becomes loose, fretting will occur. (Photos: Jabiru Aircraft Pty/AAIB)

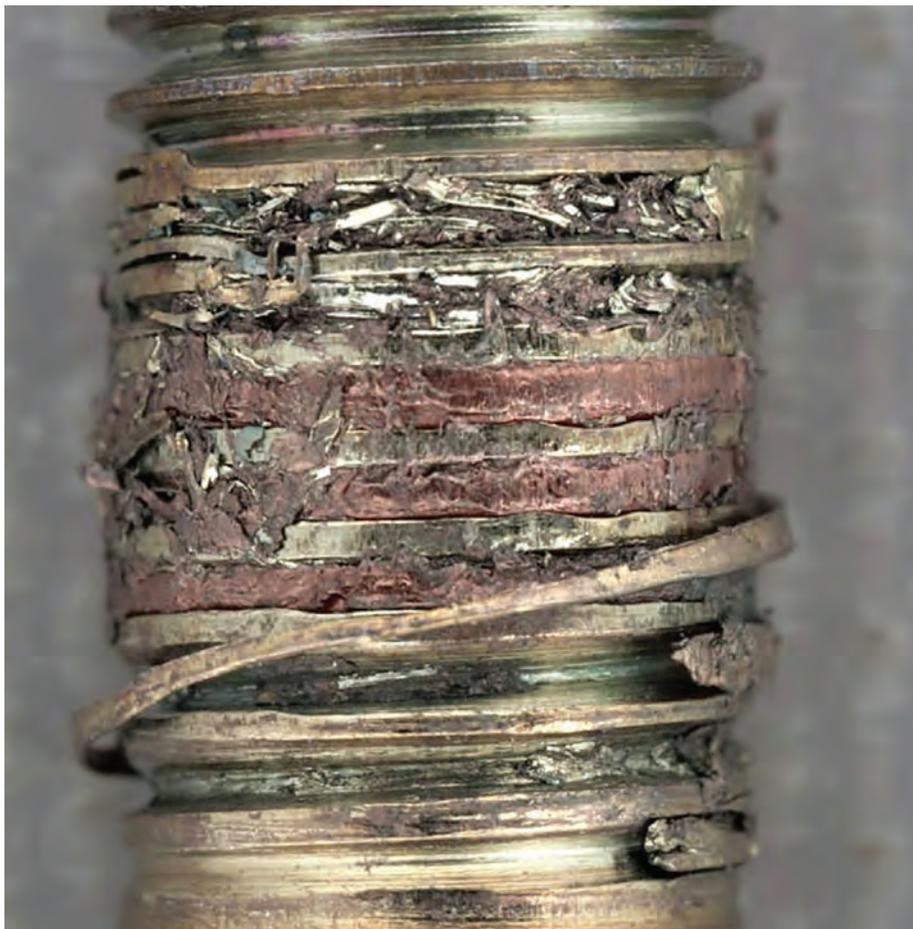
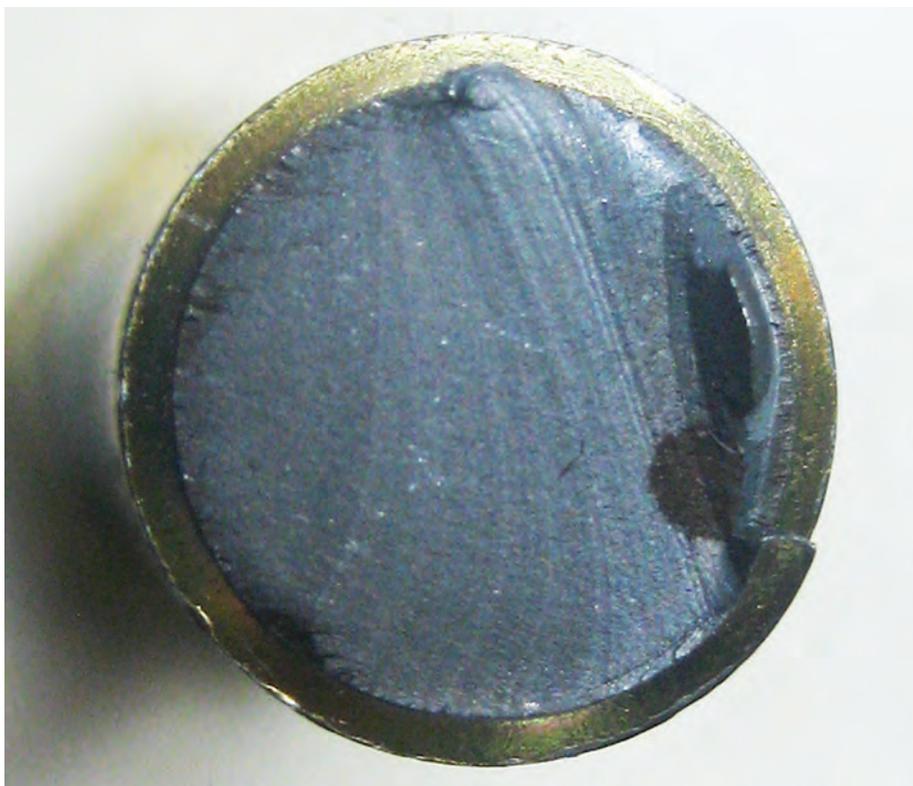
(Top & above) This pair of photos show two mechanisms of failure of the Jabiru main undercarriage attachment system. In the first example, from an earlier failure, the nut has actually failed and pulled off the bolt, and the residue of the material of the nut's threads is clearly visible. The second picture shows the fracture face from the most recent failure. Note the multiple overload (beach) lines, clearly demonstrating a failure through fatigue. And also note the small area of corrosion (at about four o'clock) suggesting an initial break, perhaps during a heavy landing, then failure due to fatigue over time. (Photos: AAIB/Malcolm McBride)

Although the undercarriage bolt hadn't quite reached its 500-hour life, the fact that it'd become loose in the clamp meant it was far more prone to the effects of fatigue. Also, evidence from the bolt suggests an early-overload partial failure, which is possible owing to a heavy landing or, perhaps, running over a rut at high cockpit weight.

"Since this incident I have ordered two new leg clamps, new centre-bolt rubbers and a complete new bolt set, which I've now fitted."

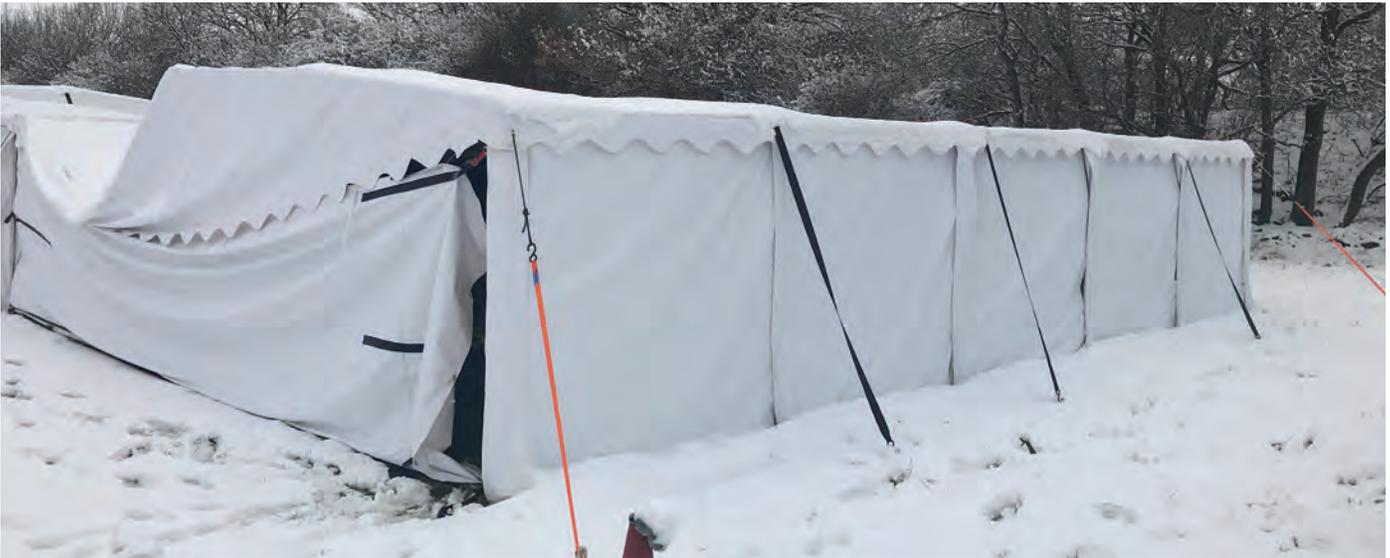
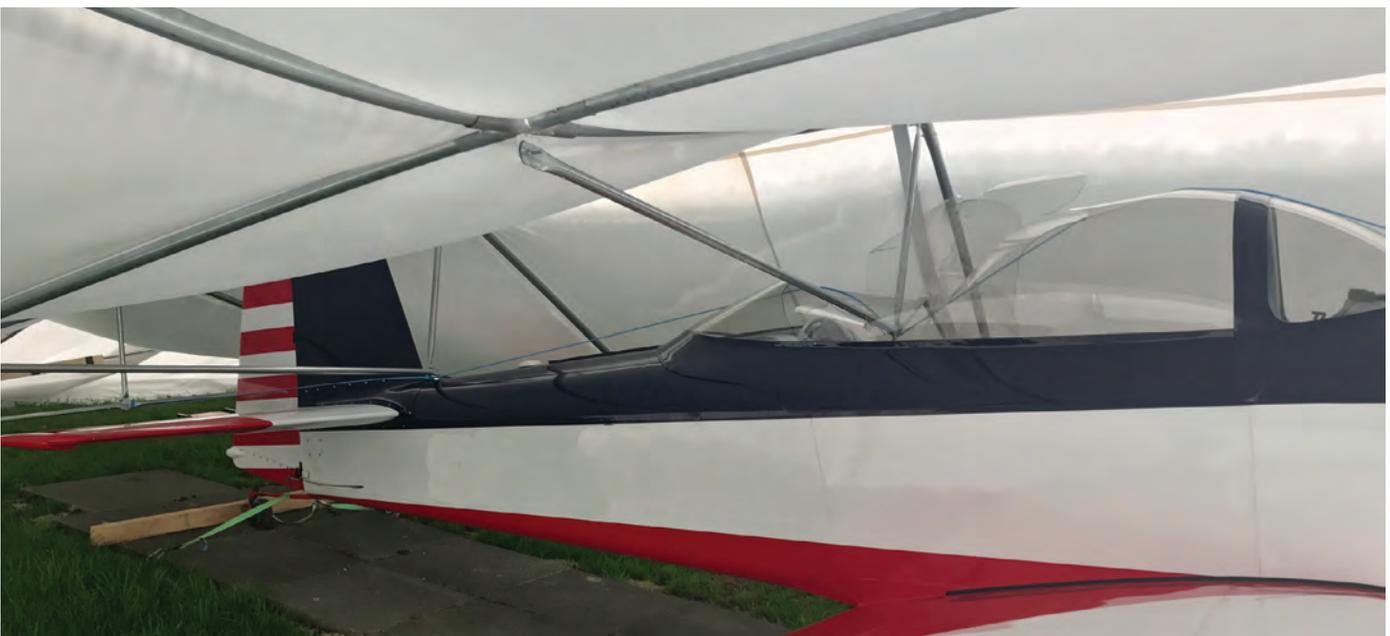
(Top & above) Another winter, another aircraft damaged by a hangar collapse. This time, the primary culprit was an unexpected snow shower, whereas normally the problem is wind. Fortunately, and rather by luck, the damage to the aircraft inside wasn't catastrophic. The lightweight structure had buckled under the snow load, which this type wasn't designed to resist – note that the damage to the aircraft was limited to the perspex canopy, which has now been replaced. However, as you can see, the empennage had a narrow escape. (Photos: Dave Stephens)
