Safety Spot  
By Malcolm McBride

# GROPPO/SAUER FUEL AND IGNITION FAIL, THE MORANE SAULNIER ON THE SHORE & ROTAX FUEL PRESSURE ISSUE

The latest LAA Engineering topics and investigations

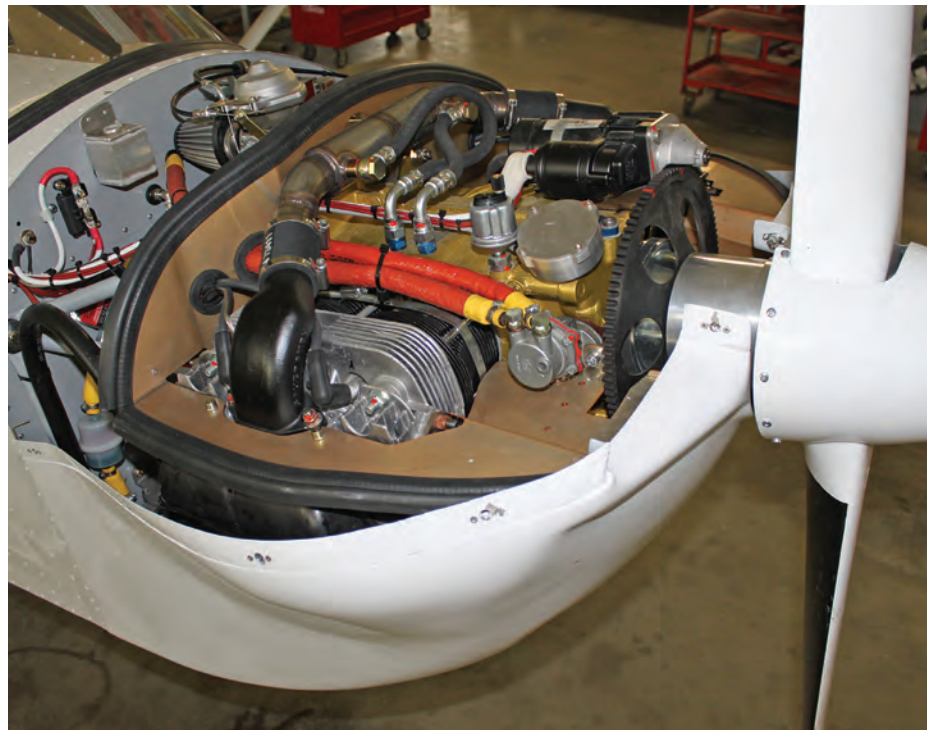
(Above) There are numerous VW aero-conversions in service today, some certified for aircraft use like the German Limbach and Sauer engines, and many operating in the world of the amateur-builder. The Sauer 2400UL engine is shown here neatly packaged into a Groppo Trail, a two-seat, high-wing kit-build. Note the position of the mechanical fuel pump and electronic ignition module (Starboard side/front). (Photo: Graham Smith)

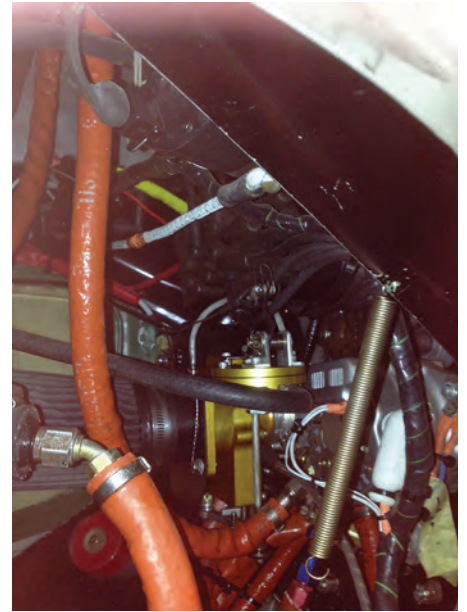
*(Above)* The mystery of the excessive fuel use on the Rotec R3600 Radial engine solved – the loss of a simple spring connection meant that the primer button remained in the ‘priming’ position, even though the cockpit control lever had been returned to the primer shut position.

Clearly, a minor design modification was required, so that if a control cable or spring failure occurs the system will fail in safe-mode – in other words, primer off. With the primer button closed, the fuel pressure regulator is effectively disabled, and it’s been estimated that the engine could use up to four times as much fuel in this condition. *(Photo: Zac Rockey)*

The outside of the fuselage bore witness to an extremely smoky exhaust after the incident flight, which suggests that the engine had been running with a very rich mixture. The reason for the excess fuel usage was discovered to be a disconnected priming lever spring, which meant that the priming button on the Rotec Throttle Body Injector (TBI) remained 'on' even though selected 'off' in the cockpit.

The lesson here of course, is that in any Bowden cable-operated system relying on a spring to return it, the failure mode should be the safe condition, if the spring should break or become detached. One other interesting feature of this incident which I should share is that, when the aircraft was checked through at Branscombe there was almost no oil in the engine at all. That was a mystery, but one engineer, LAA'er Robin King, suggested that the excess fuel was cooling the pistons such that oil was being pumped through the engine and out through the exhaust, which sort of makes sense when you think about it.

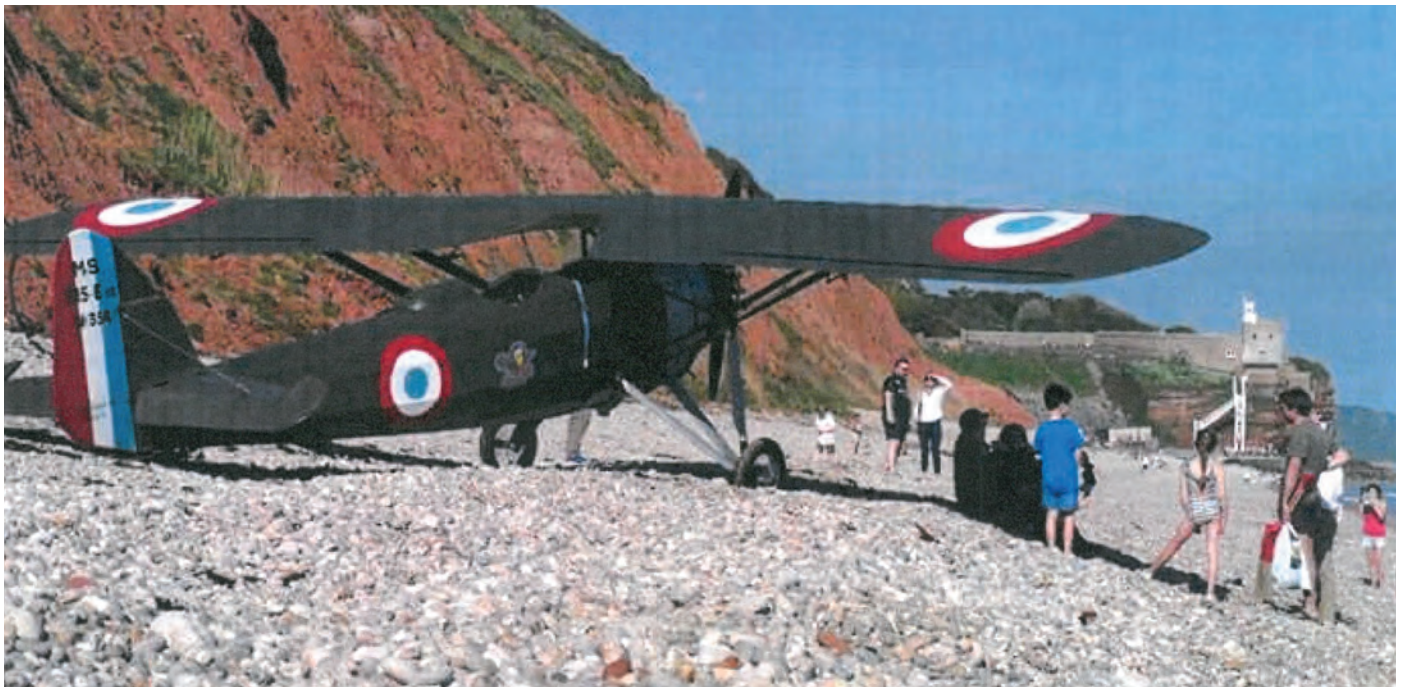
This picture shows one of only three Morane Saulnier MS. 315E D2 aircraft in existence, ‘sunning’ itself on Sidmouth beach. The pilot, LAA’er Zac Rockey, made a perfect emergency landing on the near-deserted beach after its Rotec R3600 nine-cylinder radial engine started ‘playing up’, but it didn’t take long for crowds to form and the incident soon made most of the social media platforms. Interestingly, the reason for the engine’s poor running was that the aircraft was running out of fuel, even though Zac’s consumption calculations showed that there should’ve been half a tank remaining. *(Photo: Zac Rockey)*

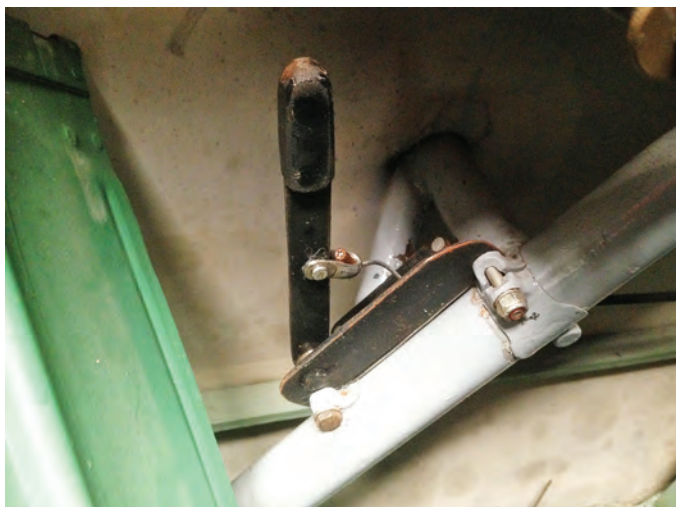
(Left) This picture shows where LAA Inspector Robin King found the position of the priming lever while investigating where all the fuel had gone – he was immediately suspicious when he saw that the cable appeared rather slack. (Photo: Zac Rockey)

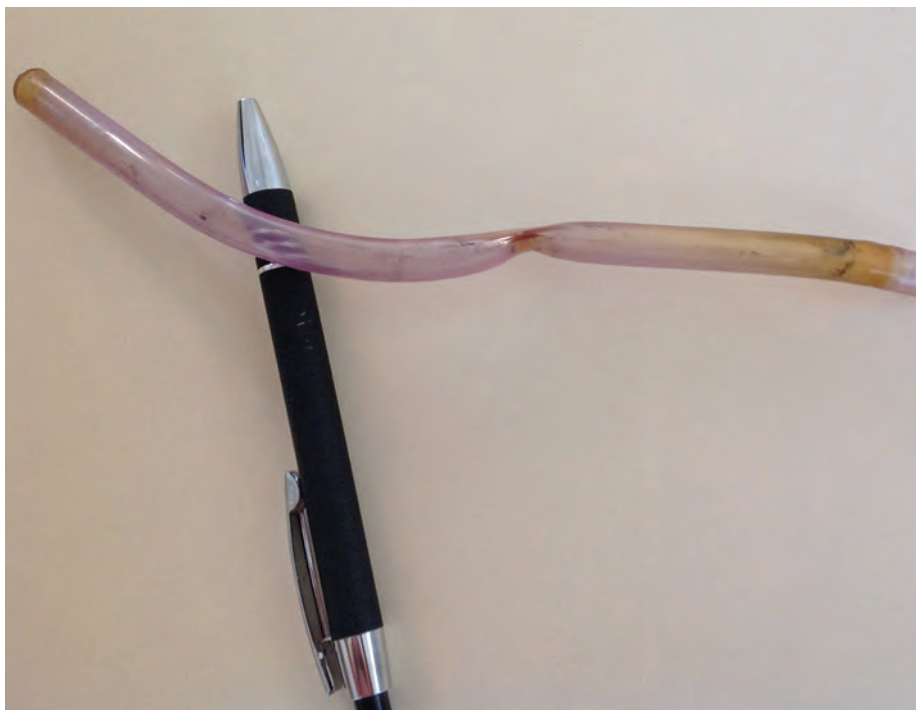
*This picture shows the condition of the fuel pump's vent pipe. A restriction in the vent will significantly reduce the pump's ability to supply fuel. Adrian spent many months trying to solve the problem of intermittent low fuel pressure but didn't notice this restriction, as it was part of a bundle of wires and pipes coupled together inside a tie wrap.*

*"When I removed this hose, we could see that it was badly restricted, and Tim explained that this could be the problem! When I fitted it to the removed pump and tried to hand operate it, indeed it was clear that, when badly restricted, pump operation was impeded.*

*"On close examination of the restricted plastic hose, it appears that, over time, the hose has been softened by contact with the hot oil hose during engine operation. I believe that, during the very cold winter, it'd hardened into the softened but restricted shape.*

*"That process was gradually becoming worse, which explained the intermittent nature of the problem. I fitted a replacement length of Semperit fuel hose, which is much thicker, walled and somewhat heat-resistant, and thus far less likely to become restricted. Since reassembly, the engine fuel pressure has been perfect."*
