Safety Spot  
By Malcolm McBride

# INSPECTION-TRIGGERING INCIDENTS, A COLLAPSING TITCH, HIDDEN DAMAGE & A TALE OF TWO REBELS...

The latest LAA Engineering topics and investigations

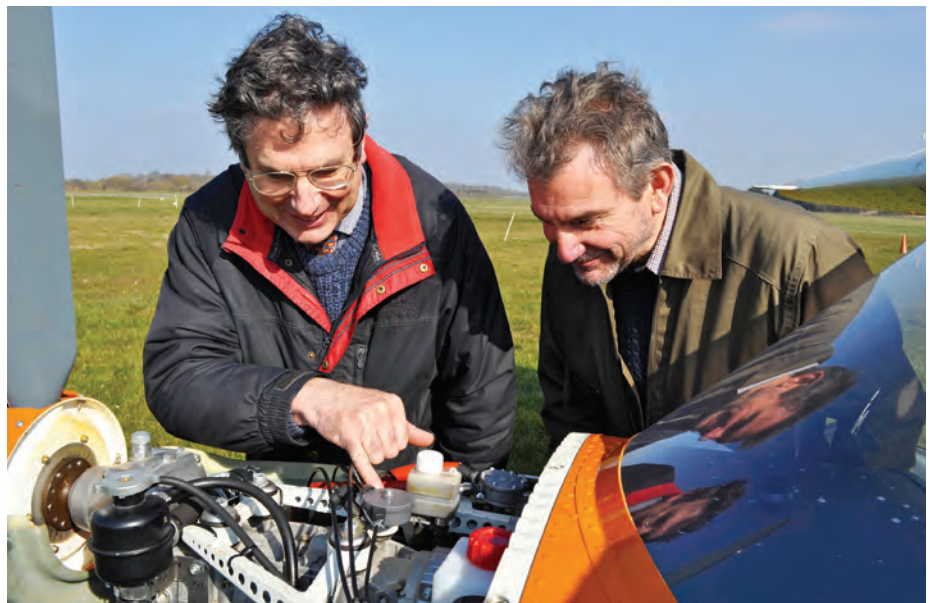
(Above) LAA Chief Engineer, Francis Donaldson, carrying out the duplicate inspection for LAA Inspector Graham Smith after an 'in the field' adjustment of an engine control. Whenever a flying or engine control is disturbed, for any reason, then it's essential that it's checked by a qualified second party before the aircraft is released for service. (Photo: LAA Engineering)

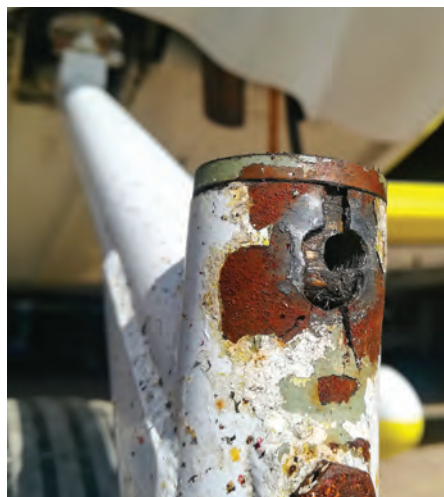
(Above) Here's a horror which was lurking unseen behind a SportCruiser's spat. LAA engine specialist, Kevin Hyam, came across this cracked spindle housing after removing the spat on a friend's machine. The aircraft is nine years old, had completed roughly 350hr and been fitted with the 'Dover spindle modification'. (Photo: Kevin Hyam)

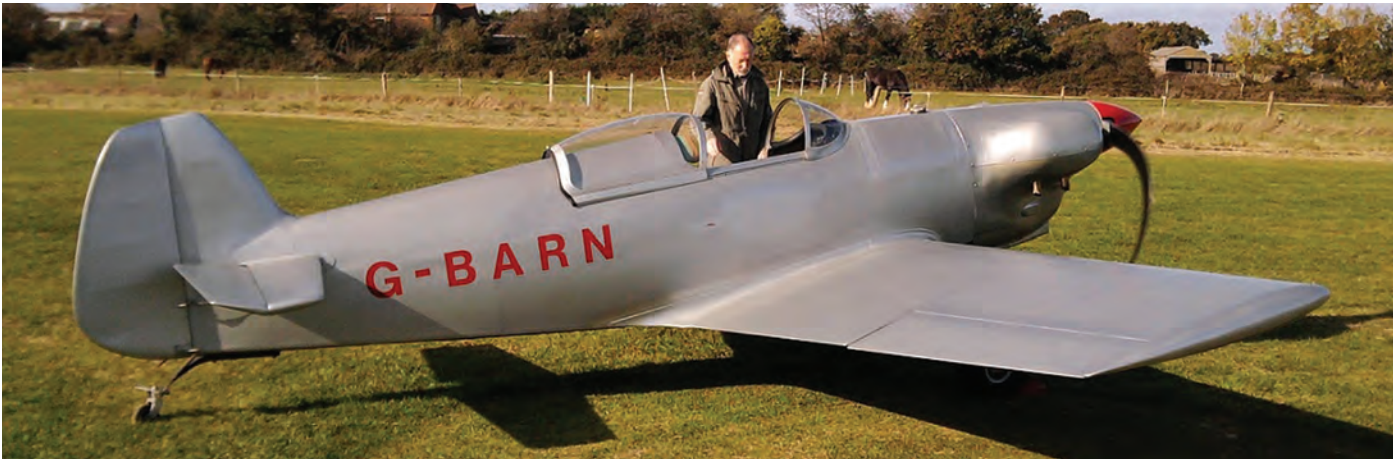
(Above) Surely, there can be no better feeling than climbing into the cockpit of an aircraft you've built from plans with your own hands. This picture shows the owner and builder of this lovely Taylor Titch, Roy Newton, at just such a moment. Roy started building his aircraft in the late-seventies and it received its first flight test authorisation in 1986. In October last year, during a perfectly normal landing, the undercarriage gave way and the aircraft settled onto its belly. Luckily, the damage to the airframe was minimal and the Titch will soon be back in the air but Roy remembered that, some months previously, he'd landed rather more heavily than normal. It was possible that this landing began a crack in one of the undercarriage mounting brackets, and a closer look at the items themselves showed that the weld penetration was poor. (Photo: Roy Newton)

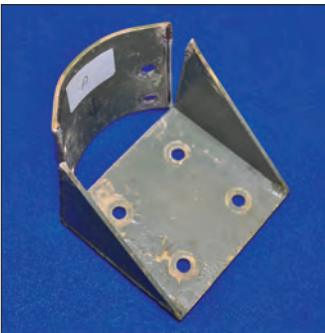
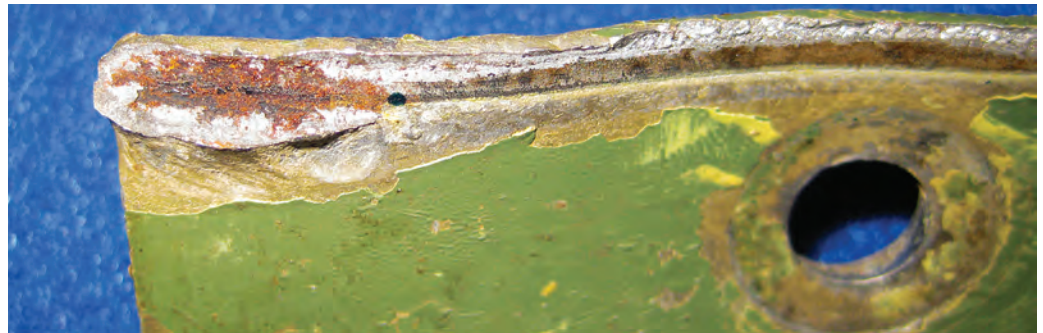
(Above & above right) The pictures above show the reason for the undercarriage collapse on Roy's Titch, namely a failed undercarriage bracket. As you can see, the bracket has failed completely along the welds, and a close examination showed that the weld itself, although looking very tidy from the outside, hardly penetrated into the supporting material. The second picture shows well-developed corrosion inside the joint, suggesting that the initial failure point occurred quite some time before the final incident, possibly during an earlier over-stress event. (Photos: Malcolm McBride)

The pictures above clearly show that the weld has failed on the centre bracket. This weld holds the strengthening side webs in place – once they failed, the bracket couldn't sustain the landing loads. Upon examination, it was clear that the penetration of the weld was very poor, which rather miffed Roy as he remembered sub-contracting it to an 'approved' welder, at great expense.

Lessons learnt? Well, this is an example where perhaps following a heavy landing, the undercarriage and its brackets should've been removed for inspection, which would've revealed the cracking in

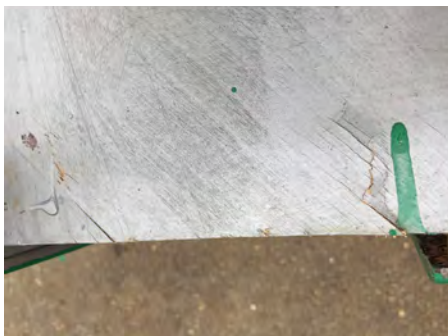
(Above) This is an example of fracture damage, most likely caused by the bursting effect of a compressive overstress, in the plywood skin of the Jodel's main spar. Because this aircraft has a section of false rib over the spar, to maintain wing top surface profile, this damage would be difficult to spot without close examination. (Photo: Alan James)

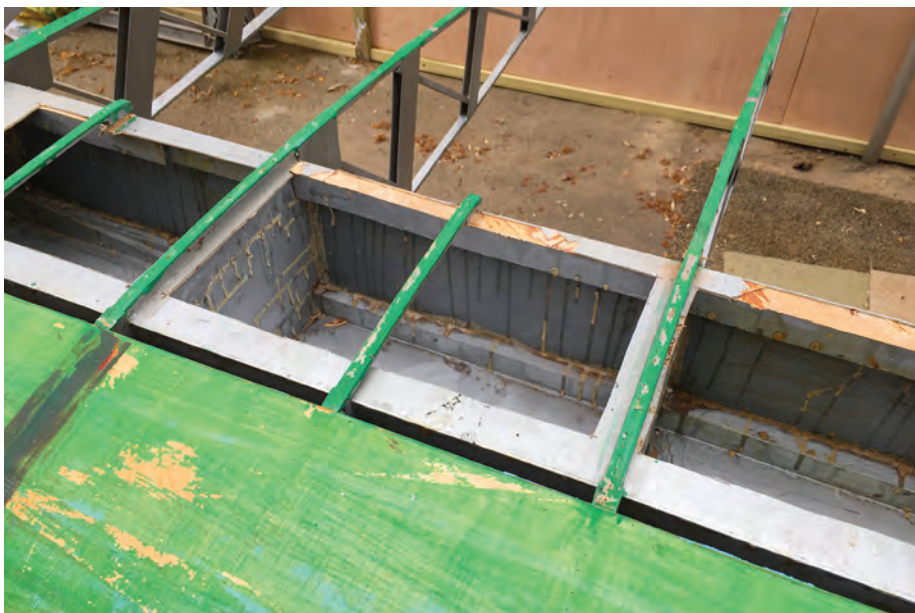
(Above) The Jodel D120 has a wood-and-fabric wing built around a thin-walled wooden box spar, comprising plywood side, bottom and top panels, bonded to corner elements of rectangular-section timber. A simple form of construction, this confers excellent bending and torsional rigidity when intact, but very little stiffness in the event of loss of integrity of the timber corner elements of the box. This picture shows the wing structure with the fabric off and the spar's top plywood panel removed so you can easily see the damage. Unless this type of damage is very severe, it just wouldn't be apparent without removing the fabric. (Photo: Alan James)

Once the fabric was removed, the structural damage was easily seen. Both of the thin wooden trailing-edge members had given way and there was a compression/shear failure of the thin upper plywood web of the box spar. Worse, once this plywood facing had been removed, severe damage to two of the four spar caps was revealed – a number of transverse compression failures were present which would’ve robbed these components of almost all of their strength. These are a box spar’s principle load-bearing elements.

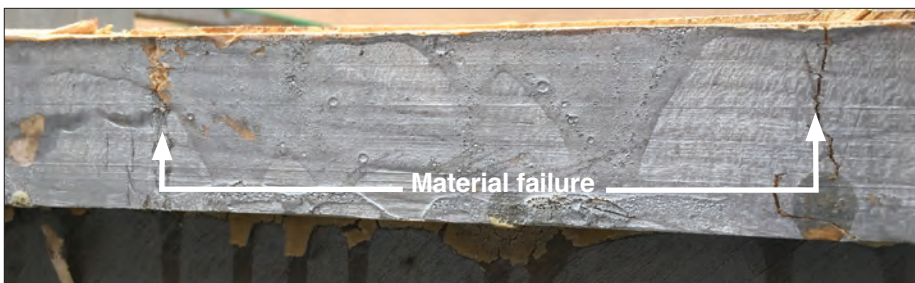
(Above) Once the plywood skin was removed, the completely unexpected damage to the main spar's corner timber could be seen. Compression failures like this are notoriously difficult to spot, and to imagine one occurring in wood it's important to understand how the material is made up. During the failure, the wood fibres have buckled (like squashed drinking straws) and, therefore, lost all of their tube-like integrity. Fortunately, this simple structure can be repaired by cutting out the damaged timber and scarfing-in a new piece, though naturally a thorough design evaluation of any proposed repair will need to be made by professionals. (Photo: Alan James)

Perhaps most soberingly, this very serious spar damage was on the starboard side of the wing, where the leading-edge damage looked relatively inconsequential. That just shows however minor the external damage might be, it’s essential to look under the skin.

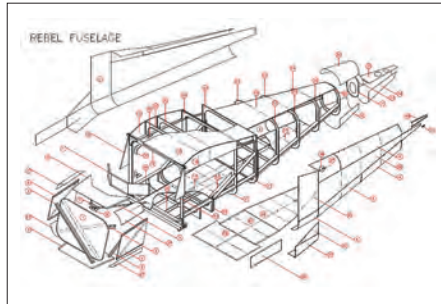
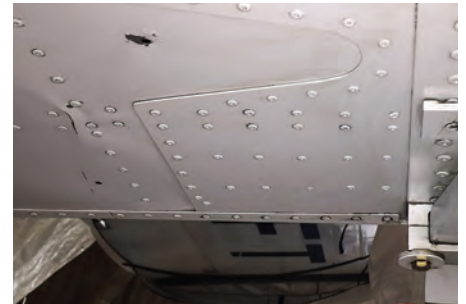
(Above & above right) The sketch above shows the numerous panels which go into a metal aircraft, and the one that’s showing cracking and needs either replacing or repairing can be seen in above right. It may be that the cracking along the rivet line is due to an overstress event at some time in the past, perhaps a heavy landing, possibly the recorded ground-loop, but both the repair and the replacement options will require the airframe to be completely stripped out and the fuselage held in a jig during the work. Fuselage structures lose their rigidity very quickly when panels are removed and it’s easy to damage unsupported structures, which is why a repair process needs much planning before any work begins.

We saw this first aircraft again, some 400 flying hours and seventeen years later, when the new owner supplied us with a *Repair Proposal* because he was worried about some skin damage to the underside of the fuselage. Incidentally, although a patch repair was considered, it was decided that the best repair option is a replacement of the complete skin.

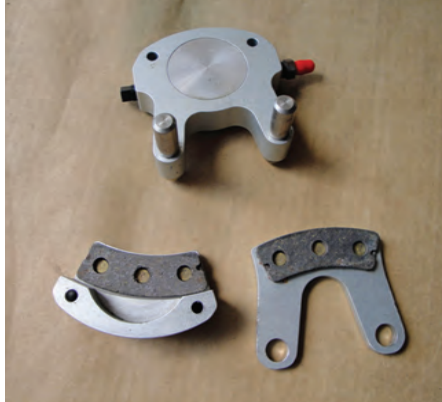
Now, what about its 'sister-ship'? Well, as its builder, LAA'er Pete Hyde, reached the final stages of his build, he started looking closely at the brakes, as supplied by the kit manufacturer. We're pretty certain that this type of brake was fitted to our 'other' aircraft though, as stated earlier, these were changed during the repair after the ground-loop incident. Well, I hope you can see from the pictures, when looking at the clearances between the various components in the brake system, there's a very great possibility that they could've jammed in service.

(Above) The main 'gripping' components of an aircraft braking system. When assembled, the inside pad carrier must be able to move freely along the guide pins without contacting any fixed structure, but there mustn't be enough freedom for it to jam sideways. Pete intends to trim about a sixteenth of an inch from the carrier, which should prevent it from contacting the undercarriage leg. Note that these pads are held onto their carriers using copper rivets, which is quite normal with aircraft brakes.

Pete suggests that the clearances can be increased quite easily by opening them up using a file, although he's going to inspect the system's operation very closely before opening the throttle for his aircraft's first flight.

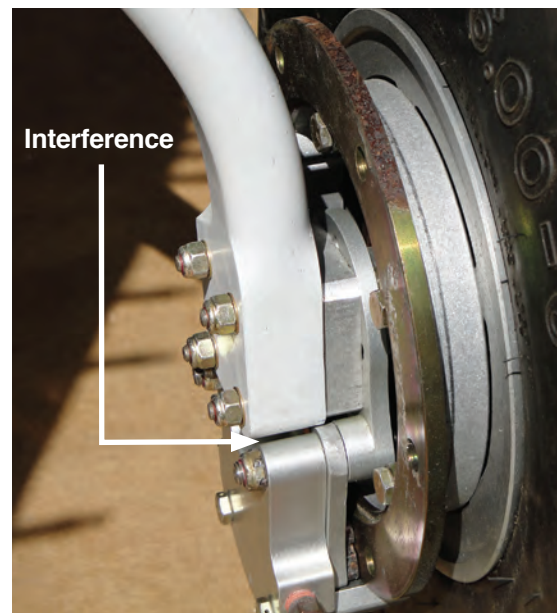
(Above) A point of possible interference between the pad carrier and the bottom of the undercarriage leg. Braking systems are particularly sensitive to issues with clearance between moving components and their stationary supporting structures – too tight or loose and they can have a jam potential. (Photo: Pete Hyde)
