Safety Spot  
By Malcolm McBride

# SPORTCRUISER NOSELEGS, GROPPO TRAIL WING-BOLT LIFE & RV-9/RV-10, CH 601 UL AND EV-97 TAILPLANES

The latest LAA Engineering topics and investigations

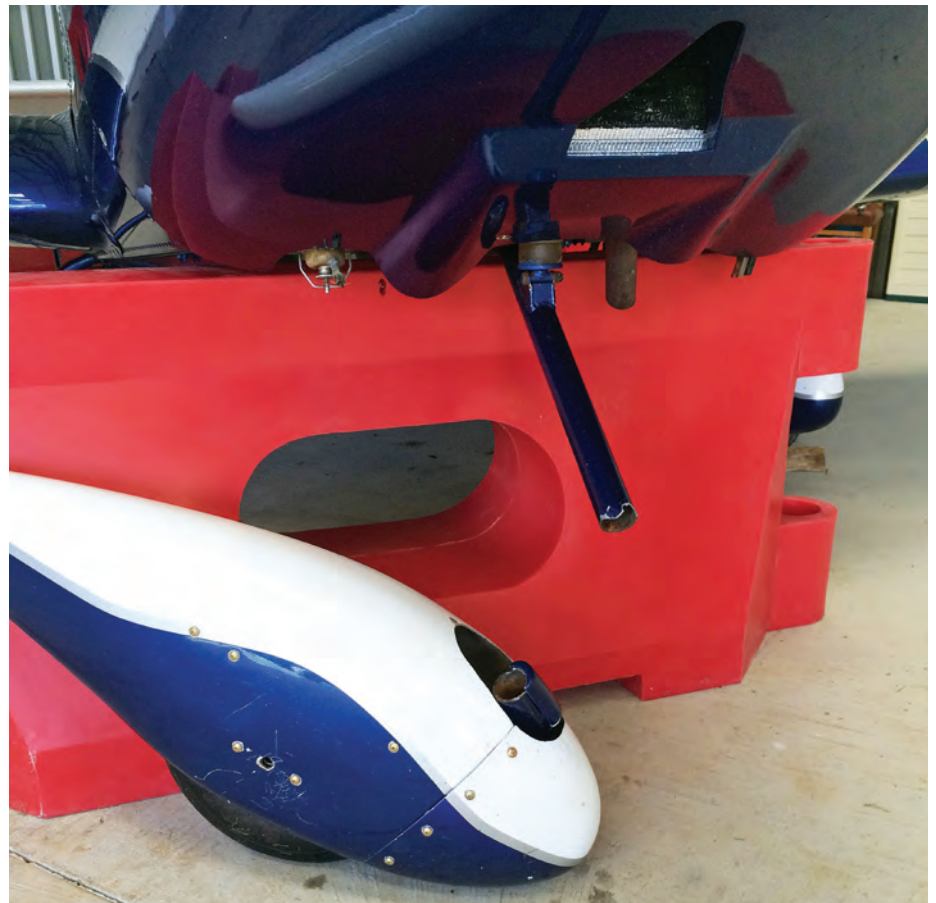
(Above) This is a sight that no aircraft owner wants to see. This failure of a noseleg on a SportCruiser is one reason why the LAA has brought the issues surrounding the design and maintenance aspects of this component out of the locker and back onto the table. Luckily, the noseleg failures we've suffered on LAA SportCruisers haven't led to any physical injury but, as we've learnt from other types, when it occurs there can be serious consequences. The LAA has recently issued a comprehensive Airworthiness Information Leaflet (AIL), listing the approved components and formally laying-out the maintenance/inspection rules for SportCruiser noselegs.

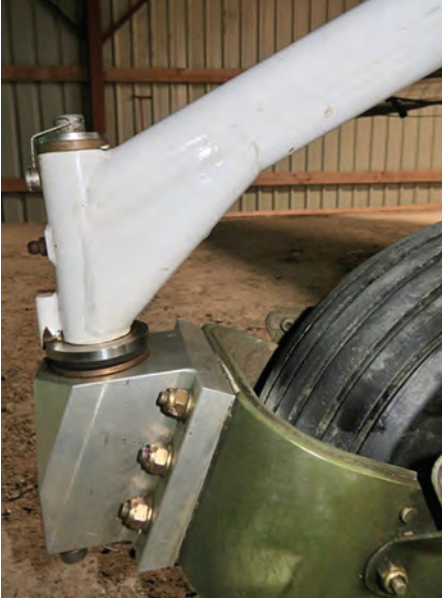
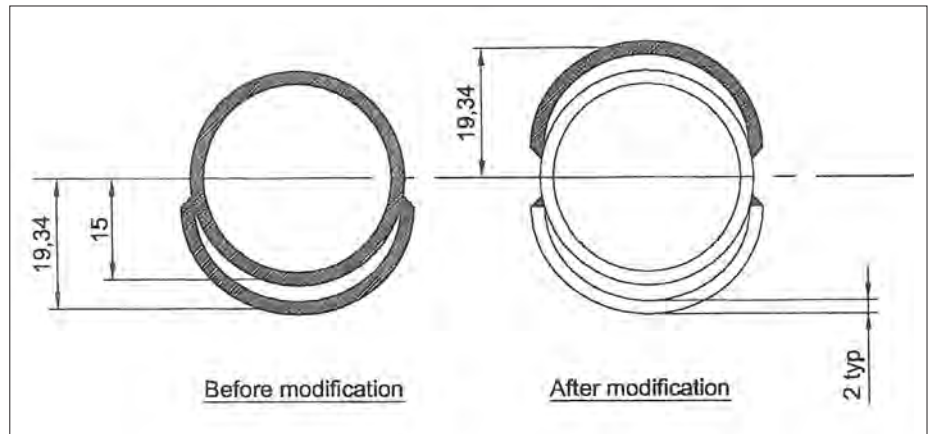
(Above & above right) This picture and the drawing show what LAA Engineering considers to be the 'gold standard' SportCruiser noseleg. Effectively, it's an original CZAW design that's been 'improved' by changing the design of the spindle housing (plus increasing the size of the spindle itself) and adding a strengthening strap along the top of the leg. The spindle change is mandatory on all UK SportCruisers, but the leg strengthening, because the failure mode is a slight bending (set) of the leg rather than catastrophic, is just highly recommended. (Photo/diagram: Feroz Wadia/Tony Palmer)

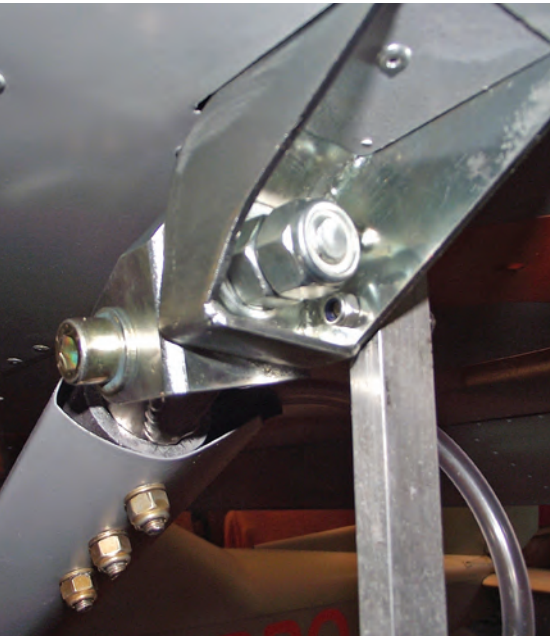
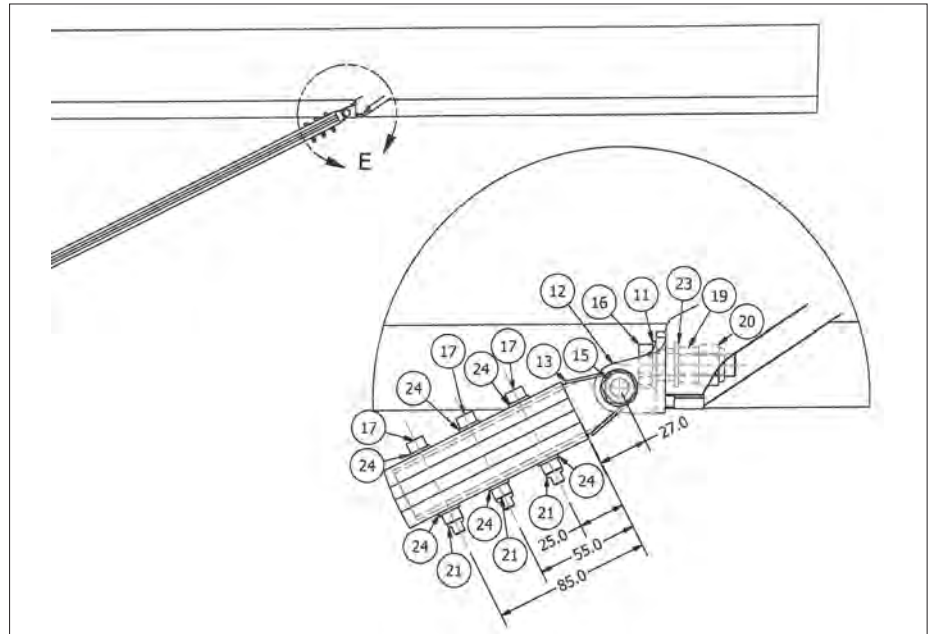
(Above & above right) Over the years, there have been many attempts at designing a quick and effective wing-folding system for sports aircraft. The first sensible system I came across as an engineer was that used on the de Havilland DH60 aircraft – I remember being very impressed by the ‘mechanics’ of the system but did wonder about the change in load paths between the folded wing and the fuselage connections. Though generally not used all the time, a wing-folding system can be a good idea but, as with most design solutions, there are both up- and down-sides. These pictures show the wing-to-wing strut connection on the folding-wing Groppo Trail – you’ll probably need to refer to them when you read the main text about the Groppo Trail, which discusses the reasons why we’ve changed the management of this component’s life. (Photos: Graham Smith/LAA Library)

One bolt in particular caused concern – this is marked as No 16 in the drawing. If you can picture the wing-to-strut joint, in your mind's eye, you'll see that to afford the wing rotation to the vertical position and then rearward fold-back, the joint needs to be free to rotate about two axes. And the normal flight loads through bolt No 16 are, in effect, trying to rip its head off – that isn't a technical

description, but I hope you can see what I mean. For that reason, at the time the Trail was first cleared by the LAA, this bolt was given a very conservative in-service life of one operational year, simply as a means of allaying any concerns in this area and allowing the Type Acceptance process to proceed unhindered.

Certainly, it's true that calendar life is an important factor in all things – after all, we live and work within a universe where entropy rules – but the technical worry over this particular joint centred around local fatigue, particularly between the bolt's head and shaft. Fatigue is quite a difficult thing to predict, but it's well known that, with a fluctuating load, the closer to the material's limit-load parts are required to operate, the fewer fluctuations they'll be able to resist.

Further consideration has now been given to this bolt so, with a good dose of safety factor, its life has now been re-defined as 200 flight hours, subject to a special check, at the initiation of this life, that the bolt is new and has been properly installed.

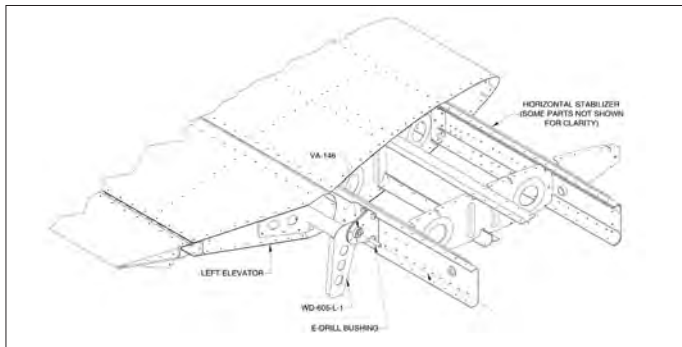
(Below) LAA Inspector, Toby Wilcox was carrying out a fairly extensive set of repairs on an accident-damaged EV-97 EuroStar when he came across this elevator connection with a nut and bolt that wasn’t split-pinned. Actually, there were quite a few other control system issues with this airframe and Toby felt that the previous annual inspections couldn’t have been very thorough. Toby points out that, if you’re signing for a job, must make sure you complete it. A control system inspection is just as it says, an inspection of the control system, including the attachments, fittings, connections, cables, fairleads and ranges. Yes, it’s a long list, but of the many things that can go wrong in an aircraft during a flight, a control system becoming disconnected has to rank as one of the worst.

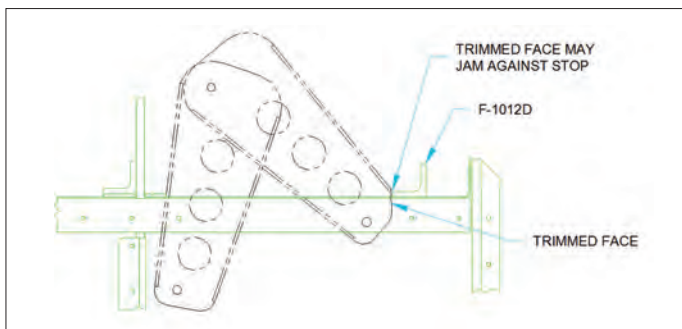
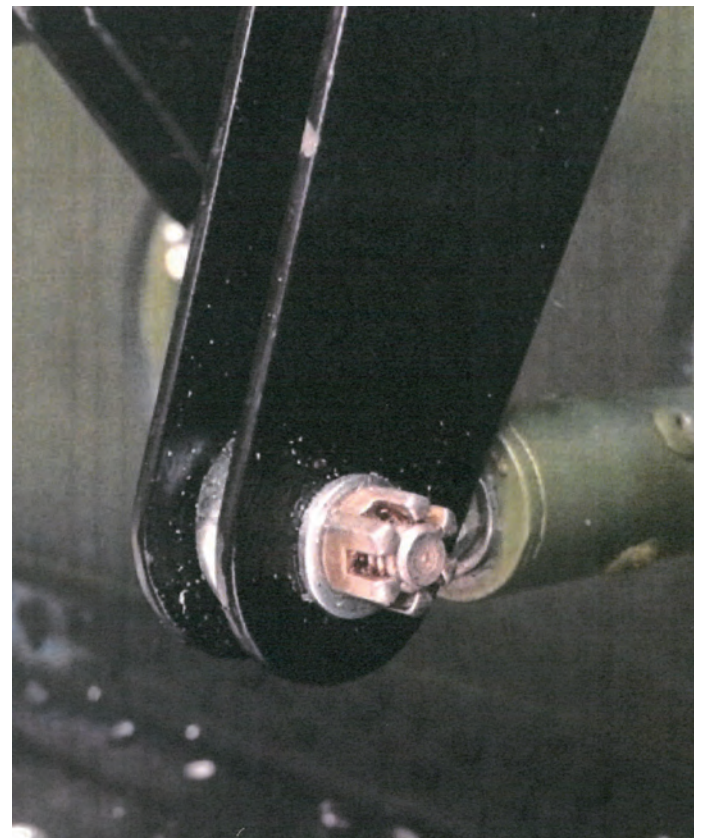
(Above middle & above) Engineering has recently written to the owners of LAA-administered Van’s RV-10s, letting them know that the manufacturer has issued a *Service Bulletin*, asking owners of examples built after 2012 to check that the elevator on their aircraft can’t accidentally jam. The problem arose because the design of this part, which is common to all Van’s types, was changed in 2012 by removing the lower aft portion of the elevator horn. On other types this portion of the horn restricted elevator movement, but with the RV-10 it’s possible that it could create a jam (see drawing above). This is just the sort of issue which should be ‘looked-for’ during an inspection of the control systems on any aircraft, and one of the reasons why most aero engineers would consider it impossible to completely check a flight control system without a competent assistant (sometimes two!). (Images: Van’s Aircraft)

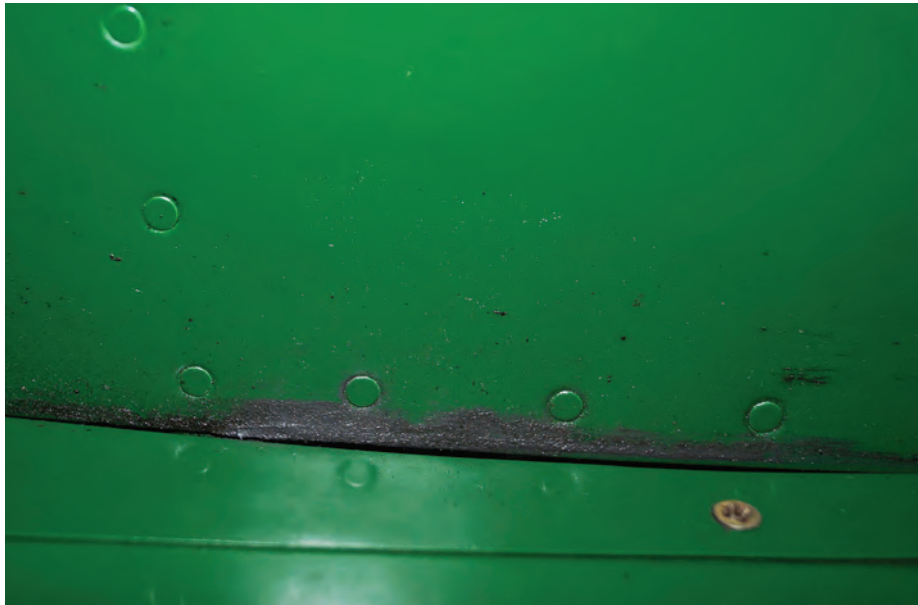
*(Left)* What's this? I'll give you a bit of spatial assistance: imagine that a green RV-9's tail is on a trestle in your hangar and you, the viewer, are looking at the junction between the tailplane and the rear fuselage – any help? LAA Inspector, Nick Seymour, who quite rightly doesn't like the owners of aircraft in his camp to clean their machines before they're presented for their annual inspection, immediately realised these marks indicated that all isn't wasn't as it should be, regarding the joint between the tailplane and the fuselage. Engineers sometimes describe this staining as the joint 'smoking' – most likely, the bracketry has come loose and the metal surfaces were rubbing together. Of course, this is a sign of a problem which must be investigated so, if you see any signs of 'smoking' on your aircraft, don't just wipe off the evidence, check out the mechanics of what's actually going on. Well, where there's smoke... *(Photo: Nick Seymour)*

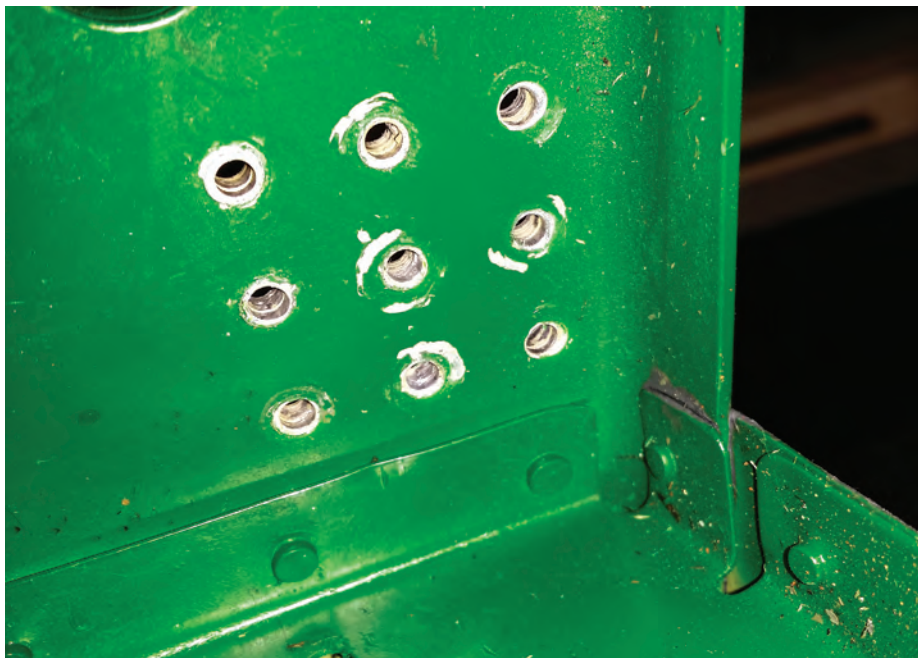
*(Left)* After removing the RV-9's tail, it was clear that the riveted joint attaching the tailplane attachment bracket to the spar had come loose and that was the reason for the joint 'smoking'. This picture shows the elongation caused by the fretting between the loose rivets and the structure of the spar. It may be that oversized rivets will need to be used during re-assembly, but before this design change can be incorporated as a repair it'll be necessary to contact LAA Engineering to check on the correct procedure as, from a design point of view, this might be more complicated than it may seem. Note: Also see the 'smoking' between the spar's forward flange and the fuselage skin – it looks like another part of the structure is showing signs of movement. *(Photo: Ian Dunn)*

Well, what's interesting about the RV-9 and the CH 601 story? Both issues involved the structure of the aircraft starting to show signs of distress and although they weren't shouting out loudly, astute and diligent Inspectors picked up the earliest signs of trouble – well done to them. Also, although this may put the cat amongst the pigeons, both aircraft had recently been sprayed with ACF-50.

Interestingly, both owners said that they might've gone a bit 'over-the-top' with the amount they squirted into the airframe – could the penetrating and lubricating properties of this corrosion-preventer be allowing riveted structures to loosen? I don't know, but it's certainly a point to consider when deciding how much to apply. Fair winds... ■

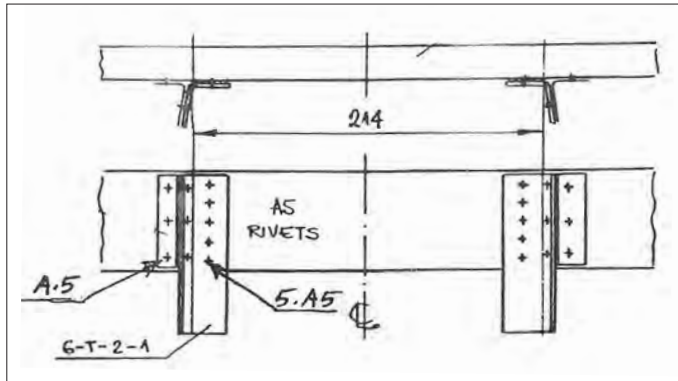
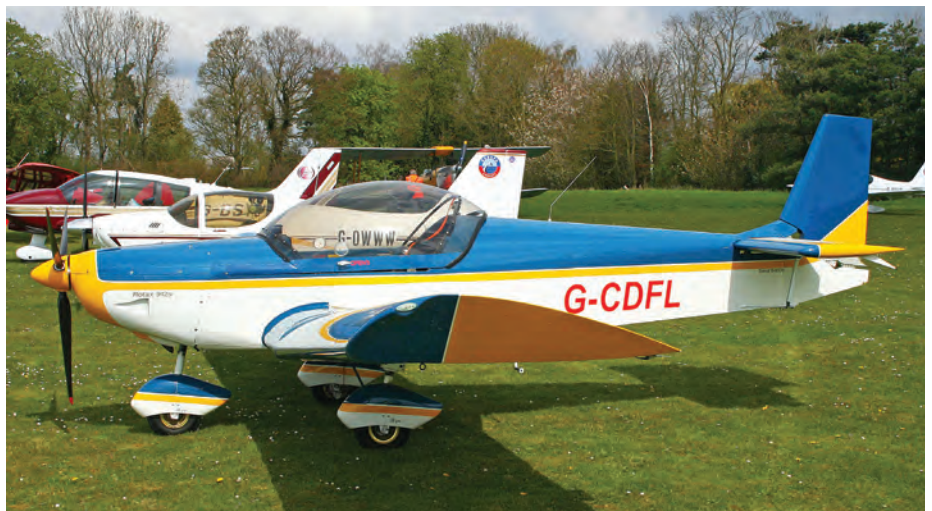
(Left & below left) The tailplane attachment fittings on a Zenair CH 601 UL can be inspected via a small cut-out in the tailplane's top skin, but it's impossible to replace suspect rivets through this tiny orifice. Once it had been established that the reason for the excess asymmetric tailplane movement was due to a number of loose Avex rivets, a 'factory-approved' access panel had to be cut out.
