Safety Spot  
By Malcolm McBride

# LOW-HOURS PROPELLER INSPECTION PROTOCOL, AEROTECHNIK WHEELS & SPORTCRUISER NOSELEGS

The latest LAA Engineering topics and investigations

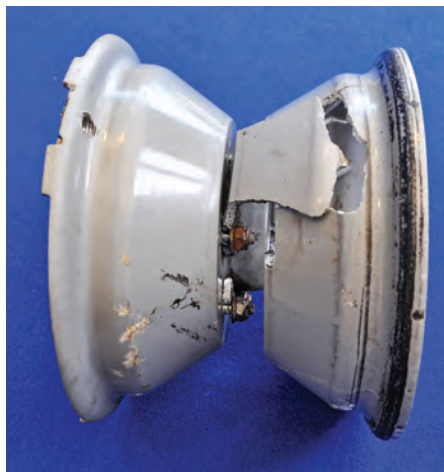
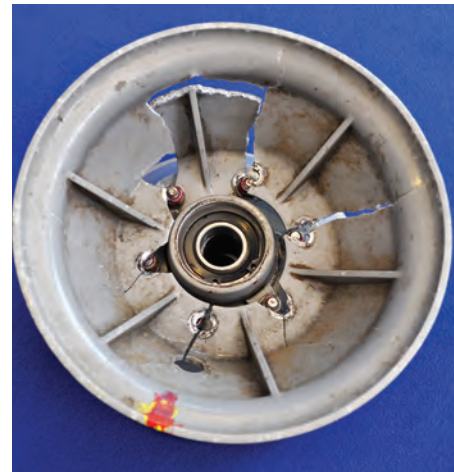
(Above left & right) A full inspection of the undercarriage assembly on an aircraft isn't complete until the wheel has been fully checked. Like the propeller mentioned earlier, these essential components are so reliable that they're often completely ignored during regular maintenance inspections. Again, just like the prop, they're one of the hardest-working components on an aircraft and fully deserve time taken to keep them in tip-top condition.

This wheel, from a EuroFOX tug aircraft, failed during taxi after launching a glider – you can see that the failure sequence has started because of cracks which have originated at the wheel-half bolt attachment holes. (Photos: Malcolm McBride)

*'We've previously removed the spats from this aircraft and I've suggested that a close inspection of the wheel needs to be made at each DI.*

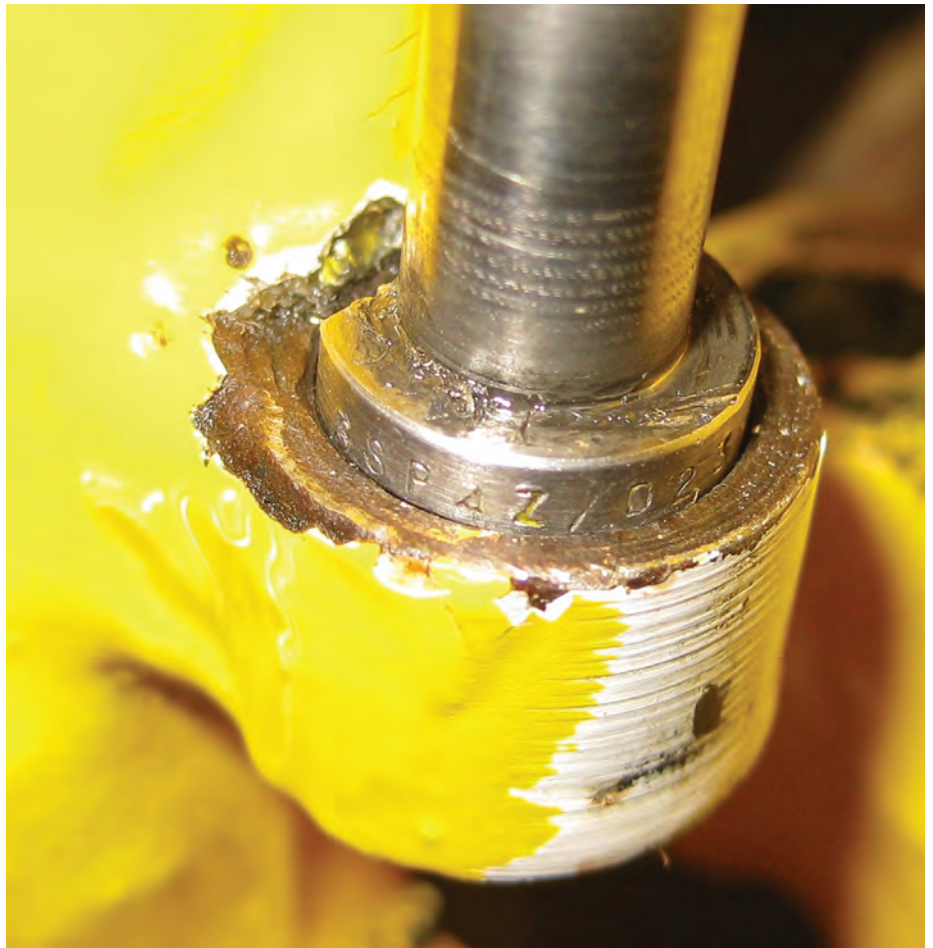
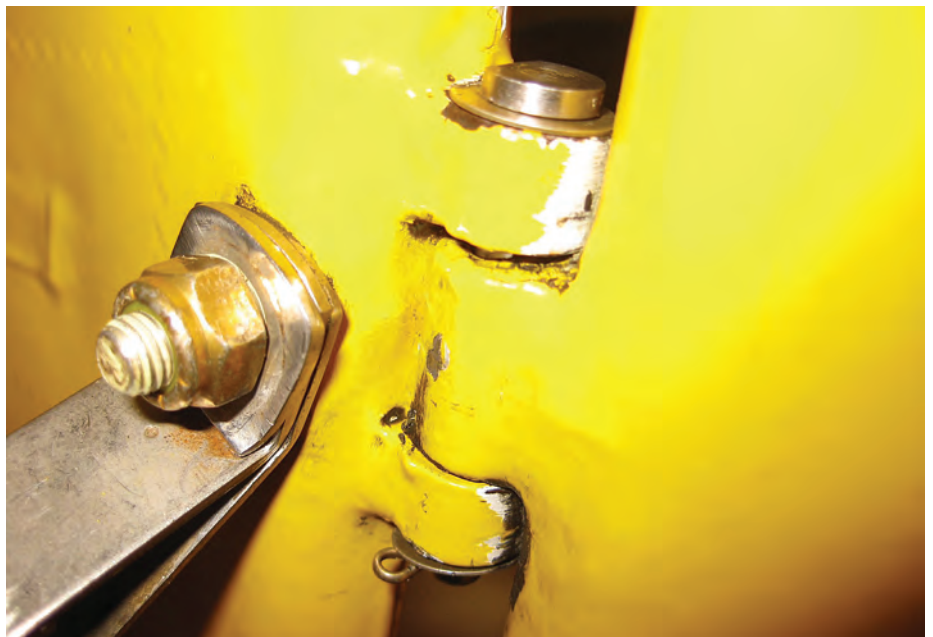
*(Top & above)* These two pictures serve to remind us about the need to recognise potential system failure modes on aircraft. That may sound a bit fanciful, but it's always worth thinking 'what if' when assembling any component part. Regular readers of *Safety Spot* will know that we've been highlighting a hinge failure which recently caused the partial detachment of a rudder on an early Piper Cub. Although this was the first record of an incident like this, it did highlight a previously un-spotted failure mode.

In the picture at top, note that the head of the hinge pin is smaller than the inside diameter of the knuckle, so the only thing holding the hinge assembly together is the friction in the interference fit of the inner bearing. Lose this friction, for any reason, and the hinge will fail. The picture above, meanwhile, shows a simple 'fix' – a thin washer fitted to the top and bottom of the pin – so, even if the bearing does become loose, the hinge pin cannot fall out. *(Photos: Malcolm McBride)*

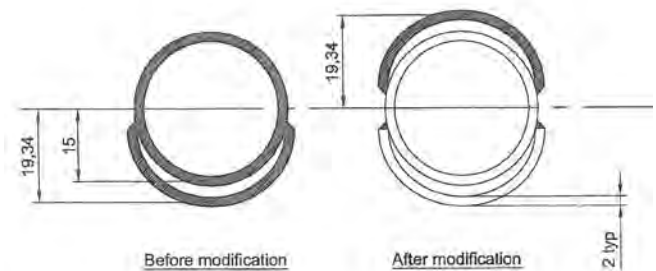
(Top & above) Tony Palmer enlisted the help of LAA Inspector Farry Sayyah to make a strengthened noseleg and quite a few SportCruisers have benefited from this less expensive alternative to the factory replacement part.

This strengthening mod is now a Standard Option for CZAW SportCruiser aircraft (as listed in the TADS) so 'sign out' can be done by an LAA Inspector (without reference to HQ). These pictures show how the leg has been strengthened. (Images: Tony Palmer/Farry Sayyah)

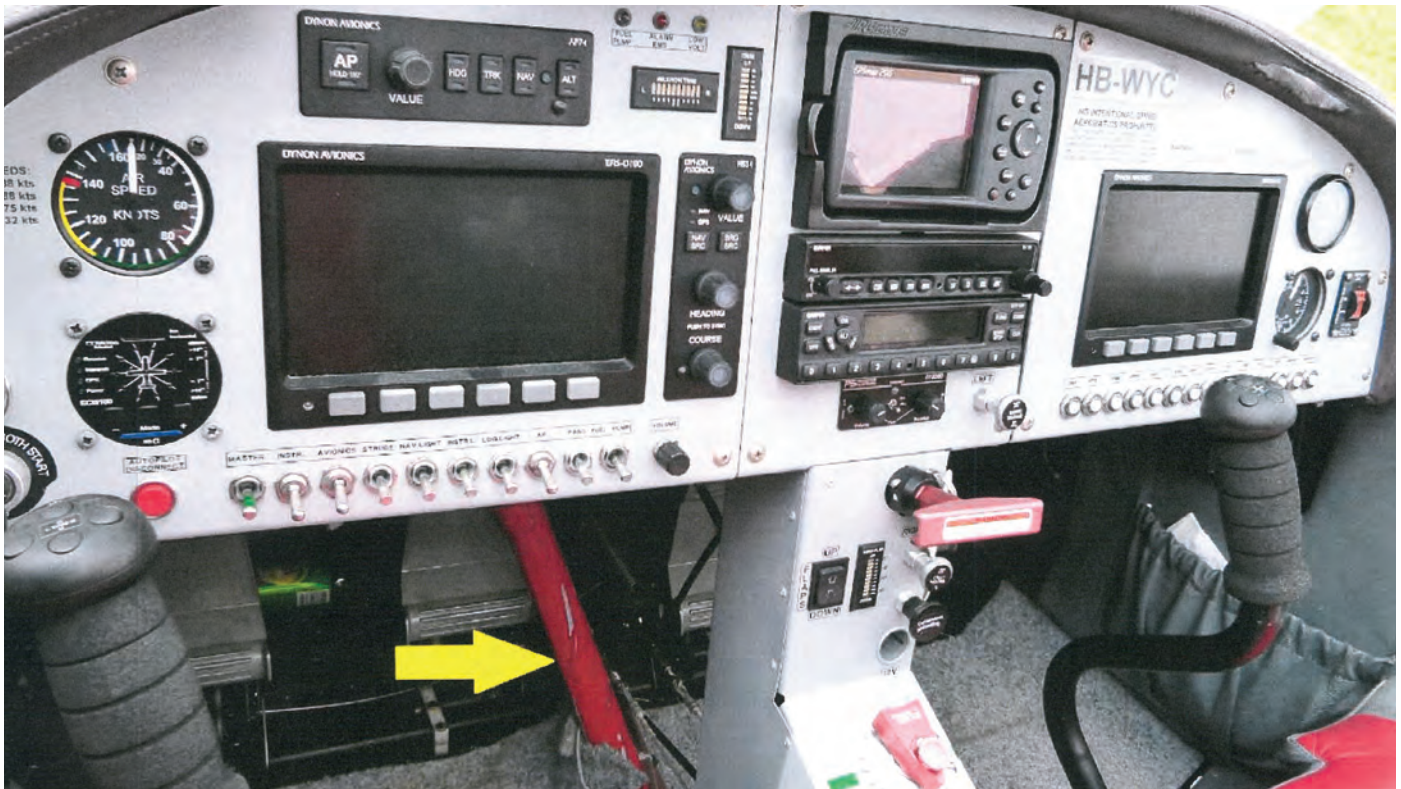
(Above) Whatever aircraft you fly, it's vitally important that its undercarriage is inspected before every flight, and a detailed inspection of the whole assembly is carried out regularly, as part of your Tailored Maintenance Schedule. Noseleg failures almost always involve extremely expensive repairs – firstly, there's the inevitable engine shock load inspection, then there's normally a new propeller, plus, of course, repairs to the lower forward fuselage structure, which, if you're very unlucky can include a firewall replacement.

There's perhaps an even more important reason to keep an eye on things – during this failure, the leg itself has broken through into the cockpit! As you can see, the part has ended up very close to the pilot's feet, which is potentially more life-changing than a dent in the bank balance. (Photo: Swiss TSB)
