Safety Spot  
By Malcolm McBride

# SEASONAL CHANGES, CUB RUDDERS, SENSENICH HUBS, EUROFOX TUG PEDALS & ROTAX VALVE PUSHRODS

## The latest LAA Engineering topics and investigations

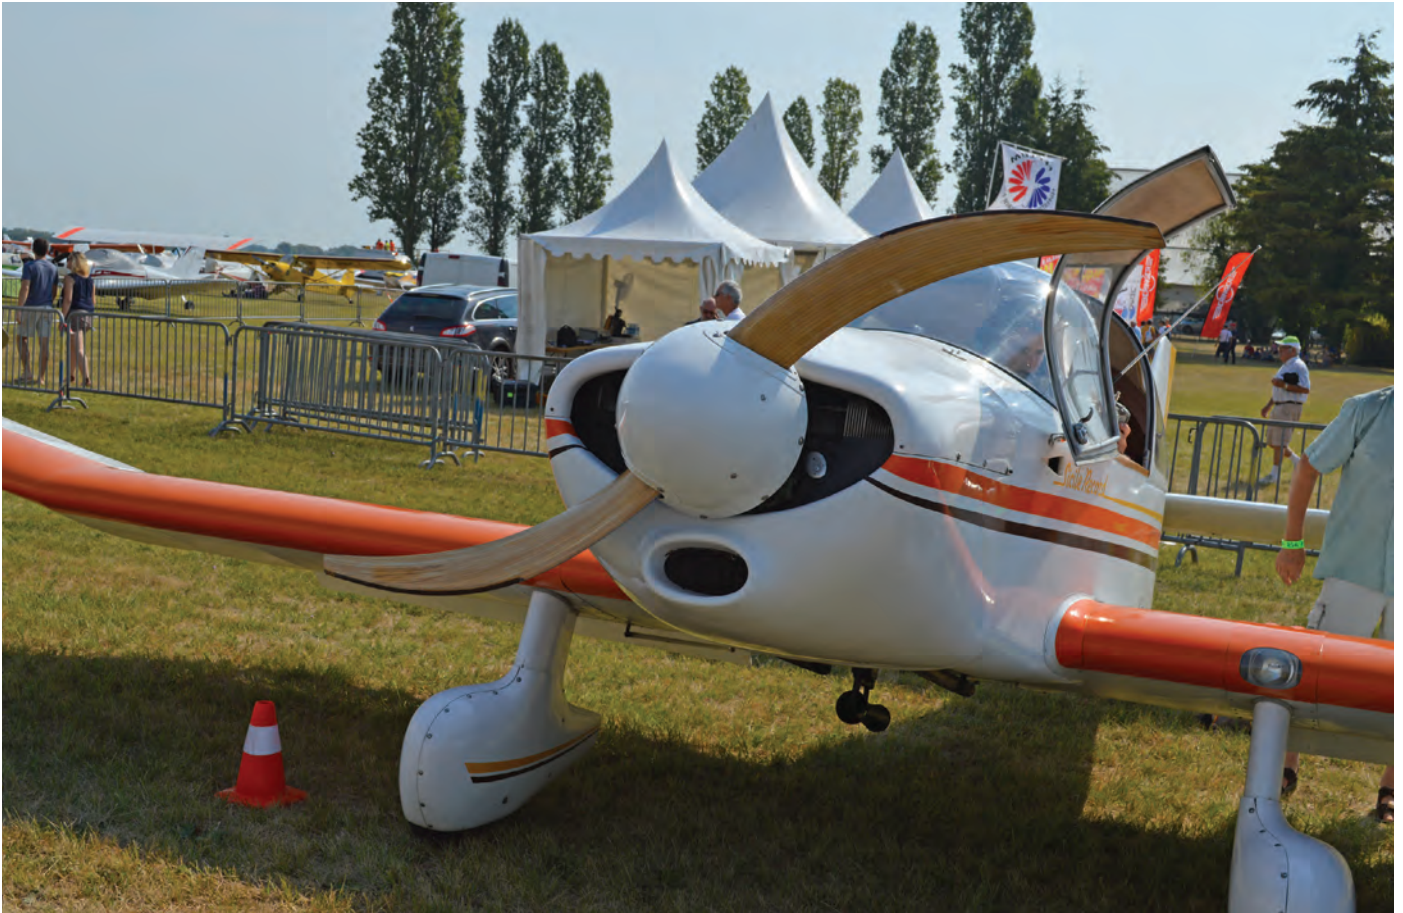
(Above) **Wooden propellers, like this impressive scimitar example, seen recently on a French Jodel at the RSA Rally at Brienne-le-Château, are susceptible to dimensional shifts as their moisture content changes with the seasons. It's imperative that owners ensure the prop bolt torques are checked seasonally, to make sure that looseness (leading to potential departure!) or over-tightness (leading to crushing) doesn't occur.** (Photo: Brian Hope)

The first reports we received concerned loosening wooden propellers, and consisted of 'What should we do?' type questions. The answer, naturally, is to re-torque the propeller to the hub – don't fly with an incorrectly tightened prop. The reason the propeller loosens is because as wood dries it shrinks. But be warned, if you've tightened your propeller during this long, dry spell, make sure that you don't leave it to become extra tight as the wood returns to its original size – what shrinks as moisture leaves swells when it returns. This growth can generate enormous pressures in attachments and crushed wood can result.

If you aren't going to fly during this seasonal change, and you have needed to re-torque your propeller because of shrinkage through the summer, then it wouldn't hurt to slacken the prop bolts off for a few days, to give it a chance to recover, and then re-torque 'by the book'. Naturally, if you do this, mark the aircraft

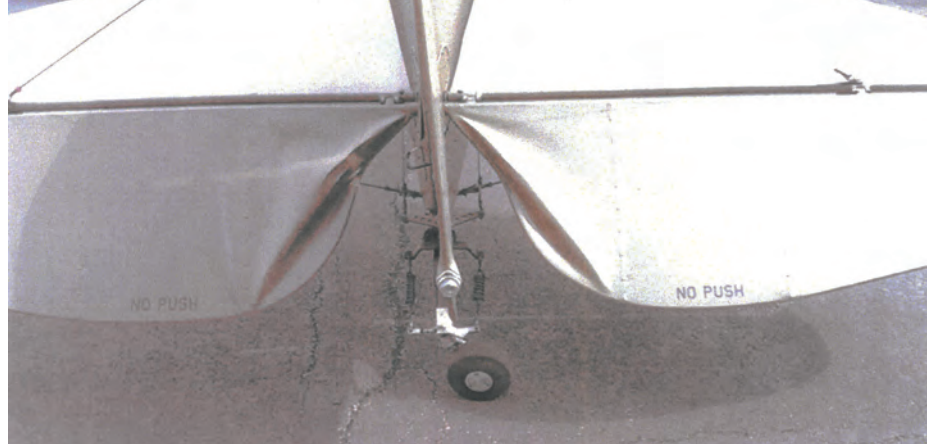
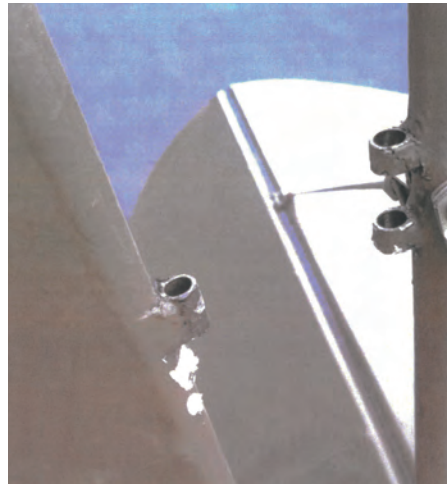
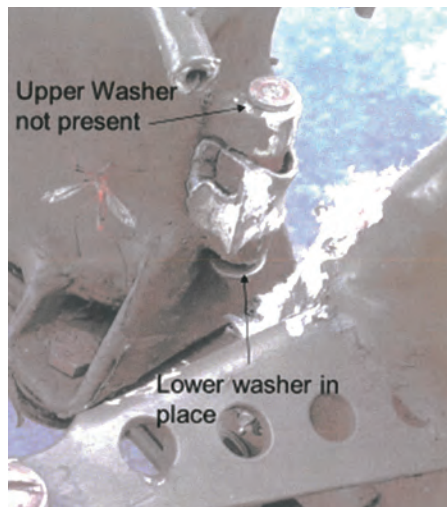
*'On inspection it was found that the top hinge pin and bearings were missing and that the lower hinge had failed under load, so the rudder was only held on the aircraft by the control cables. Both elevators were damaged on their inboard edges but had remained attached to the aircraft.'*

Looking at the photos herein, you'll notice that, in this incident, the hinge pin and its bushes appear to have slid out of their housings and simply dropped out. The diameter of the AN Clevis Pin's head is very close dimensionally to that of the outside

*(Above & left) While flying in the vicinity of Leeds East Airport, the pilot of a J3 Piper Cub started to feel a vibration through his rudder pedals, which was shortly followed by a bang and the aircraft pitching nose down. The throttle was closed and, with heavy stick forces, the aircraft was recovered back to level flight.*

*The Cub landed safely soon after, and these two pictures show the reason for the loss of control incident. As you can see, the rudder's top hinge assembly has come to pieces. That, in turn, allowed the top half of the rudder to oscillate violently in the oncoming airstream – the initial vibration felt through the pilot's feet – notice the side-to-side damage in the elevator. (Photos: Courtesy of UK AAIB)*

bushing. Therefore, should there be wear in the bush's support, the AN Clevis Pin's head could potentially slip through the tube. However, I'd be surprised if this has happened in short order – in other words, if the hinge pin and bushes have been sliding down through the hinge then there should've been a chance to spot this before the situation developed into an incident.

When we have the full facts about this incident, especially with regard to the Cub's maintenance history, we'll publish some inspection advice to LAA members with similar machines. One possibility to prevent a future occurrence like this, suggested by the UK AAIB Investigator involved, is to incorporate a washer under the AN Clevis Pin's head – a similar idea to the 'penny' washer used very frequently to prevent a complete control loss after the failure of a ball-end fitting.

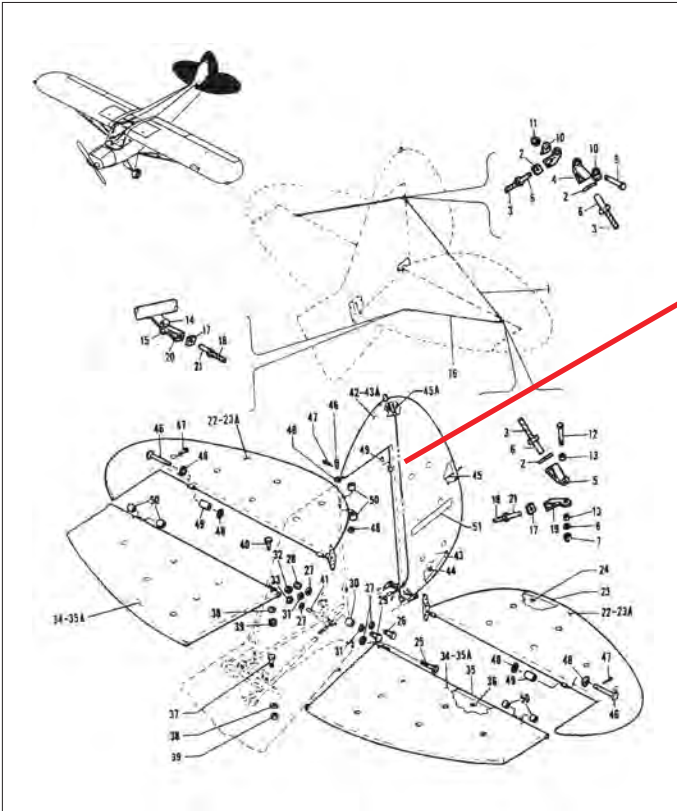
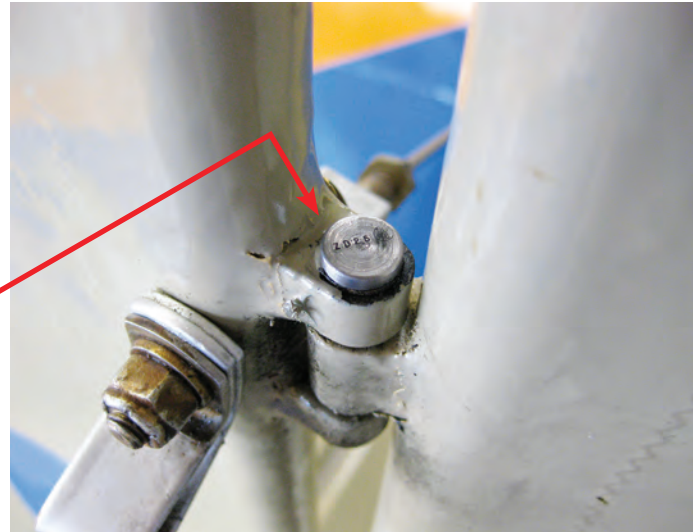
(Left & above) The rudder hinge pins on the Piper Cub series are generally quite straightforward mechanical types using an AN Clevis Pin. To avoid play, the pin is supported by bronze bushings, which are an interference fit in the hinge's supporting metal tube structure. The issue noted by the AAIB Inspector was that the outside diameter of the head of the AN Clevis Pin was dimensionally very close to that of the bushings. In other words, if interference-fit was lost for any reason in the bushes, the pin, with the bushes, could simply fall through the supporting tubes. (Photos: Piper Aircraft Corporation/Malcolm McBride)

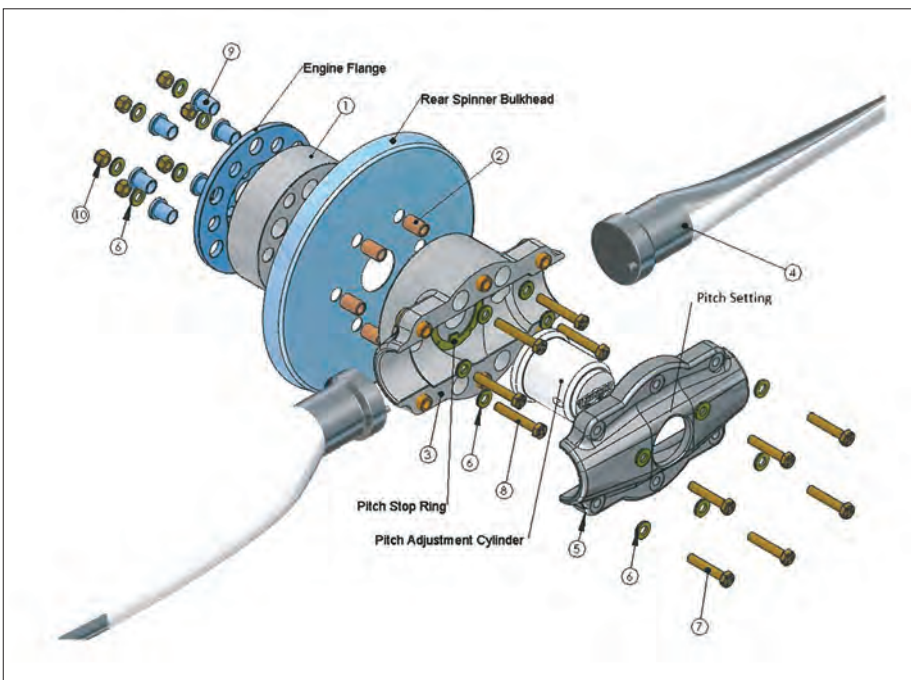
(Left) This picture shows the general arrangement of the two-blade, ground-adjustable Sensenich propeller. This type of prop is fitted to a number of aircraft in the LAA's fleet, including the Bristell NG5 Speed Wing, Van's RV-12, Groppo Trail, Europa, Jabiru J400 and CZAW SportCruiser.

A recent problem, highlighted by the manufacturer via a *Service Bulletin*, relates to cracking in the front half of the hub (item 5 in the picture) after a relatively low number of hours in service.

The cracking seen thus far is at an early stage but is very difficult to spot which is why the manufacturer is calling for the propeller to be dismantled. At the time of writing, we've had reports of two cracked hubs, both on aircraft fitted with the Jabiru engine, though I have little doubt that we'll see more.

The LAA has issued an *Airworthiness Information Leaflet (AIL)*, mandating the manufacturer's *Service Bulletin*, which required the hub to be dismantled and inspected for cracks before further flight, and thence after each fifty hours of flight (or annually, whichever comes first). This *AIL* can be accessed via the currently issued *Alert*, which is in the Engineering section of the LAA website.

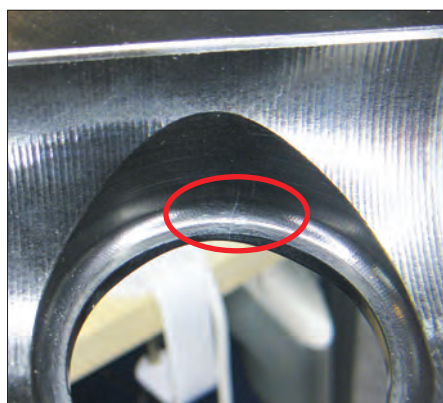
(Left) LAA Flyer, Chris Knight, who owns a Bristell NG5 Speed Wing, carried out checks on the Sensenich propeller fitted to his aircraft after receiving a copy of the *AIL* through the post. Chris' aircraft had completed 104 hours since build and this picture shows the 'very difficult to spot' crack (marked). It's necessary to completely dismantle the propeller assembly to inspect this rather safety-critical part. If a crack is found, Sensenich will replace the item free of charge, though the required checks remain in place until an upgraded component (now available, but at a cost) is fitted.

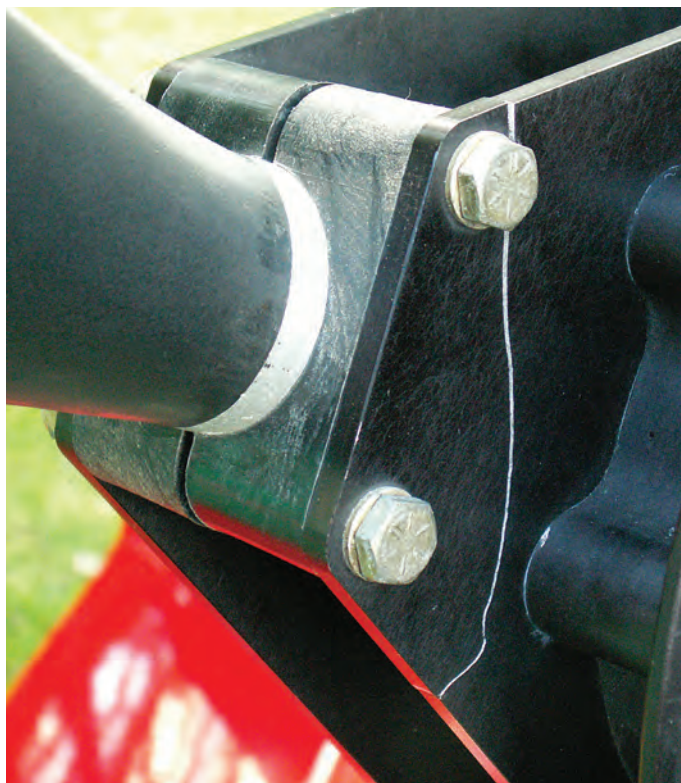
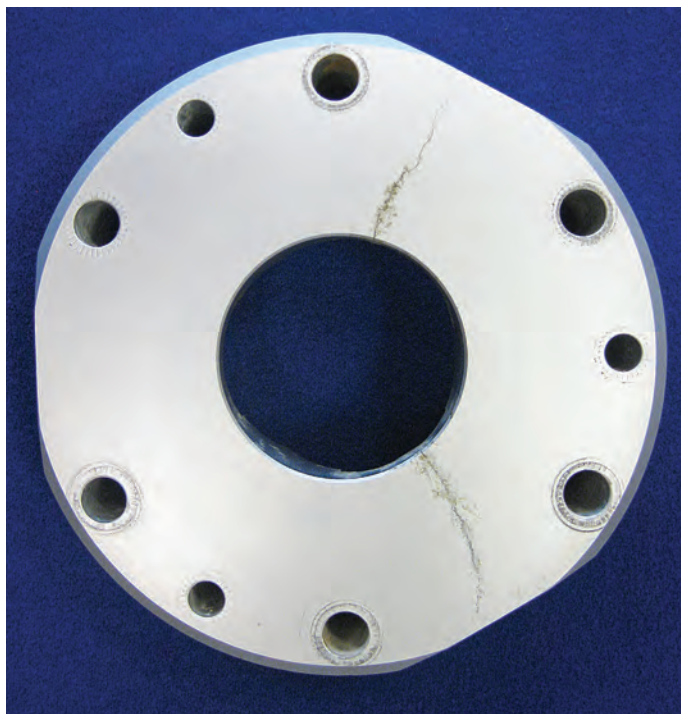
*(Left & below)*  
**It's absolutely essential that propellers are regularly checked, preferably before every flight – after all, they're working pretty hard most of the time while you're enjoying the joys of flight! Variable-pitch propeller hubs do suffer from problems, which are generally associated with high-cycle fatigue. That's particularly the case if a prop is unbalanced, either aerodynamically, because the blades are incorrectly set, or mechanically, due to differences in blade mass.**

**These pictures illustrate two problems that involve differently designed propeller hubs seen by LAA members over recent years, either of which undoubtedly would've led to an in-flight blade loss, had the failed part continued in service.**

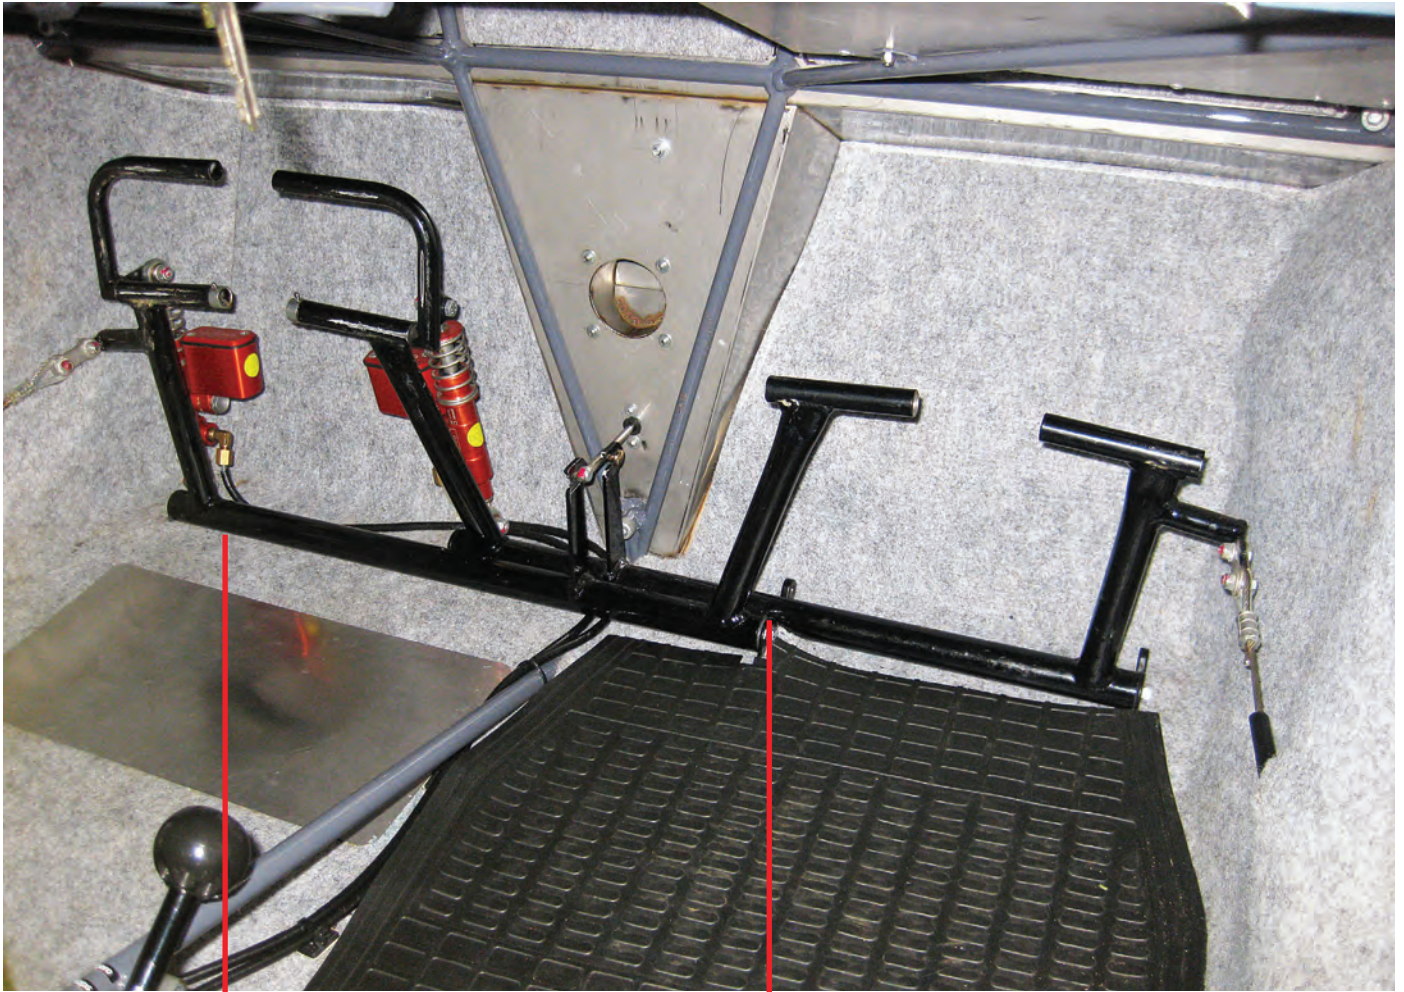
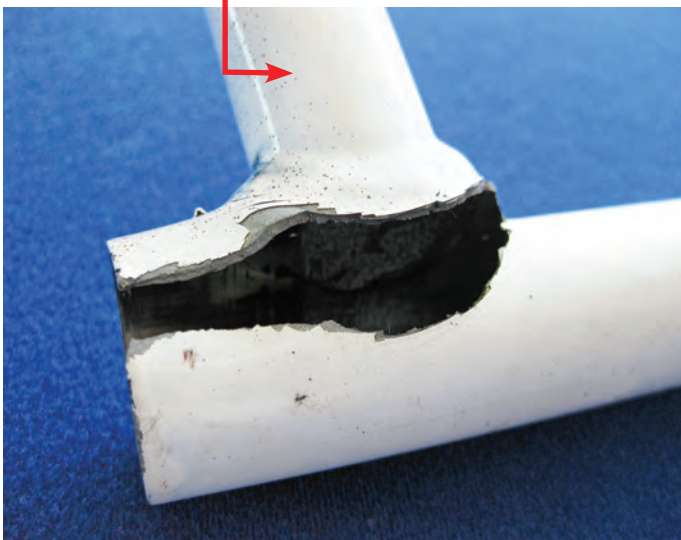
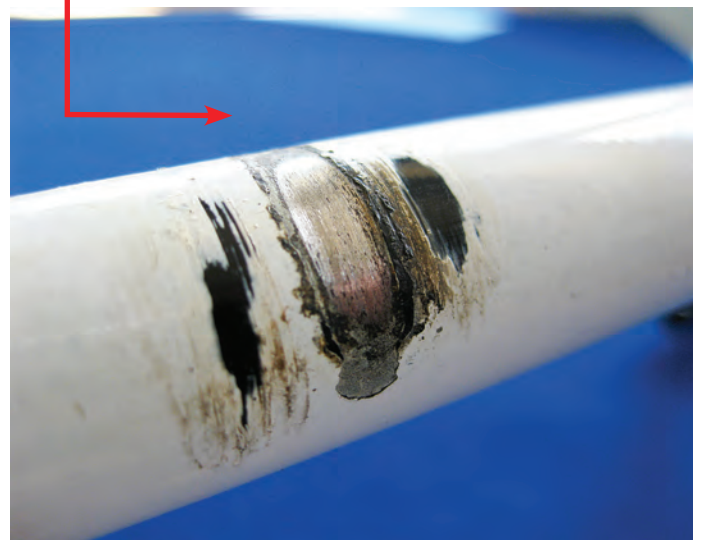
(Above) Scottish LAA Inspector Hamish Hamilton first alerted us that the EuroFOX glider tug operated by the Scottish Gliding Centre at Portmoak had suffered a rudder pedal failure during taxiing. Now, it has to be said that this four-year-old aircraft has had a pretty hard life, having accrued over 850hr in the short time since build. Perhaps more importantly, because Portmoak is situated on a ridge, many of these flights can be very short indeed – calculations made by the Tugmaster revealed that there had been 5,767 flights at the time of the rudder pedal failure. Yes, calculators out, that's just under nine minutes per flight!

These three pictures show the rudder pedal assembly as fitted into a locally-based EuroFOX and a close-up of the failed rudder pedal as delivered to LAA Engineering HQ here at Turweston. The failed pedal is obvious but, as a secondary issue, the wear point in the torque tube is a feature in the removed component which wasn't expected, and something to look out for during checks on other EuroFOX aircraft.

Although this aircraft has flown a lot more than the average LAA machine of the same vintage, we're fairly sure that this failure isn't the result of low-cycle fatigue, understrength design or a poorly-welded joint during manufacture – you'll have to read the full text if you want to know why we think this part failed! (Photos: Malcolm McBride)

After dissecting the part and studying the fracture face, carefully measuring the weld depth along the weld boundary, and generally inspecting the assembly for quality, no clue could be seen as to the reason for failure in this rudder pedal. In all appearance, this looked like a pure overload failure. It's true to say that anything can be broken by an excessive force, though after many thousand operations we struggled to see when (or why) it might've been applied. Certainly, the pilot in command at the time of the failure wasn't doing anything unusual – 'Honest, guv, it just came off in me 'ands', or perhaps in this case, '...me feet.'

So, could this be the 'smoking gun' incident that led to an eventual failure? Well, possibly. Certainly this was a close shave for the pilot of the tug and it would be very unusual for a pilot in these circumstances not to react physically. It does seem strange that the aircraft had operated successfully a further nineteen or so hours between the airborne incident and the eventual parts failure. Incidentally, those nineteen hours total represents 119 further launches, which is a measure of just how much work is being done by these little craft.

Of course, part of any failure analysis has to be a conclusion, which should always offer advice geared towards the prevention of future incidents. It's quite likely that the pilot in the aerotow event braced hard against the pedal when he realised that a ground impact was possible and, therefore, a material overstress is also quite likely. It'd seem this overstress wasn't sufficient to actually completely break the part, although it became sufficiently weakened that, during further operation, it slowly failed as a cyclic overload. Perhaps a lesson here is that, after any extraordinary event, a full inspection of the aircraft should be made, rather like a heavy landing check or an over-speed inspection.

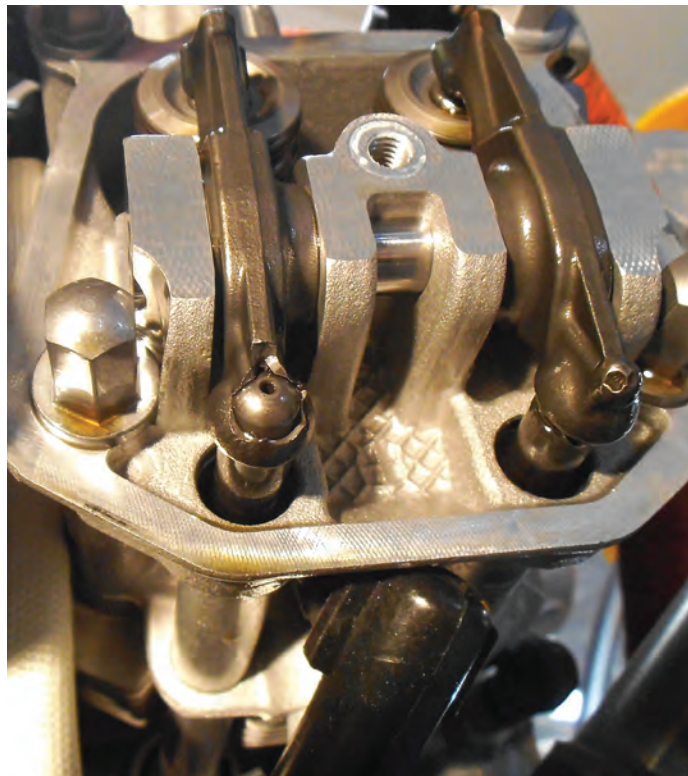
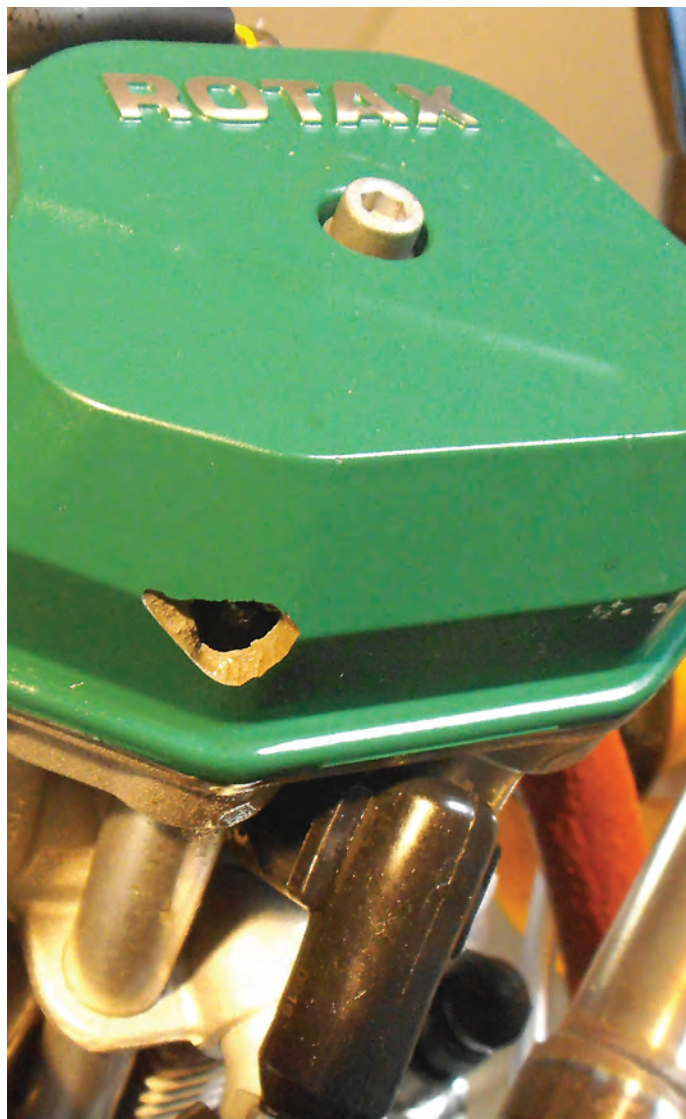
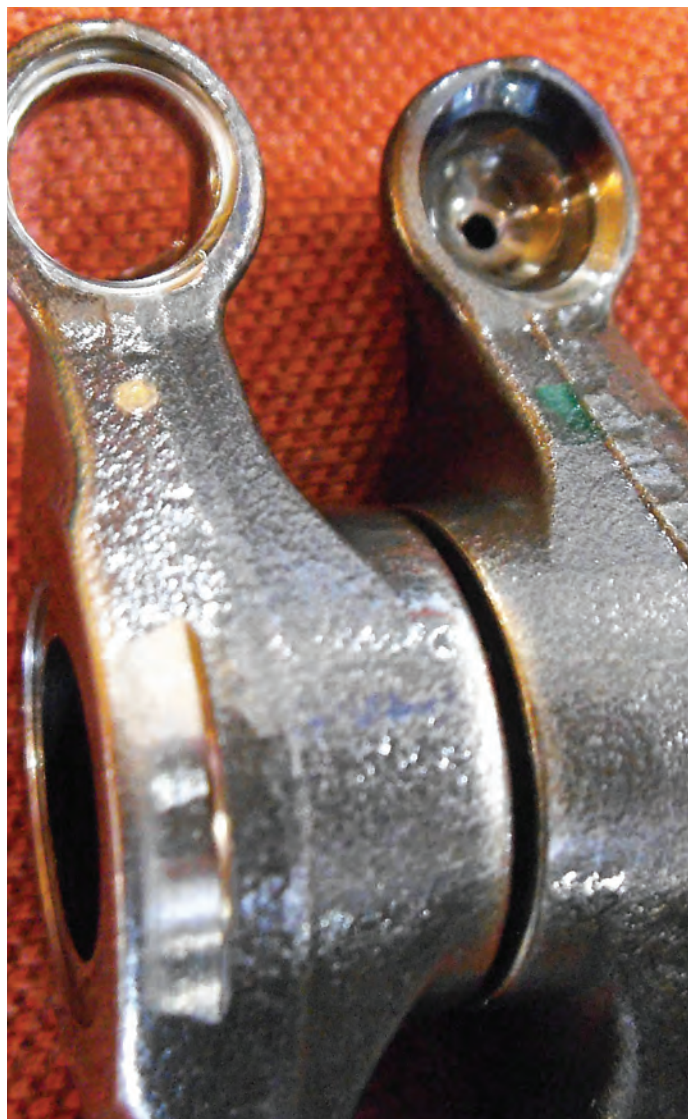
The problem, identified quickly by the manufacturer, was that a batch of pushrods had been made with an incorrect surface finish which, if left in service, could wear rapidly. The manufacturer's *SB* on the subject was subsequently mandated, with an EASA AD, which was quickly followed by a *Mandatory Permit Directive (MPD)* issued by the UK CAA. The LAA issued an *Alert* offering access to these documents and discussed the issue in *Safety Spot (LA, May 2018)*. With all this publicity, you'd imagine that anybody who was even only slightly associated with the 912/914 engine would've heard about the issue – well, apparently not!

These three pictures show the sequence of failures, caused because of faulty pushrods, which led to LAA Eurofox flyer, Eddie Scougall, and his wife having to divert back into Le Touquet-Côte d'Opale Airport after noticing falling oil pressure. Naturally, Eddie and his wife were thankful that there was a dry place to land nearby – after all, a couple of days earlier they'd flown across the Channel.

Initially, we thought that the failed pushrod wore quickly through the rocker itself. We aren't sure what actually punched a hole in the rocker cover – it could've been bits from the failed components or, more likely in my view, the end of the pushrod itself impacting the inside of the cover. (Photos: Eddie Scougall)
