# Safety Spot

Airworthiness Information Leaflets, corrosion and Chobert rivets

### Auster AOP.9 – Aileron Pushrod Failure

### Luscombe Tailplanes – Corrosion Inspection Update

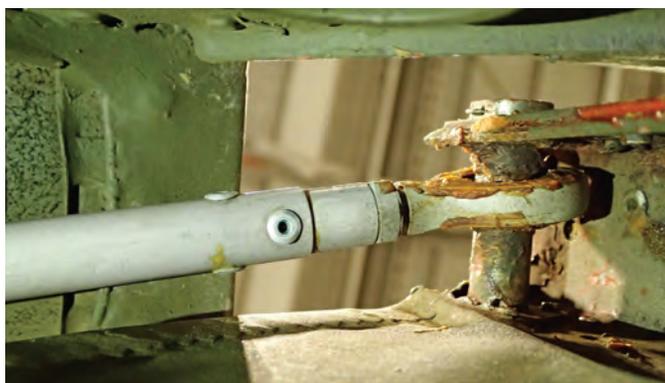
**Above** The aileron rod-end fitting as it can be seen in the aircraft; note that the rod-end bearing, which has a female thread, screws into a threaded fitting riveted into an aluminium tube. The other end is slightly different in that the rod-end isn't adjustable, though it uses rivets in the same way to attach the rod end to the tube. The aileron's final adjustment can be made by lengthening or shortening the component by, naturally, winding the rod-end in or out. This particular rod-end comes from an aircraft that's not actually on the LAA fleet and, unusually, uses Chobert rivets to secure the end fitting to the tube. These rivets wouldn't pass muster though because the sealing/strengthening pins weren't fitted when the rod was manufactured.

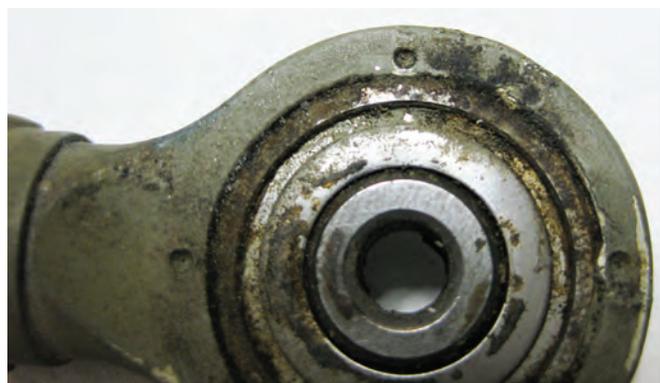
**Above** Because the AOP9 never actually held a Type Certificate, it does mean that if the aircraft's manufacturer goes out of business there's no single source of technical information. When we were first alerted by the AAIB's investigator that they'd discovered a potential 'hidden' failure mode in a failed pop rivet and suggested that we let other AOP9 owners know about it, we thought that an Auster Modification, (AM 995), involving this part meant that the failed rod actually had the obsolete type of rivets. Later research showed that Auster Mod 995 principally involved the method of securing the bearing into the housing – this is a pre-mod example where the rivet is held in place by a centre punch mark; the modification changed this to 'staking' and this is normally done with a cold chisel. **Photo: Malcolm McBride**

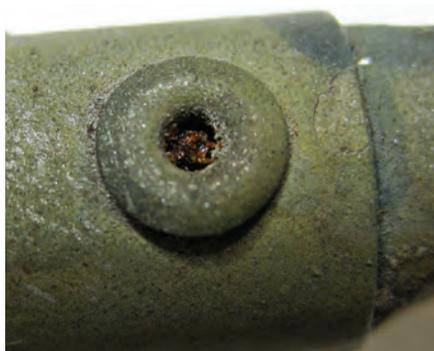
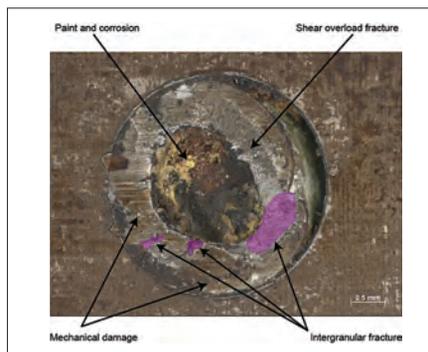
**Above and right** The picture on the left shows an example of the rivet used before the manufacturers changed the specification. We think this is an aluminium break-stem blind rivet because there is still so much of the stem itself showing (though very badly corroded), but it could be a Chobert rivet with an incorrect (mild steel) pin. The picture on the right shows us what all the fuss is about – in the view of the metallurgist who looked at the failed rivet, the failure mode showed clear evidence of Stress Corrosion Cracking (SCC), a failure mode that is very difficult, sometimes impossible, to see from an inspection point of view.

The reason for the urgency was that it had been discovered, during an AAIB fatal accident investigation involving an AOP.9, that some of the rivets securing the rod-end fittings to the rods themselves had failed. Very worryingly, the mode of failure included a

metallurgical problem that hadn't been seen before in blind rivets – Stress Corrosion Cracking (SCC).

The rivets that had failed were of a type that appeared on the Auster drawings to have been replaced by stronger rivets of a type less prone to SCC, suggesting that the aircraft might have been fitted with obsolete parts. Though it couldn't be completely ruled out, the accident investigation team don't think that the failure of the rivets was in any way causative of the accident, but rather, as a result of the ground impact – though a finding like this cannot, of course, be ignored.

Having identified a means of carrying out the upgrade, we issued the latest issue of the AIL, which requires all the early pop rivets to be replaced with the later specification pinned Choberts before the Permit Renewal inspection of 2020. Because the Chobert riveting process requires special tooling and some considerable expertise, we've only approved one inspector thus far to carry out the process; he's had to jump through a few hoops, including writing up-to-date process sheets and sending in a number of test pieces. Fortunately, we've been able to locate a source of enough of these Chobert rivets to service the UK fleet of AOP.9 pushrods. Such is the wonder of the LAA system, this inspector will be modifying the aileron control rods on an 'at cost basis', which is marvellous.

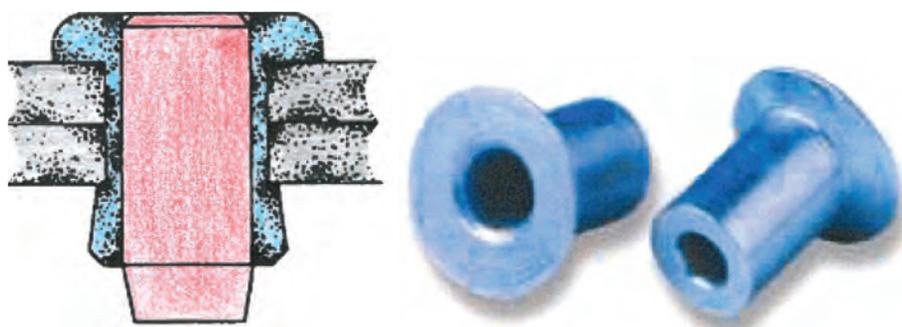
**Above, middle and right** Chobert rivets were first used when GB was gearing-up aircraft production in the decade before WWII. Unlike a break-stem or a break-head blind rivet, the forming mandrel isn't part of the rivet itself, instead it's the business end of the rivet gun. This method of rivet forming meant that a number of unformed rivet 'blanks' could be loaded onto the mandrel, speeding up the production process no end. Should the rivet need to take an increased shear load, or the hole left after the mandrel had done its work needed to be sealed, then pins could be impressed into the rivet (red in sketch), though they then needed to be ground flush to finish the job off. Each rivet 'set' needed three and a half turns of the handle on the rivet gun. I read somewhere that production fitters were expected to set over two thousand rivets a day – no wonder the chap in the advert shown had biceps to die for!

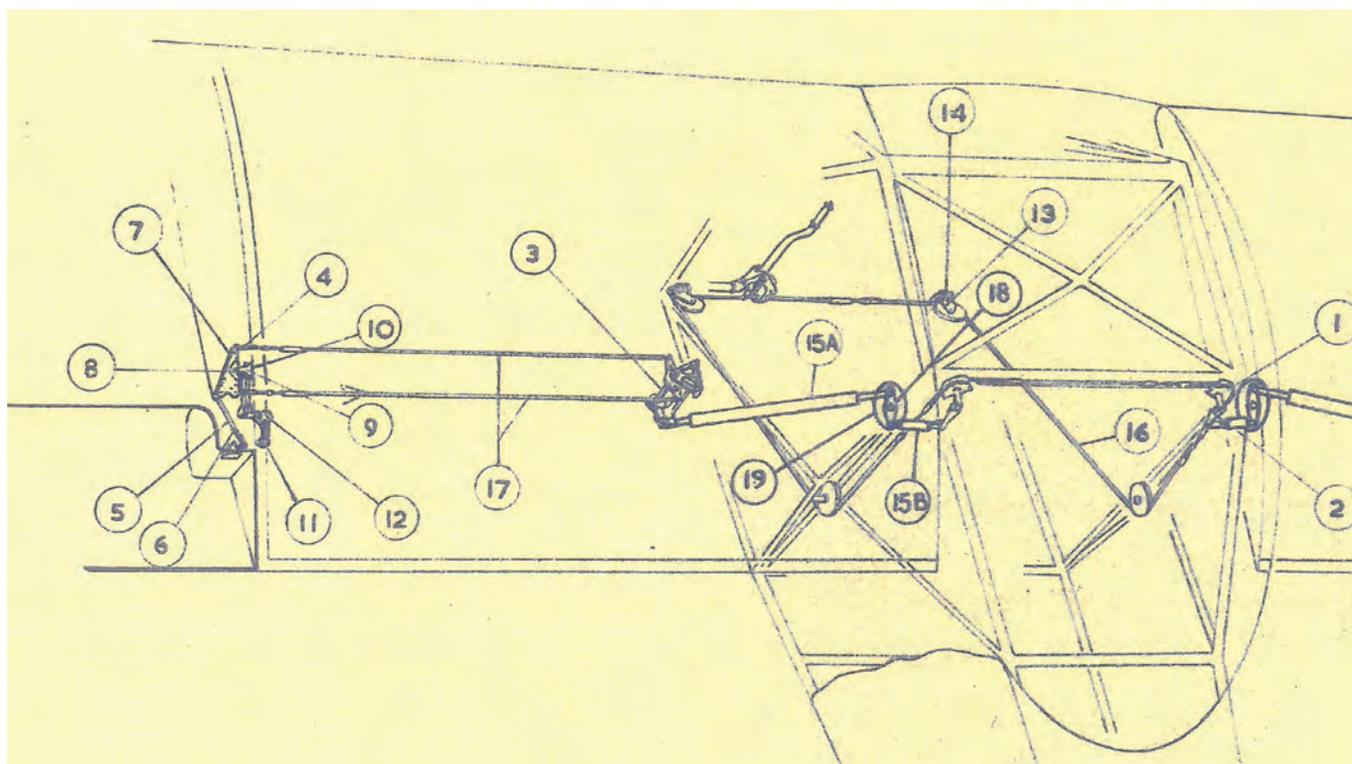
**Above** This drawing shows the aileron control mechanism on the AOP.9, which has a mixture of cables and push-pull rods. One reason why we were so concerned about the report that an aileron operating rod had failed was because the rivets in this particular component (Item 5) were particularly highly stressed. We think that Auster engineers recognised this and that's why they 'upped' the rivet strength quite considerably towards the end of the production run of the type. We surveyed the rest of the system and the safety factors of the rods in the rest of the circuits were all much better – though advice to owners suggests a complete inspection of the flight control systems on the AOP.9 regularly as part of the aircraft's TMS. **Photo: LAA Library**

– that's the factor of safety above the minimum strength to operate in-service safely – was only really small in the aileron control rod. It's a tiny rod driving a great big metal aileron. Certainly, the day to day flight loads would be small but the Auster technical office's work had revealed that the rivets would be 'on the limit' if the pilot were to apply all his strength to the stick to attempt to free a jammed control. The other rods in the AOP.9 system were all checked and they all had reasonable safety factors built in.

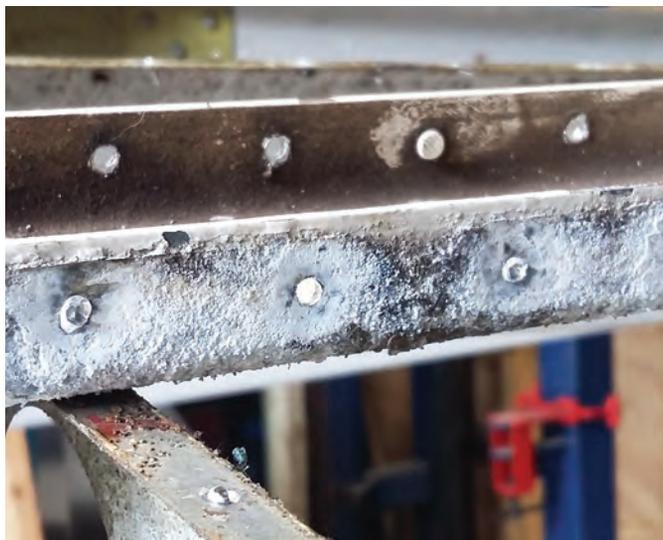
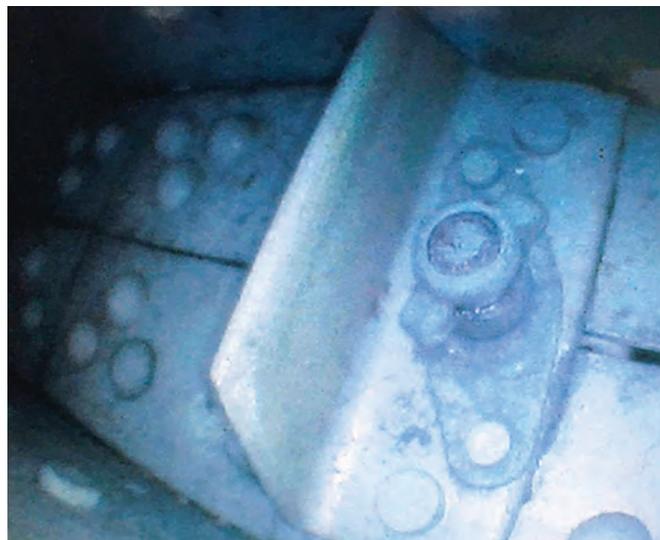
**Above and right** It's difficult to spot corrosion hidden between riveted joints or buried within a closed structure. The picture on the left shows 'between skins' corrosion in an aluminium structure; the problem here is that the rivets used are only 3/32in diameter aluminium alloy rivets, so there's not much meat in them to start with. This type of corrosion in a structure is relatively easy to spot as rivets that become loose tend to move, and this movement causes 'smoking' – easily spottable on the surface, or 'quilting' at the joint – this is where the aluminium oxide, which occupies more space than the donor aluminium, causes a raised area-in between the rivets. The picture on the right shows that the inside structure of a Luscombe tailplane can be checked with even a relatively inexpensive (and readily available) inspection borescope system.

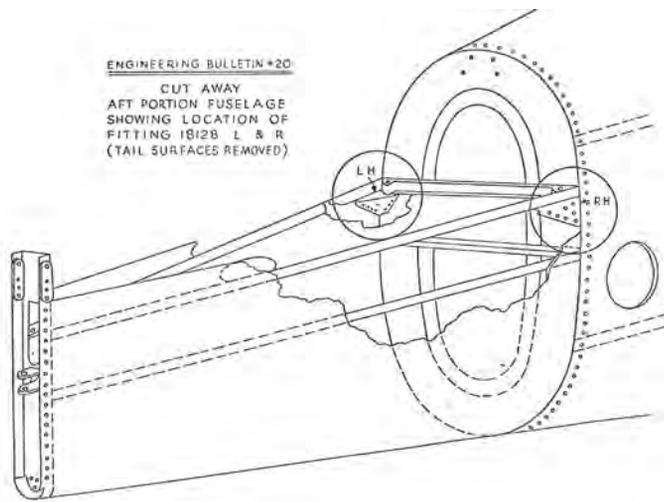
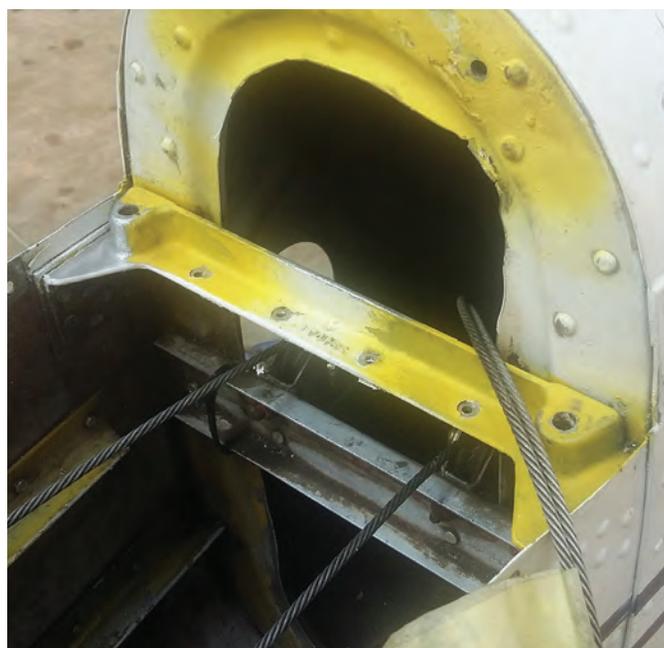
**Top** It turns out that cracking in the structural members of the Luscombe empennage has been an issue for many years, and that the design has been changed three times to date. The sketch shows the original forward attachment fitting, these were formed triangular steel plates riveted to the structure against which the tailplane was bolted. Between the plates (not shown) was a cast aluminium spreader bar. **Above** The second iteration of the design was a one-piece cast aluminium spreader. **Photos:** LAA Library/Owen Watts.

**Above, middle and right** The first picture (left) shows the cracking problems found in the initial design of the forward tailplane attachment. The second picture (middle) shows casting cracks in the second type of fitting. The third picture (right) shows the latest 'all steel' design. LAA Engineering, in the AIL covering the required inspection intervals, requires these attachment brackets to be checked every six years as part of the aircraft's Tailored Maintenance schedule (TMS). **Photos:** Jane Barrett/Peter Bentley/Owen Watts.

That said, because of an ongoing issue involving cracking of the forward tailplane attachment bracket, owners are going to have to remove the tailplane to check this component. Naturally, it's much easier to carry out a borescope inspection with these flight control

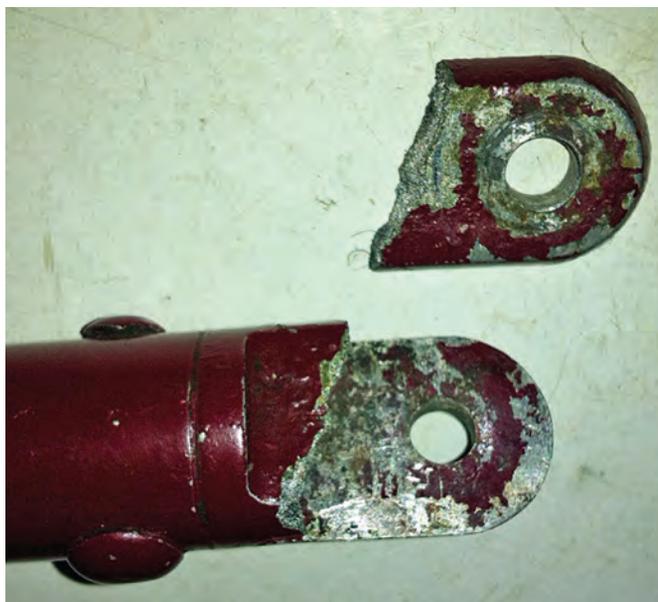
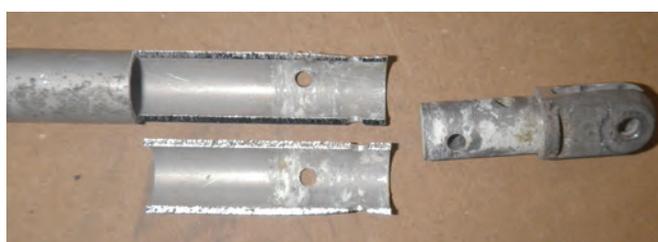
**Above** LAA Engineering has just issued an AIL requiring annual checks of the strut end fittings that support the tailplane on all Murphy Rebel aircraft. This follows a finding by Murphy Aircraft that there has been a failure of a strut rod-end, and they promptly issued a Service Bulletin letting owners know of the issue and that they had designed an upgraded strut, which is retrofittable. There are a number of reasons why a strut like this might fail, the first being overload because of an impact – Murphy think this to be the reason for the most recent failure. The second reason is of course, corrosion. Corrosion pitting in a highly loaded item will almost certainly lead to cracks forming within the structure of the part. The third reason is poor fitting practice; fork-ends like this must not be 'pinched' together when bolted onto the fuselage structure – if they are then stresses are created in the material's structure which could lead to premature failure .... especially if corrosion is also present in the surface.

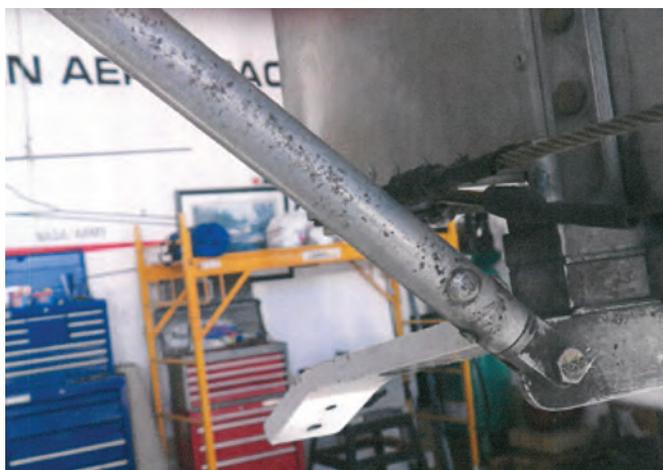
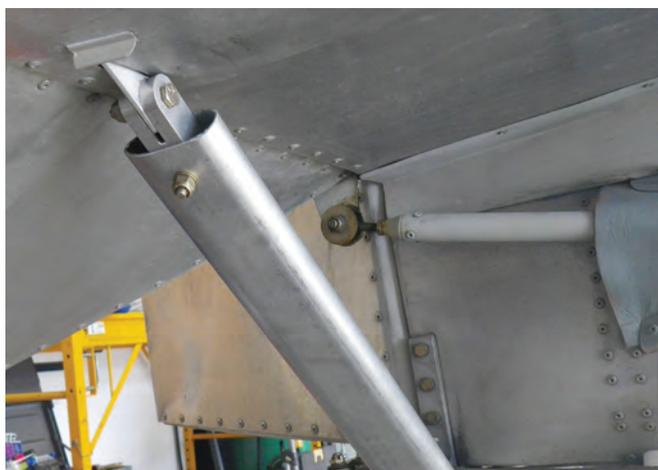
**Above and right** The picture on the left from Murphy Aircraft shows the original tailplane strut design with deep corrosion pits in the structure of the strut tube itself, and the strut's end-fitting. Of course, owners and inspectors must adopt a zero-tolerance attitude to corrosion on all aircraft structural components. These old struts are now subject to an annual strip inspection. The picture on the right shows Murphy's latest strut design, we think that this is actually a prototype as the fitting kit, available from Murphy Aircraft, uses rivets to attach the strut's end fitting to the strut itself. Either way, this manufacturer's upgrade is accepted by LAA Engineering and its fitment relieves owners of the strip part of the annual inspection. **Photos: Murphy Aircraft**

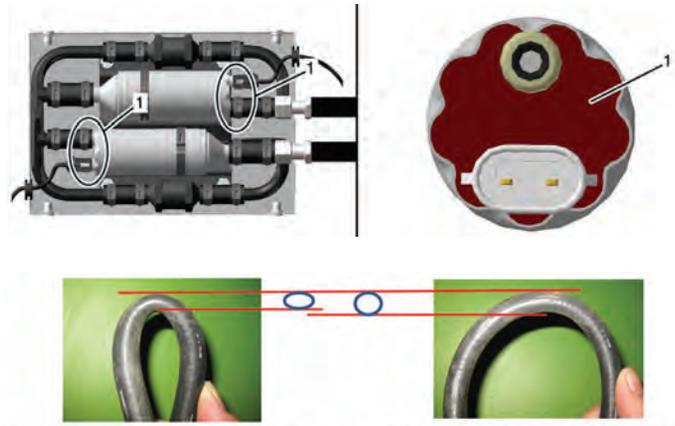
An example of a pipe with not enough of a radius – note the reduction in the pipe's internal diameter (and therefore area).

This example shows the bare minimum radius necessary to ensure no kinking in this type of rubber fuel pipe – note, different pipes will require a different minimum bend radius.
