Safety Spot

Malcolm McBride considers issues concerning Jodel DR100 series seat frame fracture problems and Alpi pioneer primary control attachment points

Jodel DR-100 (Series) – Front Seat Failure

Alpi Pioneer Aircraft (All Marks) Security of Primary Control Attachment Points G-LLOY Elevator Stop / Pioneer Centre Elevator Hinge

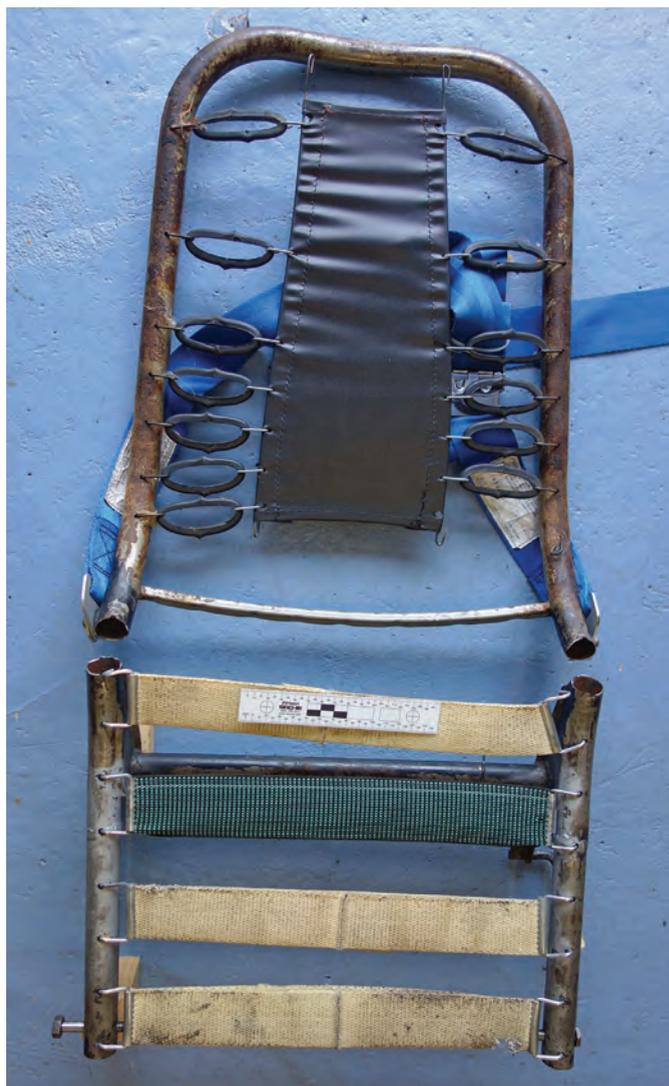
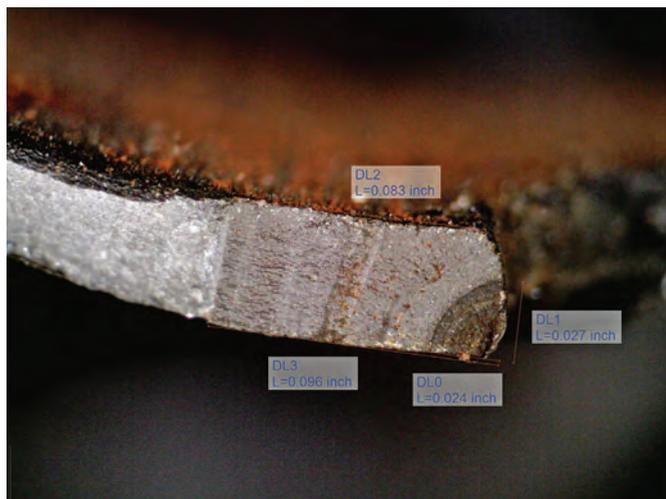
Left and above Les Bent, technical lead of the eight man 'Prestwick Tailwheel Group' sent us a very thorough technical report into a recent failure of the pilot's seat on their aircraft. The pictures have been taken from this report. This aircraft was purchased by the group in 2018, though it has been operating under an LAA administered Permit to Fly since 2008 when it joined our Jodel fleet after operating under a French C of A.

Jodel DR-100 series aircraft owners will know that there is a repetitive annual inspection requirement on these front seat frames and, though the Prestwick team accept that the crack was probably there at the last inspection point some 96 flying hours ago, it wasn't spotted. The picture on the left shows where the seat back has parted completely from the base, a close look in the failure area shows that, as has been seen in the past, the cracking starts from the hole where the seat-base strap's attaching hook enters the base-frame. The picture shows the fracture face – as you may be able to see, there's clear evidence that, once it had started, it has progressed steadily to failure over time. **Photos: Les Bent et al.**

The report details a partial failure of the pilot's seat on their aircraft; you can see from the fracture face picture taken by a group member, that the failure has been progressive and probably occurred over a substantial period of time. In this case it looks like the start of the crack was in a known weak point, where the tubular base-frame has been drilled to accept a hook. This hook holds the flexible webbing that forms seat's base, in place and when you think about it, this area of the seat is quite highly stressed. Firstly, that hook has to take a good portion of the pilot's weight, which is changing all the time as the aircraft bounces around in turbulence. Then, secondly, the hole acts as a stress concentrator as the forces through the tube have to negotiate the space. Then there's the position of this particular attachment, so thirdly, it has to resist a fair amount of bending force imparted via the seat back.

It's this third issue that I think causes the most trouble, and not necessarily because of flight loads. When you get into the aircraft, you probably lean on the seat back as you feed your feet into their respective places in the airframe, applying quite a force on that lower bend. Then there's the act of seat adjustment itself – LAA Inspector Nick Sibley, one of the professional aeronautical engineers in this group, suggests that the pivoted seat has been 'a bit stiff' for a while,

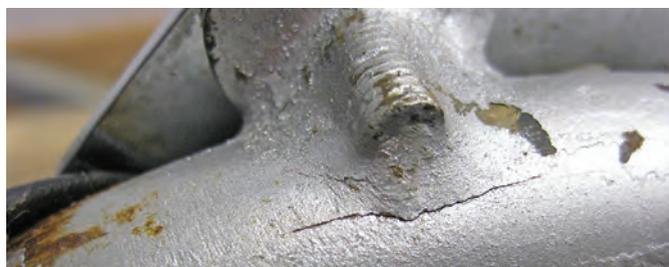
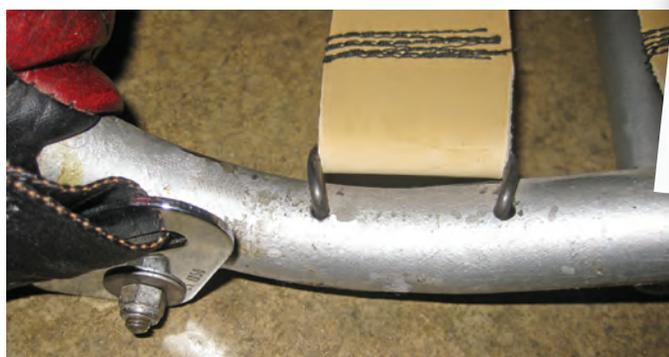
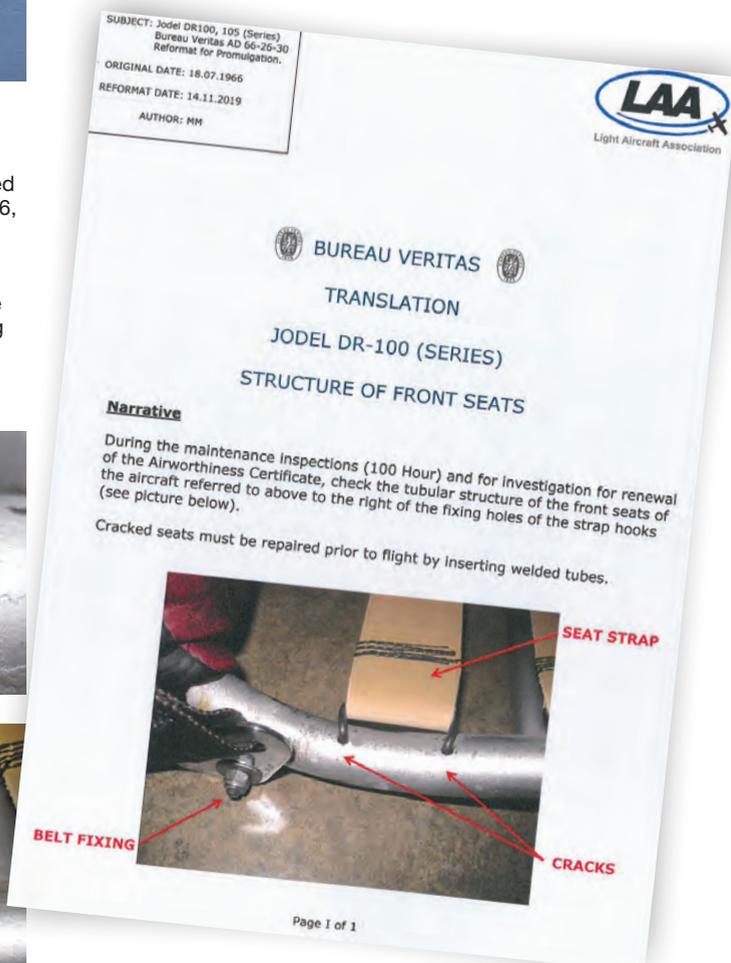
Below and right The pictures below emphasise the need for inspecting engineers to widen their problem-search area when completing an AD specified inspection. Right shows the re-formatted Bureau Veritas (BV) AD, issued by the French authorities in July 1966, which shows clearly, though initially as a sketch, where to look for cracking during the annual inspection. Whilst taking a picture of a DR-1050 seat, so that I could update the original BV, I noticed that, though the inspection of this seat had been recently carried out, the seat was starting to fail an inch or two away from the usual cracking point (top right). The bottom picture shows the crack forming alongside the heat affected zone at the lap-strap attachment point. **Photo: Malcolm McBride**

We found a 1050 that we could use, and I set about the photographic exercise. The owner assured us that the seat had very recently been inspected against AD 66-26-30, and that the seat frame was in good order. He was very happy to use his seat as a model. When we peeled back the seat fabric to take the picture, sure enough, there was no cracking emanating from the said hole. Then I looked around a bit and found that, just a few inches away, the frame was cracked.

Then, to cap it all, the seat belt is connected to a welded fitting, which will affect the material structure surrounding the weld – engineers call this area the heat-affected zone. This newly found crack runs alongside the weld, perhaps confirming the relevance of this last issue.

Of course, this means that we'll have to back up the AD with further clarification of the original crack location from way back when, and issue an Airworthiness Information Leaflet (AIL) getting owners to expand their inspection to cover the whole area of this bottom bend as affected in the crack. Incidentally, we noted that this newly discovered crack has a similar triple whammy route cause; as well as the problem of the forces in the bend, this point also attached the lap-strap, so there's the added forces applied as a pilot yanks him or herself closer to the rudder pedals before they set off.

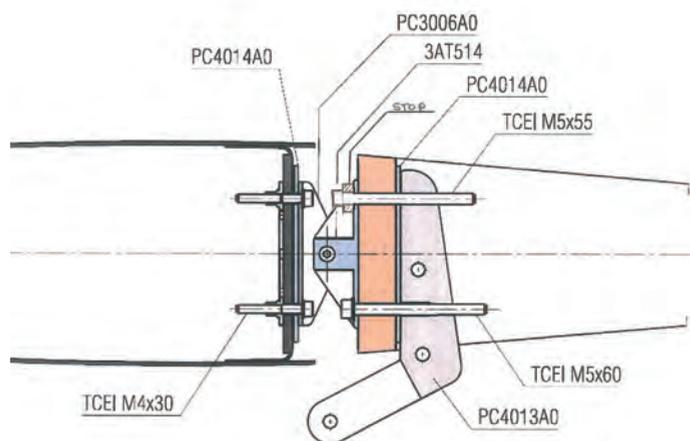
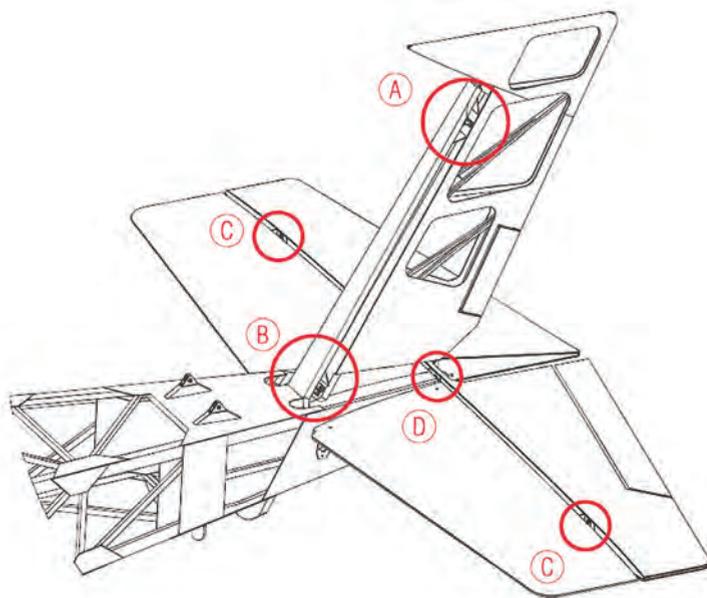
Above Earlier this year the pilot of an Alpi Pioneer 300 found himself being confronted by an inflight control restriction affecting the elevator; initially he noticed that, during the landing, he wasn't able to properly flare – after a successful go-around he realised that the elevator had limited up movement. Scary enough but it also seemed like his nose-up authority appeared to be actually reducing. After a 'rather fast' landing on the long runway at Tatenhill he investigated the cause, which was found to be a loosening hinge attachment bolt, so began an enquiry into how a primary flight control could fail in this potentially fatal way. The sketch on the right shows the attaching hinge point on the Alpi Pioneer's empennage, the sketch on the left shows the cross-sectional detail of the centre elevator hinge. Note that the elevator range limiting stop consists of a bush fitted over the top elevator hinge attachment; the bush's length is adjusted to vary the length of the attachment bolt which, as the bolt's head acts as the primary stop, determines the range of elevator travel. This was the bolt that came loose – the primary reason for it become so was that the bolt, though it had a locking 'star' washer in the system, wasn't positively locked. **Photo: Alpi Aviation**

One other point, technically the most important here, is that a rivnut isn't a locking nut. Because of this, Alpi call up star washers to be fitted between the cap-bolt head and the hinge structure. The problem here is that much of the Pioneer aircraft is wood, and wood grows and shrinks according to the prevailing environmental conditions. As we now know, when the wood shrinks the star washers can become loose, leaving the cap-bolt free to turn.

We know that, on the incident flight involving an elevator control restriction, that this unwinding of the stop bolt must have occurred quite quickly, probably over the course of one or two flights, perhaps a couple of hours. Of course, this isn't an acceptable situation either in the short and long term, after all we don't ever want to lose an aircraft through critical bolts coming undone.

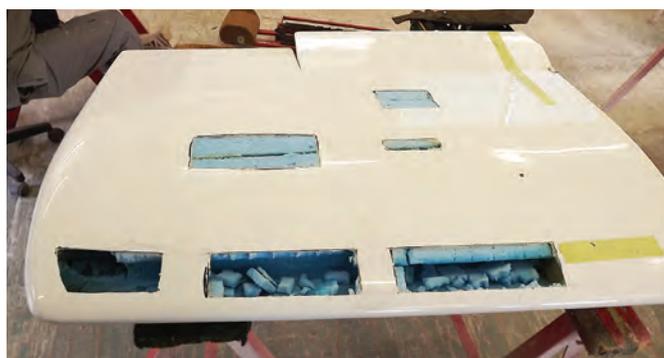
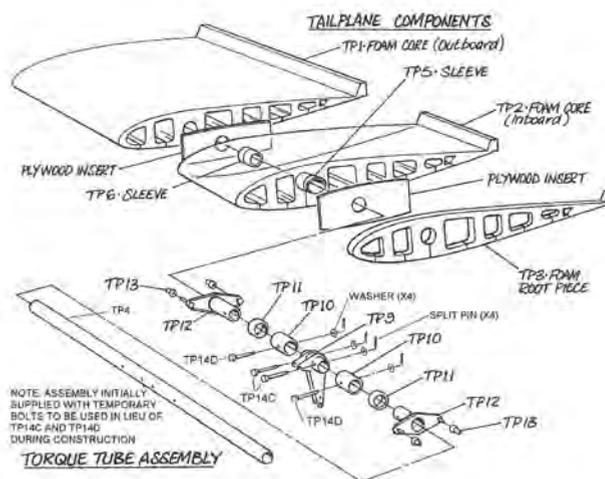
Top and above Back at the beginning of this year, I featured a picture showing what looked like either 'time-related' degradation or chemical, possibly fume damage, of the foam that forms the core of a Europa tailplane. There are a number of sport aircraft designs that employ this 'fibreglass over a foam core' construction method, so you can see why we might be worried by the picture above left. I wrote at the time: *The picture above shows one half of a Europa all-moving tailplane which 'didn't feel quite right' to the engineer during an inspection. It's pretty drastic when it's thought necessary to cut into a structure to see whether all's well within. In this case, for reasons yet to be established, clearly all was not well – the foam core material has degraded and become soft and spongy.*

Well, after a 'behind the scenes' investigation led by LAA Inspector Alan Thorne, Europa, Rutan Varieze/Long-Ez and a variety of other types can breathe a sigh of relief – the degradation damage found on this tailplane was almost certainly caused by mechanical means. The sketch on the right shows the build-up of the Europa tailplane and, as you can see, there is quite a bit of air space inside the tailplane and, unless there's some kind of ventilation, in some circumstances this air can become trapped inside the structure. Naturally, as the aircraft climbs, the outside pressure will drop and, as the pressure inside the tailplane's cavities remains the same, there will be a force trying to expand the tailplane. This tailplane was found not to have had any ventilation holes incorporated when built. **Photos: Bob McLean / Europa Aircraft Ltd.**
