The latest LAA Engineering topics and investigations By **Malcolm McBride**

Safety Spot

Seat belts, defective control systems and the importance of inspections

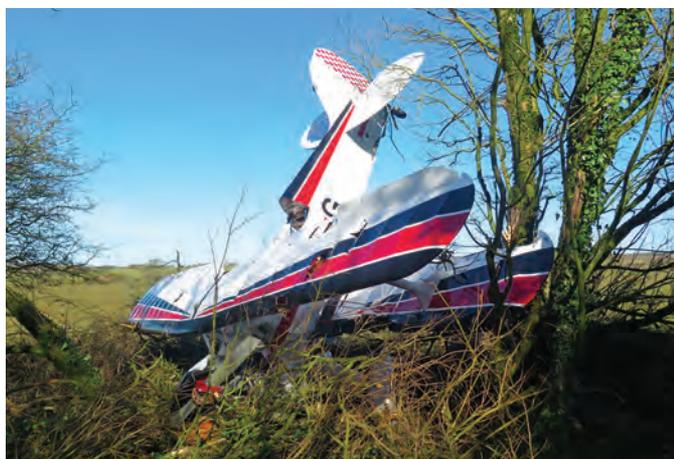
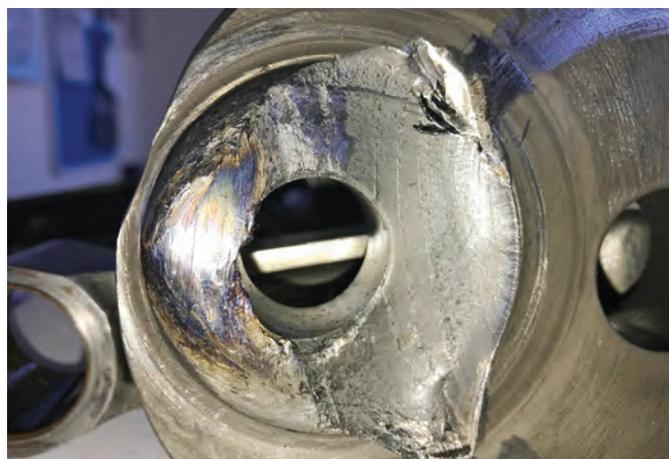
Above A sudden engine failure can happen to any pilot at any time and, when it does, it always comes as a shock. This Steen Skybolt had recently been imported from the US by experienced flyer, LAA'er Nigel Musgrave. Before the aircraft was put up for sale it had been completely refurbished and the engine overhauled – the aircraft had also flown for 12 or so hours in the States without any sign of trouble – what could possibly go wrong? The picture on the right shows the fracture face from the broken crankshaft which stopped the engine rather suddenly on its second flight in the UK ... I haven't put these pictures in as a prelude to a discussion about engines breaking, rather, Nigel is walking around quite happily today because the five-point 'Hooker' harness in his aircraft held him tight after he made less than a perfect job of the following arrival on terra firma.

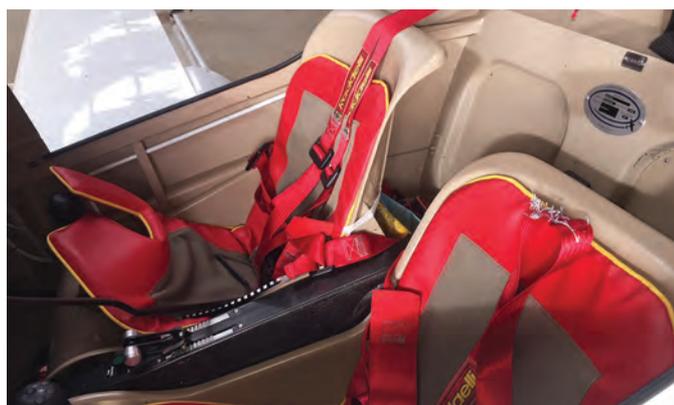
Above The cockpit of a Dyn Aero MCR-01 ULC microlight aircraft shortly after coming to an abrupt stop. At the time of the incident the aircraft was being flown solo and, if you look at the picture closely, you can see that the shoulder harness has failed during the impact. Because of this restraint failure the pilot suffered some heavy bruising on his forehead, though fortunately no long-term damage was done. Because the passenger restraint matched the pilot's perfectly in terms of design, age and condition we decided to carry out some pull tests to see just how strong the belt was. A seat belt on a sports aircraft is required to support the pilot in a 9G acceleration event – to put things into perspective though, if you wanted to drive a racing car then the minimum strength for the seat belts is a 40G acceleration!

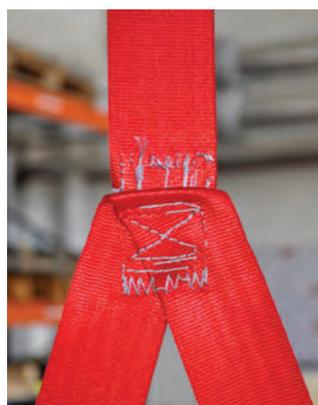
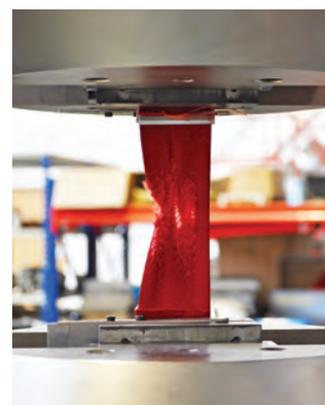
Above We tested the seat belts from the MCR-01 in two ways – the picture on the left shows the pull test on the stitching, we were concerned that this 'fold-over' design has a built in weakness as when loaded there would be a natural tendency for the belt to twist, which would focus the load into small areas of the belt. As it turned out, the stitching failed at about 2.5 times the required strength, so no worries here. We also wanted to find out just how strong the belt material actually was and took up an offer of help from Cranfield University. The picture on the right shows the test of the belt itself at the point of complete failure. Interestingly, even though this belt had been in service for at least 10 years, this pull-test showed that it was six times stronger than it needed to be to meet certification rules.

Very happily, especially as we were dealing with a restraint system type that actually failed during an incident, the stitching held together right up to an applied load of 766kgf (1,690lb), just about two-and-a-half times stronger than the minimum requirements (the belt on its own did even better, reaching some six times the requirement).

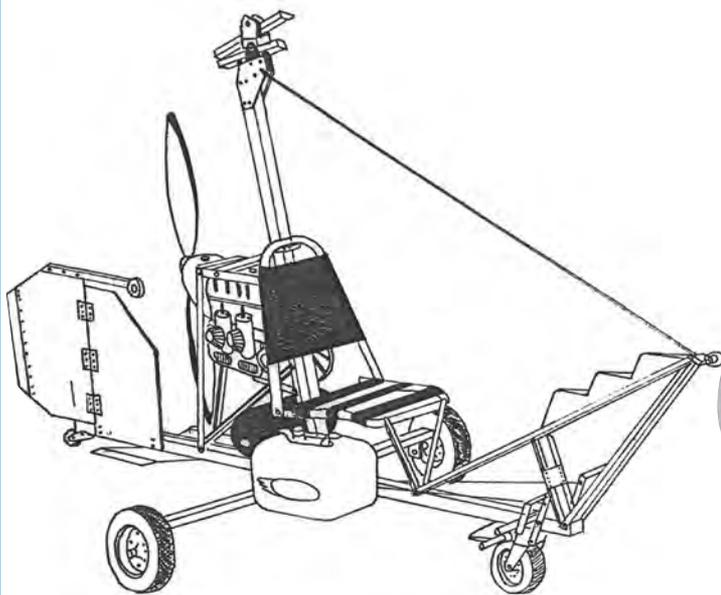
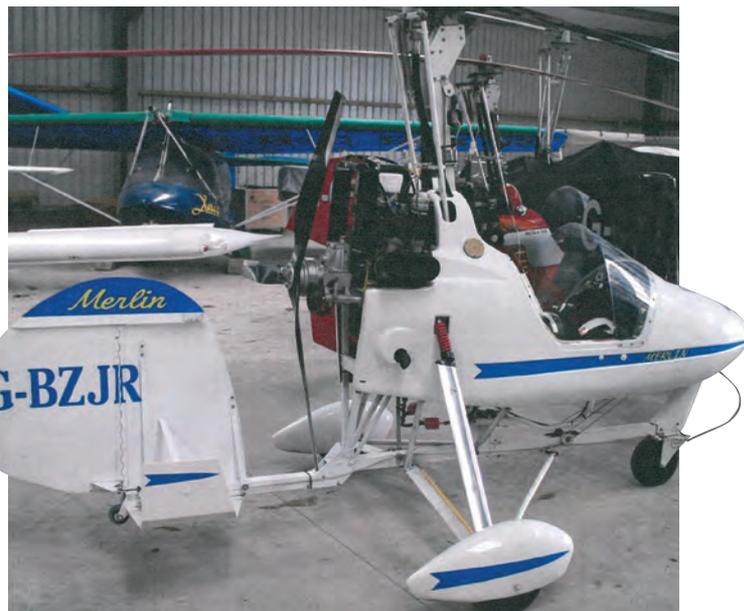
Above Of course, it is really important in any design that all parts can be inspected fully from time to time. The nature of aircraft structures means that this can sometimes be quite difficult; sometimes extraordinary measures need to be taken to gain access to hidden areas of an aircraft's structure. The inspection of aircraft harnesses is an often overlooked aspect of a pre-flight inspection – though, when you think about it, it shouldn't be. Pictured left is an original Bensen gyroplane as first designed ... Certainly, this type of open structure allows for full access for inspection. The lap strap, not shown in this sketch, is attached to the structure behind the base of the pilot's seat.

The picture on the right shows Jim Montgomerie's re-design ... A slicker looking piece of kit but, because the fuel tanks are squeezed into the fibreglass cockpit fairing behind the seat, it's impossible to inspect the lap strap and it's attachment. **Photos: LAA Library/Derek Heley**

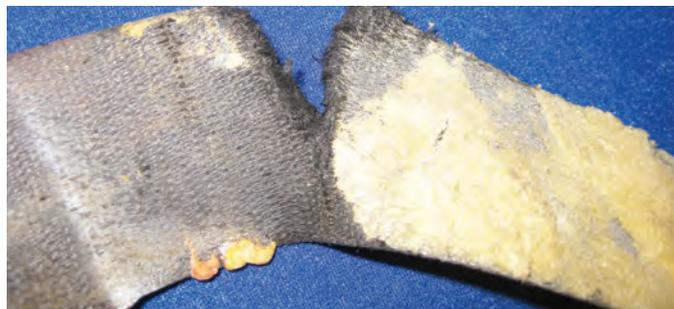
Left LAA'er Kevin O'Neill decided that it would be an interesting project to completely refurbish a rather sad looking Montgomerie-Bensen B8 gyroplane and set about stripping the aircraft back to its component parts. He dropped into the engineering office here at Turweston with an envelope containing the lap strap as he found it. We have since issued an Airworthiness Information Leaflet (LAA/AIL/ MOD/G01A/003 Issue 1) requiring all Montgomerie-Bensen owners to gain visual access to the lap strap's connection to the structure on their aircraft. As you can see, this belt wouldn't have been much use if called upon to hold a pilot secure in the aircraft – being bounced out of any seat in an aircraft is a scary enough thought – but in an autogyro with all that whizziness going on just above your head, it doesn't bear thinking about. **Photo: Malcolm McBride**

Still on the subject of harnesses, LAA Engineering was recently made aware that there might be a bit of an inspection issue with some of our Montgomerie-Bensen gyroplanes, as the connection of the harness with the fuselage structure (frame) of the gyro is completely hidden in this design by the fuel tank contained in the cockpit fairing. We've issued a 'before next flight' Airworthiness Alert requiring owners to gain access to this connection, and you can see what was found during a complete refurbish in the associated pictures – scary stuff.

The pictures (page 46) showing the failed seat belt found during a deep strip of a Montgomerie-Benson Gyroplane serve, as already mentioned, as a good example of what might be found lurking in the shadows. Clearly if this belt had been asked to perform in anger it wouldn't have been able to cope.

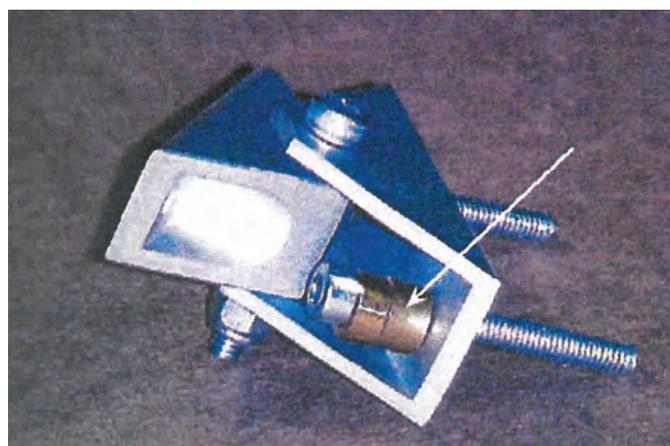
Above Recently, the pilot of an Alpi Pioneer P300 noticed that his landings were becoming faster and faster. Initially he thought that this might be due to the crosswind that was in any event making things a bit tricky, though thinking about it he realised that this couldn't be the case. He decided to take a look at the elevator control horn and set about removing the tail cone. He was shocked to find that the top hinge attachment bolt was slowly winding its way out and, because this bolt acts as the primary elevator stop, the elevator's range of movement was considerably reduced. The sketch on the left shows the general arrangement of this hinge and the picture on the right shows the hinge itself; notice the brass spacers which are filed to get the correct movement. **Photo: Alpi Engineering.**

Mike reports that from the cockpit, the controls felt normal, though after removing the fibreglass tail-cone the cause of the elevator's upward restriction could easily be seen – the top centre hinge attaching bolt, which acts as a limit stop for the elevator, had come loose and was winding out.

Had the bolt wound itself out much further it is possible, perhaps likely, that pitch control could have been restricted to the point where the aircraft went into an unrecoverable dive.

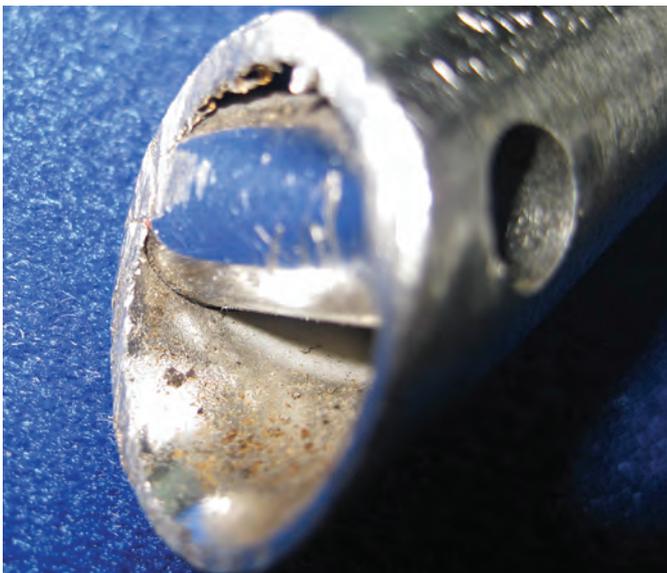
Above, Here's a picture of the end of a pitch control rod taken from an LAA administered RotorSport MT03 gyroplane which had been in service for some years. I think that the problems with this component don't need explaining, though it might be worth pointing out that there's no bush protruding from the tube to support a bearing area (and that the bush itself is only just supported). Had there been an extreme control event, perhaps a blade sail, then it's possible that this connection would have failed. Never assume that just because something's been fitted, that it's OK. A pre-flight inspection is all about making absolutely certain that the aircraft that you are about to fly is absolutely, without question, up to the job. **Photo: Malcolm McBride**

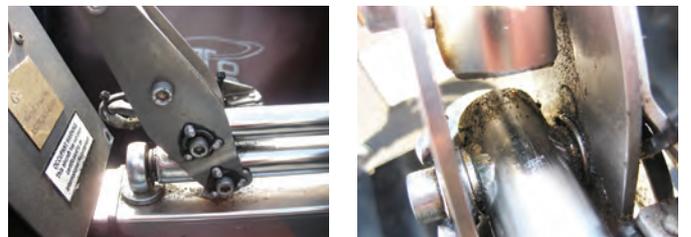
Above It pays to be critical during a pre-flight inspection – don't be frightened to question whether something is OK or not OK. Even if it looks like it's part of a manufacturer fit. The pictures show a close-up view of the front control stick on a RotorSport MTO-3 gyroplane. Note that the plate which is attached to the base of the stick is attached to two steel tubes, one above the other. These tubes form part of the primary control system, the bottom tube rotates left and right, and controls roll input, it also acts as a pivot for the pitch control rod above. The picture, right, is what you should be seeing during your pre-flight – notice that there's plenty of material at the end of the tube, the area looks tidy and there's nothing to obstruct this moving connection. **Photo: Malcolm McBride**
