# Safety Spot

This month Malcolm McBride stresses the importance of thorough inspection – it's not just ticking a box!

## Inspection: It's not just ticking a box

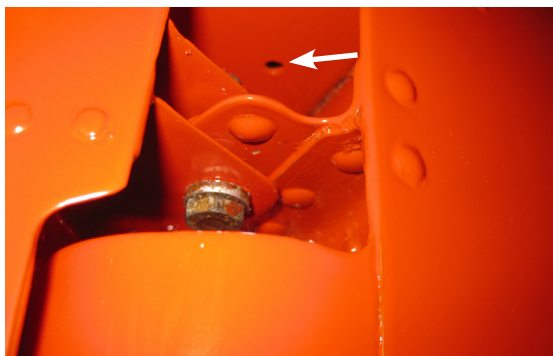
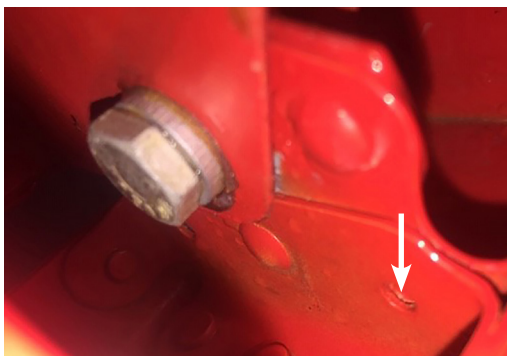
'Hats off' to LAA Inspector Nick Stone for spotting an only half-completed hinge replacement job, quite probably, many years and perhaps hundreds of 'inspections' after the job was first completed. Nick emailed: *Hello Malcolm, Good to speak the other day, it reminded me that I was going to send you a picture of the starboard elevator (both outer brackets) on an SAL Bulldog. It is an odd one but may affect other Bulldogs in service.*

*On inspection, I found that rivets from the elevator support brackets were missing. Further investigation revealed that, at some time in the past, the split elevator on the starboard side had been changed (during RAF service). To remove the bearing assembly from elevator, this has to be taken apart.*

*Potentially, with the rivets missing, the structure may be compromised, more so with two of the three retaining brackets missing rivets. To resolve the issue, after consulting DH Support at Duxford, A113 bolts have now been fitted in the vacant holes and, naturally, checked to ensure no movement has been restricted, or there's any clash with structure. It was felt that replacing the rivets could potentially cause damage, so bolts were substituted. Best wishes, Nick Stone.*

**Left** 'Now you see it – Now you don't (1)'. Inspecting an aircraft to ensure that it's fit for flight takes skill and experience; a quick glance will never be enough to establish whether something is OK or not OK. Would you have noticed the missing rivet in this Bulldog elevator hinge? **Photos: Malcolm McBride/Nick Stone**

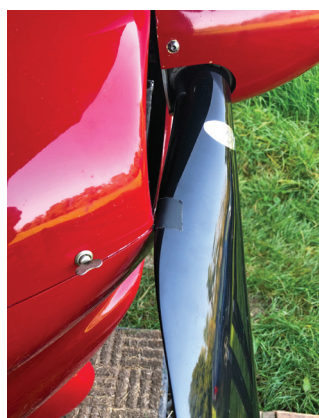
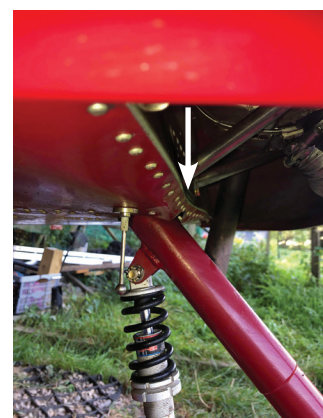
**Above** When Foxbat flyer, David Howell, carried out his pre-flight inspection, the first sign that all was not well with his aircraft was that the trailing edge of the propeller was clipping the engine cowling. Further investigation revealed the area of firewall and fuselage floor supporting the nose undercarriage attachment had buckled. David couldn't recall having suffered a heavier than normal landing – what on Earth could be going on? **Photos: David Howell**

the front of the engine cowling. Clearly something was up, and it didn't take long to spot the problem – the firewall and the cockpit floor had buckled and had allowed the front of the engine to drop.

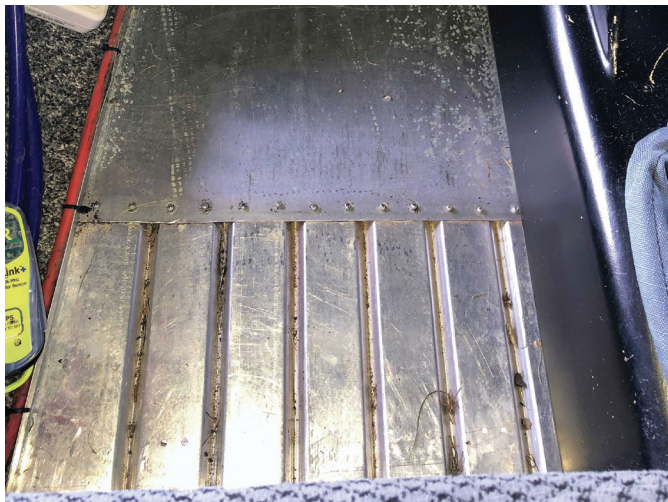
**Above** The aircraft suffered a minor accident and the fuselage was 'repaired-by-replacement' and returned to the owner, where final assembly was completed and rigging checks carried out. He noticed that the floor, which had previously been corrugated, had been replaced with a flat sheet. The LAA Inspector responsible for signing the aircraft out after reassembly insisted that the aircraft be checked by the UK manufacturer's representative and, after this had been carried out, he received assurances that this design alteration was 'factory approved' and as accepted on other later LAA examples. **Photo: David Howell**

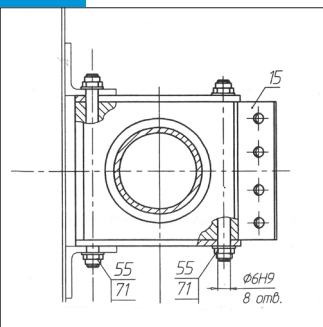
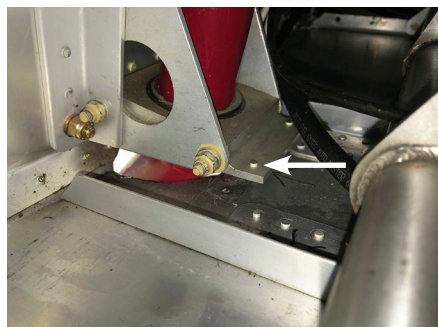
Looking at the pictures when they arrived, the failure sequence became clear; probably after some sort of unplanned overload, the nose undercarriage support bracket had broken free from its mounting.

As you can see from the pictures, the two rivets holding the bracket in

**Above** Closer inspection revealed that a contributory factor to the structure having failed was that two rivets attaching the undercarriage bracket to the fuselage floor had broken. When we checked the drawings held in the LAA library, we saw that the design calls for four solid rivets in this attachment, not two. It turned out that the part had been received from the manufacturer with just the two end pilot holes CNC-drilled, leaving the other two rivet holes up to the installer to drill on assembly – a recipe for a 'human factors' failure. LAA Engineering is writing to all Foxbat owners to check their aircraft to ensure that this mistake hasn't been made on any other LAA machines. Though not always easy to do, it's important that manufacturer's drawings (or detailed instructions) are carefully adhered to when repairing an aircraft. **Photos: David Howell/Aeroprakt**

place had failed, allowing the bottom of the firewall to move back. Correspondence with the Foxbat's designer and the UK agent revealed that the block and bracket had been supplied as repair items from the manufacturers with two 'pilot' holes drilled, but the installer was expected to drill additional holes on assembly for the extra rivets, making up the group of four rivets shown on the drawings, which were required to carry the expected loads generated by the nose undercarriage. Some of the Foxbat variants use three bolts rather than four rivets, apparently, so these repair items were perhaps intended as 'universal' components that could be drilled to suit either configuration, depending on the aircraft they were being fitted to.

LAA Engineering is carrying out a review to establish exactly what's gone wrong with this aircraft's repair process. We're writing to all Foxbat owners to ensure that this error hasn't occurred on any other aircraft in our fleet, and, I have no doubt, further advice about what is and, importantly, what shouldn't be, considered a 'repair-by-replacement' will follow. We'll also be contacting aircraft kit and parts manufacturers to remind them that an LAA Permit to Fly aircraft is certified 'as initially cleared'. Any design change, however minor, or for whatever reason, must be first accepted by LAA Engineering before an aircraft can be cleared for flight with a new design fitted.

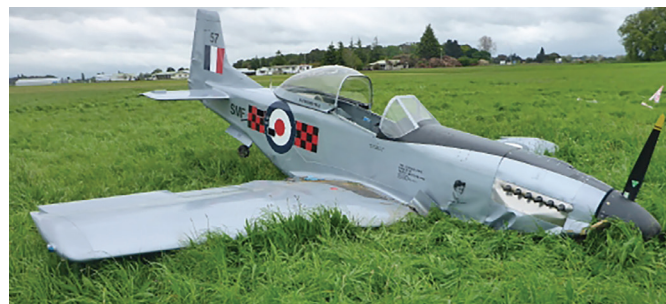
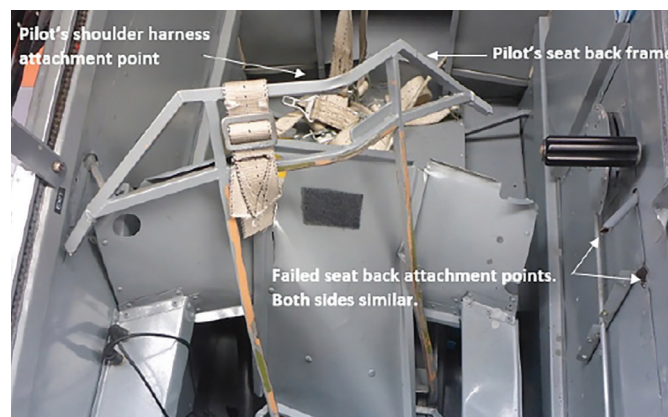
**Above** LAA Engineering has recently been made aware of an accident report published by the New Zealand Airworthiness Authority concerning a fatal accident involving a Titan T-51 Mustang. The pilot, the owner of the aircraft, suffered an engine failure shortly after take-off and conducted a 'straight ahead' forced landing. It is thought that he didn't react quickly enough to get the nose down and, because the speed was low, the aircraft had a high rate of descent on impact. The fitting of the shoulder harness was apparently non-standard and the accident report suggested that it would have been survivable had the harness been fitted correctly and its attachment not failed in the crash. We've promulgated the NZ CAA Continuing Airworthiness Notice (25-01) to all our Mustang owners and issued an Airworthiness Alert, with a link to the accident report, which is available from the LAA website.

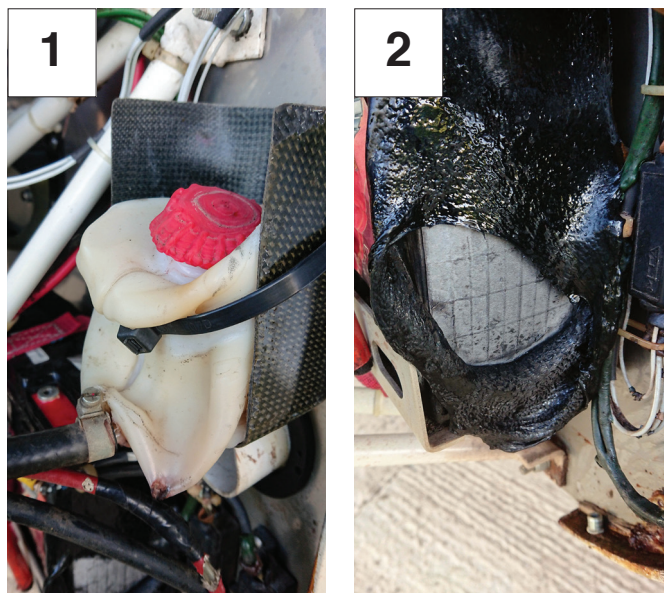
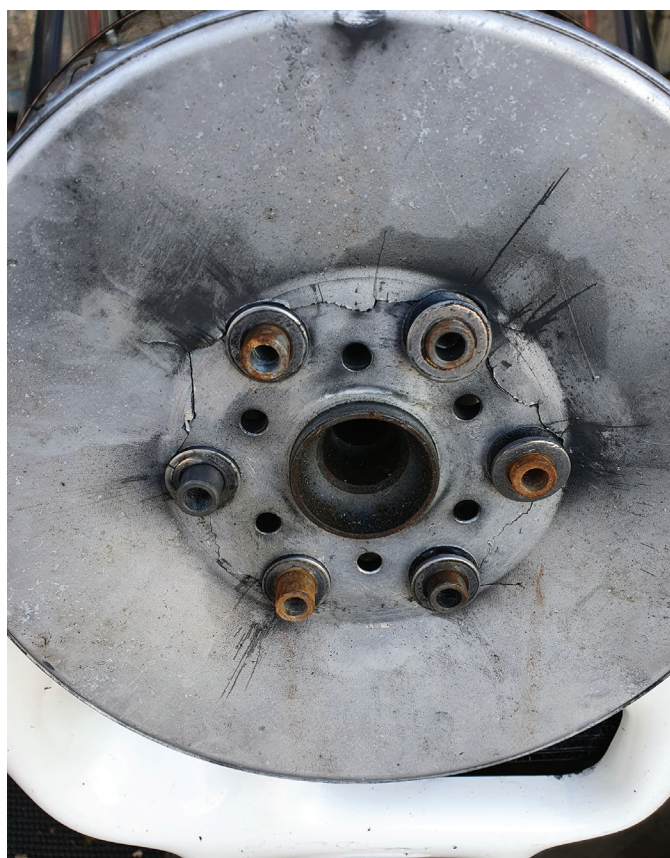
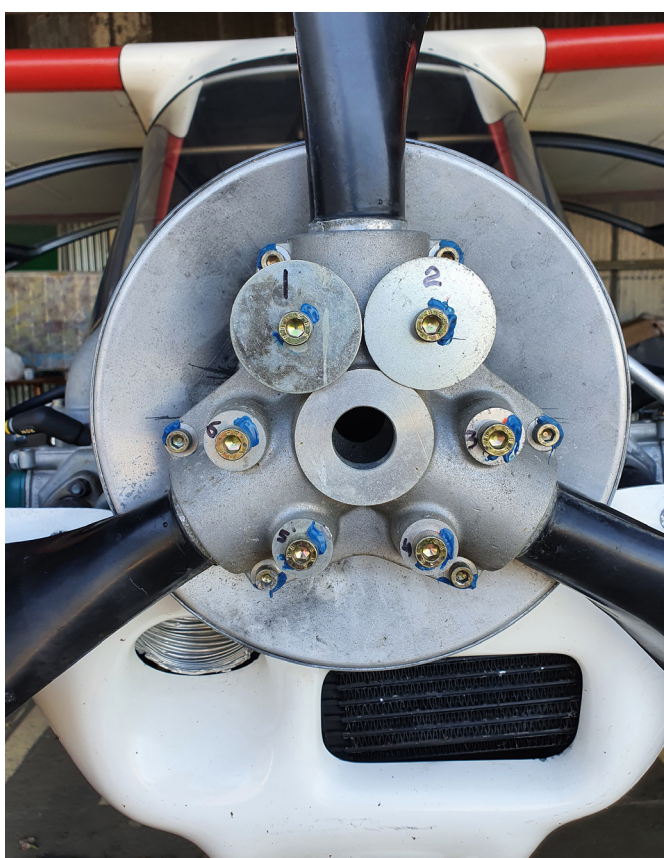
**Above** Now you see it (left). Now you don't (right)'. There are tell-tale signs that all is not well with this Ikarus C-42 spinner back-plate, though you need to know what to look for. It's essential to remove all spinners at an annual check and, if there's any sign of 'smoke streaks' created by powdered aluminium oxide, fretting is likely to be the cause – and this needs investigating. **Photos: Philip Meech.**

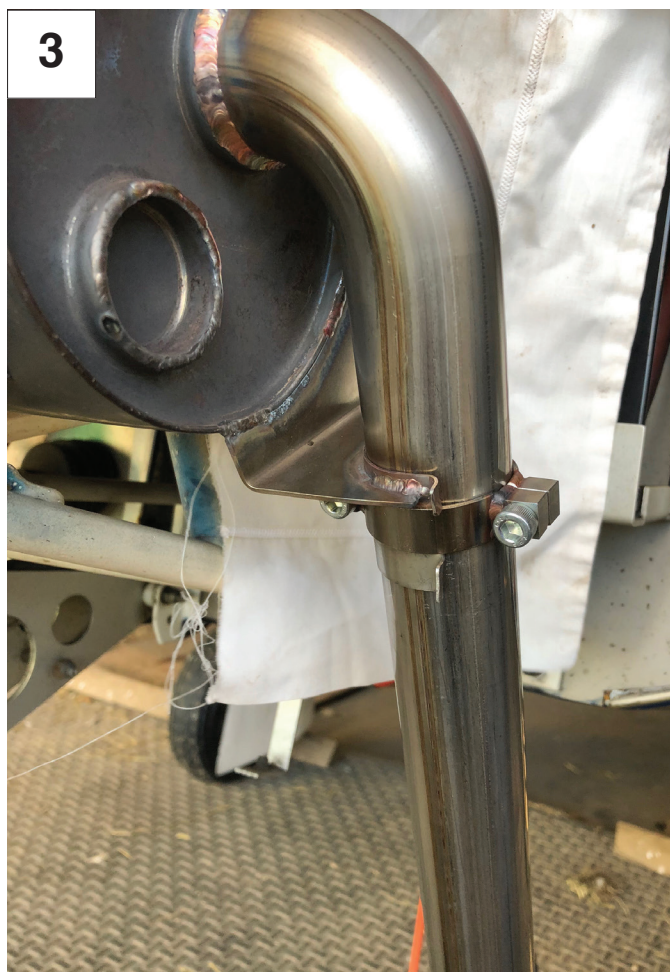
**Picture 1** is of the water bottle and **picture 2** the battery, bad enough, but it wouldn't have been long before serious structural damage could have occurred – the Pioneer 300 is a wooden aircraft after all.

This lengthening has led to a number of failures of the welded connection between the tailpipe and the silencer box and the manufacturer of the system, CKT Engineering recognised this issue and have modified the exhausts by fitting a strengthening bracket – **picture 3**.

If you have a Pioneer with the lengthened tailpipe, but haven't had the strengthening bracket fitted, we'd recommend getting this done, and CKT will modify your exhaust free of charge.

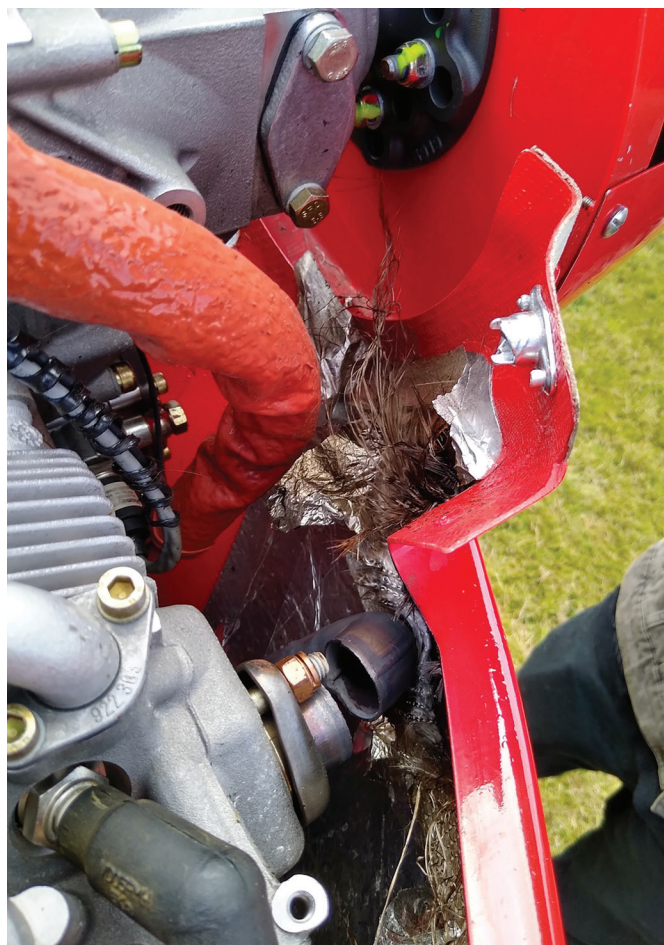
**Above** The picture shows another exhaust system failure, this one on a Rotax 914-powered Eurofox glider tug. Whilst a complete failure of the welded joint connecting the pipe to the flange can lead to a dangerous inflight situation, which is why a thorough inspection of the exhaust is recommended at each pre-flight inspection, in this instance, the pilot wasn't just confronted with the danger posed by fire and fumes, the failure occurred suddenly whilst launching a glider. Fortunately, both the glider and tug landed safely. **Photo: Ros Sibbald**
