The latest LAA Engineering topics and investigations. By Malcolm McBride

Safety Spot

Malcolm discusses Stampe propeller failures, Jabiru control surface hinges and airspeed indicator problems

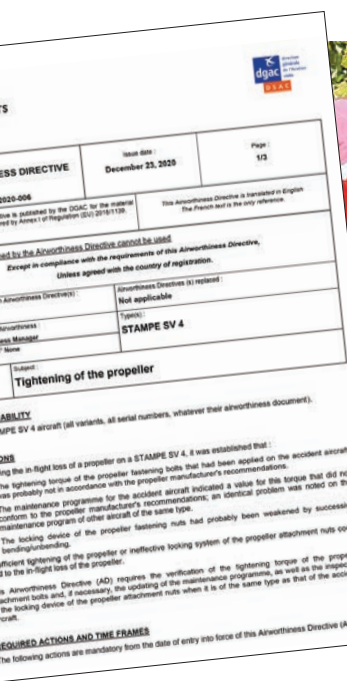
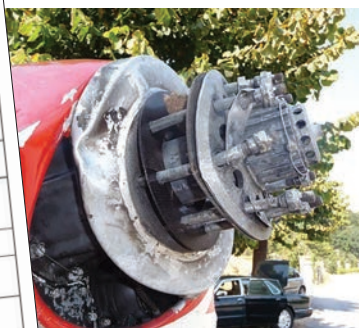
The reason for the propeller's failure was not established completely, though loosening of the propeller clearly led to friction heating of the wood. I have attached a picture showing the failed propeller.

Left and above A recent DGAC AD requires owners of Stampe SV-4 aircraft to check the attachment of their propellers following a ditching incident, caused by a propeller detachment – in 2009. Note the failed Tab Washers behind the attachment nuts. **Photos: DGAC/Mark Jeffries**

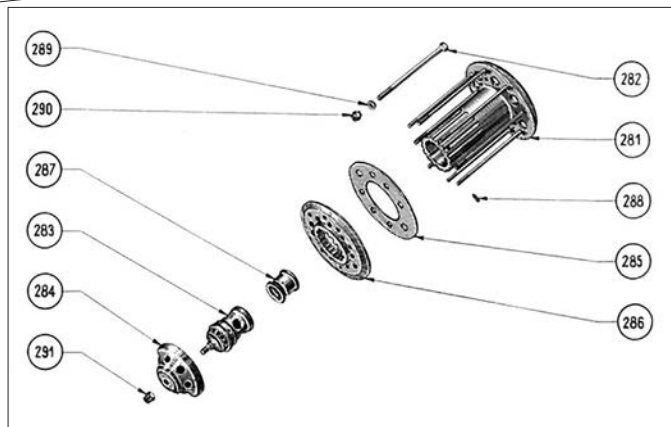
Above Here's an exploded diagram showing the correct (original) method of attachment of the propeller to the propeller drive flange (engine's crankshaft). Here's how the system works: the hub's main nut (287) is externally serrated at its leading edge outer circumference. The locking tube (283) is internally serrated and slides inside the hub and locks the nut. The locking tube is then secured by four grub screws (288), that are attached and wire locked after the front hub plate is installed. Finally, the cone (284) is fitted, this locks all the propeller nuts. It stays in place with a centre attachment stud that is on the locking tube, it has a castellated nut and is split pinned. **Photo: Andy McCluskie.**

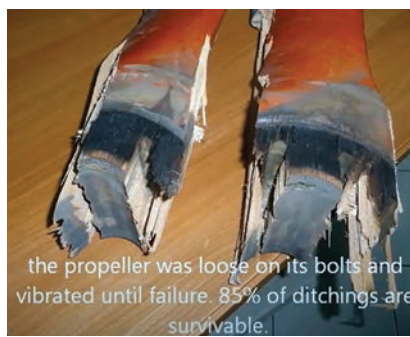
Left Overheating and burning of wooden propellers is a common indication of loss of torque in the mounting system. If the propeller bolts become loose, friction is lost and the relative movement between the two surfaces causes friction, heating and eventual failure. **Photo: Mark Jeffries**

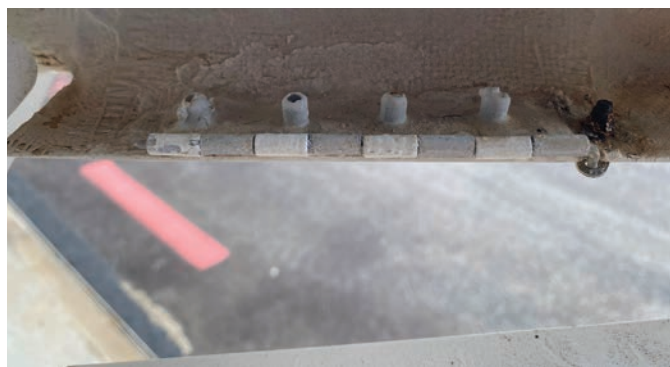
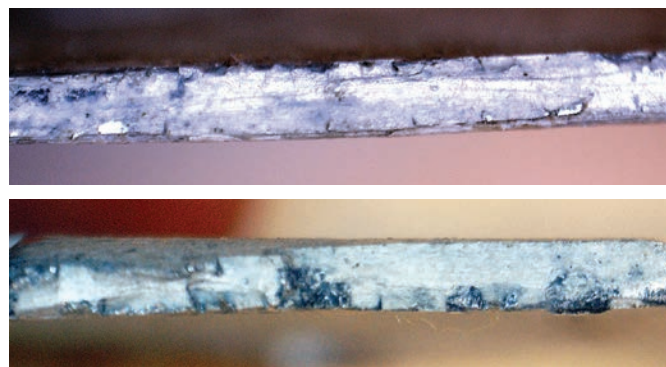
Above Following the recent discovery of a failed hinge, thankfully during a pre-flight inspection, Jabiru Aircraft has issued a Service Bulletin (JSB-044) reminding the Jabiru community of the importance of checking the control surface piano hinges on their aircraft. Left shows one half of the failed hinge in position, the two pictures on the right show the fracture face using different filters. The top picture shows clear evidence of fatigue, note the four beach lines, suggesting that the hinge hadn't been moving freely. The lower shot shows evidence of inter-granular corrosion, weakening the hinge progressively as the oxidation ate into the hinge material.

Certainly, close contact between steel and aluminium can create an electrical potential that, as we know, drives an oxidation process. When this corrosion occurs, the hinge itself can become stiff, though this can be difficult to 'feel' among all the other small resistances in the system. As you can see from the photographs showing the failed hinge, it looks like corrosion has stiffened the hinge and, because the leaves of the hinge are having to work much harder during each movement to overcome the increased stiffness, the leaf has broken due to fatigue.

The Bulletin asks that the leaves of the hinge are inspected for corrosion and cracking, and the pin's securing screw is removed, and the pin is manipulated to ensure that it's free to move.

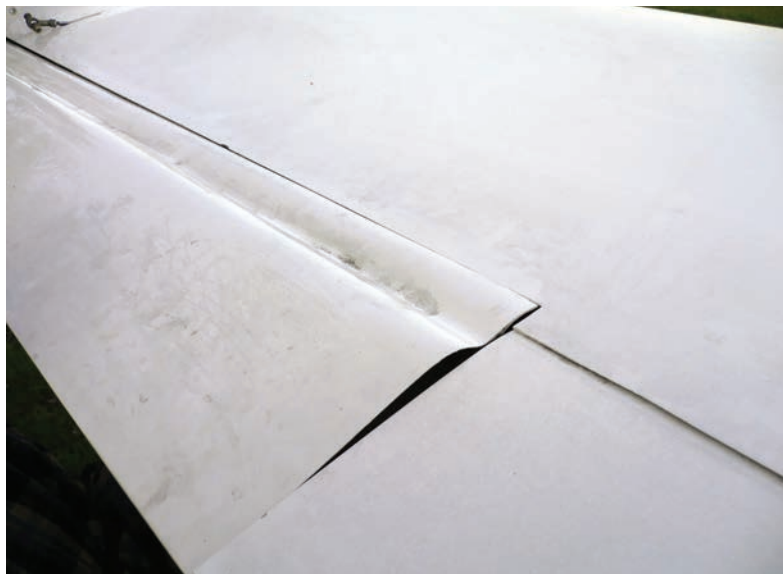
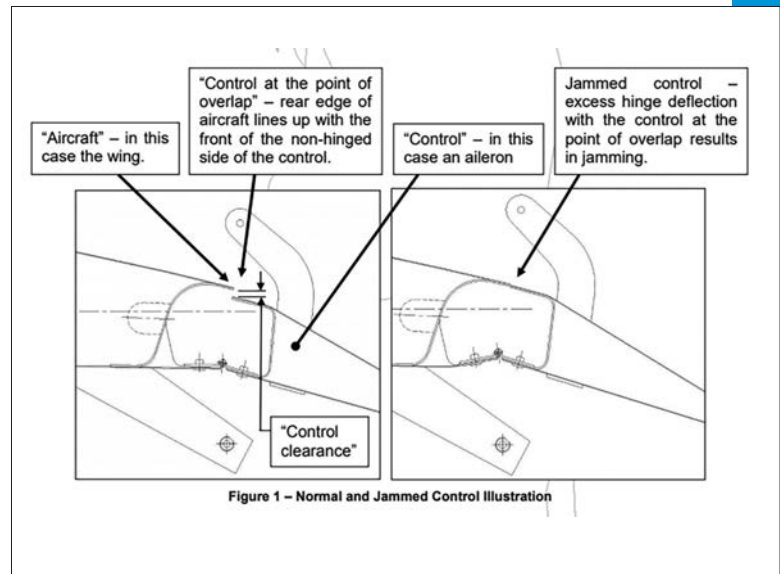
Above The importance of checking the control surfaces and their attachments regularly on all aircraft cannot be over emphasised. Back in 2008, following a couple of in-flight control surface jam events, Jabiru issued a Service Bulletin (JSB-019) requiring owners to ensure that there was sufficient clearance between the control surface and the supporting structure. The LAA followed this up by mandating the SB using an Airworthiness Information Leaflet (AIL). **Photos: Gary Cotterill/Jabiru Aircraft**

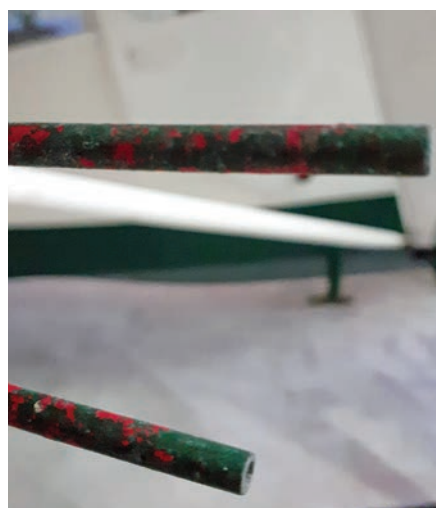
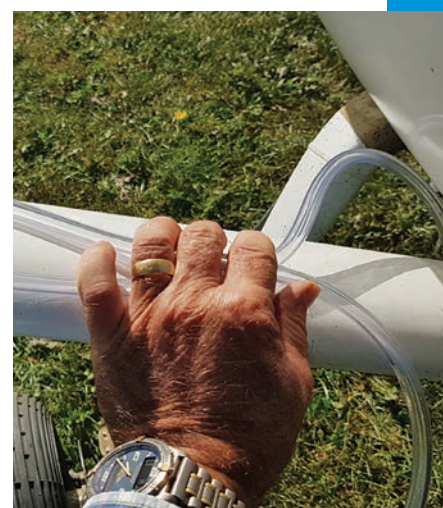
Above Three pictures to go with the two stories about problems with incorrectly reading ASIs. The first shows a simplified sketch of the mechanism inside a mechanical ASI; though they're precision instruments, in their simplest form their mode of operation is pretty straightforward. When flying sports aircraft of any class, the ASI is the most important measuring device on the instrument panel if you're going to keep safe, especially during the approach and landing phase. The picture in the middle is Bill's Christmas quiz picture and the one on the right shows why Mike had problems! **Photos: StudyFlying.com/Bill Brooks/Mike Williamson**

Thinking that something had gotten into the pitot, I disconnected the clear plastic tube that appears out at the bottom of the lift strut, tried blowing through but almost impossible to do. Thinking again, that something had got into the tube, I took a closer look at the tubing as it comes out of the strut, gave it a tug and it came free. Eventually, about an extra metre of tubing had been fed back into the strut with a loop at the end... the loop had developed into a permanent kink, which was obstructing the air flow.

I think the recent hot weather had caused the tubing to soften, causing an initial crease, which became permanent when it cooled. I trimmed the extra metre off, reconnected and carried out a test flight, all perfect again. The fix, in the end, was simple, but the cause was 17 years in the making and, in other circumstances could have caused much more serious problems.

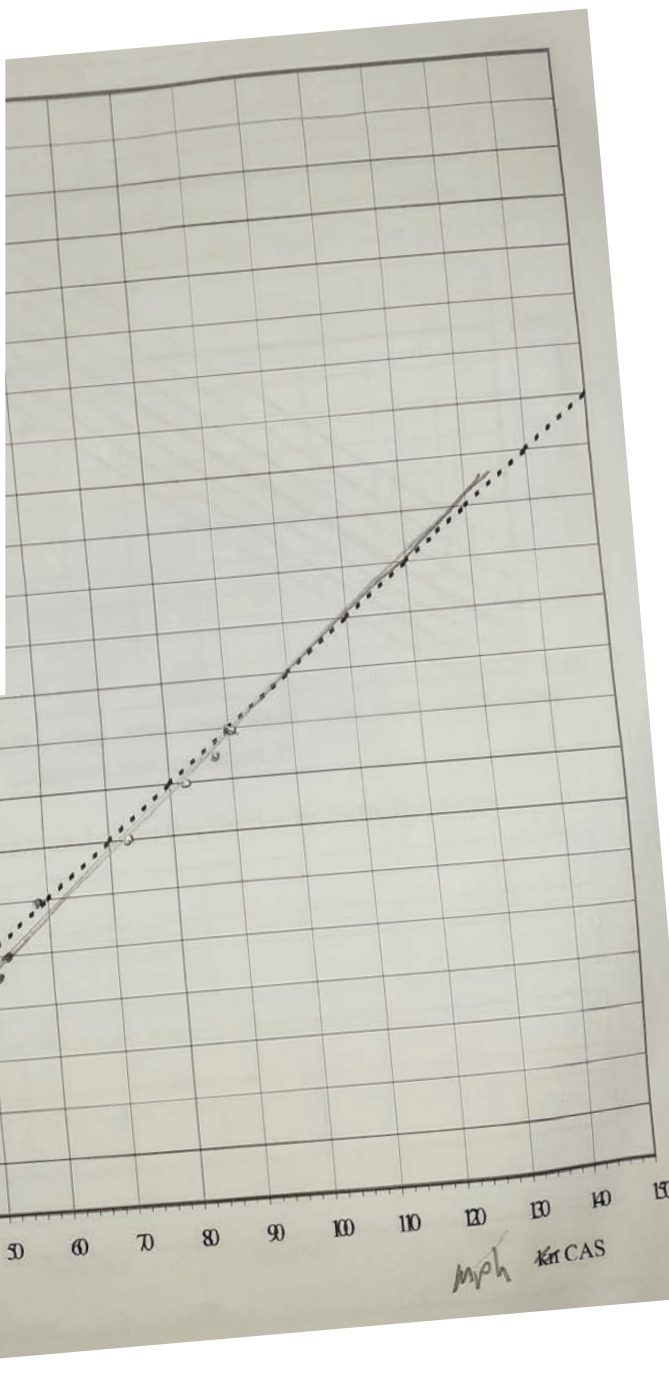
Above and right It's important to ensure that the ASI is showing an accurate representation of airspeed. Both the LAA and our colleagues in the BMAA publish guidelines as to how to do this – right is a screenshot of the LAA's online spreadsheet and right shows the graph drawn from results obtained by Bill, once he'd sorted out the plumbing 'pickle' he discovered during an inspection of an Aeronca Champ – what should be and what was look pretty close to me!
Photos: LAA Engineering/Bill Brooks

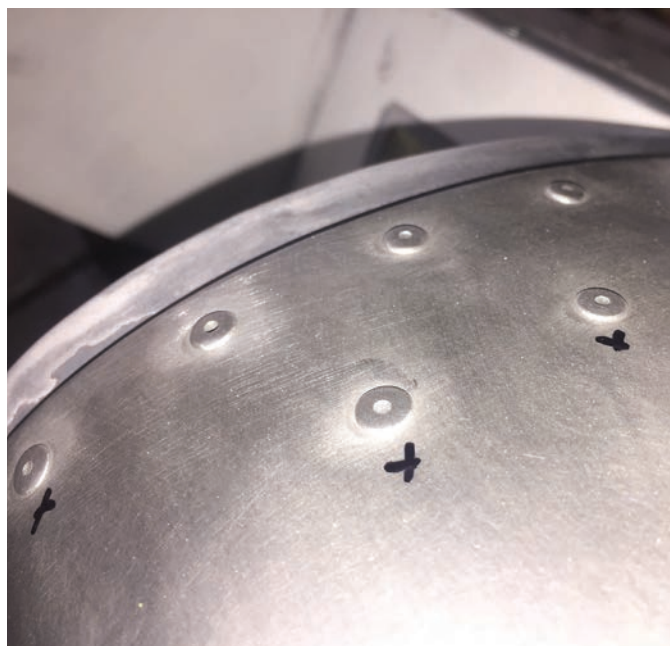
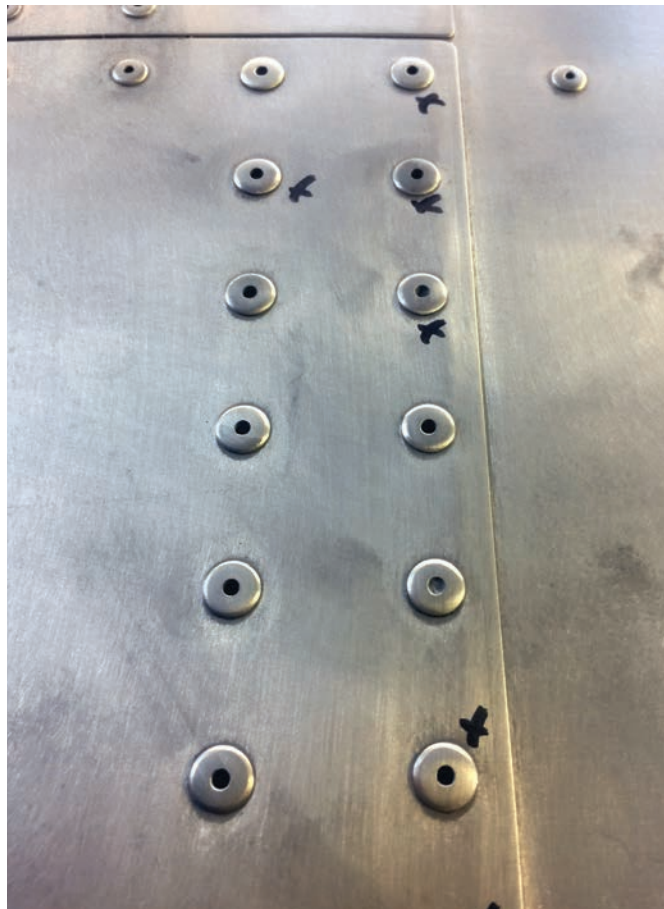
Above and right LAA Inspector, Nick Stone, came across a problem on a Bristell that was being prepared for respray recently, and got in touch. As you can see, especially when looking at the picture above, the Avex (pulled) rivets, have lost quite a bit of their head during the pre-primer preparation process. In a few cases, so much material has been lost that, in Nick's view, the aircraft's structure had been compromised. Both wings were returned to the aircraft's manufacturer for repair, an expensive exercise as quite a few rivets, and the fuel tanks, needed replacing. Happily, the wings have been returned to the owner and have been refitted to the fuselage. **Photos: Nick Stone.**
