Pioneer Aircraft

Servo-Driven Trim Operating Rods

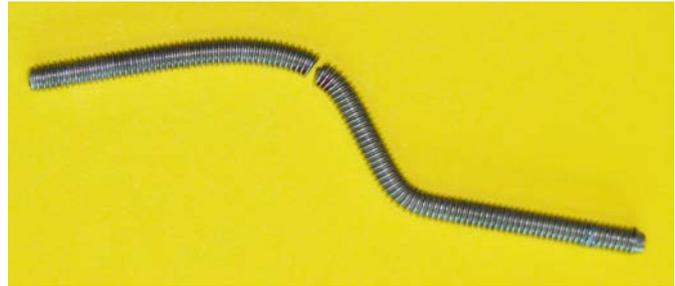
A recent incident involving a Pioneer 200 Microlight aircraft, where severe elevator vibration created handling difficulties during an otherwise normal take-off, was found to have been caused by the failure of the rod linking the servo to the trim tab.

Subsequent examination of the broken part has led to the belief that it is likely that this rod had been overstressed during its initial forming and had partially failed during manufacture; the part finally completely failing after approximately 100 hrs. in service.

The stainless steel trim rod that failed was coupled to a Ray Allen Servo and, to afford correct alignment between the servo and the tab, was bent in two places (see Fig. 1.) ... a practice cautioned against by Ray Allen in their installation instructions because of the potential for a serious reduction in the pushrod's strength.

One exacerbating factor was that the Pioneer trim operating rod was manufactured from threaded bar where the root of the thread was acting as a stress

Fig. 1. This picture shows the broken actuator rod removed from the incident aircraft.

Because of design similarity between the trim operating rods on all Pioneer aircraft, Airworthiness Information Leaflets (AIL) have been issued requiring all the trim rods to be changed to parts manufactured from un-threaded bar.

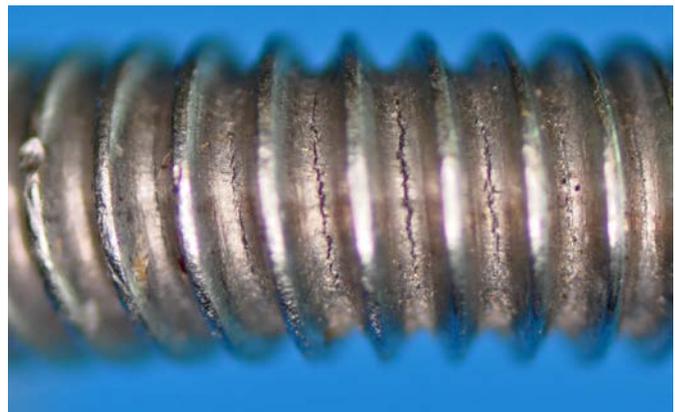
Fig. 2. Cracks are clearly visible in this close-up in the area of the bend.
