ALL OF A FLUTTER

The latest in the ongoing saga of the Zenair wing flutter problems, and also the underlying problems of two failed undercarriages

SAFETY SPOT

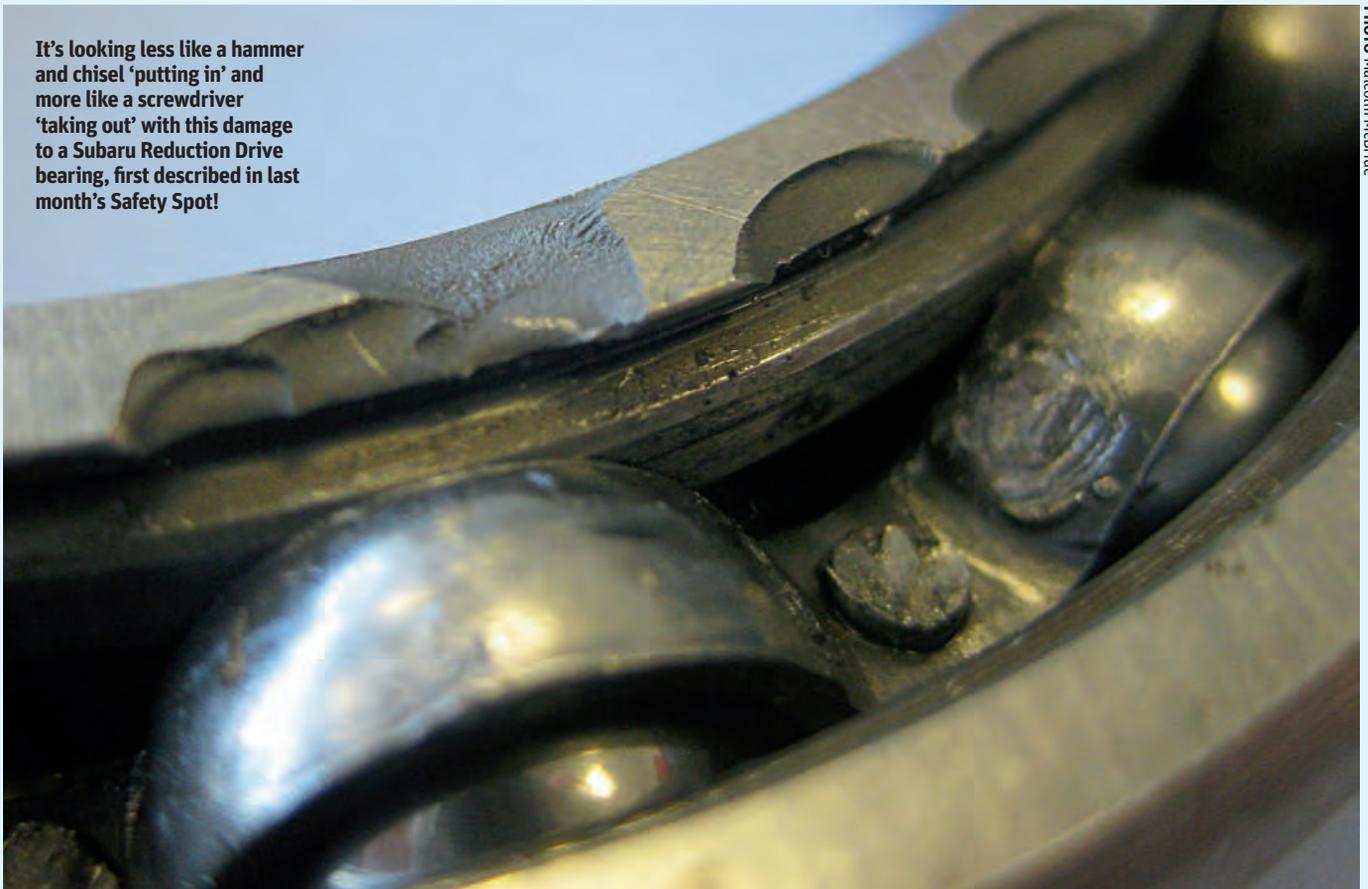
bearing face was the result of ungentlemanly behaviour, possibly with a hammer and a cold chisel. I have been assured that this was not the case by the builder of the machine, the surface damage to the bearing having been caused during the extraction process after the failure. I popped up to the LAA's Black Museum and took another look at the actual bearing; I can see how this damage would be caused trying to get the thing out. So, apologies to all concerned, I should have been more thorough with my checking process.

Speaking of checking; this particular Pietenpol is (from one or two accounts) a brilliant example and beautifully made, so I can understand why the builder took exception to my rather rude inference. What was the reason for the bearing failure? Well, we'll have to assume that lack of lubrication due to the fact that the bearing had been put in back to front. The installation manual is being updated by the technical chaps from the Pietenpol Owner's Club to stop this happening again.

It's looking less like a hammer and chisel 'putting in' and more like a screwdriver 'taking out' with this damage to a Subaru Reduction Drive bearing, first described in last month's Safety Spot!

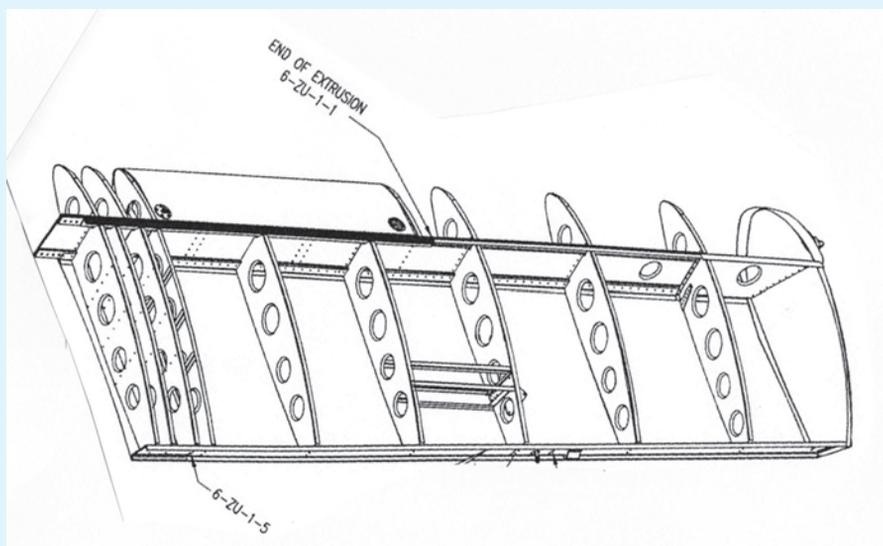
You can imagine my reaction when, after returning to work after a pleasant weekend, I was confronted with a Safety Alert/Directive requiring substantial modifications to CH601XL aircraft issued by the Zenair manufacturers AMD. Such is the worldwide nature of the sport aeroplane business. We weren't involved in the creation of this Directive which, at first sight, looked as if it would ground the UK fleet again.

Naturally, we're looking closely at the AMD modifications to see whether they actually improve the aircraft, but right now LAA machines must not be fitted with these modifications; they've not been approved. We're a bit worried about AMD's reasons for issuing this modification package so suddenly, and without consultation, but AMD's boss, Mathew Heintz, has assured us the test figures given to the LAA for UK certification purposes in the past (and recently) are 100% correct.

The modification diagram by AMD showing the additional modifications to kerb the flutter problem

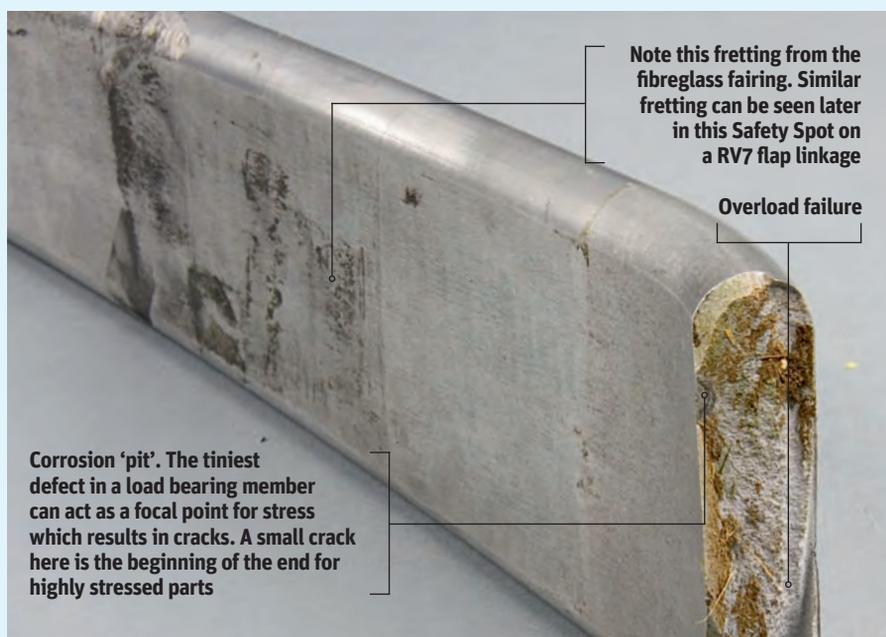
This particular incident – involving the wonderful Extra 230 aerobatic aircraft – began one Friday lunchtime in October last year. The pilot was taxiing out to the holding point for runway 21 at White Waltham when the right undercarriage leg fractured at the top bend inside the composite fairing. The starboard wing tip contacted the ground and the wooden propeller disintegrated. The aircraft was recovered and the undercarriage completely removed. It should be said that this aircraft had completed a fair number of hours (about 1700) but had only flown about 28 hours since its annual. I've mentioned that White Waltham is a bit on the bumpy side and the pilot reports that he was taxiing very slowly because of this.

This picture shows the broken undercarriage leg. I've marked the tiny corrosion pit that was the origin of the crack. As the crack grew the area of material left to resist the stress reduced increasing local stresses. This led to an eventual overload failure.

To cut straight to the chase as they say, this failure was the result of a fatigue crack which originated at a small corrosion pit on the inner surface of the bend radius at the top of the leg. It was virtually impossible to inspect this area during a normal pre-flight inspection. In fact to be inspected fully the undercarriage would need to be removed from the airframe. Close inspection of the other side (port side) showed evidence of a crack forming in, more or less, the same place. This is a really good example of the effects of fatigue on a system – the port and starboard legs were failing at the same time. A bit like my shoes incidentally, last week they both started to leak water on the same day – incredible!

This sort of failure – gradual, inevitable, but difficult to inspect against – could have been prevented if the leg had been removed and inspected from time to time. It demonstrates the need for pilots operating on a Permit to Fly to create and manage a sensible inspection programme tailored to suit the

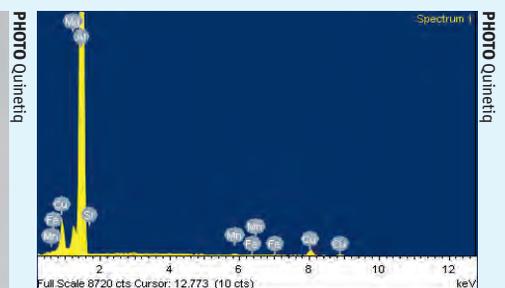
Using the technique of Energy Dispersive X-ray (EDX) analysis it is possible to work backwards and find out what material was used in the undercarriage's construction (it's one of the add-ons often fitted to electron microscopes). EDX works by energising atoms in the material being analysed and recording their energy response. Each element has a different response. By some clever maths the constituent of the material are revealed. In this example, the three biggies are aluminium (Al) which is off the scale, copper (Cu) a transition metal, magnesium (Mg) an alkali earth metal and another transition metal, manganese (Mn). It's the copper in this material that makes it very susceptible to corrosion cracking. This material, by the way, is 2024 aluminium alloy. Credit: Courtesy of Qinetiq.

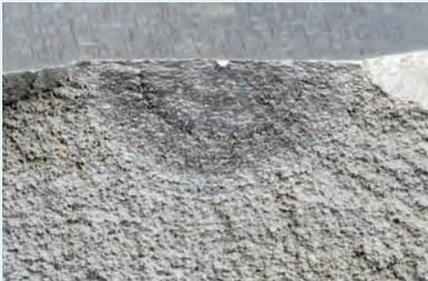
Closer look at the corrosion pit that wrecked the propeller of the Extra 230. The growth rings can clearly be seen in this optical picture.

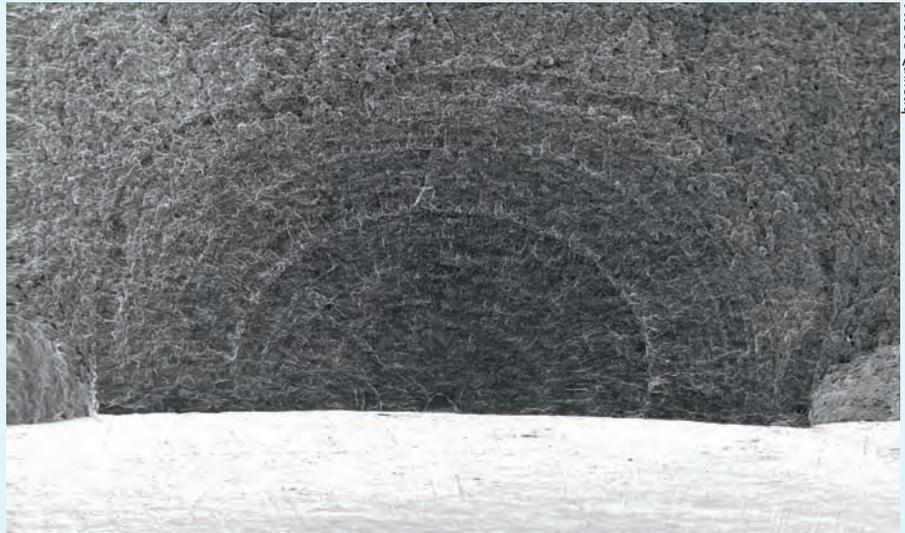
An electron microscope picture reveals the growth rings emanating from the corrosion pit. Corrosion pitting is dangerous because it is very difficult to spot. The high copper content of 2024, a common alloy used in aircraft manufacture, means the material is electrically quite active; it is postulated that corrosion pits are often caused by local cathodic sites in an otherwise normal surface.

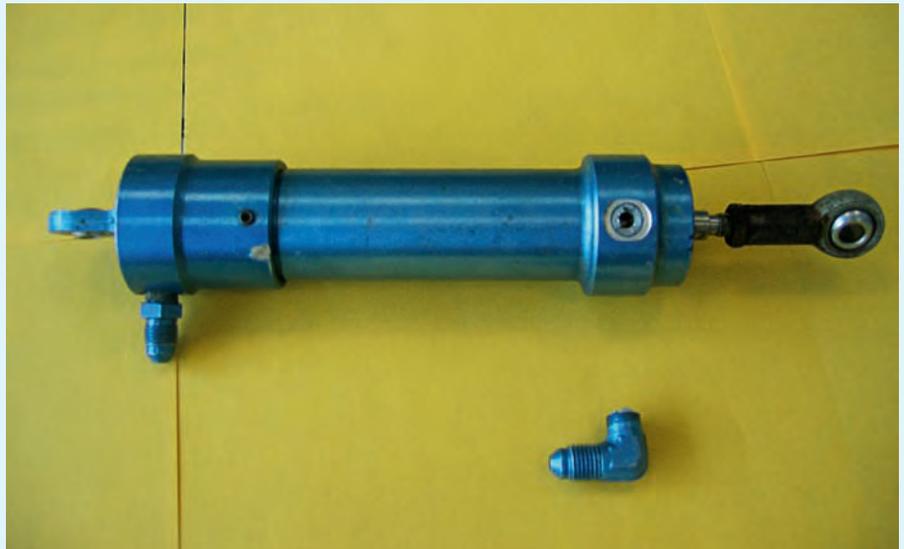
This hydraulic failed during the event. It couldn't have failed completely at the point of impact because it's on the up side of the jack and the pilot wouldn't have been able to raise the gear on this side.

It is very probable that this impact also weakened or partially fractured the AN fitting supplying hydraulic fluid to the 'up' side of the starboard undercarriage jack, initializing a failure sequence in this component, beginning with a small leak and ending in complete separation. It is likely that the bent undercarriage jammed fairly solidly into the wheel bay after retraction and, once the hydraulic fluid had been pumped out of the system as the motor ran, desperately trying to re-establish 'up' pressure, the stage was set. If you are really following this story then you should be wondering why the nose wheel didn't come down after system pressure was lost. Well, it was found that the gas pressure in this strut was too low to oppose the aerodynamic force generated by the leg itself.

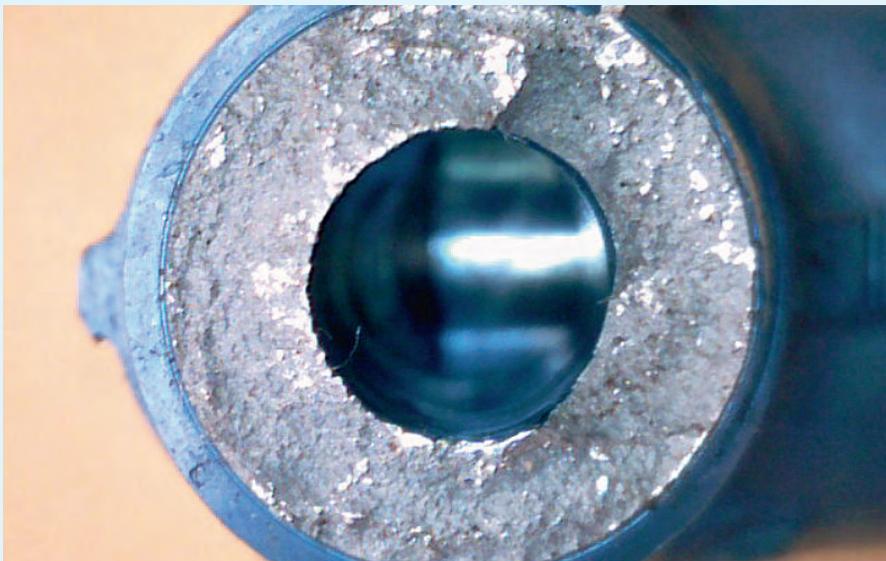
There's no evidence of a sequential failure in this close-up of the failed AN hydraulic fitting. A tapered thread is usually found on this type of fitting. It is easy to over stress whilst assembling the pipework.

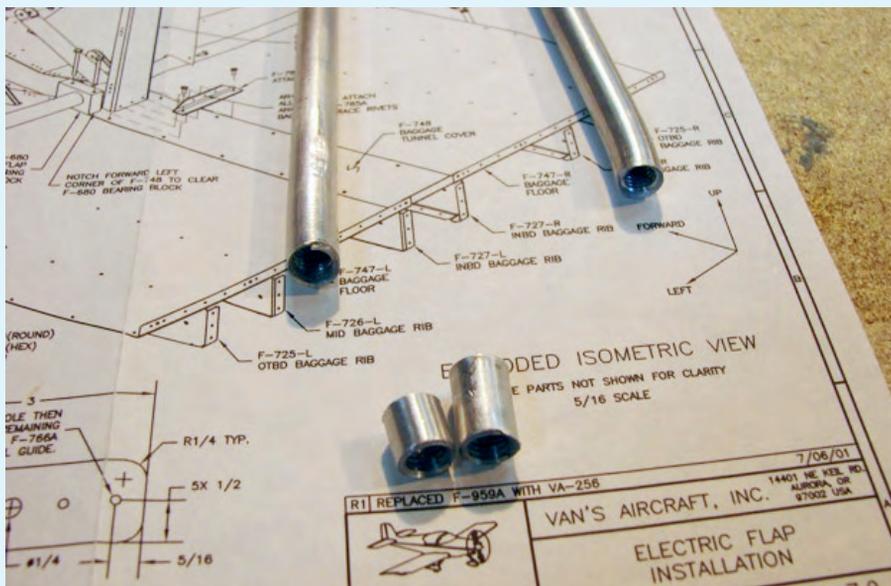
work I have disconnected the electric screw jack system which raises and lowers the flaps; such actions can make access within the aircraft painful as the flap actuating arm sticks up and will readily bite one in the rear. This is annoying, so the flaps are tie-wrapped up. Witnesses were looking at the aircraft when the tie wrap snapped and allowed the flap to fall past the full down position. Less than a minute later the port flap linkage, then the starboard flap linkage, snapped."

It's true that the failure of the tie-wrap probably overloaded this flap linkage and this is probably a fairly one-off event. I've not had other reports of flap linkage failure occurring to UK owners, although this has happened before in the US. Note the witness marks on the pictures. When Steve reassembled the flap drive he noted the hole in the fuselage was not big enough to afford proper clearance between the link and the fuselage - in the US this same lack of clearance may have contributed to a flap drive failure that ended up in a totalled RV6 back in 2001. Manuel checked his aircraft and found a similar situation. Remember, if a component is being placed regularly under a stress that it's not designed to take, it's almost bound to fail eventually. Now, where's that Saxophone? Oh, and where are my manners... Have a great Christmas!

The result of this double flap drive rod failure. In the workshop the flaps 'free fell' beyond their normal range and failed at the top of the internal threaded portion. Subsequent investigations revealed the cut-out made to accommodate the flap drive was not big enough, the chafing can clearly be seen.

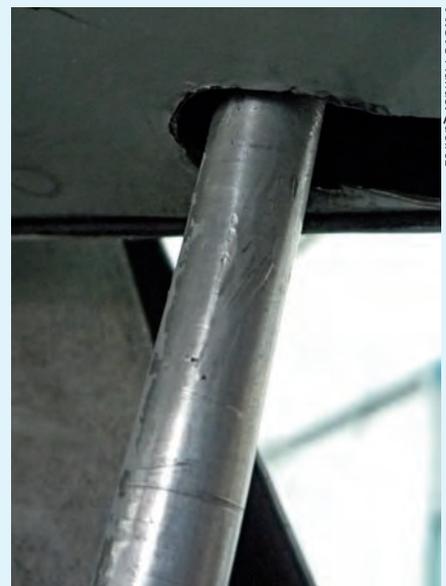
Manuel Queiroz found the clearance between the flap drive rod and the airframe was far too small and that his flap drive rod had been chafing.
