# Mystery of the Tippy sunglasses

# Spark plug failure

# Investigating on-going power loss

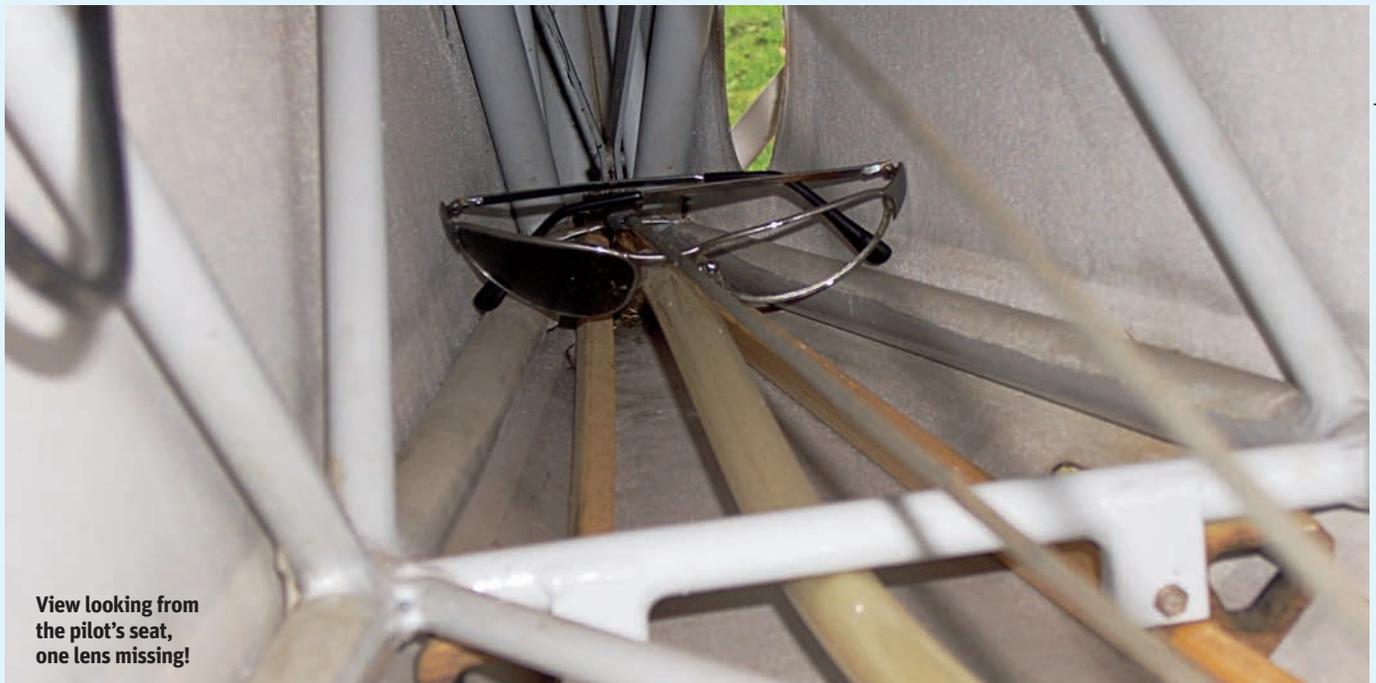
Neil's glasses were found balancing, like an acrobat, on an elevator control cable dangerously close to the elevator's 'mechanics'. Good spot Neil and thanks for sharing.

View looking from the pilot's seat, one lens missing!

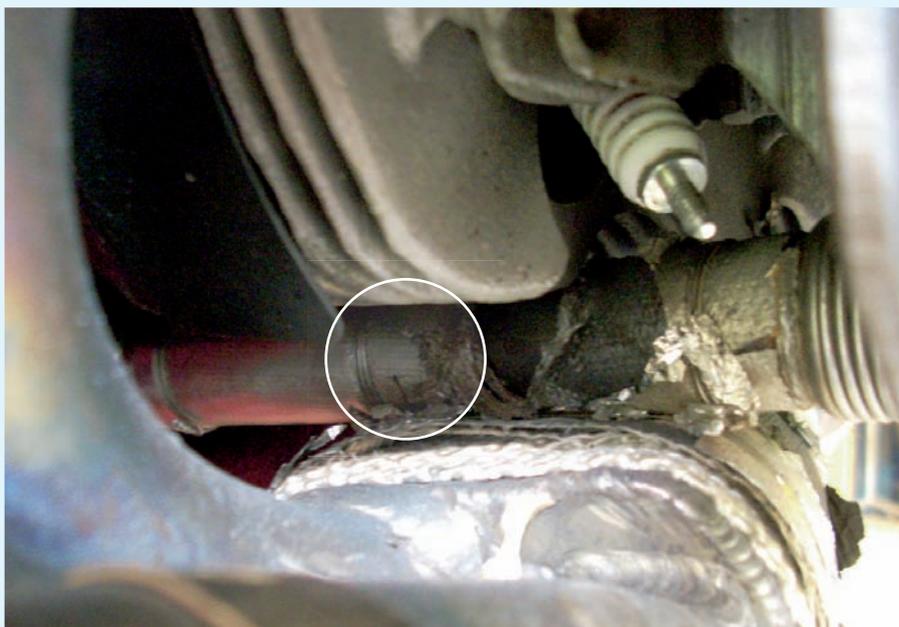
Neil allowed the engine to cool down a bit before removing the engine cowlings. He continues: "It would seem that the exhaust gases had leaked past the insulator and burned their way through the metal side of the body. The hot gases had then started to burn the cylinder head cooling fins and the pushrod tube just below it. (This would have then set fire to the leaking engine oil.) I had fitted a fire retardant/heat insulator cloth around the pushrod tubes to reduce heat soak into the

Gas flame can act like a blowtorch: Damage to push-rod tube shown above.

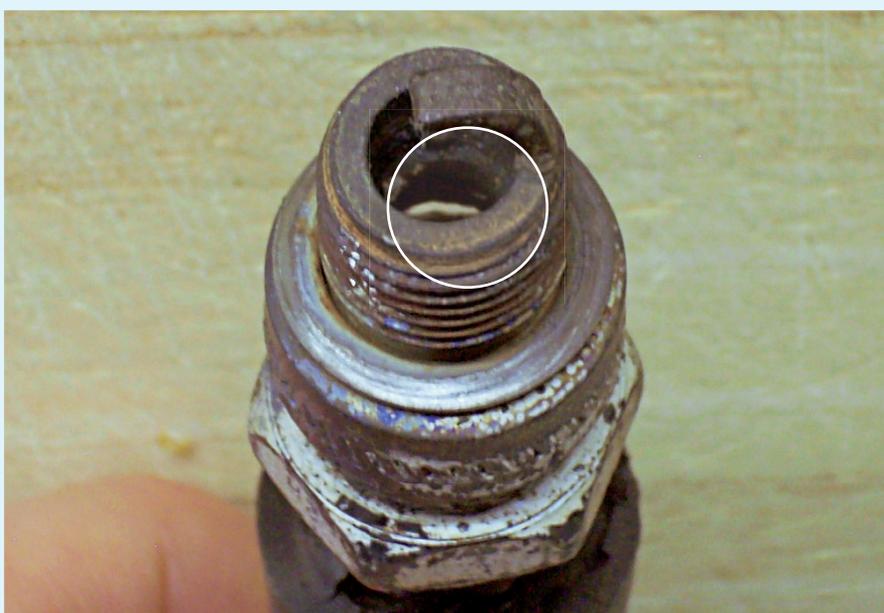
"Err... how did you say one should adjust the plug gap?": Centre electrode and insulator completely missing. The fact that there was no damage to cylinder bore or piston crown suggests that the debris of this failure exited the engine through the exhaust valve.

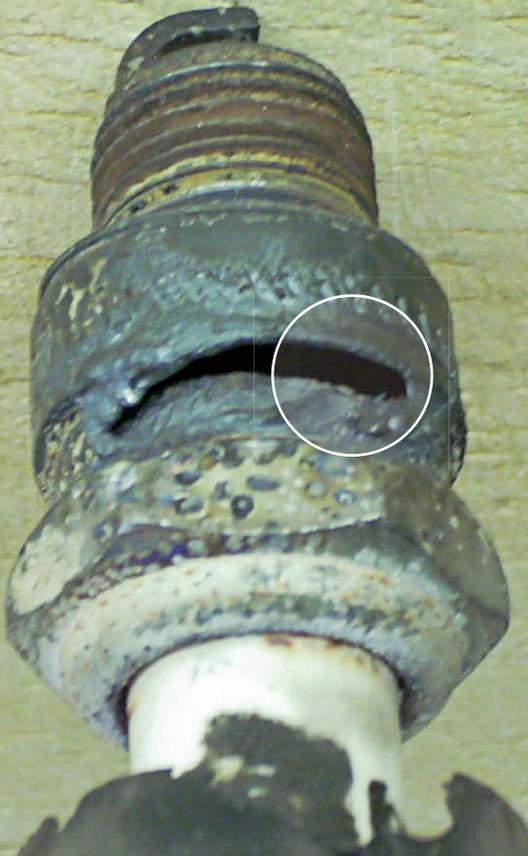
The reason for the misfire was a more-or-less complete loss of compression on one of the cylinders. The four-cylinder 1835 Volkswagen engine had, in effect, become a 1376 three-cylinder – a bit ahead of its time! The fourth cylinder had been converted to a blowtorch and Neil did a good

**The failed sparking plug. It probably didn't take long for the flame, at very high pressure, to burn through the plug body once the thermal runaway got started.**

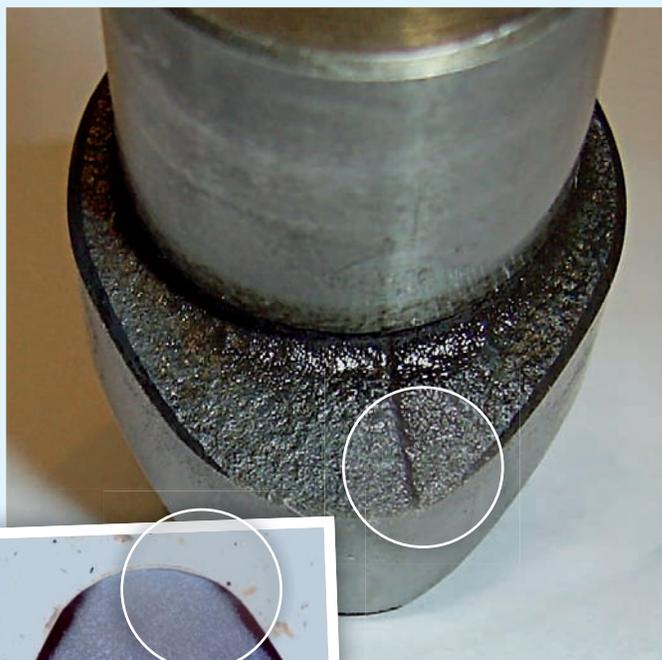
story descends into the kind of madness 'oft found in despair' but, eventually, Neil had a chat with an engine expert who suggested that the 'bottom end' should be inspected. The engine casings were duly split in half and the cause of the low power became very clear; the camshaft was worn out.

**BAD CAM:** 'Normal' wear point on a cam (highlighted above). Once the surface hardening has gone, wear will occur very quickly.
