FIRST FLIGHT FAILINGS

This month we focus in detail on a particular accident which highlights the importance of following your Inspector's advice

ENGINE FAILURE AFTER TAKE OFF DURING AIR TEST – ONE.

ENGINE FAILURE AFTER TAKE OFF DURING AIR TEST - TWO.

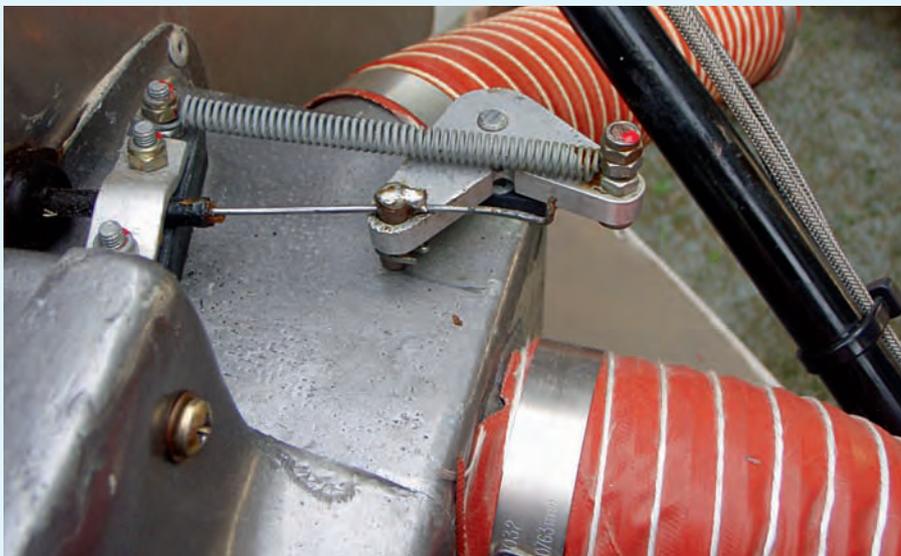
He explained that he didn't know the aircraft very well as it was new to him and he later employed the services of an LAA Inspector to go through the technical aspect of the aircraft with him (a very good idea). During this training session it was noticed that the carburettor heat control had become disconnected at the engine end and that the carburettor was receiving hot air all the time. This was very likely the cause of the poor take off performance and subsequent poor climb.

When I heard about this I was a little uneasy when it was suggested that the type of connection used was considered "bad engineering". You can see from the accompanying photograph that the Bowden cable connection is made using solder. I checked that this was normal with the UK agents and they said that this was indeed normal practice for Jabiru Hot Air systems and that, if done properly, this kind of connection shows good service life and that they have never had a report of a failure. Roger Lewis, an LAA Inspector who specialises in Jabiru engines explained that, "the good thing about this type of connection is that it is easily inspectable. A tug will reveal a dry solder joint and the connection will, under this circumstance, fail." Roger has come across 'dry joints' during his inspection career but had never heard of a properly soldered joint failing in service.

The controversial connection which has demonstrated good service so far amongst the Jabiru fleet worldwide. As an aside, I like the way important bolts have been marked but, as an engineer, I don't like the way in which the wire has been left with its bare end unprotected.

There are a few lessons to be learnt here. It is very important to thoroughly check all control connections during the 'check A'. This is the title given by engineers for the first flight of the day check; glider types call this the DI. This event also reinforces the need to check the hot air system on the ground during the ground run phase of the pre-take off checks, get used to the feel of this control, if there's a change in the feel, check it out. Don't get lazy with this check,

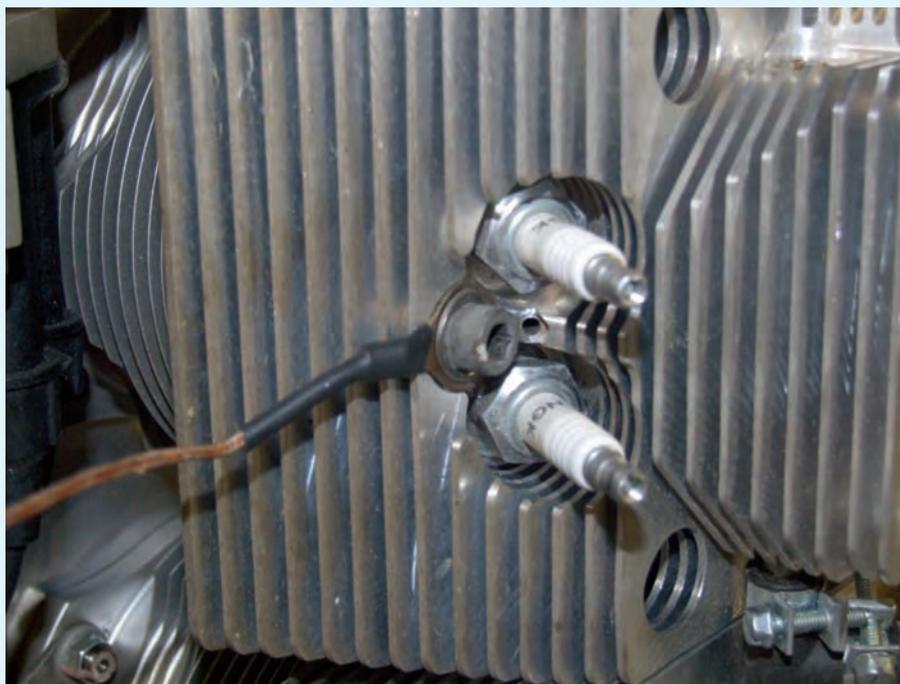
This picture reveals the incorrectly positioned CHT probe. This probe is designed to go under the sparking plugs. If fitted in the way shown here, the probe will under read

The report, written by the dismantling engineer makes for some sobering reading but space prevents me from dwelling on the dreadful state the engine ended up in. Suffice to say that it was effectively destroyed. The reason was that the engine, for various reasons, ended up running very lean, probably dangerously so in the climb and destructively so when the aircraft was levelled out at the top at 2500 feet. The pilot was not aware of these dangerous temperatures because the aircraft was not fitted with an exhaust gas temperature probe and the cylinder head temperature sensing probe had been fitted in the wrong place.

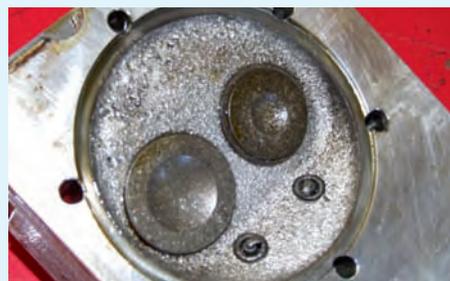
The damage to the cylinder head has been caused by the huge forces during detonation combined with molten metal from the piston

In general, if an engine is running lean it will be running hot, and when the gas temperature rises in the cylinder there is more chance of detonation. A normal burn can be considered as deflagration (where the flame front pre-heats and then ignites the material or gas) and is a relatively slow event (in chemical terms) with the wave front travelling at around 50 cm/sec across the chamber. During detonation the charge explodes virtually instantaneously (during gas pipe experiments 2000m/sec have been recorded). Some engines are designed to operate with light detonation at some points in their operating cycle; aluminium cylinder heads and pistons don’t like it at all. This is principally due to the fact that the rapid combustion experienced during a detonation event destroys the protective fuel barrier around these components which serves to cool the metal, offering a sort of ‘thermal inertia’. Combustion chamber temperatures often exceed 980° C, which far exceeds the melting point of aluminium (about 750° C). High output engines will destroy themselves within

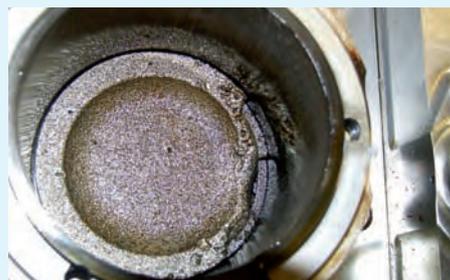
Corresponding damage to this Jabiru 5100’s piston surface. Note the edge of the piston has evaporated, exposing the top compression ring

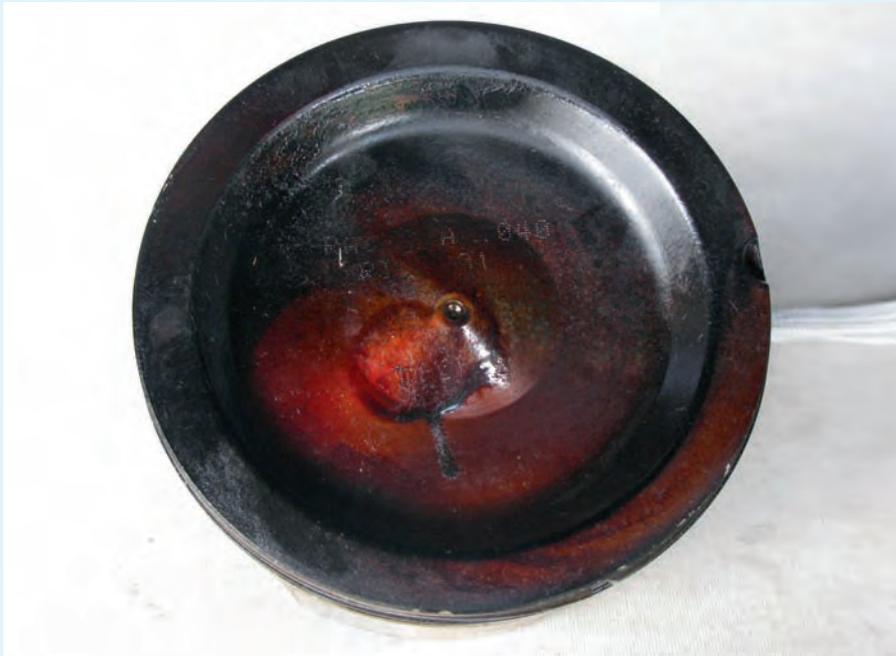
This shot, from LAA'er Jim Gale, shows that while this piston has clearly overheated, there is no sign of detonation. Mixture is a front runner as the cause but poor cooling shouldn't be ruled out. Small changes in propeller pitch, and therefore mass flow, can often mess up mixture settings

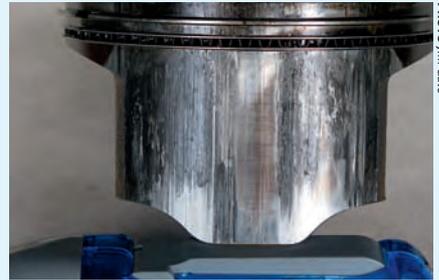
Classic scuff marks on piston through over expansion. Pistons are designed to expand but allowable temperature limit is about 260°C

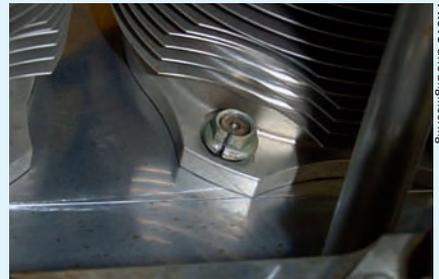
This photograph clearly shows a split nut caused by the thermal expansion of the crankcase material. This is a first for me

THE POST MORTEM: After the aircraft was recovered the engine was shipped to GRC engineering which is the engineering expertise base for the UK Jabiru agency. The engine was stripped in the presence of the UK agent and representatives from the insurance company. It became clear very quickly that the engine had got extremely hot, so hot in fact, that the crank case had expanded sufficiently to split the nuts on the through bolts - a failure feature I've

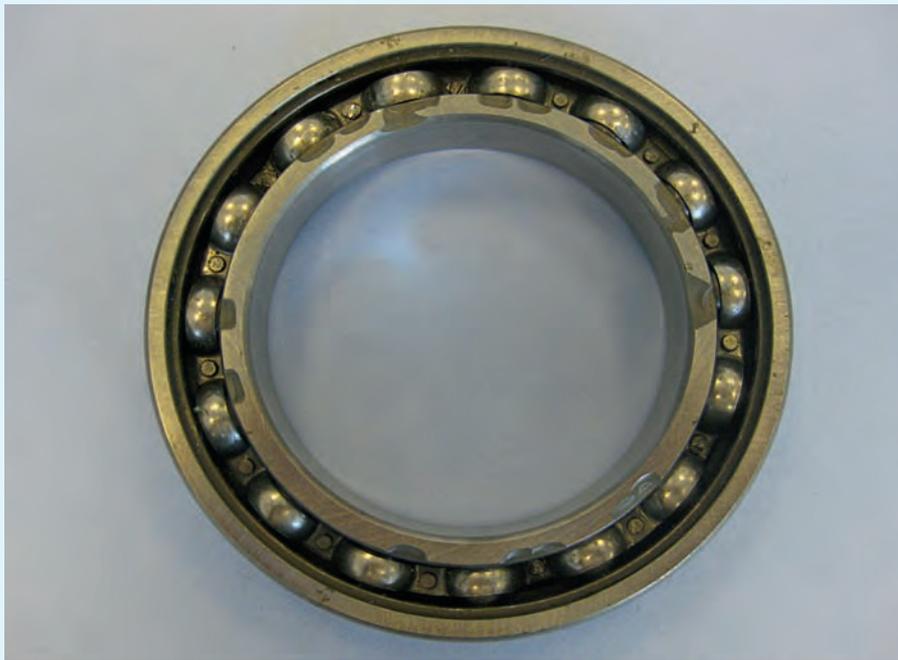
1. Showing the caged ball bearing with its open face, this is the face that should be engine side in so that the bearing can receive splash lubrication

The inspector in charge of the project noted that the AMEX reduction drive was extremely hot “even some time after the forced landing”. When it was stripped it was noted that the main bearing for this device was in the wrong way round and was therefore not receiving any lubrication. When he ‘pulled’ the bearing he was surprised to see the extent of the damage to it. It wasn’t only the lack of lubrication that caused this bearing to fail. It looked like it had been smashed in with a hammer and cold chisel. Makes you wonder sometimes.

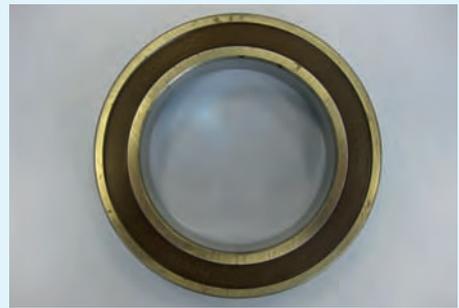
2. Here, showing the sealed face

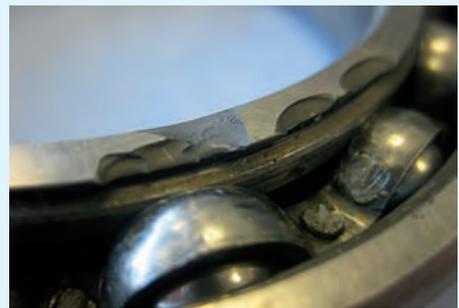
3. A close up of the damaged caused when incorrectly fitting the bearing. Fragments of this bearing have damaged the ball cage
