DESIGN PROBLEMS OR REPORTING FAILURES?

Pioneer 300 and Pioneer Hawk – Main spar update and undercarriage issues

The worrying incident of the Speedtwin ST2 propeller failure

Woodcomp SR3000 Propeller failure

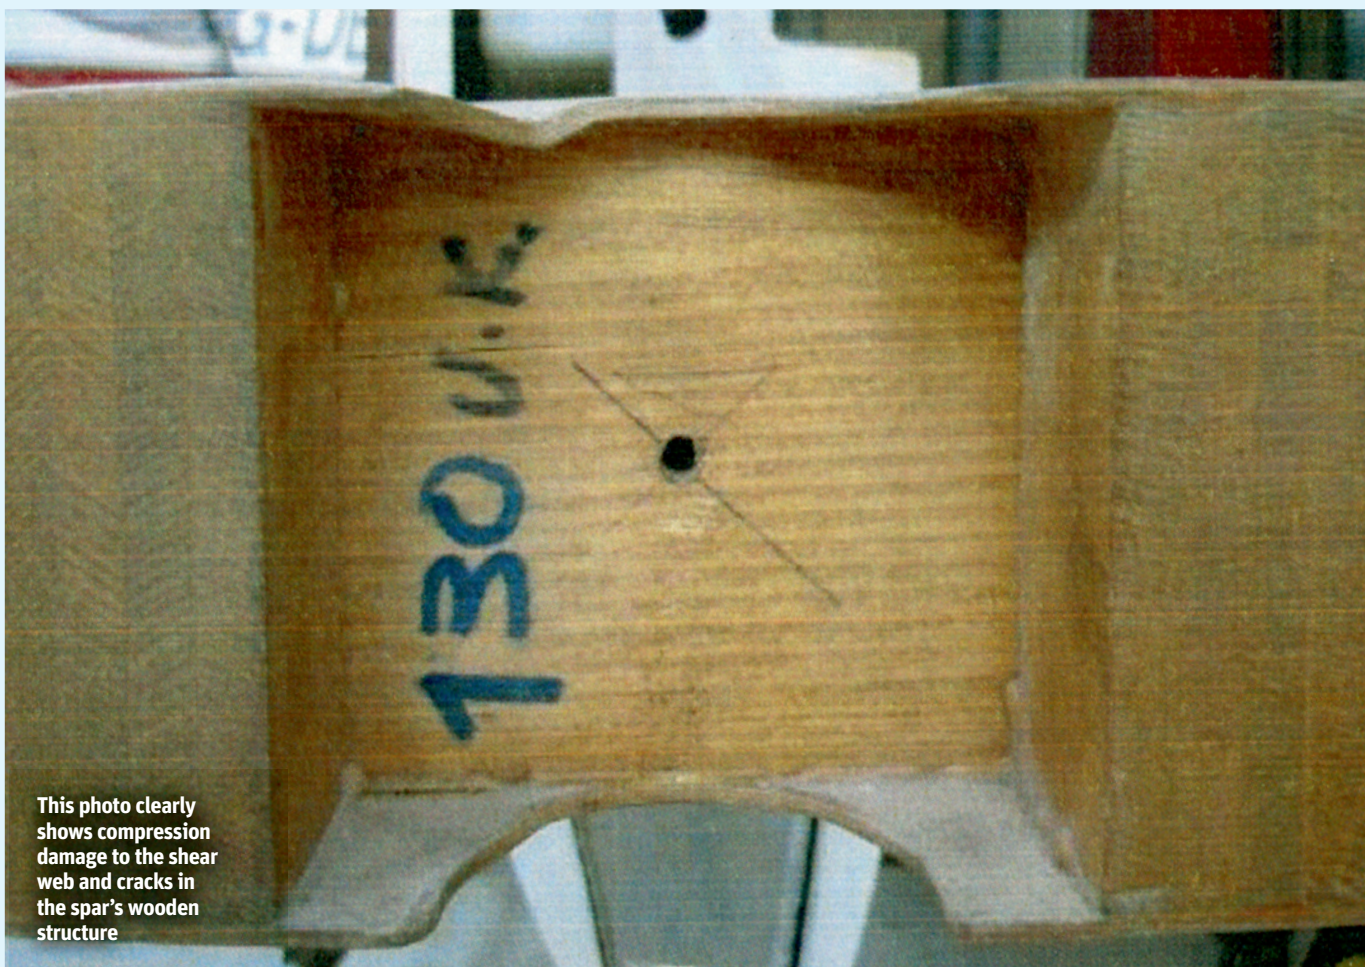
This photo clearly shows compression damage to the shear web and cracks in the spar's wooden structure

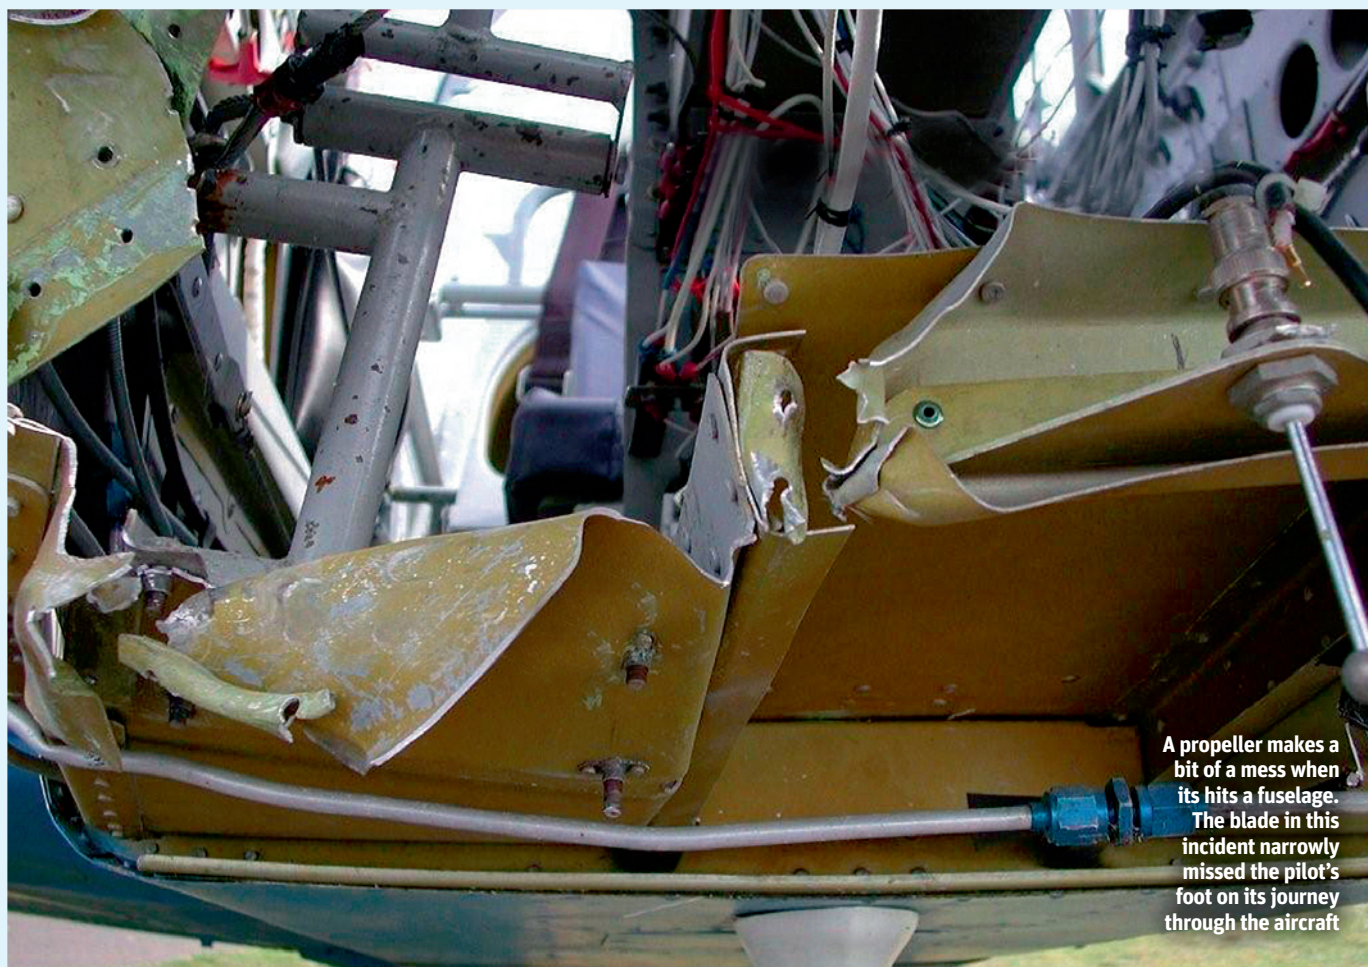
A propeller makes a bit of a mess when it hits a fuselage. The blade in this incident narrowly missed the pilot's foot on its journey through the aircraft

In this case the crew did everything right but the aircraft systems let them down. First, let's look at what happened to cause all the fuss. Examination on the ground revealed that one of the starboard propeller blades had left the hub. The out-of-balance forces at this point must have been phenomenal and it is a credit to the aircraft's design that the engine stayed with the airframe. In any event, the failed blade hit, and passed through the fuselage from right to left, just missing the pilot's feet on the rudder pedals. The unrestrained blade struck the port propeller which, although damaged, held together. I will discuss the cause of the propeller failure, which has now been established, later in this article. For now I would like to look at the other aspects surrounding this event. There are a few lessons to be learned and a few that were learned years ago which were adopted during the design, meaning the pilot is still walking around.

Last lesson first. When the aircraft was designed a stainless steel plate was added to protect the pilot's feet in the 'unlikely' event of a propeller blade failure. It did its job. Well done

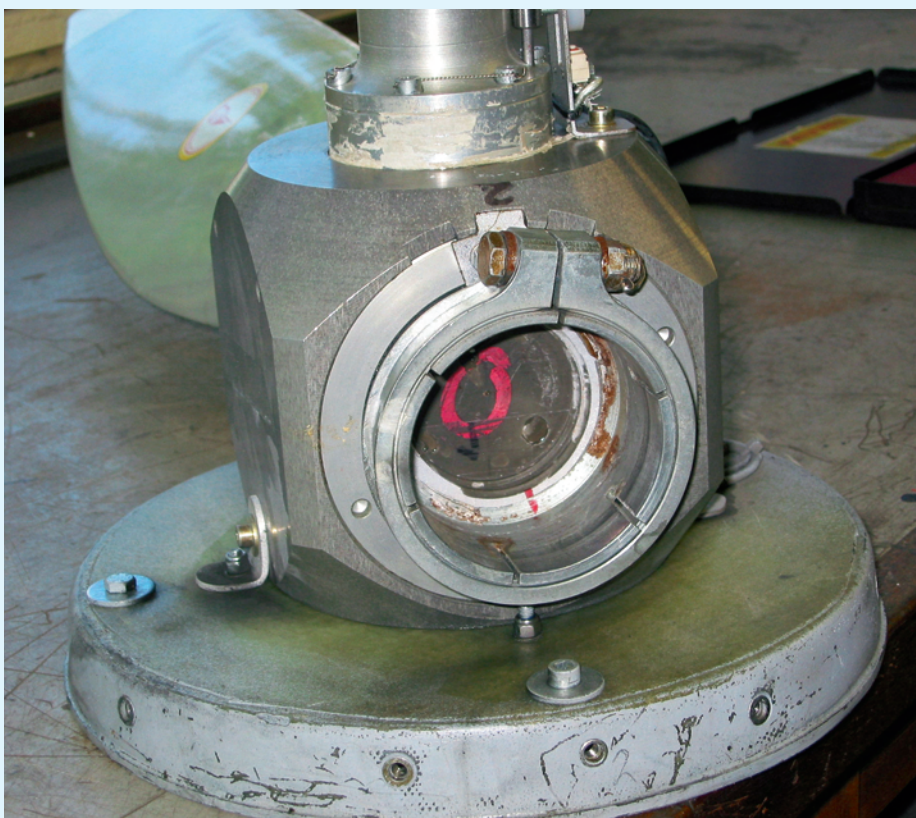
Corrosion can clearly be seen inside the hub of this GT propeller

corrosion on the inside of the hub, especially on the blade-securing screw threads. There was no evidence of jointing compound being used in the assembly either. In fact in this design there was no way to keep moisture out at all. Cracks are evident in the failed blade root section and an examination of the threads showed that they were cut by a tool rather than rolled.

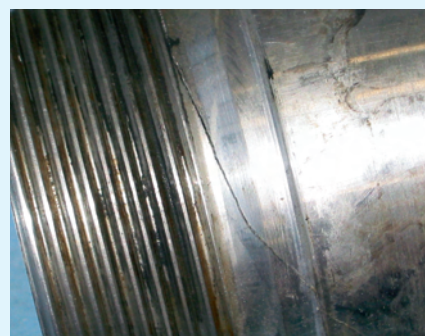
The crack on the blade can clearly be seen emanating from these cut threads. Residual stress and corrosion leads to stress corrosion cracking even in a low stress environment

Cut threads also leave an end grain which makes materials susceptible to stress corrosion cracking. Incidentally, aircraft bolts are always rolled for this very reason (and a few other applications too, which time and space prevent me from discussing).

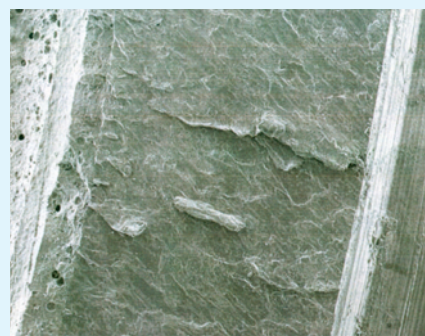
Micrograph showing delamination of the fracture surface

A closer look by using a scanning electron microscope (set at very low power) revealed fracture surface delamination; this is a crack feature we've seen before and is a characteristic feature of stress corrosion. Readers will remember the MCR-01 tailplane bracket that failed last year due to a similar process although, in this later incident, there is no doubt about where the stress component originated from – the cut threads. There are always residual internal stresses which, unless relieved, will remain in machined surfaces.

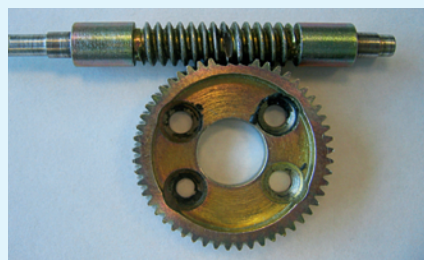
Graham travelled down to John's workshop and together they stripped the propeller, the results of what was found can be seen in the accompanying photographs. The text explains what I think is going on here; it seems that the components were under-strength. This failure

appears to be an early fatigue brought about by the increased load applied by the larger blades of the two bladed propeller – the assembly is the same as in the three bladed propeller which, so far at least, hasn't had problems.

John Massey's propeller pitch change mechanism showing failure point

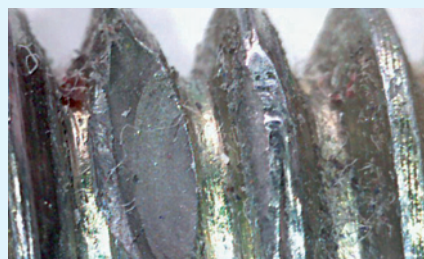
Close up of a failed section of worm from the SR 3000 pitch change gears. Beach marks can be clearly seen in this photograph which indicate a sequential fatigue failure

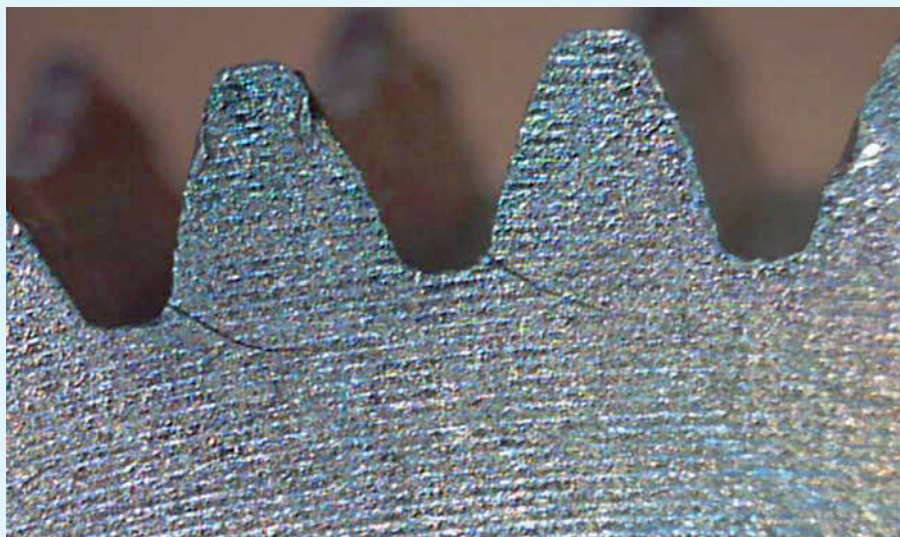
Close up of another SR3000 drive cog supplied by Graham Smith of the UK Woodcomp Service Centre. Note poor machining and check out the cracking which is not visible to the naked eye. These two teeth were not far away from failing

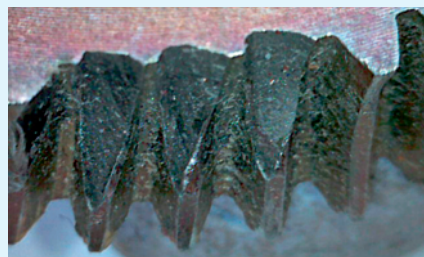
Closer view of failed section of operating cog

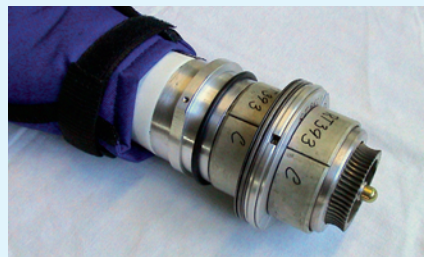
The SR 3000 blade at the root end disassembled from its hub
