Europa Aircraft – All Marks Fuel System Inspection

LAA Engineering has recently issued an Airworthiness Information Leaflet (AIL) detailing a required inspection on Europa fuel systems.

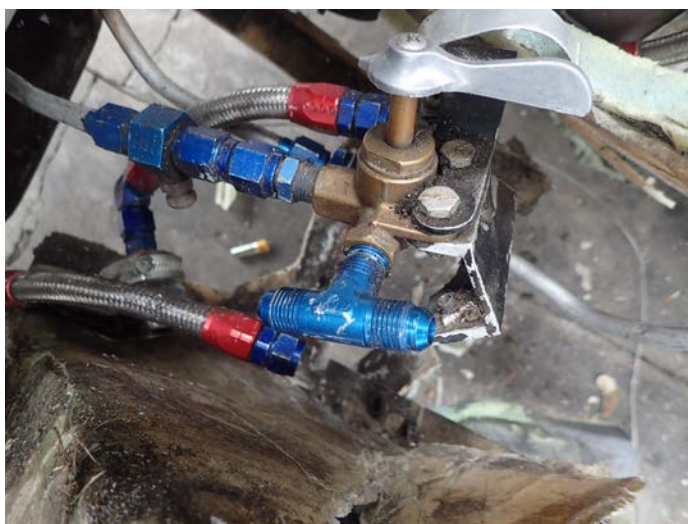
The reason for this inspection is that during the investigation into a recent accident involving a Europa aircraft it was discovered that the vapour return line was routed back from the engine to tee into the fuel feed line at the fuel selector valve, in effect allowing the return fuel and any entrained vapour to circulate, rather than being returned directly to the fuel tank where the fuel can be cooled and any vapour can disperse. This may have led to a system vapour lock and therefore the reported loss of power which preceded the accident.

Fig. 1. This picture shows the return tee fitting as found on the aircraft involved in the accident; unused (return) fuel must be returned to the fuel tank where it has the opportunity to release any vapour bubbles that may have formed and can be cooled.

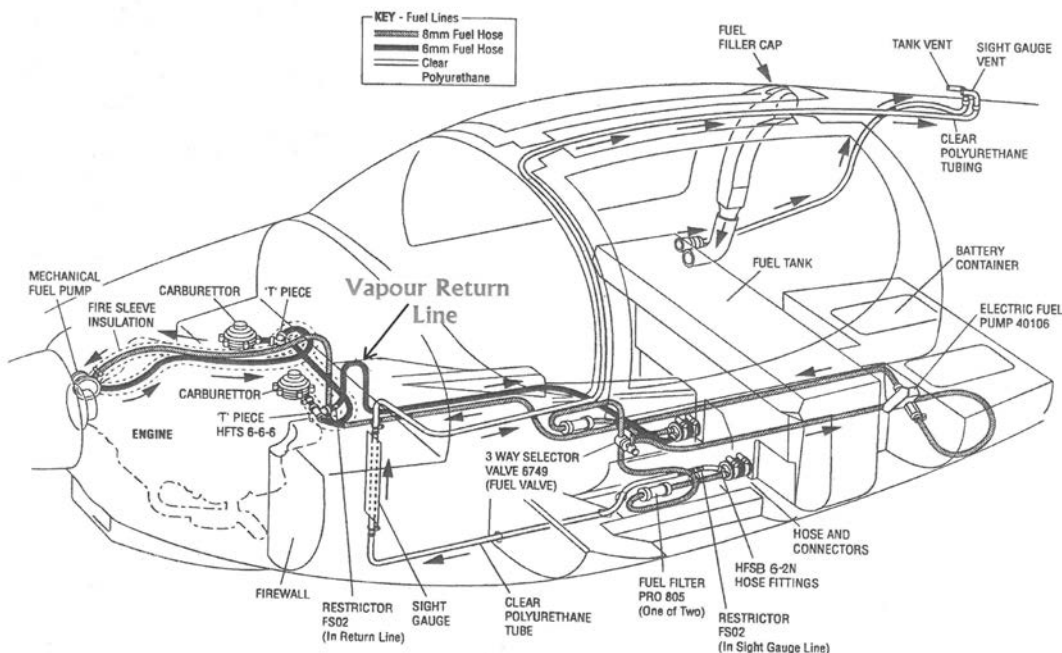
Fig. 2 This schematic of the fuel system on the Europa aircraft shows the return system. Note that the vapour return line takes fuel from a point as close as possible to the carburettor and that the fuel is delivered straight into the starboard fuel tank (reserve on the Europa) via a special fitting.
