AIRWORTHINESS ALERT

LAA/AWA/15/03 4th March 2015

EuroFox Aircraft

Inspection of Undercarriage Guide Bracket Bolt

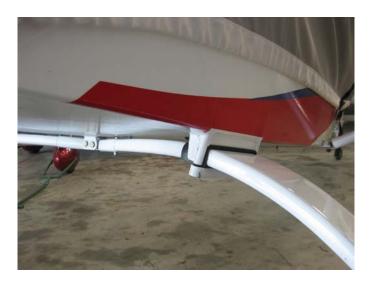
During a routine daily inspection, the pilot of a EuroFox aircraft noticed that the hex drive head from one of the two bolts holding the undercarriage leg clamping bracket was missing; the bolt was therefore no longer securing this side of the clamping bracket.

A subsequent examination of the bolt's fracture face suggested that it had failed as an indirect result of being over-tightened. After discussions with the inspector who initially signed-off the aircraft's build, it was established that the attachment bolts had been unnecessarily torqued down when the aircraft was first assembled.

Fig. 1 This picture shows the general arrangement of the EuroFox undercarriage attachment

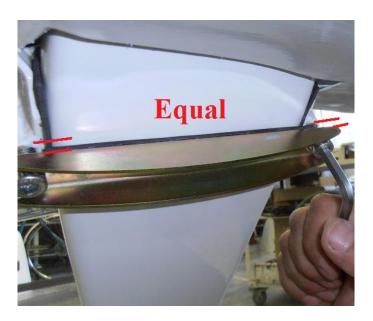
Fig. 2 This picture, taken from the EuroFox UK Bulletin, shows the method of assembly; it is important to maintain an equal clamping force across the undercarriage leg and this is achieved by ensuring an even gap between the clamp and the leg during tightening.

The EuroFox manual has been subsequently updated to include the correct assembly instructions and EuroFox UK have issued a Service Bulletin (SB/02/2015) recommending that all pilots operating a EuroFox aircraft check the bolts on their aircraft to ensure that they haven't been over-tightened by mistake; the Bulletin also recommends that all EuroFox pilots include, in their daily inspection of the aircraft, a visual inspection of these bolts.
