CHECK, CHECK AND CHECK AGAIN

An insight into the day-to-day operations of LAA inspectors, both in the office and in the air, plus Jabiru failures update.

Jabiru control failures update

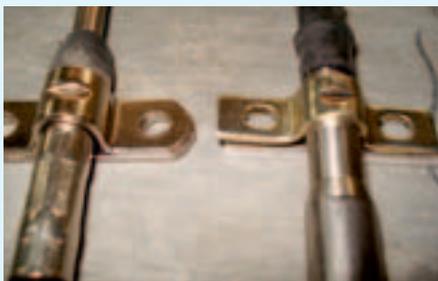
Clamps correctly assembled with the 'tang's' in place and the clamp fitting snugly around the body of the cable

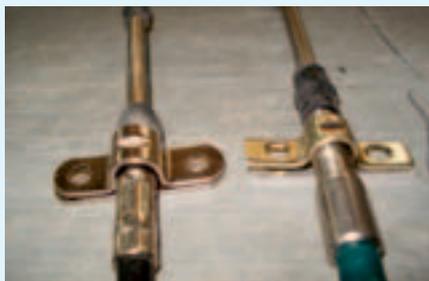
After a thorough investigation, a series of inspection failures were uncovered. It was found that the clamp itself had been assembled incorrectly during the aircraft's build and this fact had not been noticed during subsequent checks. There were a number of factors that mitigated here. One was that the clamp itself is very difficult to see and that when it is assembled it is almost impossible to ascertain whether the locating lug on the clamp is correctly fitted into the groove in the cable outer. If the lug missed the groove then the only thing holding the outer in place would be friction.

Clamps incorrectly assembled, the locking 'tang's' are misaligned and the clamp is not fitting properly around the body of cable

We got in touch with the Jabiru factory in Australia and they agreed that both the failures seen in the UK were a result of poor inspection techniques. We agreed that it would be a good idea if the factory produced a Service Bulletin requiring regular checks on these control components and offering advice about what the inspector/pilot should be looking for during a pre-flight or other maintenance inspection.

The Jabiru factory has now done exactly this and all owners should be aware of this document. The LAA, with regard to its longer term responsibilities, is deciding whether to require compliance with this inspection by issuing an Airworthiness Information Leaflet (AIL) or asking the CAA to issue a Mandatory Permit Directive (MPD). (The Jabiru document can be downloaded from the LAA website as JSB 027-1 if you are interested.)

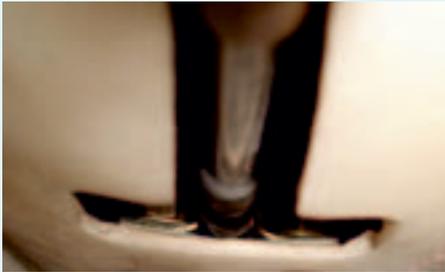
A correctly fitted elevator clamp – very difficult to inspect requiring a torch and mirror. A failure here could lead to loss of control of the aircraft

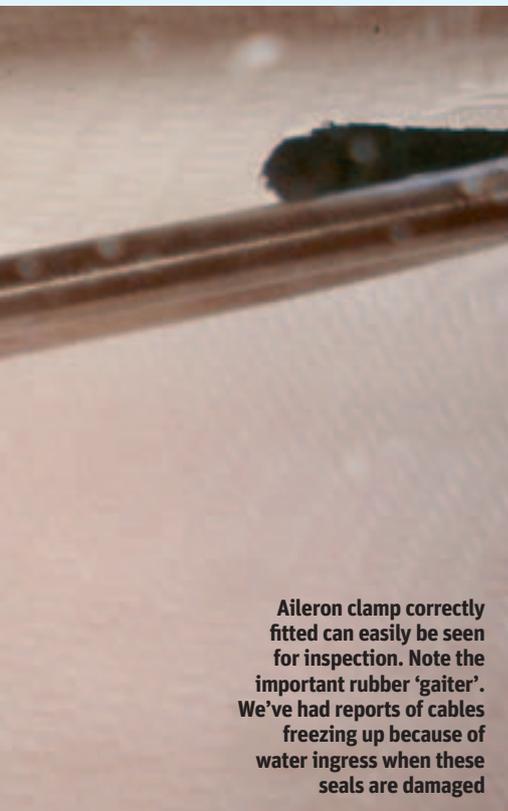
Aileron clamp correctly fitted can easily be seen for inspection. Note the important rubber 'gaiter'. We've had reports of cables freezing up because of water ingress when these seals are damaged
