## BROKEN 'HEATER' SPRING

Small section of spring jams the carburettor butterfly valve causing loss of power and subsequent forced landing

### PIETENPOL AIRCAMPER CARBURETTOR HEAT MUFF

### RANS S-10 RESTRICTED ELEVATOR

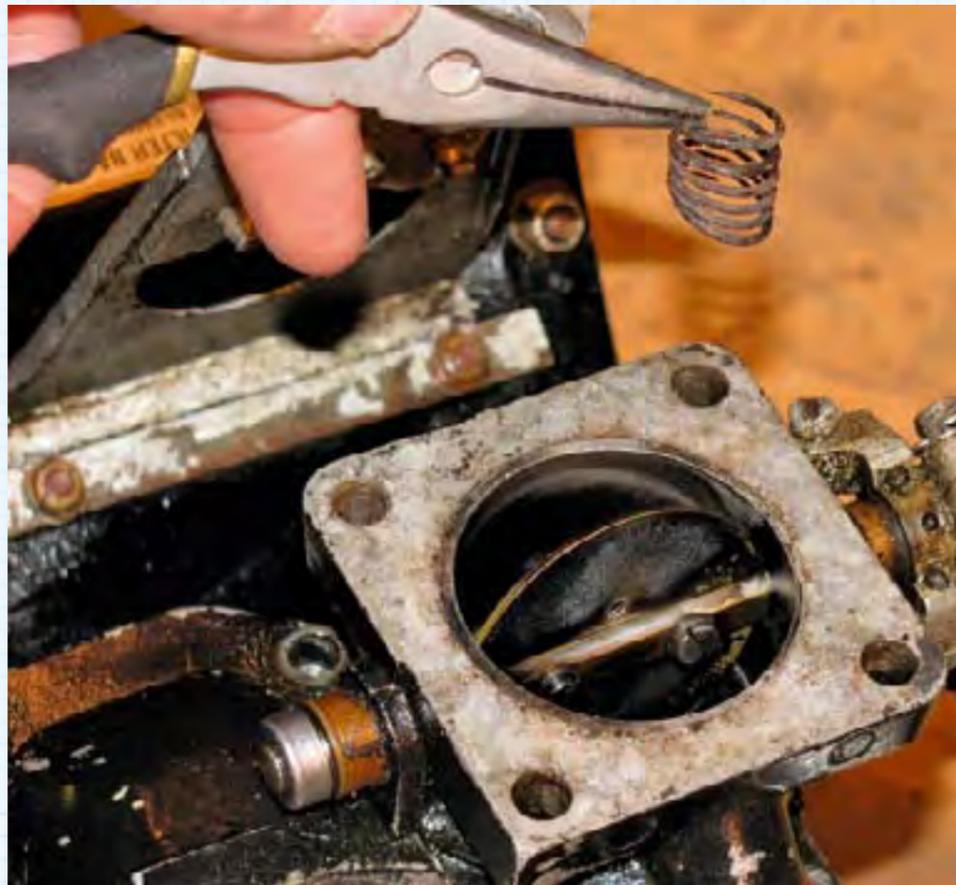
After Alan James had a partial engine failure overhead White Waltham he checked all the usual likely culprits – fuel system, ignition system – and he did a compression pull through. All A-OK. Finally, he took the carburettor off and found this spring jamming the butterfly valve, which had prevented it from fully opening. He had to scratch his head a bit to work out how this spring had found its way into the induction system then, before causing damage to his scalp, he remembered that he had taken a tip out of Tony Bingelis' excellent book *Firewall Forward* when he originally built the machine and the origin of the broken spring became clear. (Photo: Alan James)

'I finally got down to removing the carburettor last night and found, to my amazement, a rusty spring trapped between the top of the main jet and the carburettor body. I was completely floored for a few moments until I realised what it was.

'I have always had long springs wrapped around the exhaust pipe under the hot air shroud to increase the temperature - as copied from Tony Bingelis' book *Firewall Forward* - and one of them had broken up into several pieces.

I found more parts of the same spring rattling around in the casing. I have now removed all the springs and funnily enough, I still have the same rpm drop when selecting hot air, so they are probably not necessary.

'It was just luck that the broken spring didn't get past the venturi and get ingested, otherwise it could have been very nasty and quite expensive! If anyone else has something similar, best check it out or chuck it out.

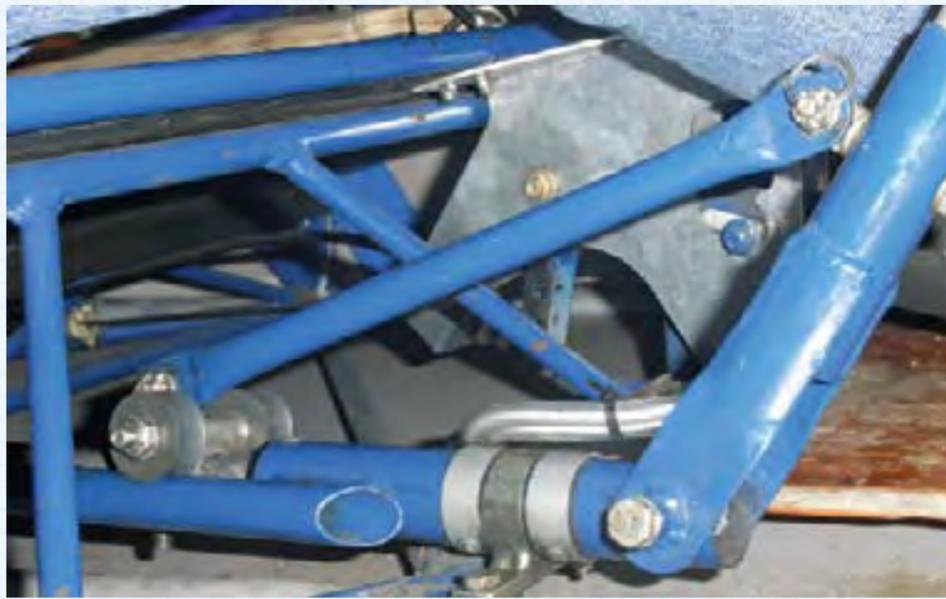
Here is a picture of the general installation of the control stick on Tim's Rans S-10; the rollers have been refitted correctly and no longer restrict the up elevator movement. (Photo: Tim Wood)

'I refitted the control tube assembly to the aircraft with the rollers forward of the drive pin and checked the elevator range and this now matches that defined in the build manual. I am confident that the sleeve was indeed incorrectly fitted.

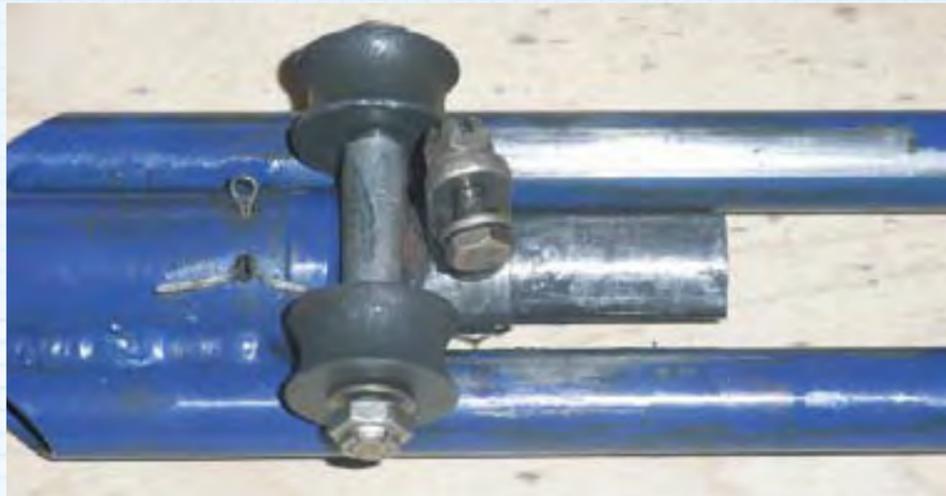
Right or wrong? (1) This picture shows the modified control system well... the only problem is that the roller assembly has been fitted the wrong way round. As fitted, up elevator movement has been severely restricted. (Photo: Tim Wood)

'It is obvious from the wear marks on the side tubes that the roller assembly has been fitted in this orientation for quite some time, although simulating the extremes of elevator control motion quickly showed that whilst the 'down' stop is not impacted by the addition of the sleeve and roller assembly, the 'up' stop is. With the sleeve as fitted the 'up' elevator stop occurred around 10-15mm before the point that would have occurred if set by the drive pin.

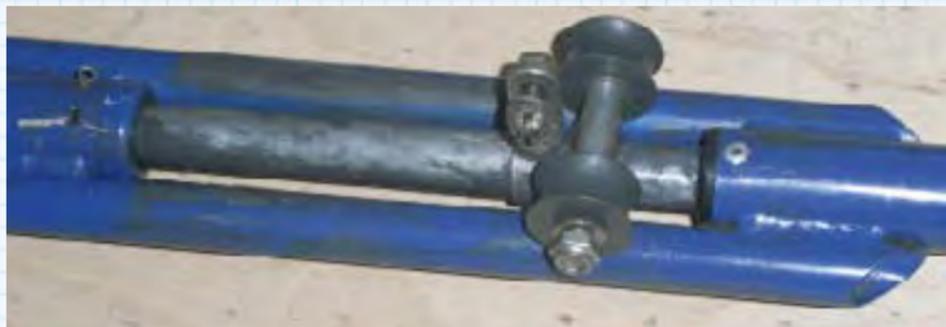
Right or wrong? (2) Here the rollers are the right side of the lower link attachment. This sort of information is often lost to history; it certainly took me a long time to work out what was actually going on. Very well done to Tim Wood (and, of course, Tony Hewitt) for getting to the bottom of this problem. (Photo: Tim Wood)

'It is immediately obvious that, by reassembling the sleeve and rollers such that the rollers are forward of the drive pin (rather than aft of the pin), that the sleeve would have minimal impact on the 'up' stop. Indeed, on reassembling in this manner and checking the control movement, it can be seen that the 'down' stop is unchanged.

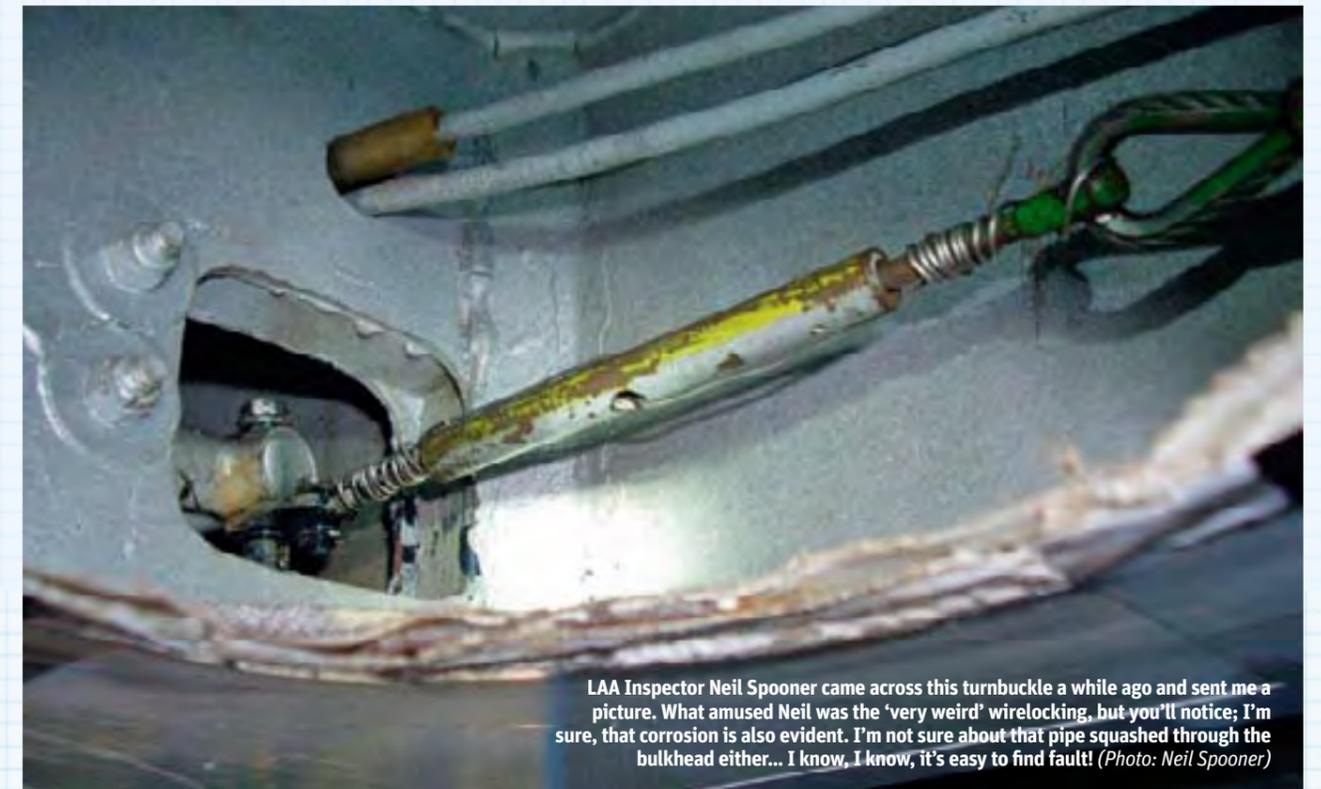
LAA Inspector Neil Spooner came across this turnbuckle a while ago and sent me a picture. What amused Neil was the 'very weird' wirelocking, but you'll notice; I'm sure, that corrosion is also evident. I'm not sure about that pipe squashed through the bulkhead either... I know, I know, it's easy to find fault! (Photo: Neil Spooner)
