SAFETY SPOT

PIPER TAILDRAGGERS

— CRACKING & CORROSION

CRACKING AND CORROSION DEMAND TAIL STRUCTURE INSPECTIONS,
WHILE UNLATCHED DOORS, NOTABLY GULL-WING, PRESENT PROBLEMS

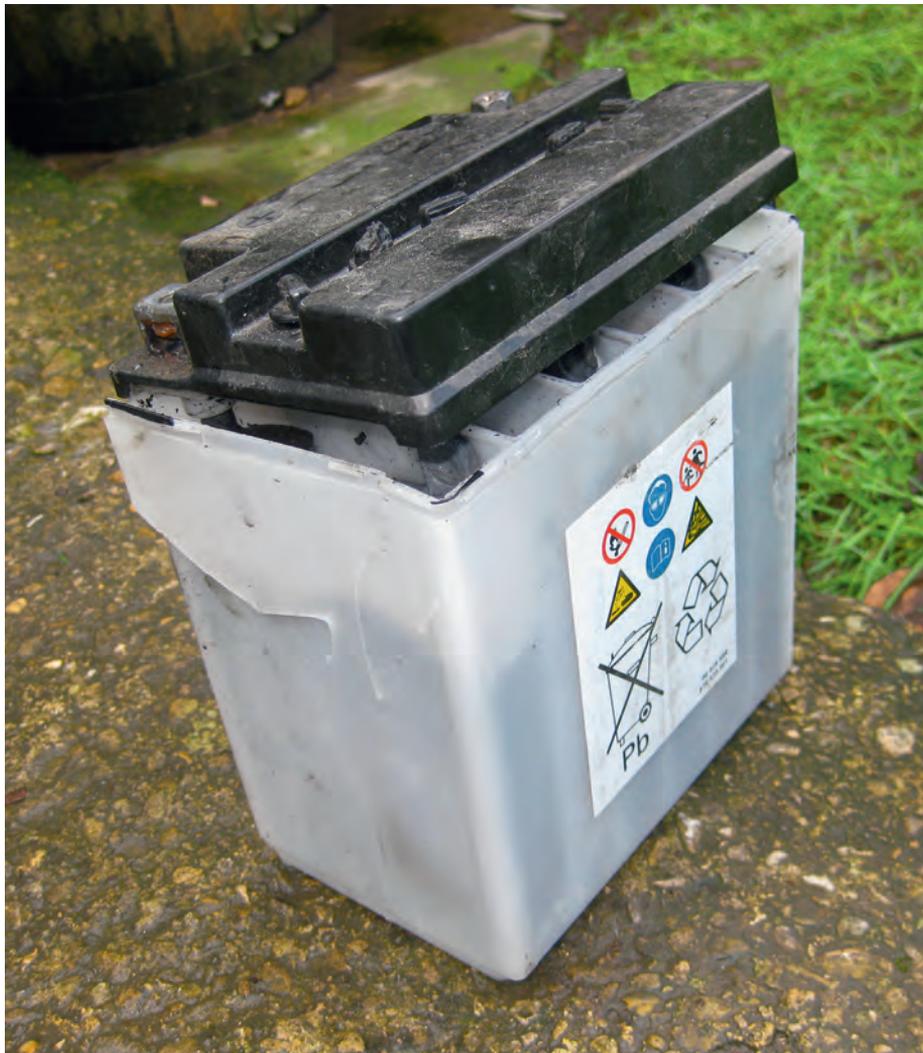
I was reminded of a couple of safety lessons the other day which are worth passing on... actually, a rather sore patch on my upper thigh caused by the resulting splash of sulphuric acid throbs a message, 'You are a twit, you are a twit.' Lesson one, naturally, is that you shouldn't bring a battery into service straight after disconnection from a battery charger, even if you are in a terrible rush (see accompanying text!). Why? Well, there's an explosion risk due to the possible build-up of hydrogen gas. Lesson two, if you know something important is failing (this battery has been dodgy for a couple of months) then change it, you never know when circumstances will conspire together such that you really need it. I really did need to change my underwear when this battery exploded under the seat of my motorcycle! (Photo: Malcolm McBride)

You will see from the picture that my tale of woe continued and that I have ended up having to buy two batteries (and a new pair of jeans), one I didn't really need and one I should have bought ages ago. The explosion was due to two things, one, demanding a large current from a battery that had just come off the charger... a lesson, incidentally, worth remembering when you bring your aircraft back into service after the winter lay-up. The second, well, rather embarrassingly, I've known that this battery has been on its last legs for some time.

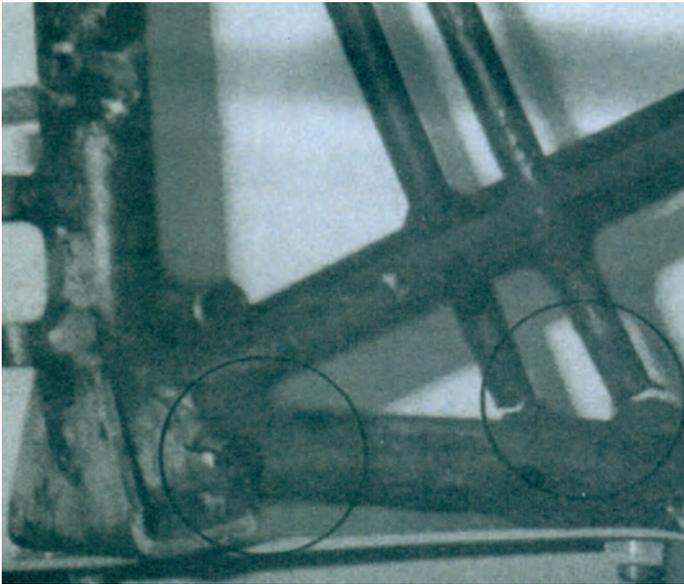
This rather grainy picture shows cracks found in the structure of a PA-15 (Vagabond) after the fabric was removed. I have spoken to a number of specialists in tube repairs and they tell me that the real problems generally occur in the bottom longerons. This area of the fuselage, as I'm sure that you will be aware, on all taildragger types suffers the compound problems of being quite highly loaded, difficult to inspect and prone to corrosion.

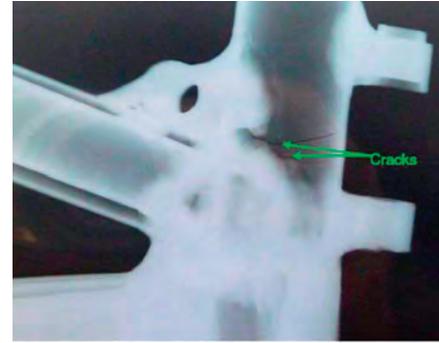
One way of seeing through fabric is to have a specialist NDT firm X-Ray the rear fuselage. This picture shows cracking that would otherwise have been missed until the Fin Post finally gave way, possibly jamming the rudder. (Photo: LAA Library)

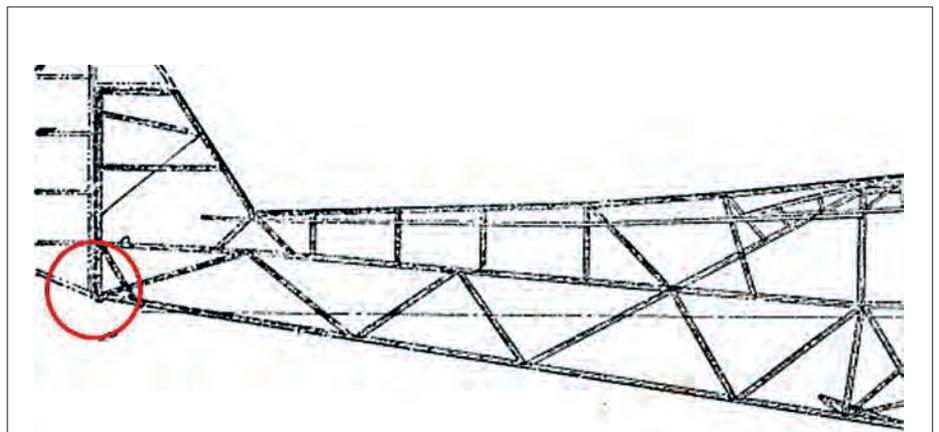
Here is a general arrangement of the tubular structure found on most Piper taildraggers. FAA SAIB CE-13-14 recommends that, within 100 hours, the area ringed red is thoroughly checked for cracking and corrosion. The recommendation is that this check is subsequently done every 1,000 hours but perhaps this hours-based advice may not be the best approach to creating a Tailored Maintenance Schedule on an LAA machine.

If you are the owner of a Piper taildragger, you will have recently received an LAA Safety Alert advising that you check the area at the rear of the fuselage for corrosion and cracking within the next one hundred hours and then, subsequently each 1,000 hours. Our current Piper owners account for some 150 airframes. I have featured this item in 'Safety Spot' both because we know that there are a similar number of Piper airframes in the UK not currently showing up on our radar, possibly undergoing long-term rebuild, and that the advice given in this Alert would sensibly apply to many other types of LAA machine.

We first got to hear that this issue, known about for many years, had resurfaced after a diligent LAA member sent us FAA Special Airworthiness Information Bulletin (FAA SAIB CE-13-14). I contacted the investigator in charge at the FAA and, whilst he had decided that the recommendations of the bulletin were important, they didn't warrant an Airworthiness Directive. I think that the reason for this decision is that the likely failure mode would only result in loss of tailwheel authority and not loss of the fin or tailplane. Not that the loss of tailwheel authority should be treated lightly of course as, under the right circumstances, a failure here could lead to an accident and possible injury.

Engineers know that this area on any taildragger can be problematic; firstly, it's often really difficult to inspect thoroughly without taking skins off. In the case of Piper types of course, these skins are fabric and removal should be fairly straightforward, but, in reality, it can still be quite a big deal pulling otherwise perfectly serviceable covering off the airframe to get a good look at the structure underneath and so, year after year, this important area of the structure can get overlooked.

The second reason why this area can throw up problems is that it's quite highly loaded, especially in the area that supports the tailwheel, and this can lead to fatigue cracking and subsequent structural failure. Thirdly, just because it is often the lowest point on the airframe, moisture tends to collect here so this area can be very prone to corrosion.

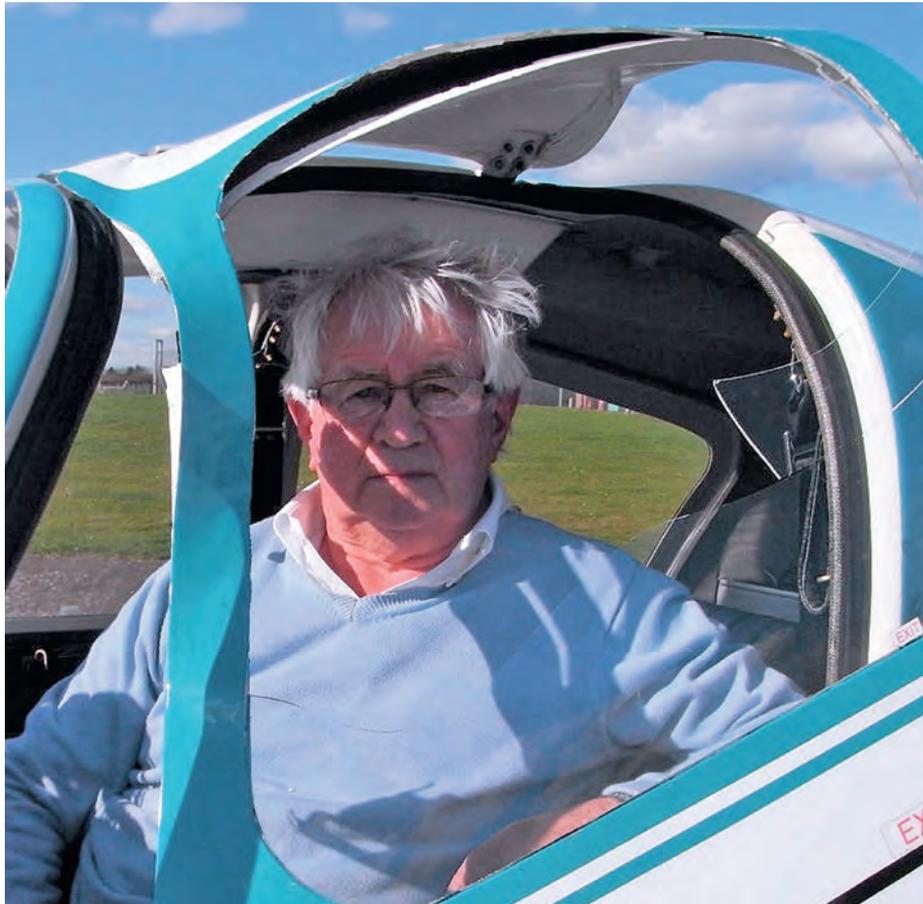
You can see from this picture that this Wassmer WA52 door is going to need some specialist help before it enters service again. Well done to the, from the picture at least, quite disgruntled pilot, LAA'er John Curtis, for dealing with the in-flight emergency such that there was no further harm done. This is not always the happy outcome when a canopy or door fails for some reason in flight. Major issues subsequent to a door failure can include: serious environmental changes in the cockpit; distraction, loss of aerodynamic control; and a significant loss of performance. These are all very good reasons not to forget to physically check that the door is closed and latched before flight. (Photo: John Curtis)

Well done to John for sorting things out by the book and, subsequently, a repair schedule was agreed and the door fixed by composite specialist and LAA Inspector, Tim Dews. Naturally, we asked Tim to try to establish why the Perspex windscreen had suddenly broken and whether this structural deficit could have led to the door opening. Tim couldn't find anything amiss with the door's latching mechanism and even though John was 'nearly' certain that the door was properly closed and locked before the flight it looks like the rear latching pin couldn't have been properly engaged before flight.

John and Tim Dews checked the broken door thoroughly after the event and couldn't find anything amiss with the hinges or locking mechanism, so it looks like the rear locking pin hadn't engaged correctly before flight and, as the door twisted, the Perspex was overloaded and shattered.

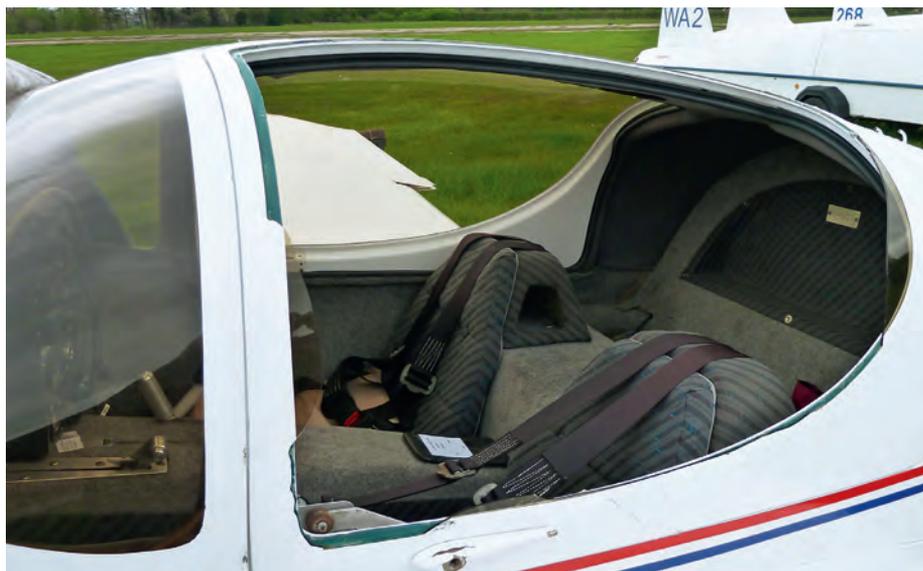
This is what happens (if you're lucky!) if you don't ensure that the rear pin is fully engaged on a Europa aircraft. If luck isn't on your side it is likely that you'll lose your door completely (which is not good for your image when you have to collect your lost property from the police station). To afford a sensible entry size and maximum visibility, the gull wing design on the Europa necessarily needs to be fairly short on structure for its size. These design constraints mean that the door is longitudinally quite easy to twist out of shape. Because the rear pin is behind the shoulder, it's easy to forget to check it before take off and if it isn't in place before flight, the door may fail. (Photo: Malcolm Gibson)

and explained, "We've seen a few problems with door failures on Europa aircraft and, in every case so far, it's because the rear locking pin hasn't engaged correctly." I asked whether the mechanism designed to drive the locking pin home was at fault and Andy said that he didn't think so. "The actual operating rods are quite short so there's not much chance of them bending; of course, if they're not set-up correctly then there is the possibility of the pin catching on the side of the door frame and the slack in the system taking the strain. The door would look closed and latched but wouldn't be."

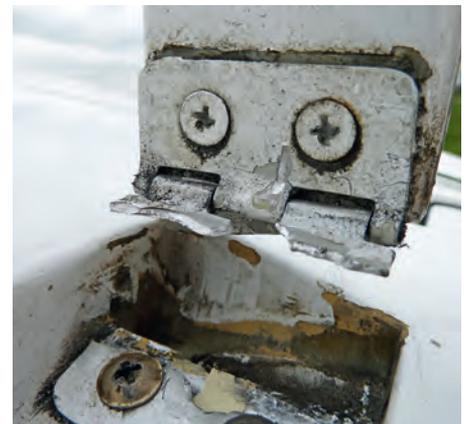
Here's Malcolm's broken door hinge, initially thought to be the cause of the door failure but, later, part of the after-shock. (Photo: Malcolm Gibson)

Back on the ground, I had a look at the rear hinge, which had broken in the incident. The break is across one face of the hinge. It is quite clean but the aluminium in the fracture looks dull and grainy, maybe that is indicative of existing stress cracking. There does not seem to have been any bending or twisting of the hinge, which you might expect from the force on it as it flew up, nor have any of the fastening screws pulled free. What I am starting to think is that the door may well have been correctly closed and latched, but at some point in the flight, the rear hinge actually failed, allowing the airflow to lift the rear part of the door. When I increased the speed I think the door may have lifted at the rear to such an extent that it was causing enough drag to prevent the level speed going above 120 knots and allowed the rear shoot bolt to come out of its locating hole.

I wrote back to Malcolm letting him know Andy's thoughts and my impression that the failure face in the hinge looked to me more like an overload incident than something that had occurred over a long time. Malcolm wrote back as follows.

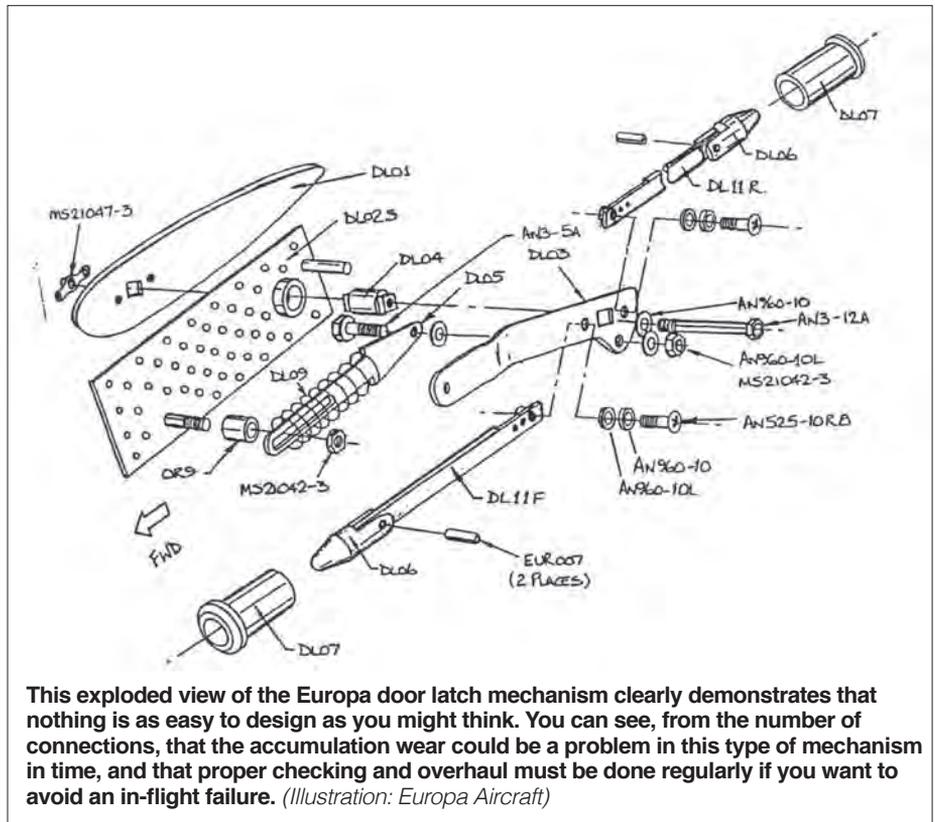
This exploded view of the Europa door latch mechanism clearly demonstrates that nothing is as easy to design as you might think. You can see, from the number of connections, that the accumulation wear could be a problem in this type of mechanism in time, and that proper checking and overhaul must be done regularly if you want to avoid an in-flight failure. (Illustration: Europa Aircraft)

If you recall, the doors on the Europa are hinged at the top, with a gas strut to hold them up, and a forward and aft shoot-bolt operated on a single lever, which, when closed, is behind a protective plate to prevent inadvertent opening. This event is not unheard of according to Neil France, my Inspector, but usually occurs when the rear shoot-bolt has not engaged in its socket correctly. Thing is, it is pretty obvious when this happens, the rear of the door stands off from the recess and you can easily see the gap.

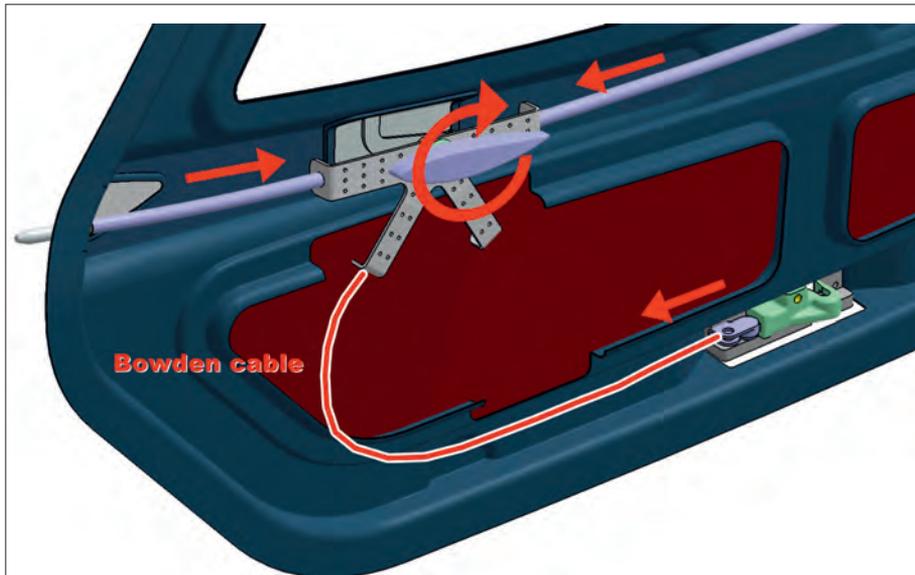
This picture shows the final Pioneer 400 bottom latch which was designed to prevent an inadvertent door opening. It is interesting that as VLA types get heavier (the Pioneer 400 is a four-seater), the design problems of the past come back to haunt modern designers and that the solutions that they come up with, in the end, are very similar to those from a different era! (Photo: Pioneer Aircraft)

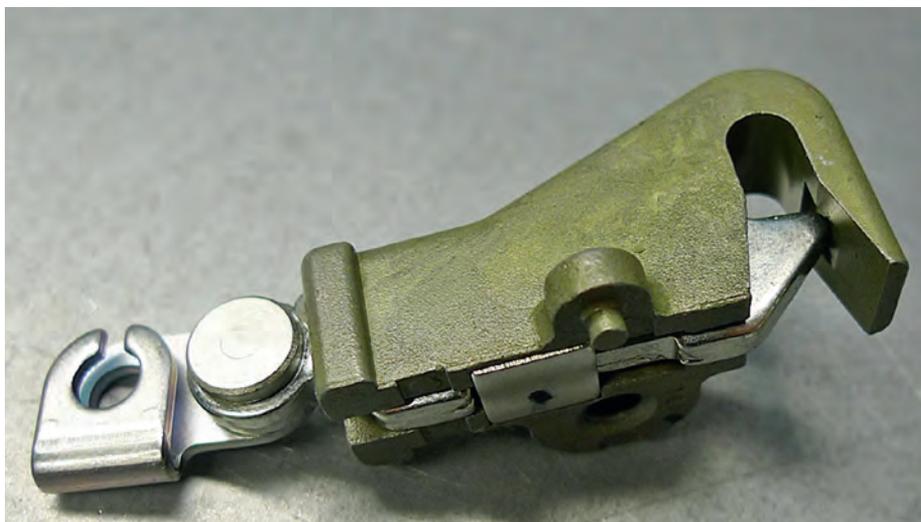
A fairly recent failure of a door on a prototype Pioneer 400 demonstrated the difficulty in designing a fail-safe latching mechanism into a relatively flexible structure. The original design was based upon the earlier, and very successful, Pioneer 300 system which employed, a bit like the Europa, a forward and aft pin. During the first UK test flight at maximum weight of this aircraft, the door came open during take off and the aircraft was seriously damaged. A subsequent investigation revealed that the pins weren't going into their sockets far enough and, with the aircraft at maximum weight, the fuselage movement was enough to release the pins. That's what prototype testing is all about! The manufacturers have since redesigned the door to increase the pin's 'throw' and to add a specially designed safety catch at the base of the door. This picture shows an early sketch of the idea. (Credit: Pioneer Aircraft)

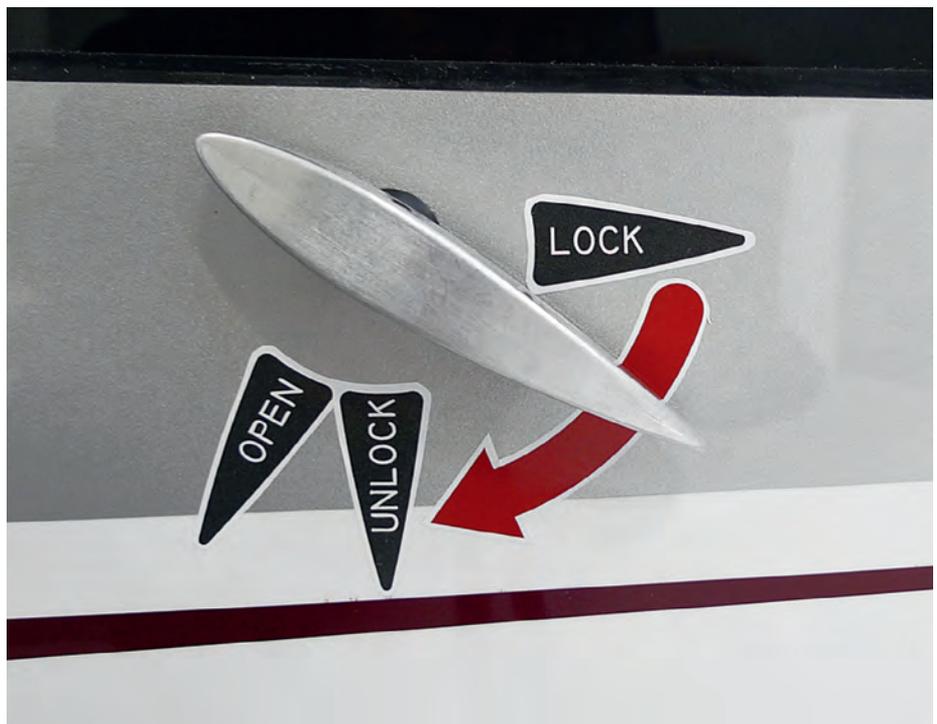
Here is a picture of the door handle from the Pioneer 400. Note that the first movement operates the door pins but, even in the unlocked position (as you might find if a pin failed to engage for some reason) the door wouldn't open until the bottom latch was released via the Bowden cable. A good safety feature if you ask me. (Photo: Pioneer Aircraft)

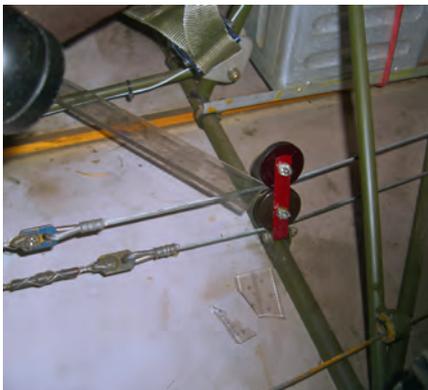
'Things that go 'bump' in the Flight.' One thing that can spoil your day is a control jam; LAA Inspector Peter Sturgeon sent me this picture and the following tale. Recently I embarked on a cross-country flight into Lincolnshire from my base in Suffolk. Using the most modern means of flight planning, i.e. a map (current issue), ruler, red maker pencil and stop watch, the plan was made. The flight outward was on Sunday 18 February and readers in East Anglia will remember this date because the sun shone on that day! This factor made both legs of the flight most enjoyable and it was easy to follow the red line on the map.

However, when nearing base on the return leg, power was reduced and the aircraft was pitched up slightly to reduce speed. Well, that's the theory, but it didn't happen as planned as, for a heart stopping moment, the elevator controls jammed! In these circumstances it is natural, after your heart picks up again, to apply more back pressure on the control column. In doing so there was a sudden snap, a freeing of the controls and, well, normal service was resumed.

After landing and some exploration under and behind the seats, the aforesaid ruler appeared, slightly the worse for wear. It just goes to show, make sure you know what you have in the cockpit inventory and that it is correctly stowed. In this instance it could have been an even bigger bump than the normal landings by this owner! (Photo: Peter Sturgeon)
